REMEDIAL ACTION REPORT
STEVENS PASS SKI AREA
SKYKOMISH, WASHINGTON

Prepared for
Stevens Pass Ski Area
December 8, 2011

Prepared by
SLR International Corp
22118 20th Avenue SE, Suite G-202
Bothell, Washington 98021

Project 101.00418.00005

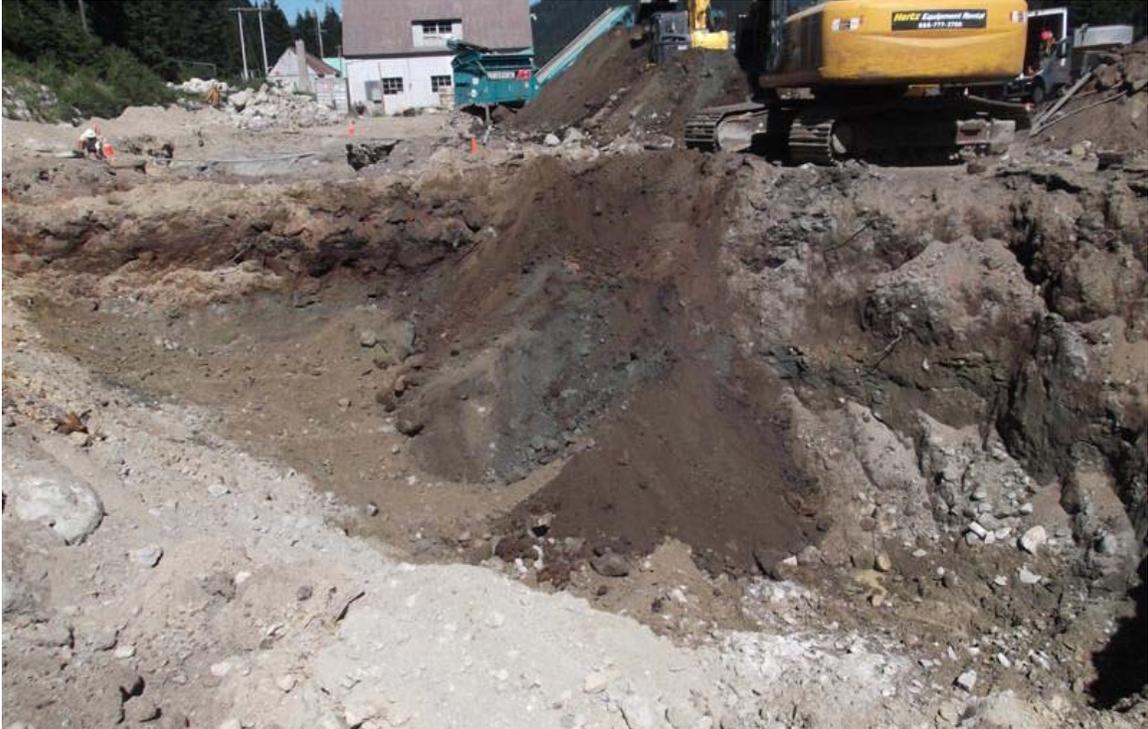
South to north view of southern part of southern Mini Mart area excavation.

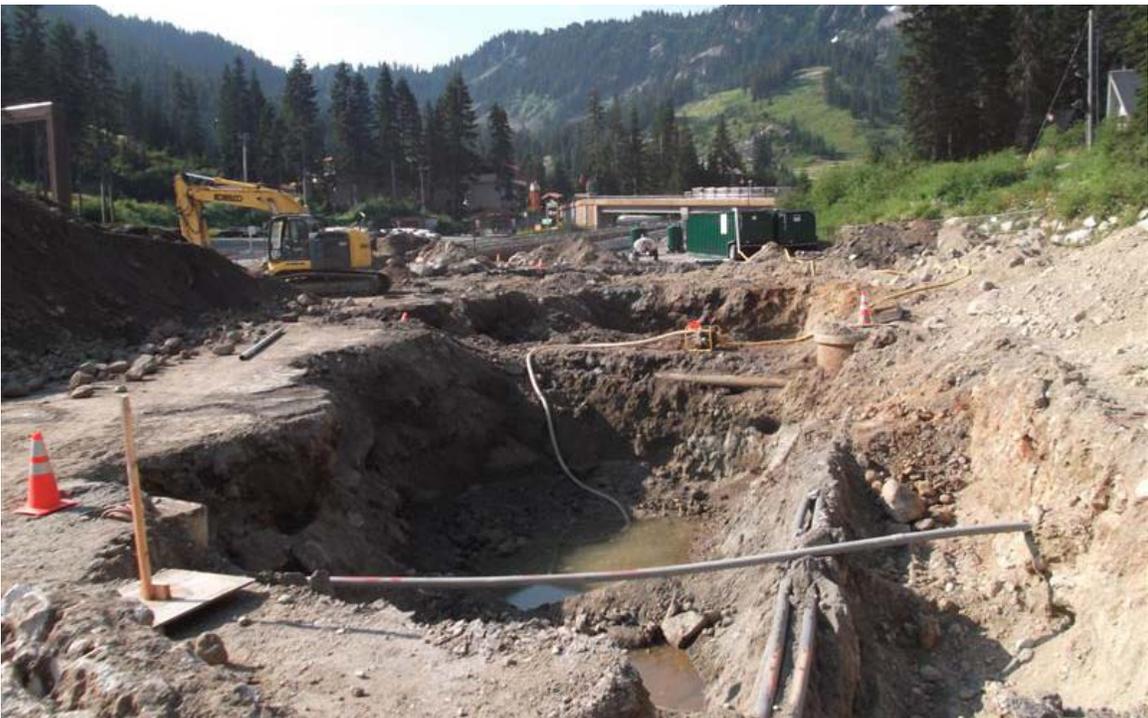
North to south view of southern Mini Mart area excavation after digging around several underground utilities. Groundwater extraction is being conducted at nearest excavation area.

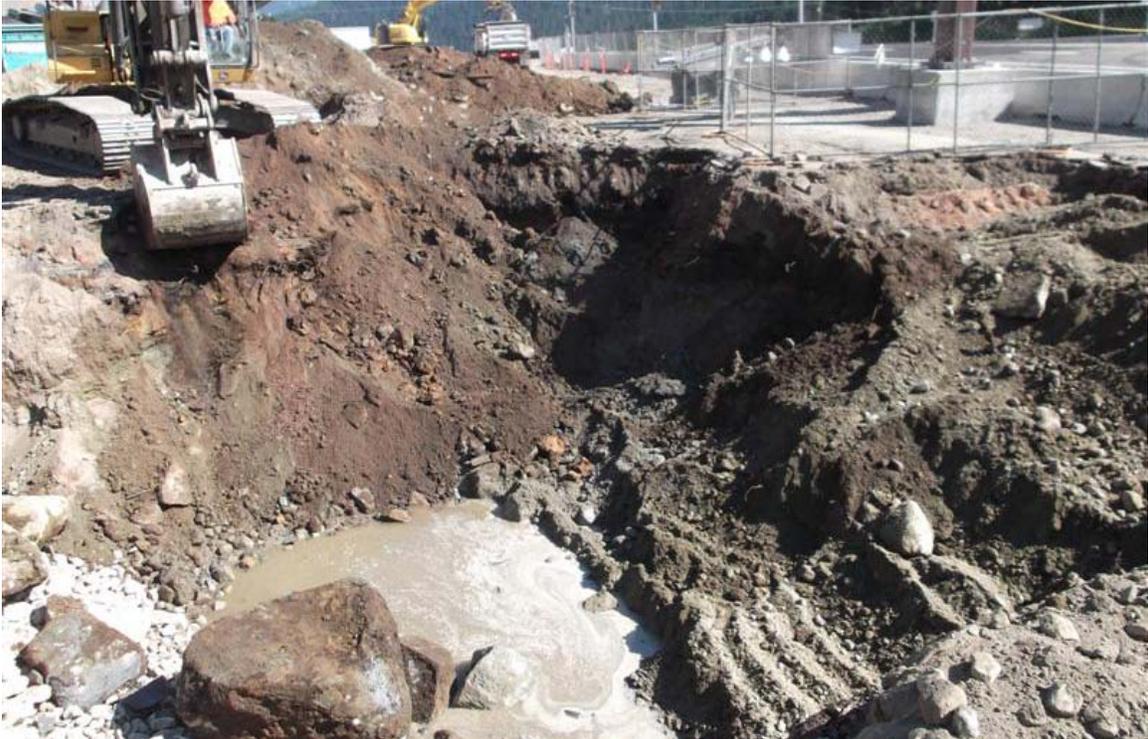
Southwest to northeast view of southeastern part of southern Mini Mart area excavation.

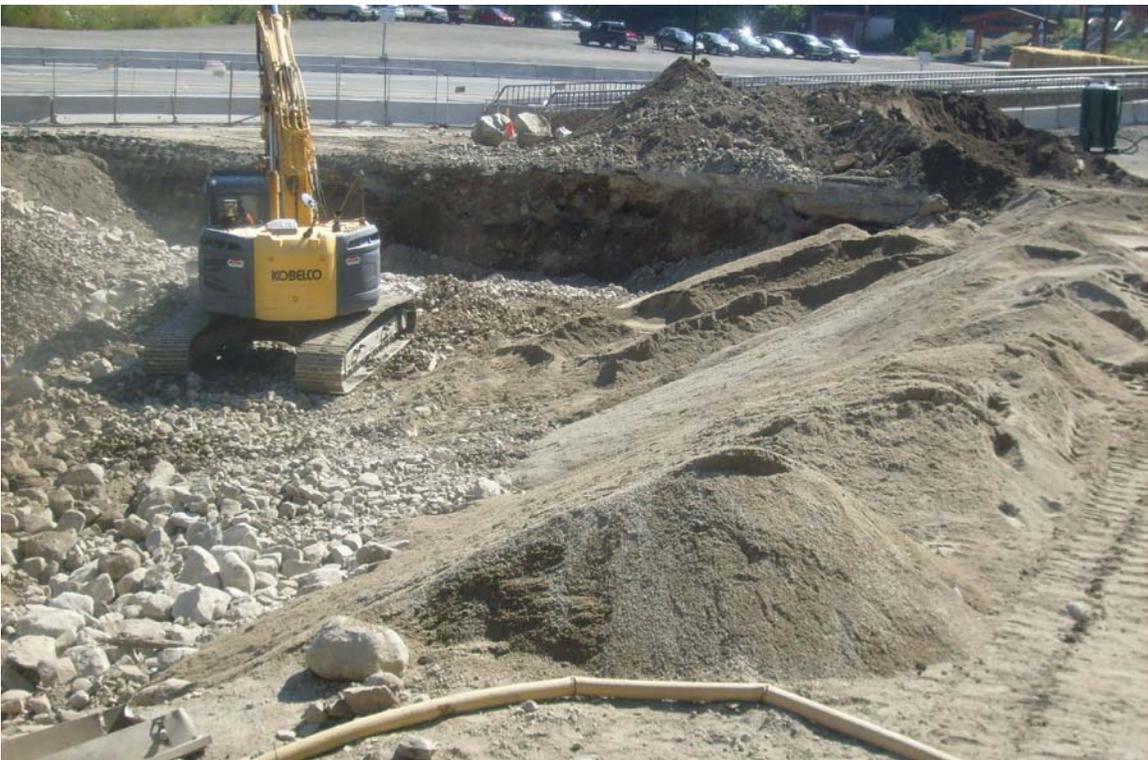
Northwest to southeast view of backfilling the southern part of the southern Mini Mart area excavation with cobbles and boulders.

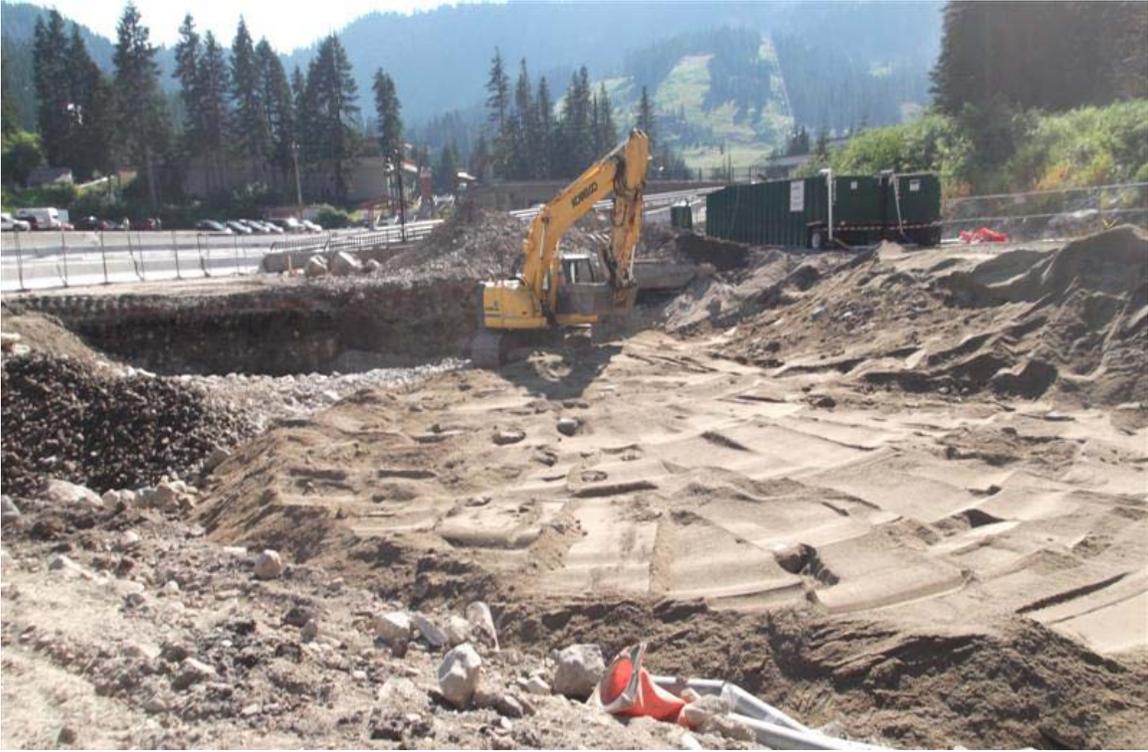
North to south view of backfilling of southern part of southern Mini Mart area excavation with finer-grained material.

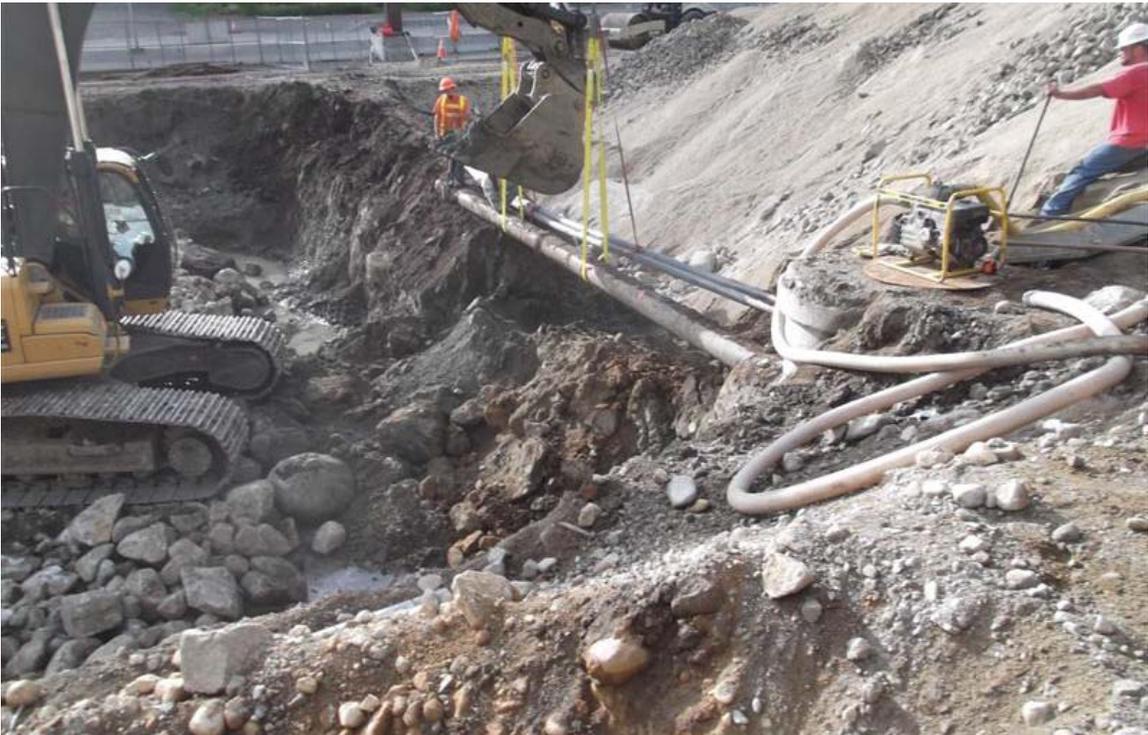
Northwest to southeast view of excavation of soil beneath a sewer line and electrical conduits.

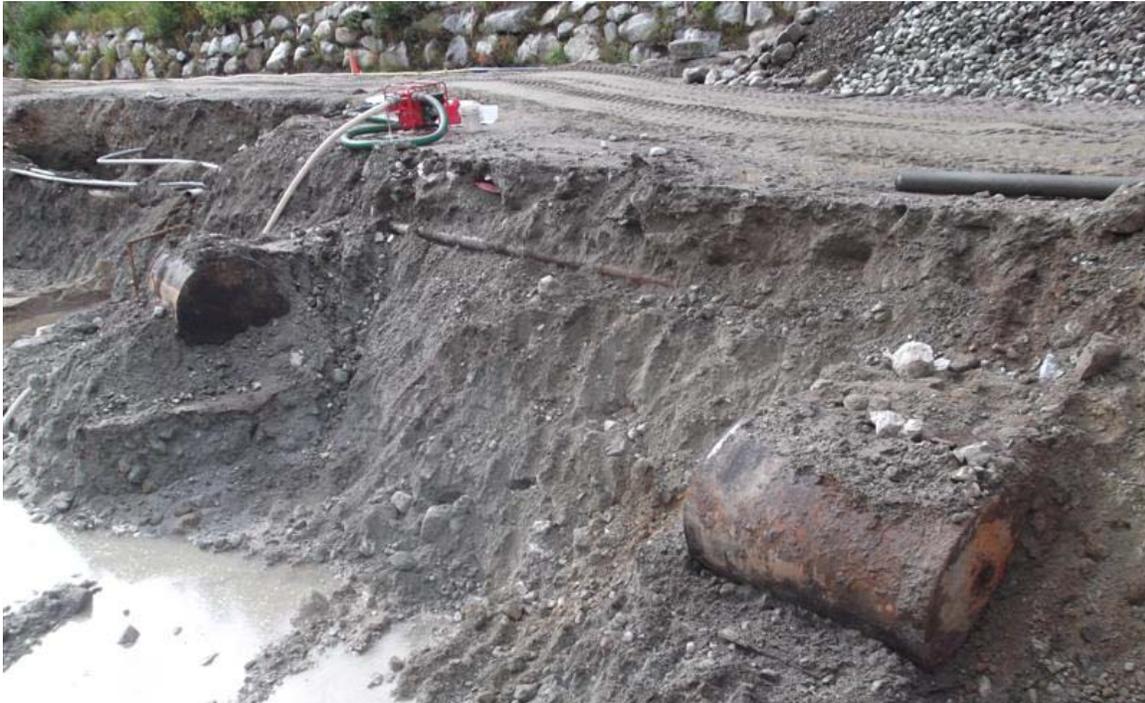
Northeast to southwest view of two 550-gallon USTs that were discovered in the northern part of the southern Mini Mart area excavation.

While excavating in the northwestern part of the excavation, behind the location of the former service station building, two 550-gallon USTs were discovered. Based on the presence of copper tubing coming out of each tank, the tanks were likely used to store heating oil. The steel tanks were in poor condition, and each tank contained pitting and holes. Each tank contained over 400 gallons of water, but no product. Prior to removal of each UST, the water from each tank was removed, and the tanks were rinsed by MarVac. The tanks were then inerted by Sound Testing. A total of approximately 1,000 gallons of water from the tanks were hauled to the MarVac facility in Seattle, Washington, for

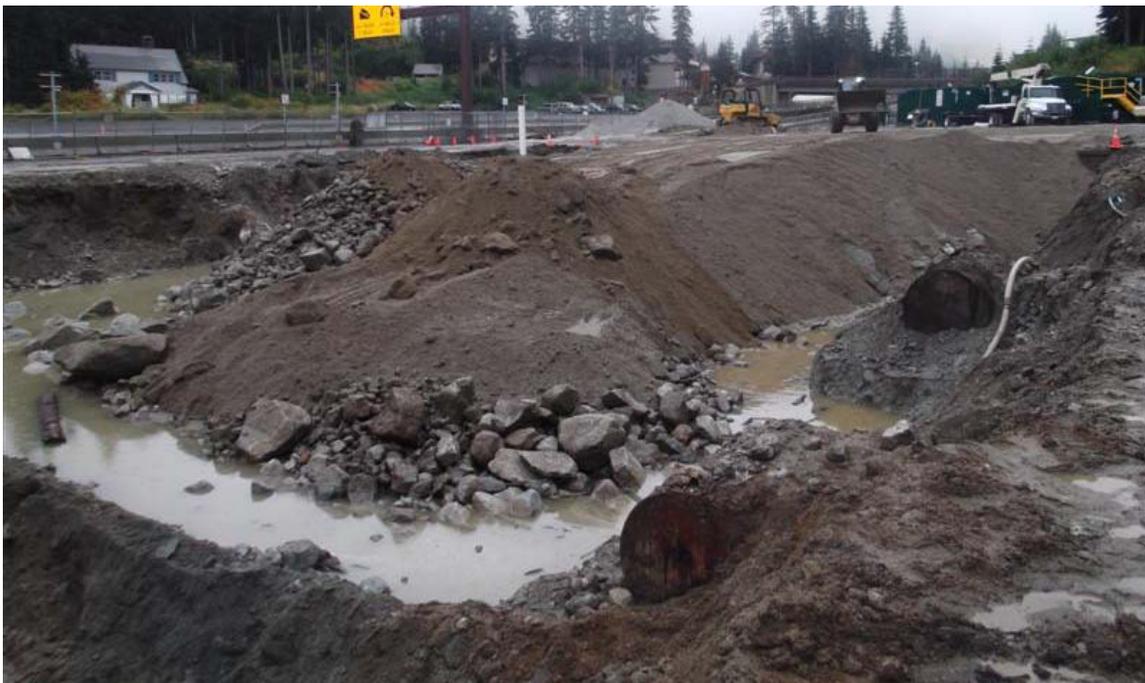
North to south view of northern part of southern Mini Mart area excavation. The central part of excavation is partially backfilled, and the 550-gallon USTs are on the right side of the photo.

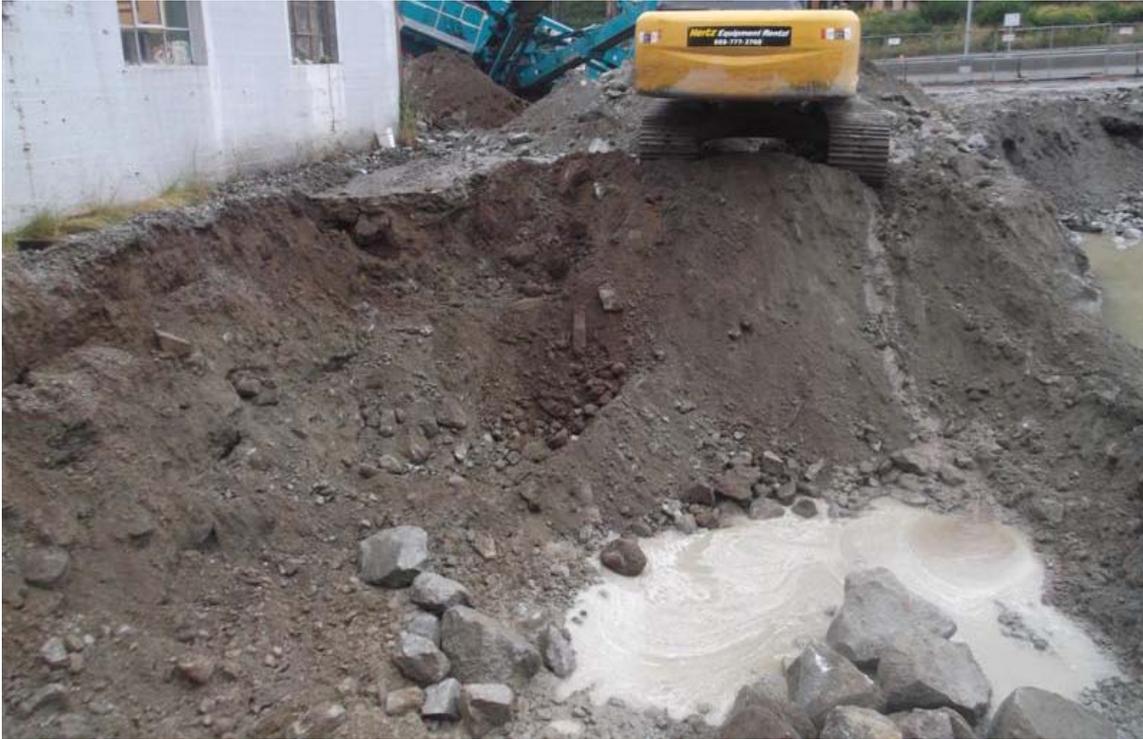
West to east view of northern end of southern Mini Mart area excavation, along the former maintenance building.

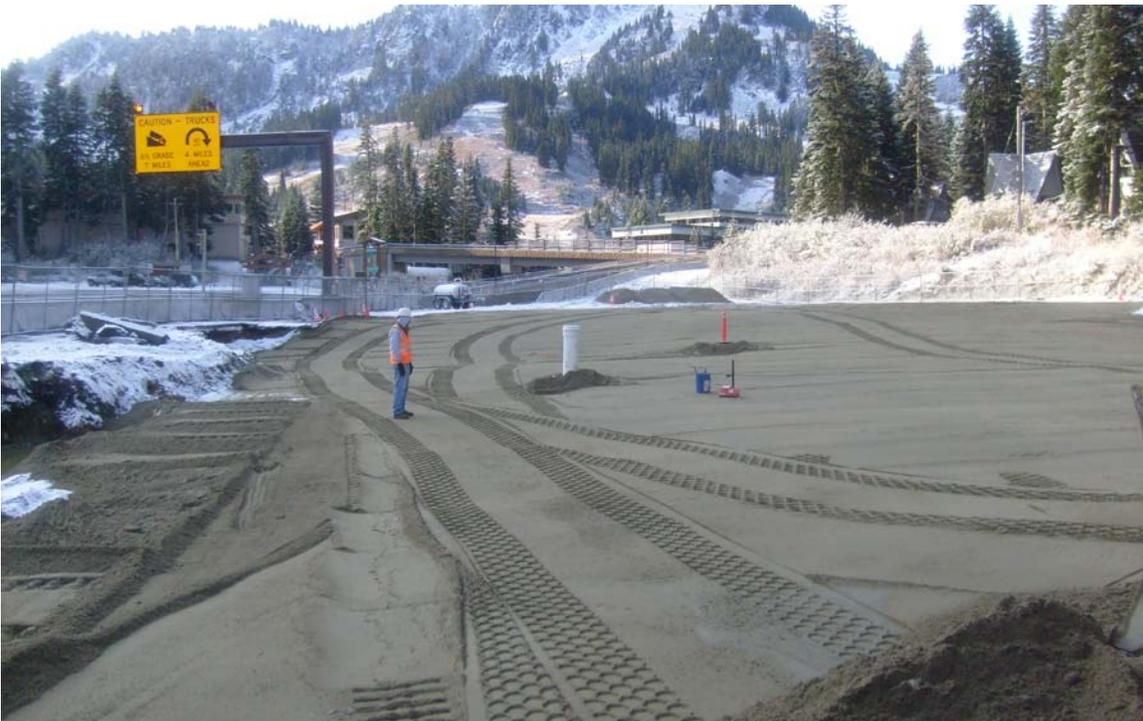
Northeast to southwest view of backfilling of southern Mini Mart area excavation. PVC pipe is for the installation of monitoring well SMW-4.

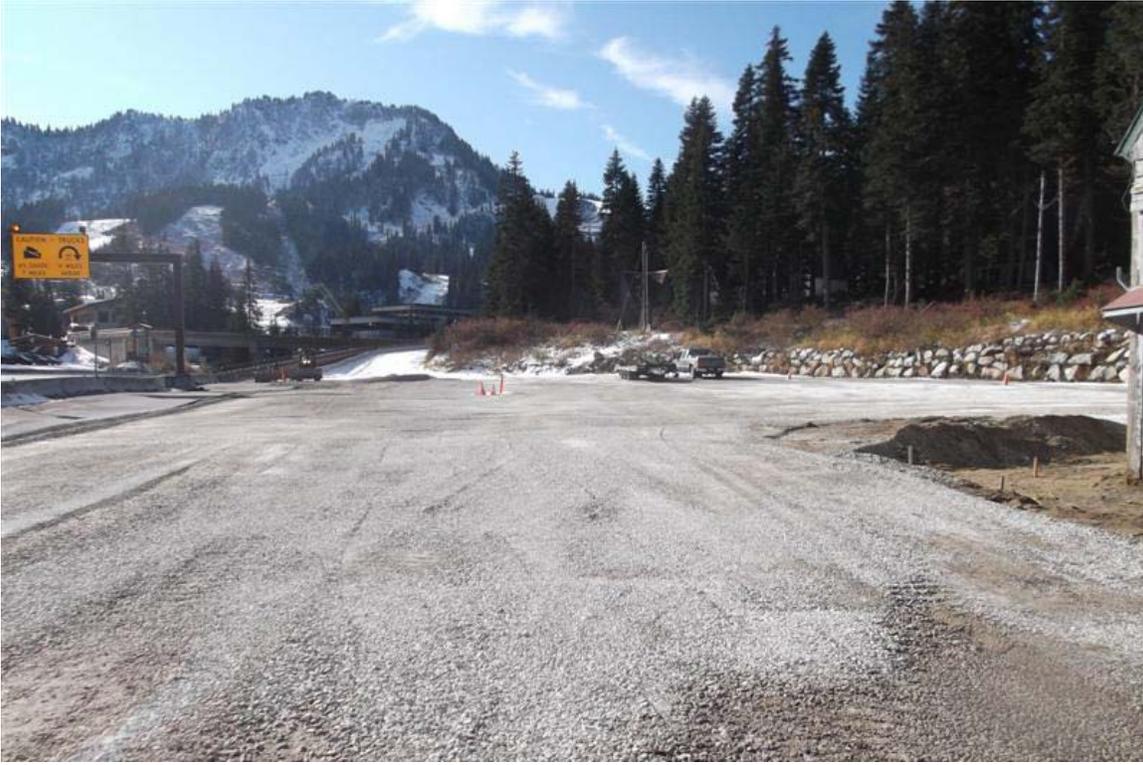
Northeast to southwest view of backfilled southern Mini Mart area excavation, prior to installation of concrete surface cap near south corner of former maintenance building.

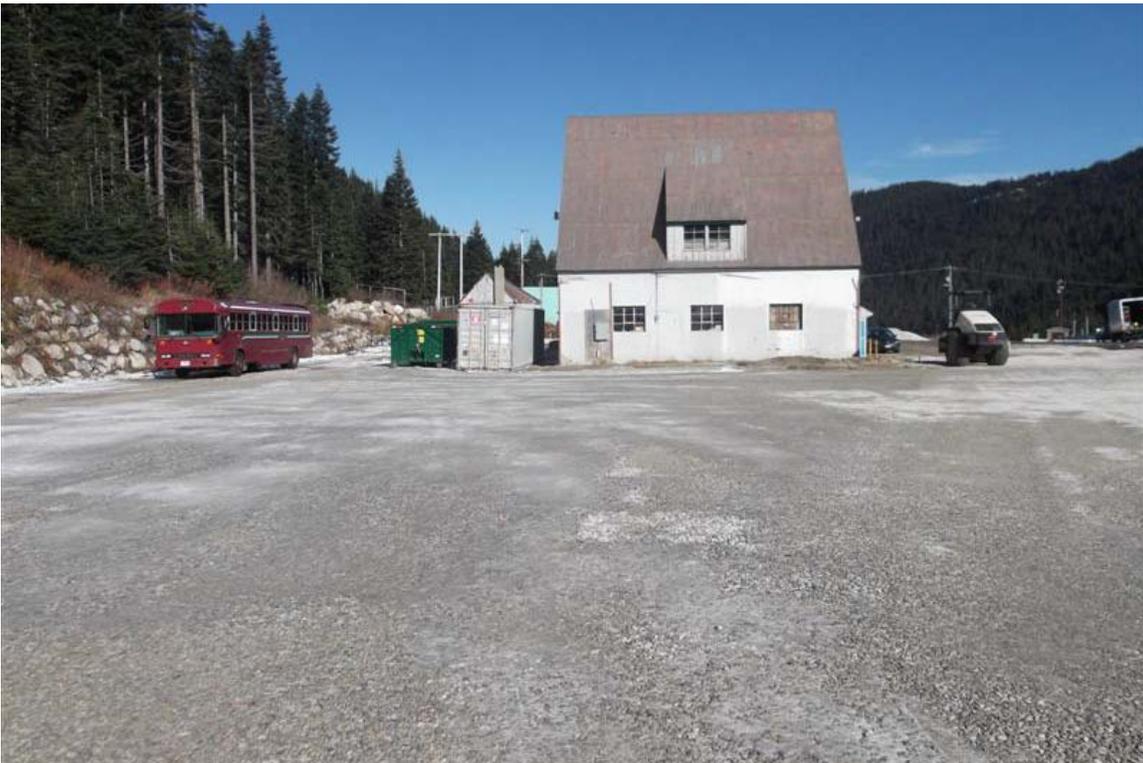
South to north view of backfilled southern Mini Mart area excavation.

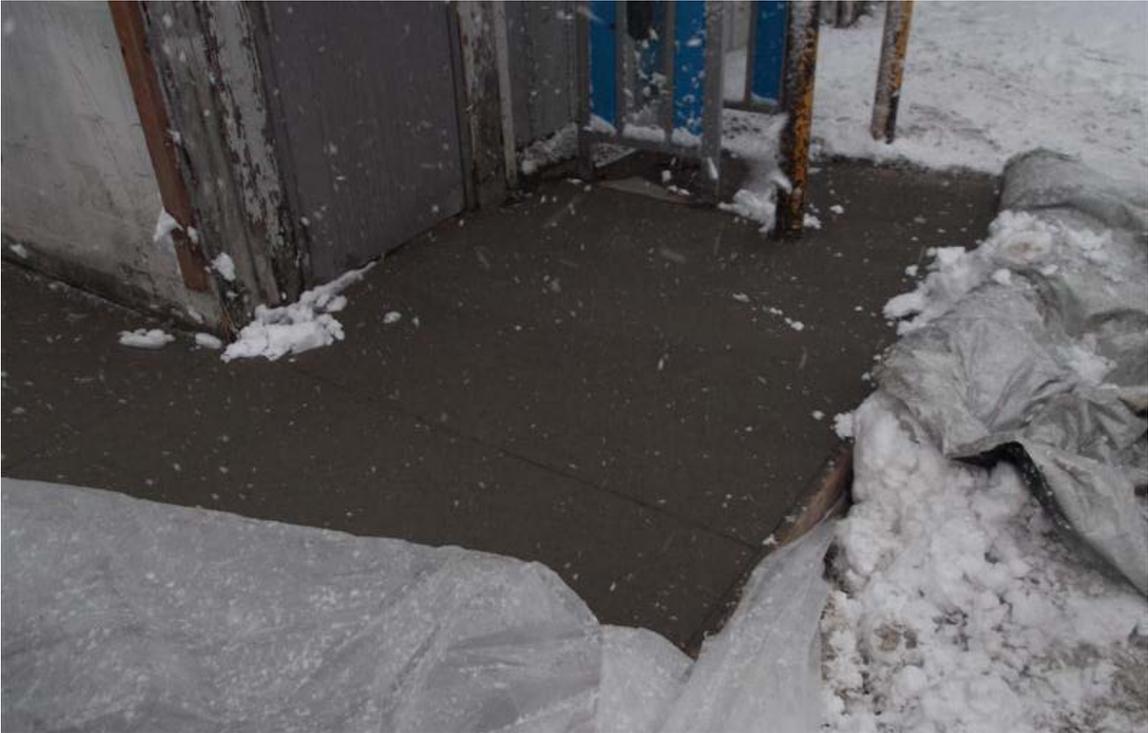
Eastern part of concrete surface cap near southeast corner of former maintenance building.

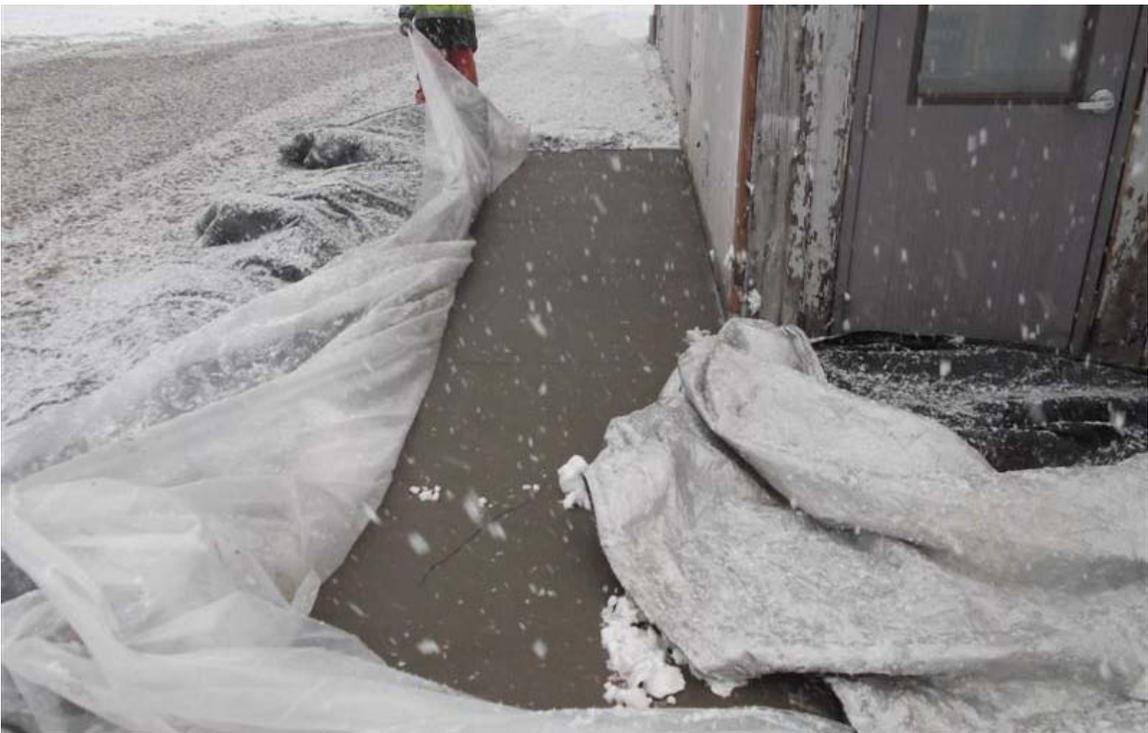
Western part of concrete surface cap near southeast corner of former maintenance building.

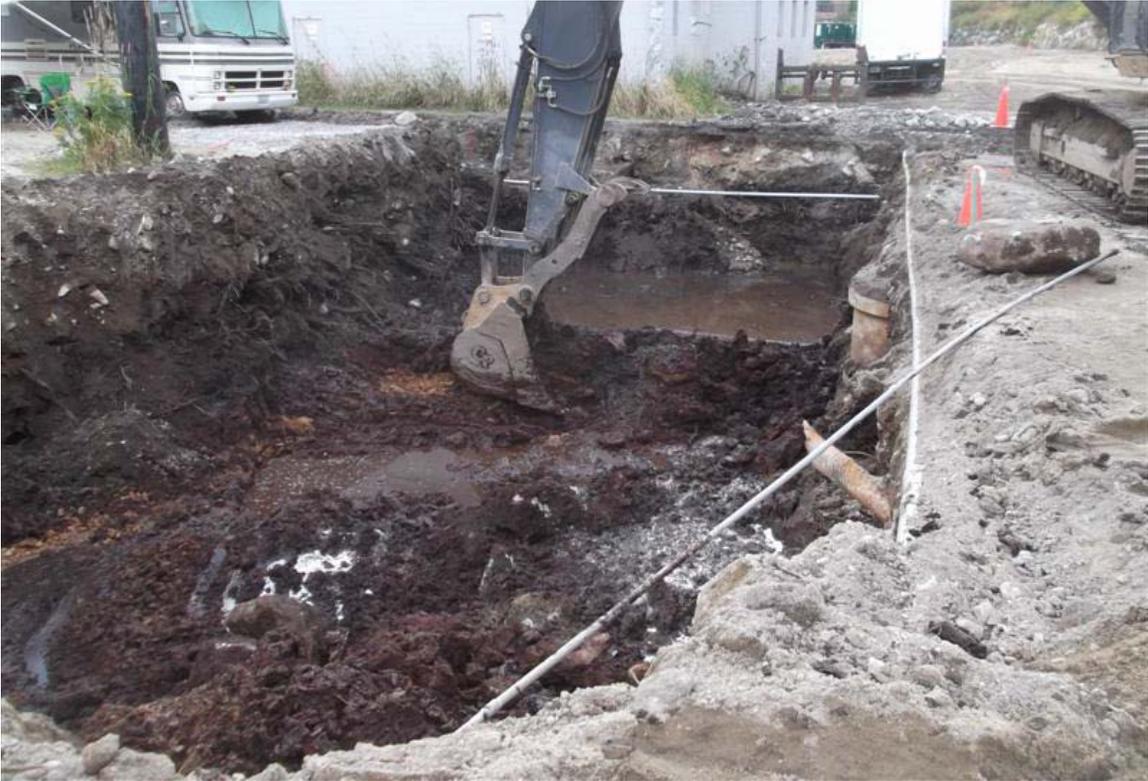
North to south view of northern and central portions of northern Mini Mart area excavation.

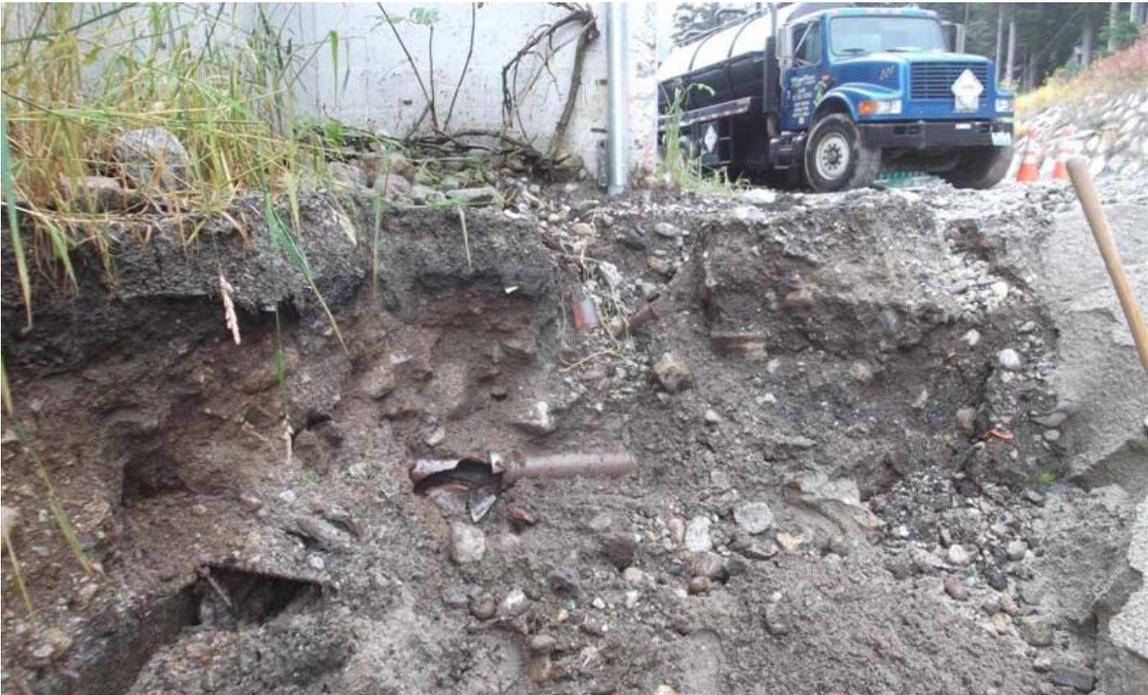
Northeast to southwest view of drain pipe that appeared to be the source of the impacted soil at the northern Mini Mart area excavation.

While excavating near the former maintenance building, a clay drain pipe was encountered and broken, resulting in oily water draining from the pipe. Wyser traced the pipe back to an inactive sump in the former garage portion of the building. The oily water was recovered and pumped through the groundwater treatment system, and Wyser filled the sump with concrete and capped the end of the drain pipe. The approximate locations of the former sump and drain pipe are shown on Figure 7.

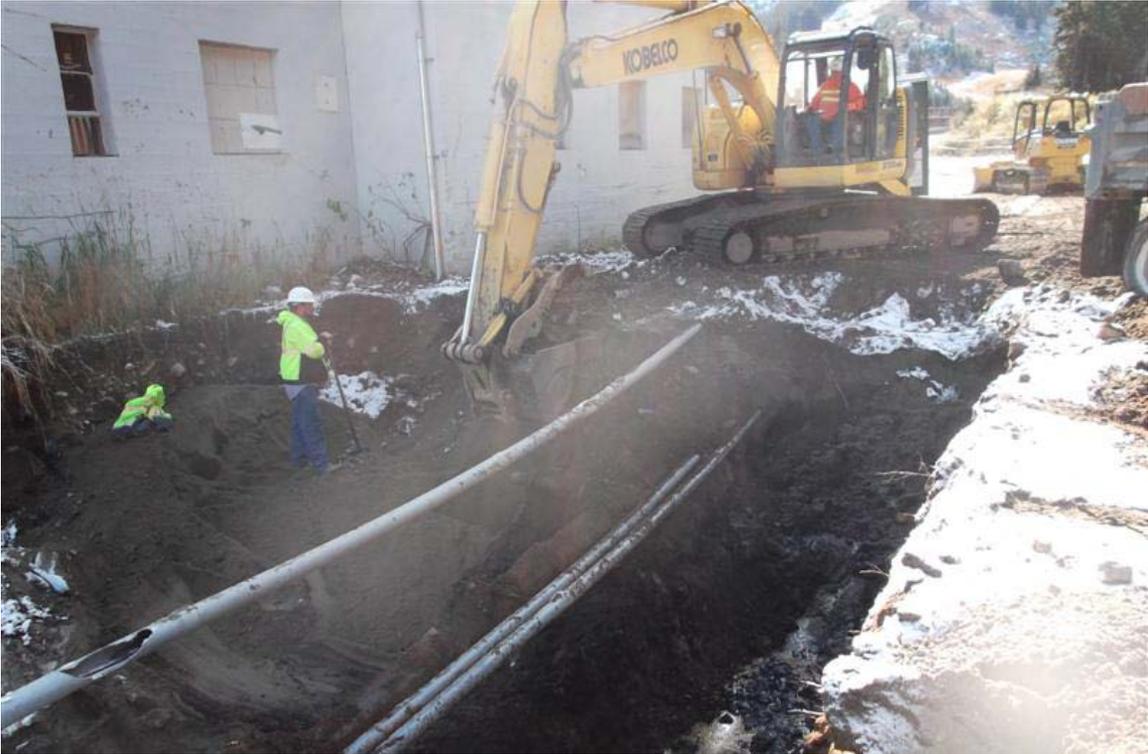
North to south view of southwestern part of northern Mini Mart area excavation.

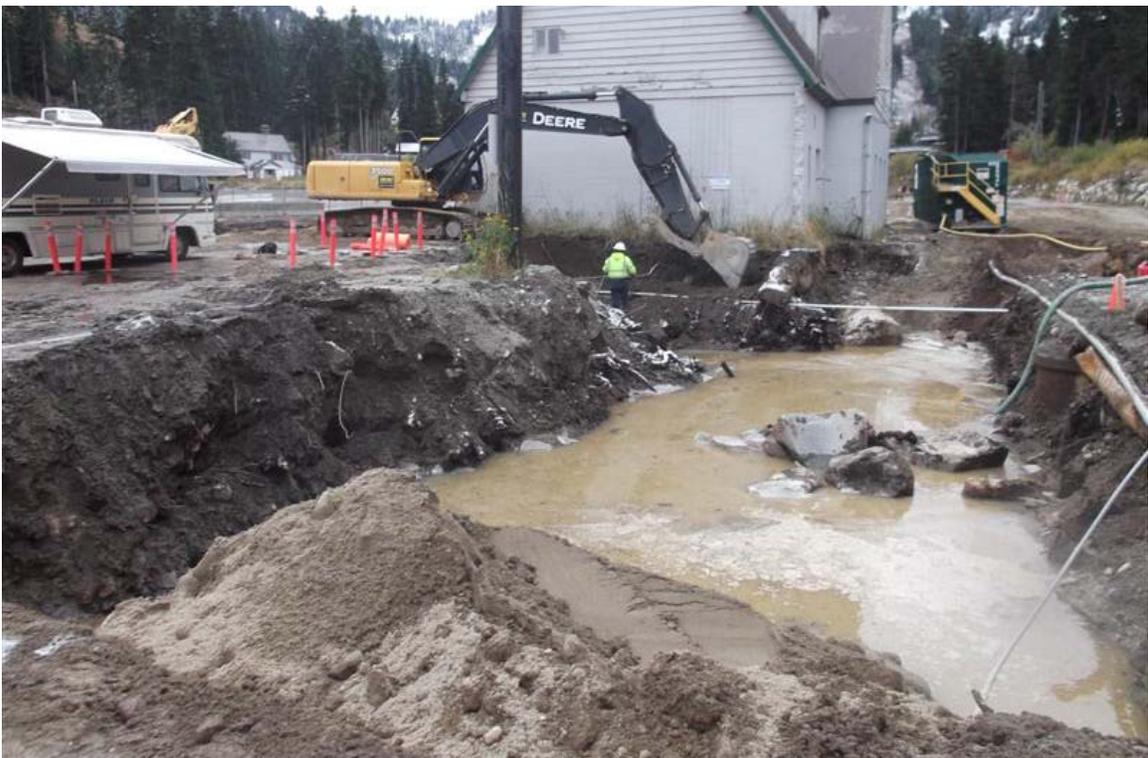
North to south view of groundwater extraction and initial backfilling in the northern part of the northern Mini Mart area excavation.

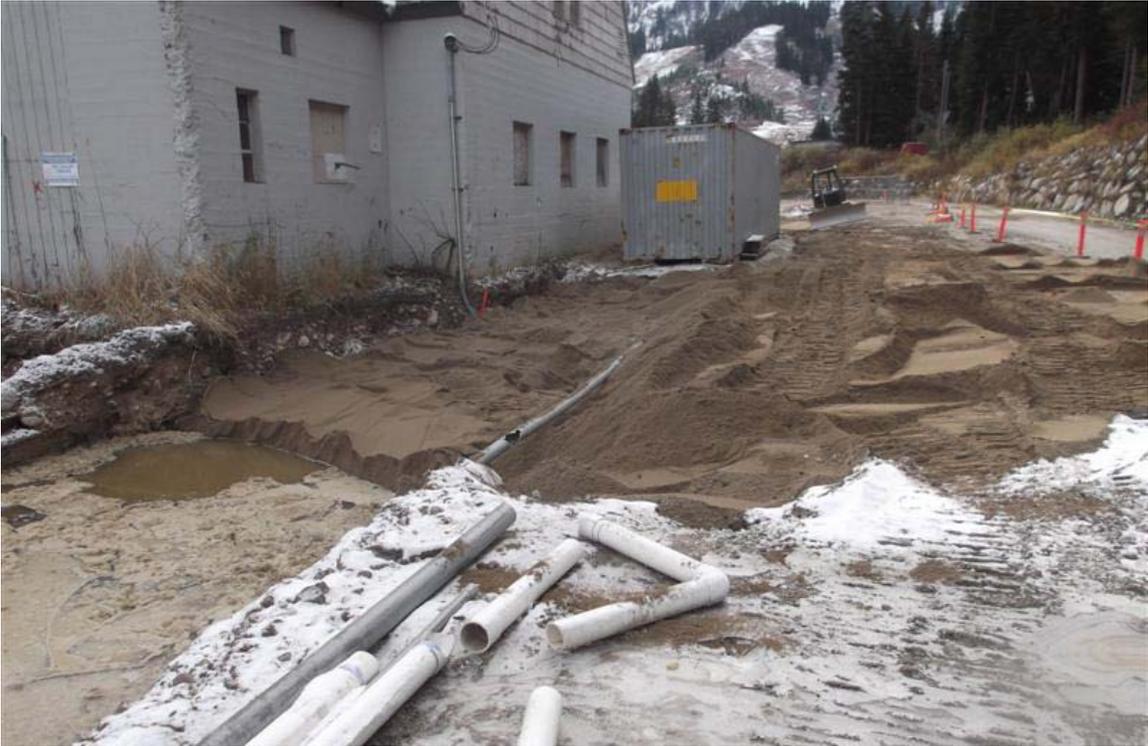
North to south view of backfilling of southwestern part of northern Mini Mart area excavation.

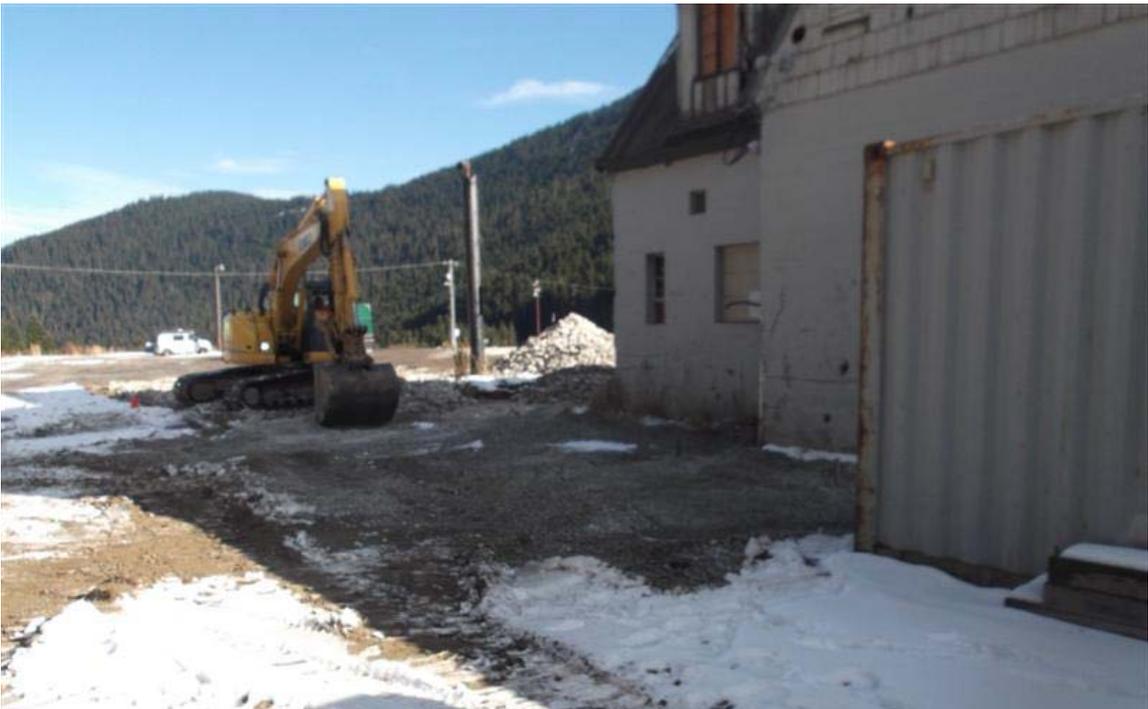
Southwest to northeast view of final backfilling of northern Mini Mart area excavation.

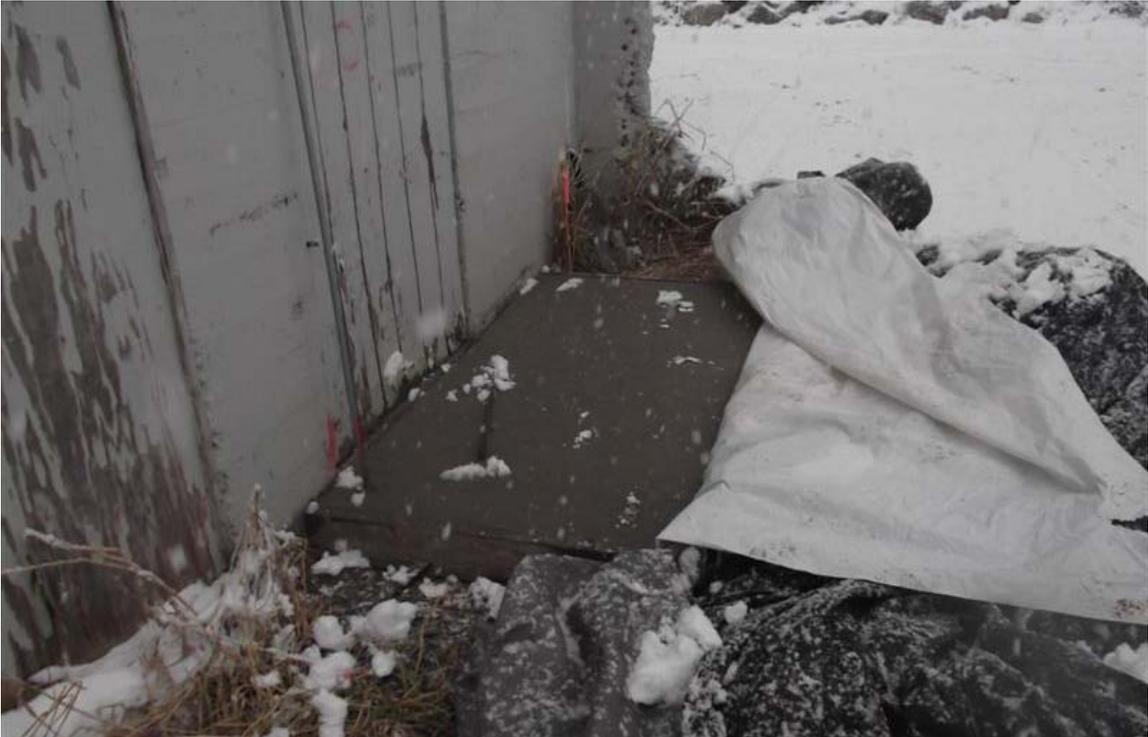
East to west view of concrete surface cap along northeast side of former maintenance building.

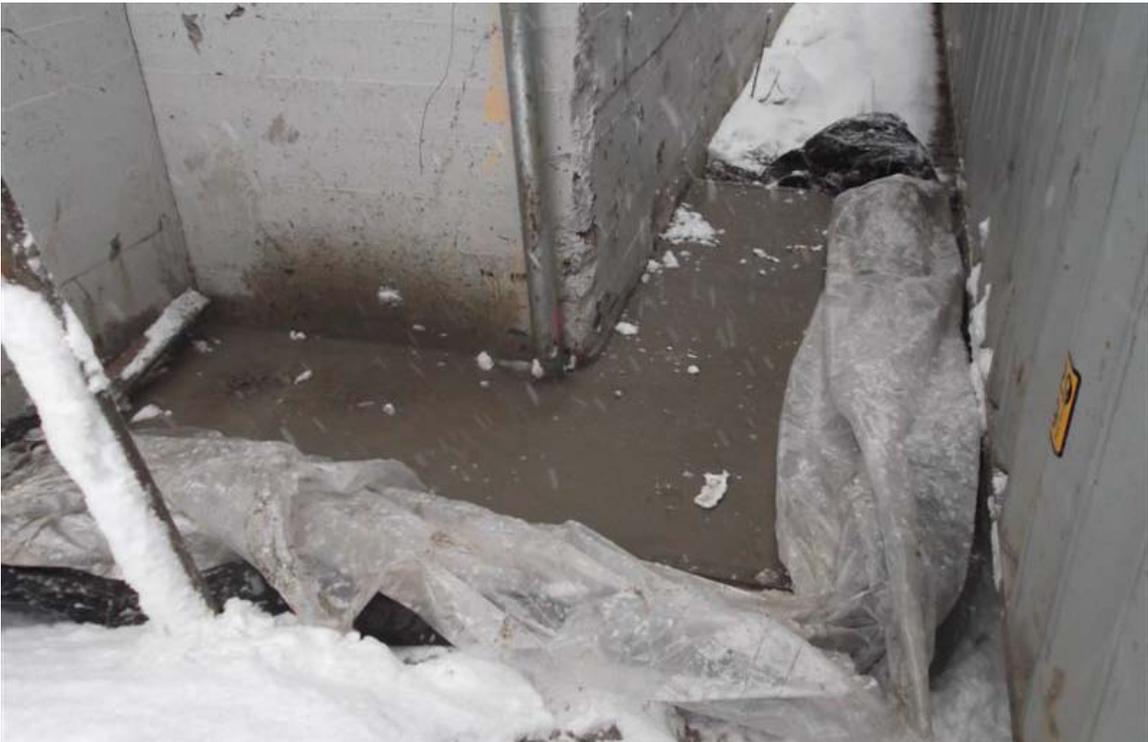
Concrete surface cap that wraps around the northern corner of the former maintenance building.

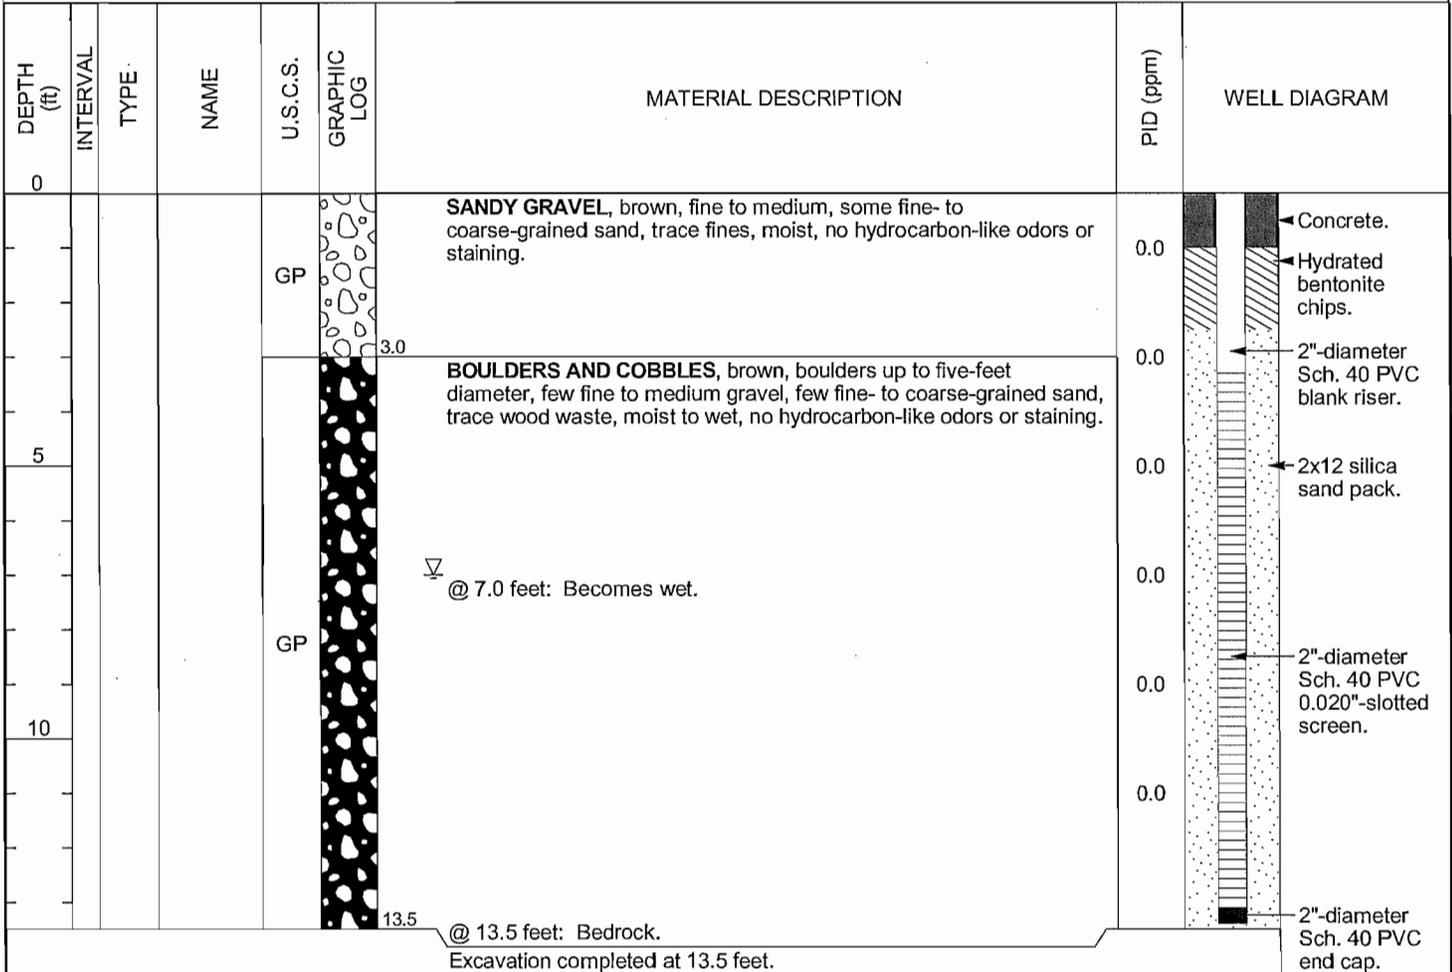
WELL NUMBER SMW-5

WELL COMPLETION DETAILS:

0.0 to 3.3 feet: 2"-diameter Sch. 40 PVC blank riser.
 3.3 to 13.1 feet: 2"-diameter Sch. 40 PVC 0.020"-slotted screen.
 13.1 to 13.4 feet: 2"-diameter Sch. 40 PVC end cap.
