PHASE III ENVIRONMENTAL SITE ASSESSMENT

**154TH AVENUE PROPERTY
3970 154TH AVENUE SE
BELLEVUE, WA 98006**

Project Number 2016-07-012

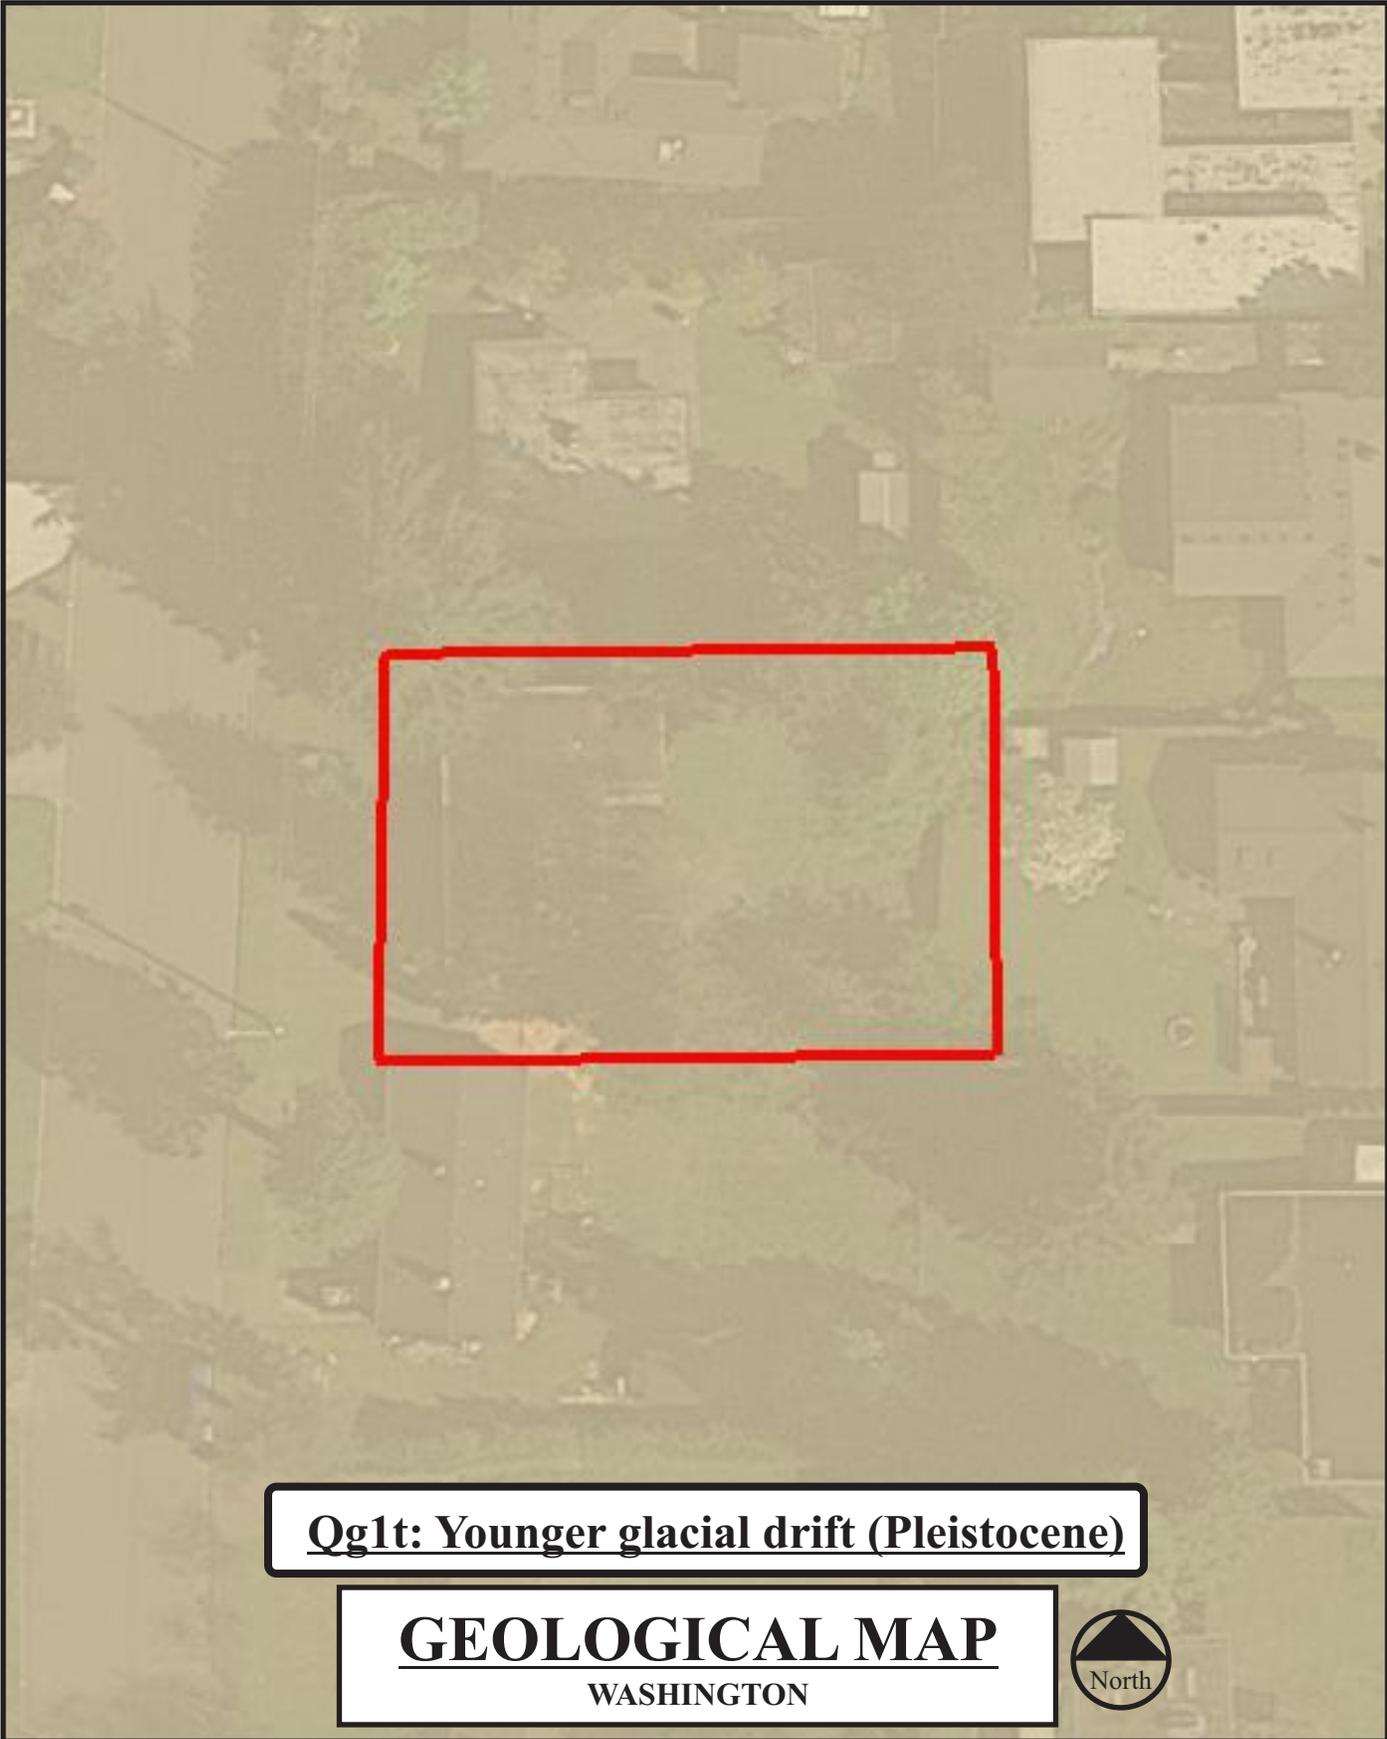
2016-07-012
AUGUST 4, 2016
PLATE: A3

Qg1t: Younger glacial drift (Pleistocene)

GEOLOGICAL MAP
WASHINGTON

According to the Geological Map of Washington, the subject property is located within the Qg1t: Younger glacial drift (Pleistocene)

Young glacial drift is defined as consisting of till (hard, blue-gray to gray concrete-like mixture of clay, silt, sand, and gravel deposited as end or recessional moraine). Principally Wisconsin in age. Possibly some outwash from the Fraser Glaciation (which encompassed the Vashon and Sumas Stades) occurs in this unit; most of it, however, is mapped within WAQg1o.

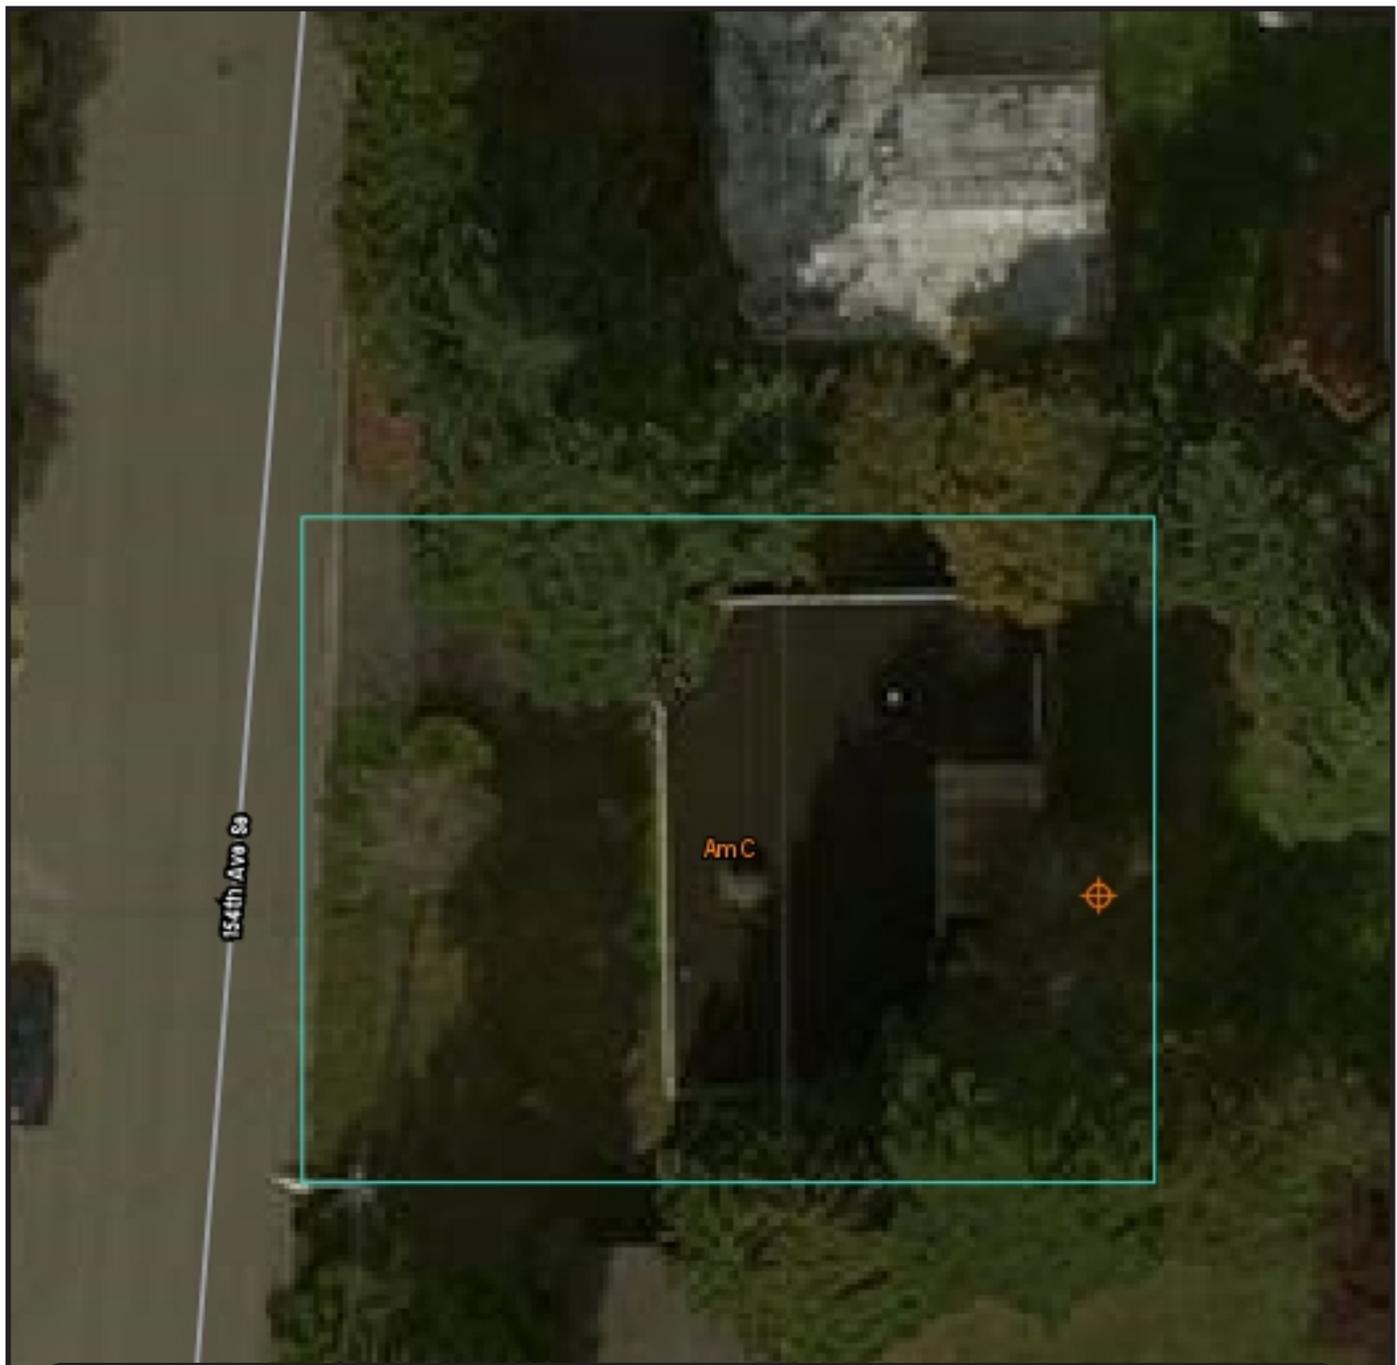
2016-07-012
AUGUST 4, 2016
PLATE: A4

King County Area, Washington (WA633)

Map Unit Symbol	Map Unit Name	Percent of AOI
AmC	Arents, Alderwood material, 6 to 15 percent slopes	100.0

SOIL MAP

The soils of the subject property are reported by the USDA as King County Area, Washington (WA633) composed of Arents, Alderwood material, 6 to 15 percent slopes (100%).

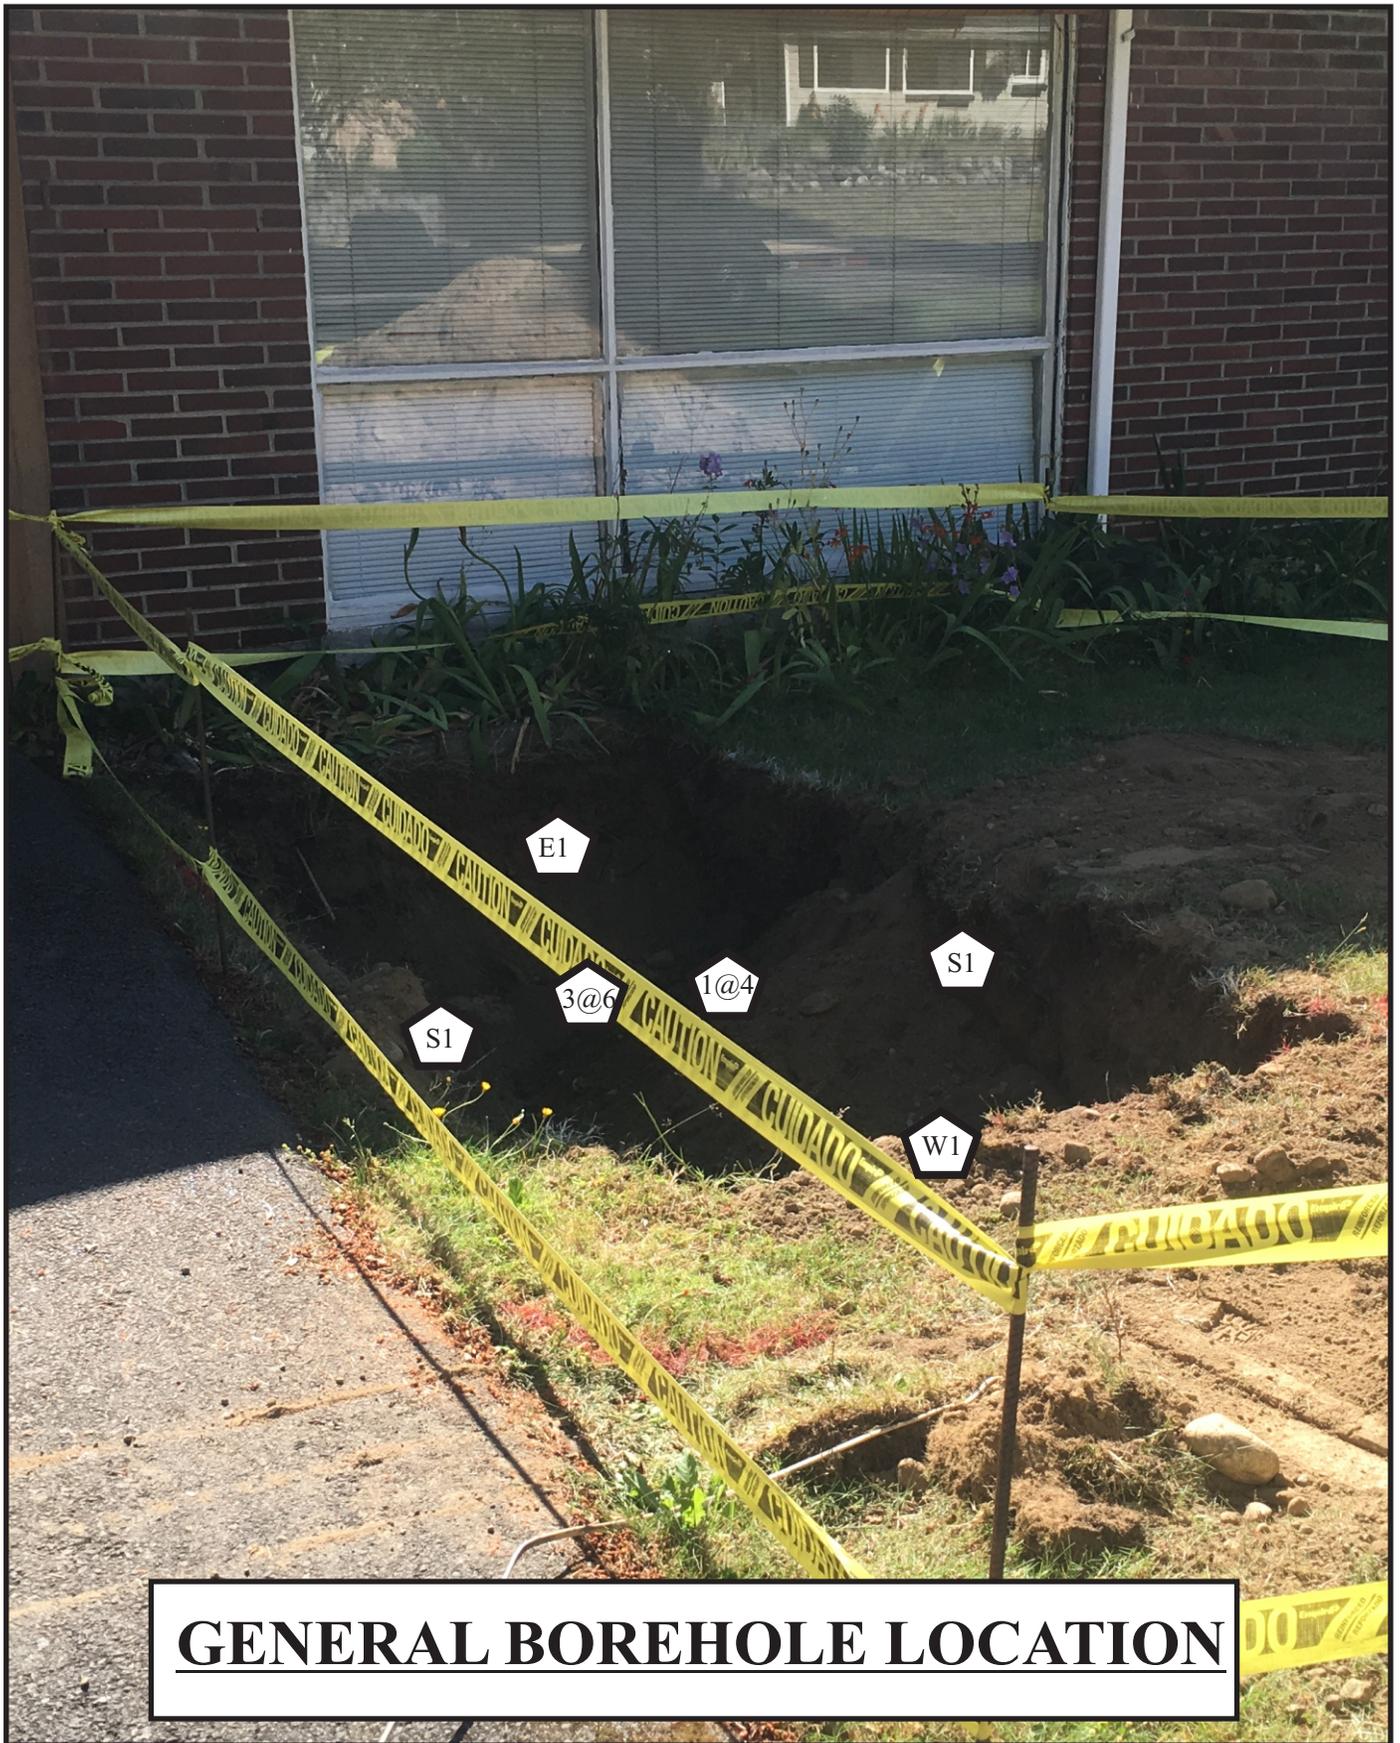
2016-07-012
AUGUST 4, 2016
PLATE: A5

GENERAL BOREHOLE LOCATION

requirement from the state. The tank cavity has been left open pending a response from the State to determine whether the hole can be filled. Once cleared by the State, the cavity will be filled with clean soils or the native soils that are currently on site. Please refer to Plate A5 for the sample location map. Please see Table 1 below for laboratory results.

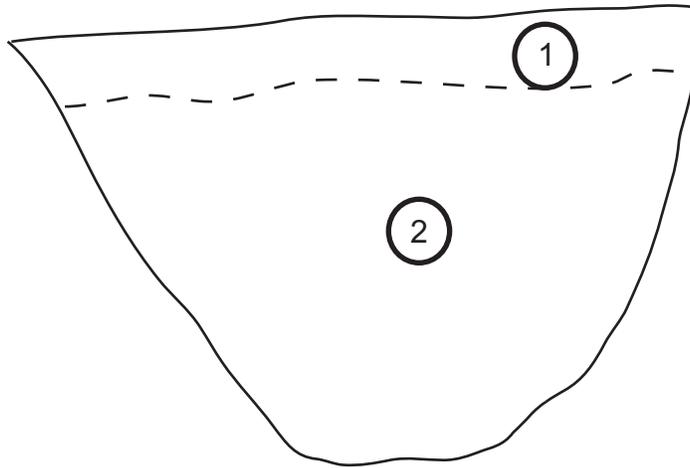
TP - 1
NO SCALE

① 0" to 4" Vegetation.

② 4" to 6' Sandy SILT, brown, loose, moist.

Test Depth = 6. No water encountered. Logged on 07/20/16
