**INDEPENDENT REMEDIAL ACTION REPORT
GROW COMMUNITY
BAINBRIDGE ISLAND, WA**

Resolve Project 16-027G
June 26, 2016

**Bainbridge Island Holdings LLC and
PHC Construction
710 John Nelson Lane
Bainbridge Island, WA**

**INDEPENDENT REMEDIAL ACTION REPORT
GROW COMMUNITY PROPERTY; SOUTHEASTERN PORTION
BAINBRIDGE ISLAND, WASHINGTON**

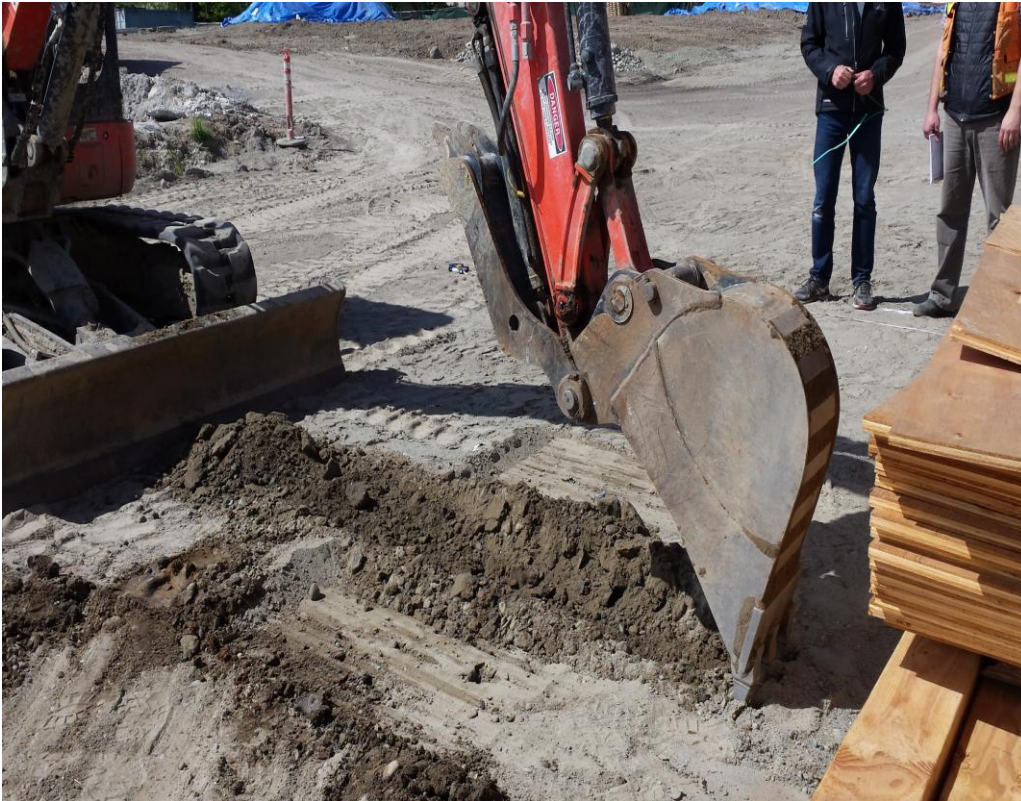
1. Initial excavation for characterization began in the eastern portion of the Grow Community Phase III site. Covered piles of contaminated soils can be seen in the background.

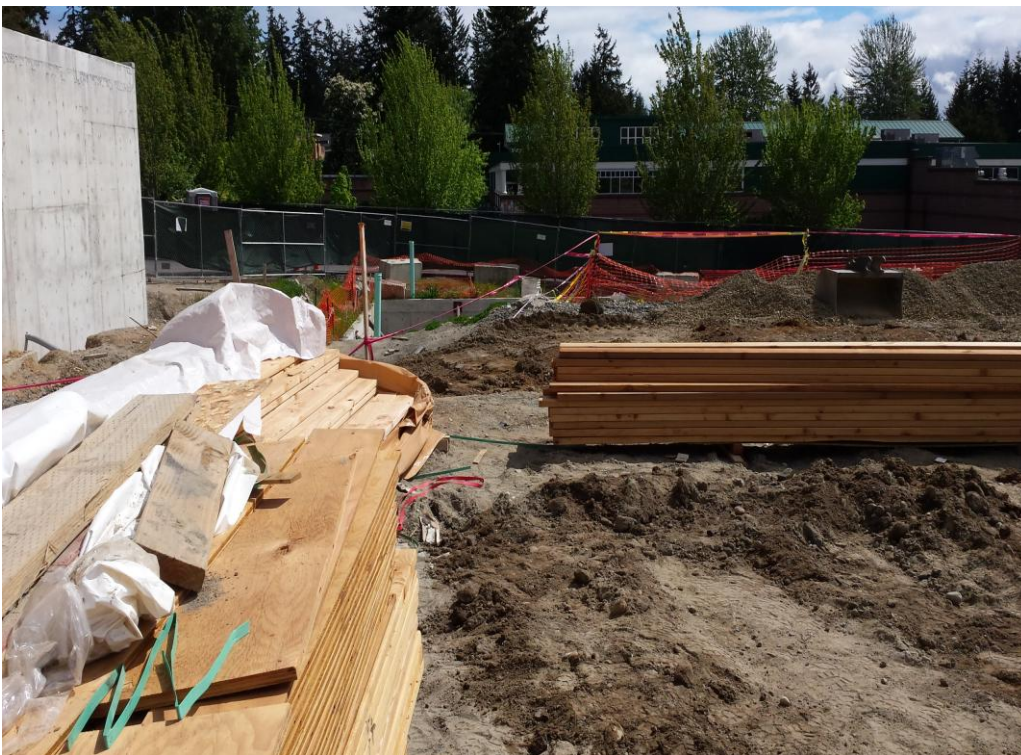
2. Several initial test pit locations were excavated for soils characterization. Building H is the concrete structure to the left of the photo.

Excavation of narrow trenches for investigation began with Test Pit H-1, approximately 23 feet from the southern wall of the building, and approximately 40 feet from the eastern margin of the building, where apparently contaminated soils were encountered at a depth of approximately 2.5 feet below the existing ground surface (bgs). The suspect soils appeared to extend to a depth of approximately 4 feet bgs. Another narrow test pit was excavated approximately 2 feet east of the first trench to a depth of greater than 4.5 feet bgs, and no soils with suspected contamination were encountered, indicating that the first trench had been initiated at the northeastern-most margin of contamination.

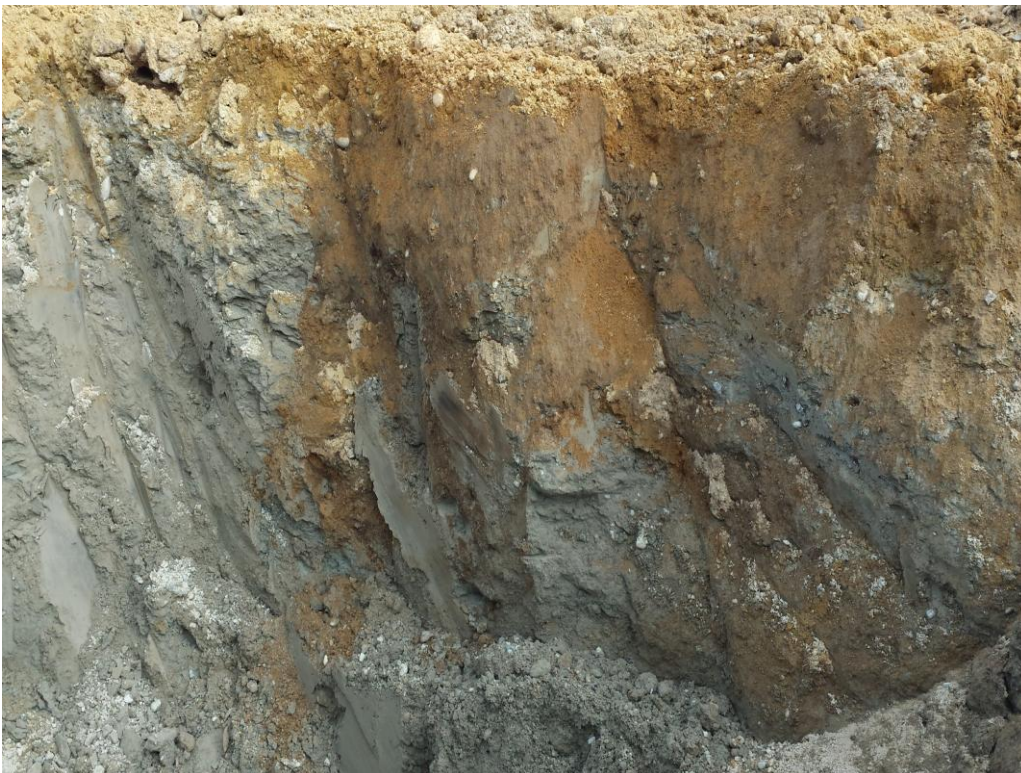
3. Beneath the fill and topsoil, some of the gray silty sand with gravel and sand were found to be contaminated with diesel range hydrocarbons.

Subsurface soils encountered during the exploratory excavations were generally a thin (one to two foot) layer of topsoil and fill material, underlain by generally brown, damp, dense, silty sand with gravel (USCS SM), followed at depth by gray silty sand with minor gravel, and some intervals of gray, moist, dense silt sand with gravel (USCS SM) and minor sand.

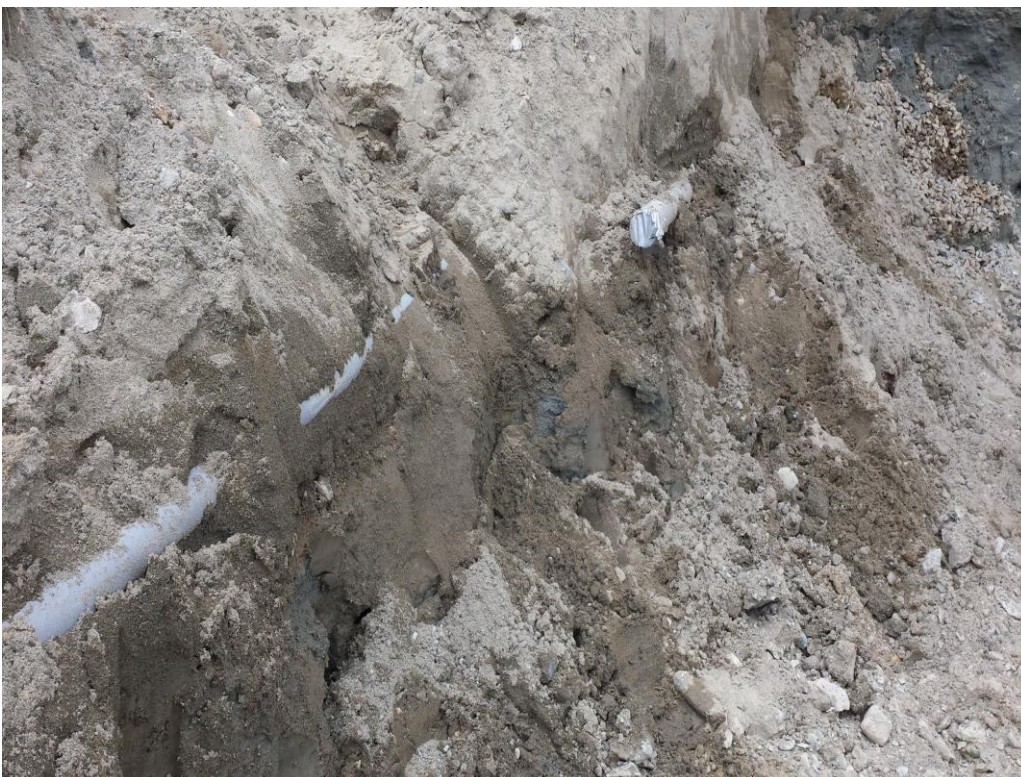
4. These conduits were being emplaced when the contamination was initially discovered.

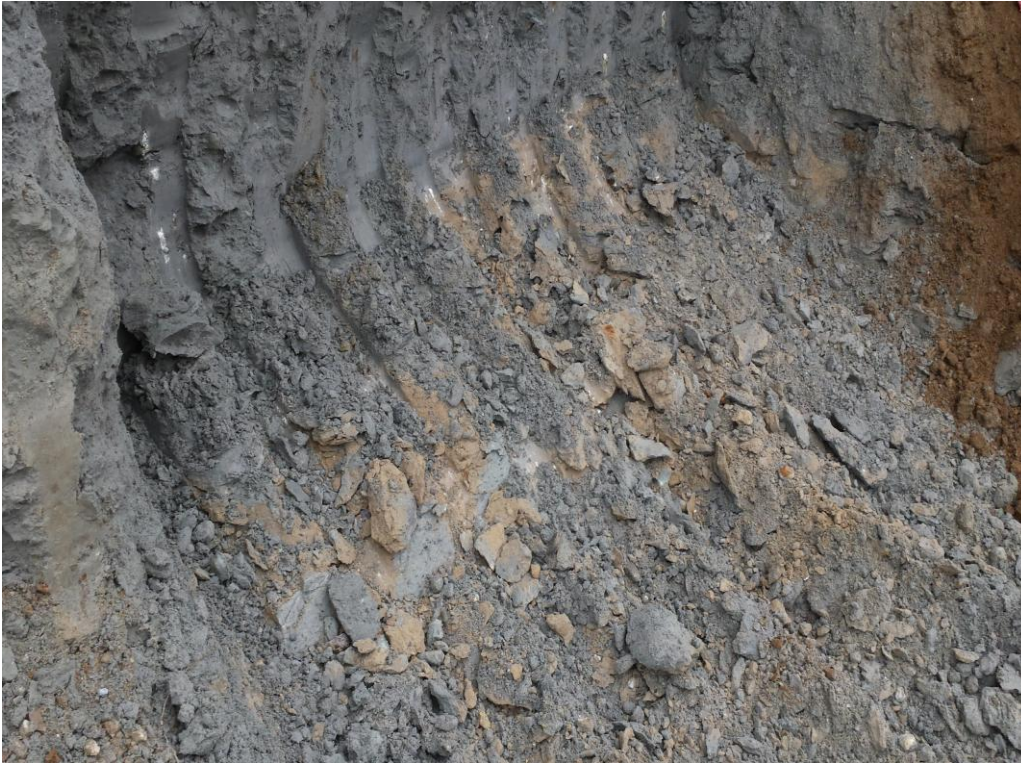
5. Obvious decreases in contamination along the margins of the excavation were noted. Some expansion of the plume was observed as remediation was underway.

The discovery of additionally contaminated soils extended the remediation excavation, with some obviously contaminated soils extending deeper than originally estimated, and to the north of previously delineated contaminated soils. The contaminated area was found to extend to a depth of approximately 6.5 feet bgs, and northward beneath Building H.

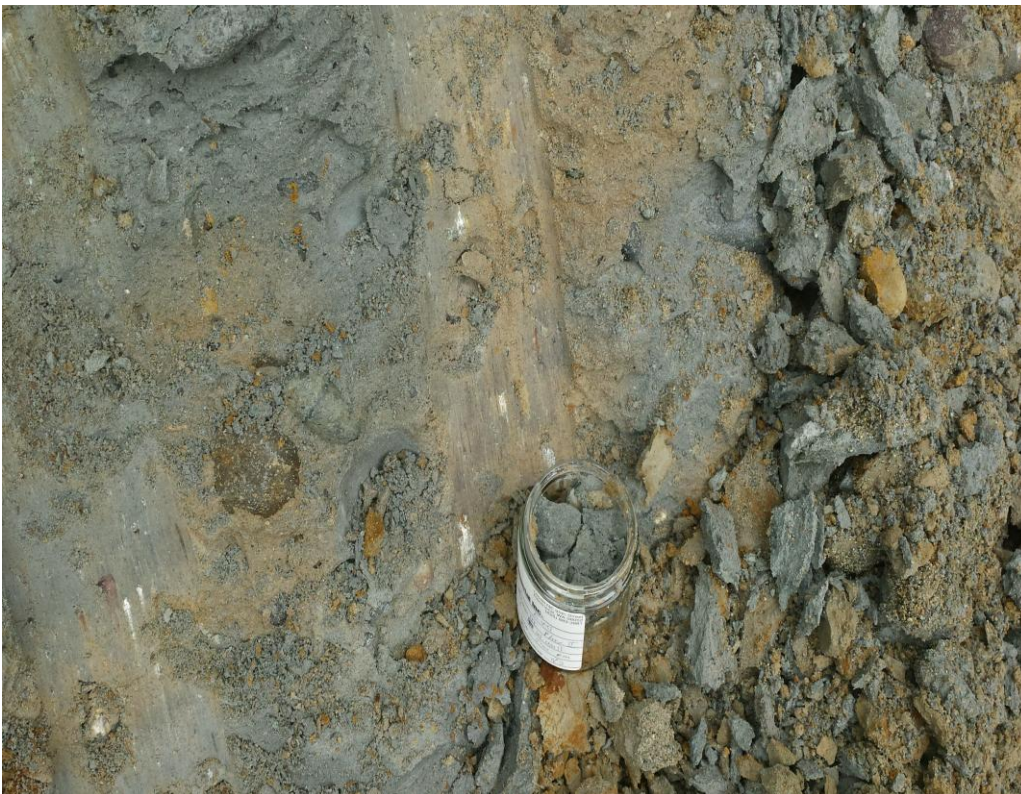
6. Samples were collected for laboratory testing from walls and floors of the trench area excavation.

Following excavation of the trench area and apparent removal of the contaminated soils from the site, verification samples were collected and laboratory tested. Samples from the southern and western portions of the excavation site were collected on May 20, 2016. Further samples, including from below Building H, were collected on May 25, May 30, and June 7, 2016. Laboratory results are attached to this report. The following table summarizes laboratory results as tested and analyzed:

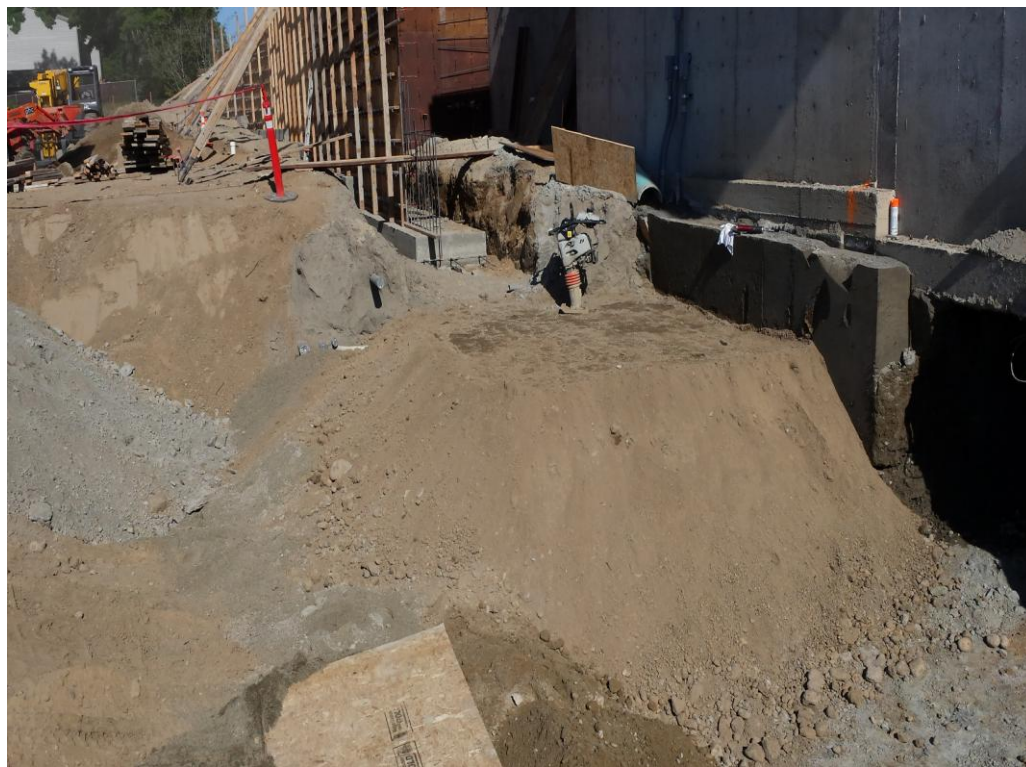
7. The western portion of the site was excavated beyond what appeared to be the margins of the plume, to where contamination was no longer indicated or suspected.

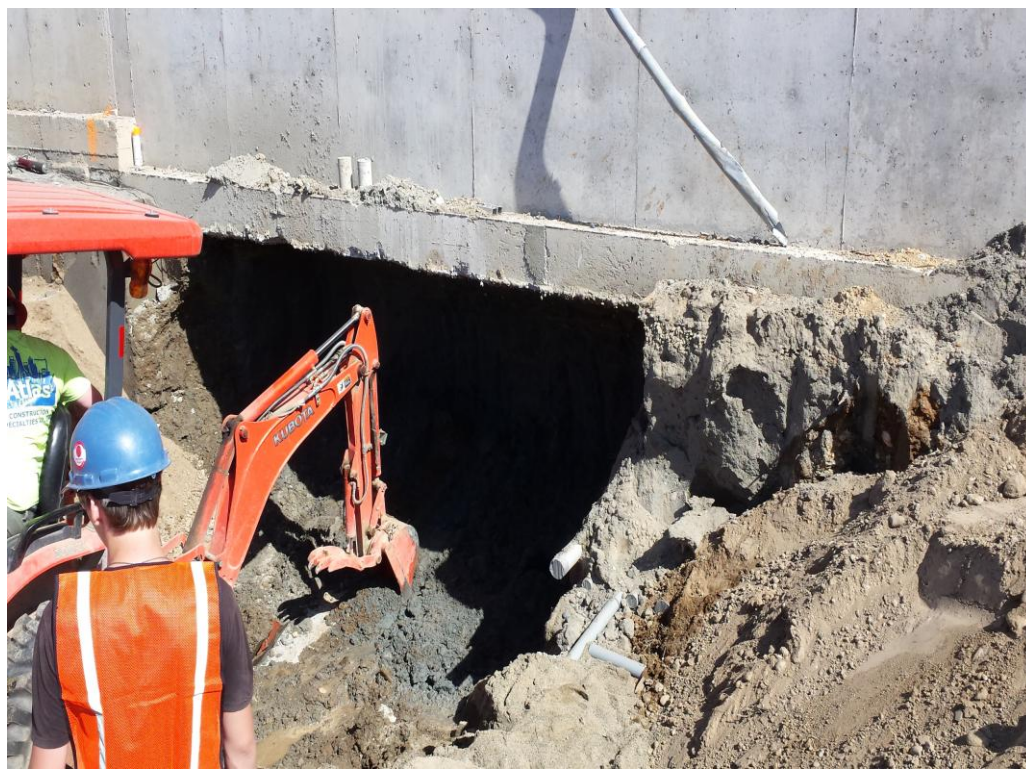
8. Following approval of undermining by structural and geotechnical engineers, contaminated soils were removed from beneath Building H.

It was determined that a structural engineer should be contacted prior to undermining of Building H to remove soils, and limited undermining was approved. At approximately 4.5 feet beneath the southeastern margin of the building, soils appeared to be free from, or have low concentrations of, the subject contaminant.

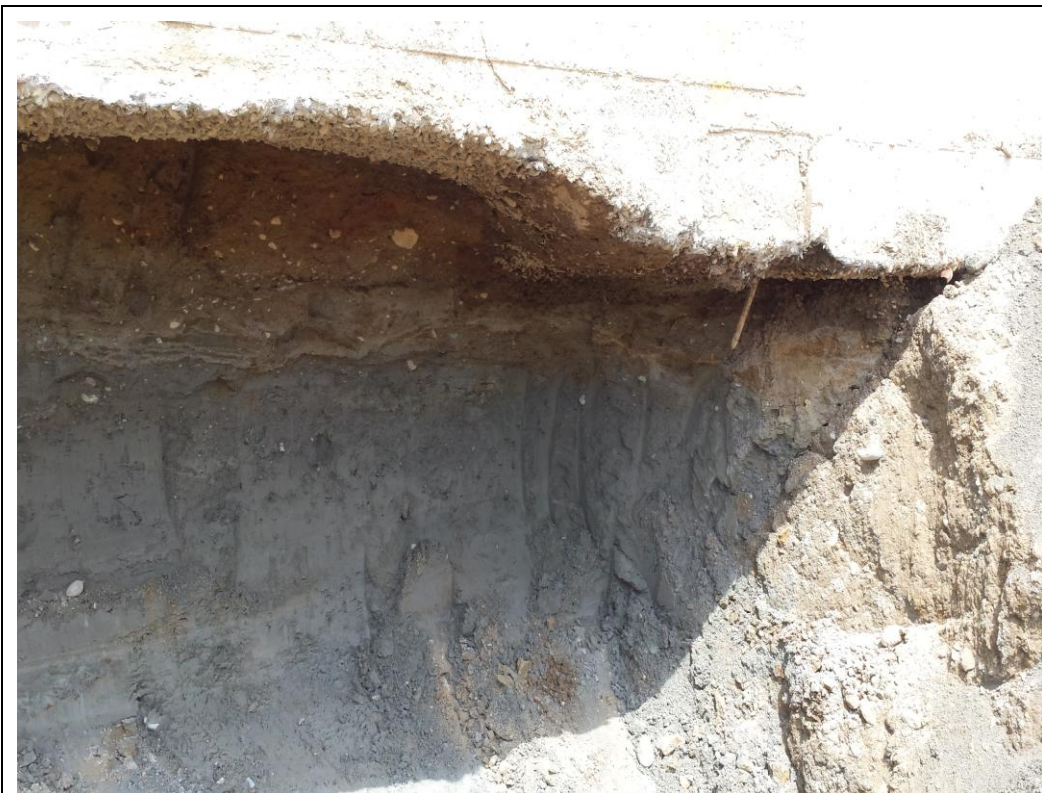
9. Excavation proceeded beneath Building H until it was determined that contamination was either very low in concentration or not present.

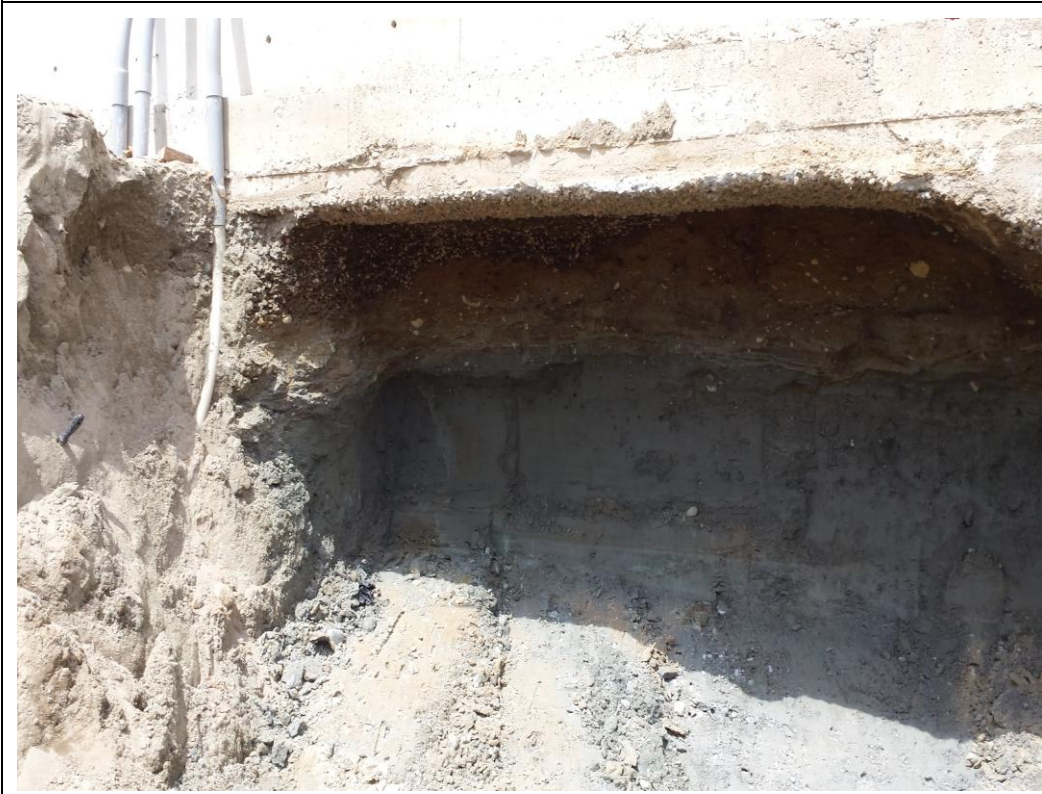
10. A total of five feet was excavated beneath Building H in order to verify that contaminated soils had been removed.

Excavation beneath the building continued to an undermine depth of approximately 5 feet, at which point verification samples were collected for laboratory analysis. A total of approximately 250 cubic yards of contaminated soil were removed from the site. Photographs of the excavation are attached to this report.
