# INITIAL INVESTIGATION FIELD REPORT

<u>Site Name (Name over door):</u> Rector Property	<u>Site Address (including City, State and Zip):</u> 6361 Wing Point Rd NE Bainbridge Island, WA 98110	<u>Phone</u> <u>Email</u>
<u>Site Contact, Title, Business:</u> Ron Nance, Owner, Resolve Environmental & Geotechnical	<u>Site Contact Address (including City, State and Zip):</u> 8842 NE Lacey St Indianola, WA 98342	<u>Phone</u> (360) 297-8870 <u>Email</u> resolveEG@comcast.net
<u>Site Owner, Title, Business:</u> Robert D Rector & Jessamine Talavera	<u>Site Owner Address (including City, State and Zip):</u> PO Box 11546 Bainbridge Island, WA 98110	<u>Phone</u> <u>Email</u>
<u>Site Owner Contact, Title, Business:</u> None	<u>Site Owner Contact Address (including City, State and Zip):</u>	<u>Phone</u> <u>Email</u>
<u>Previous Site Owner(s):</u> None	<u>Additional Info (for any Site Information Item):</u>	
<u>Alternate Site Name(s):</u>

**Single Family Residence Site Remediation  
6361 Wing Point Road NE  
Bainbridge Island, Washington**

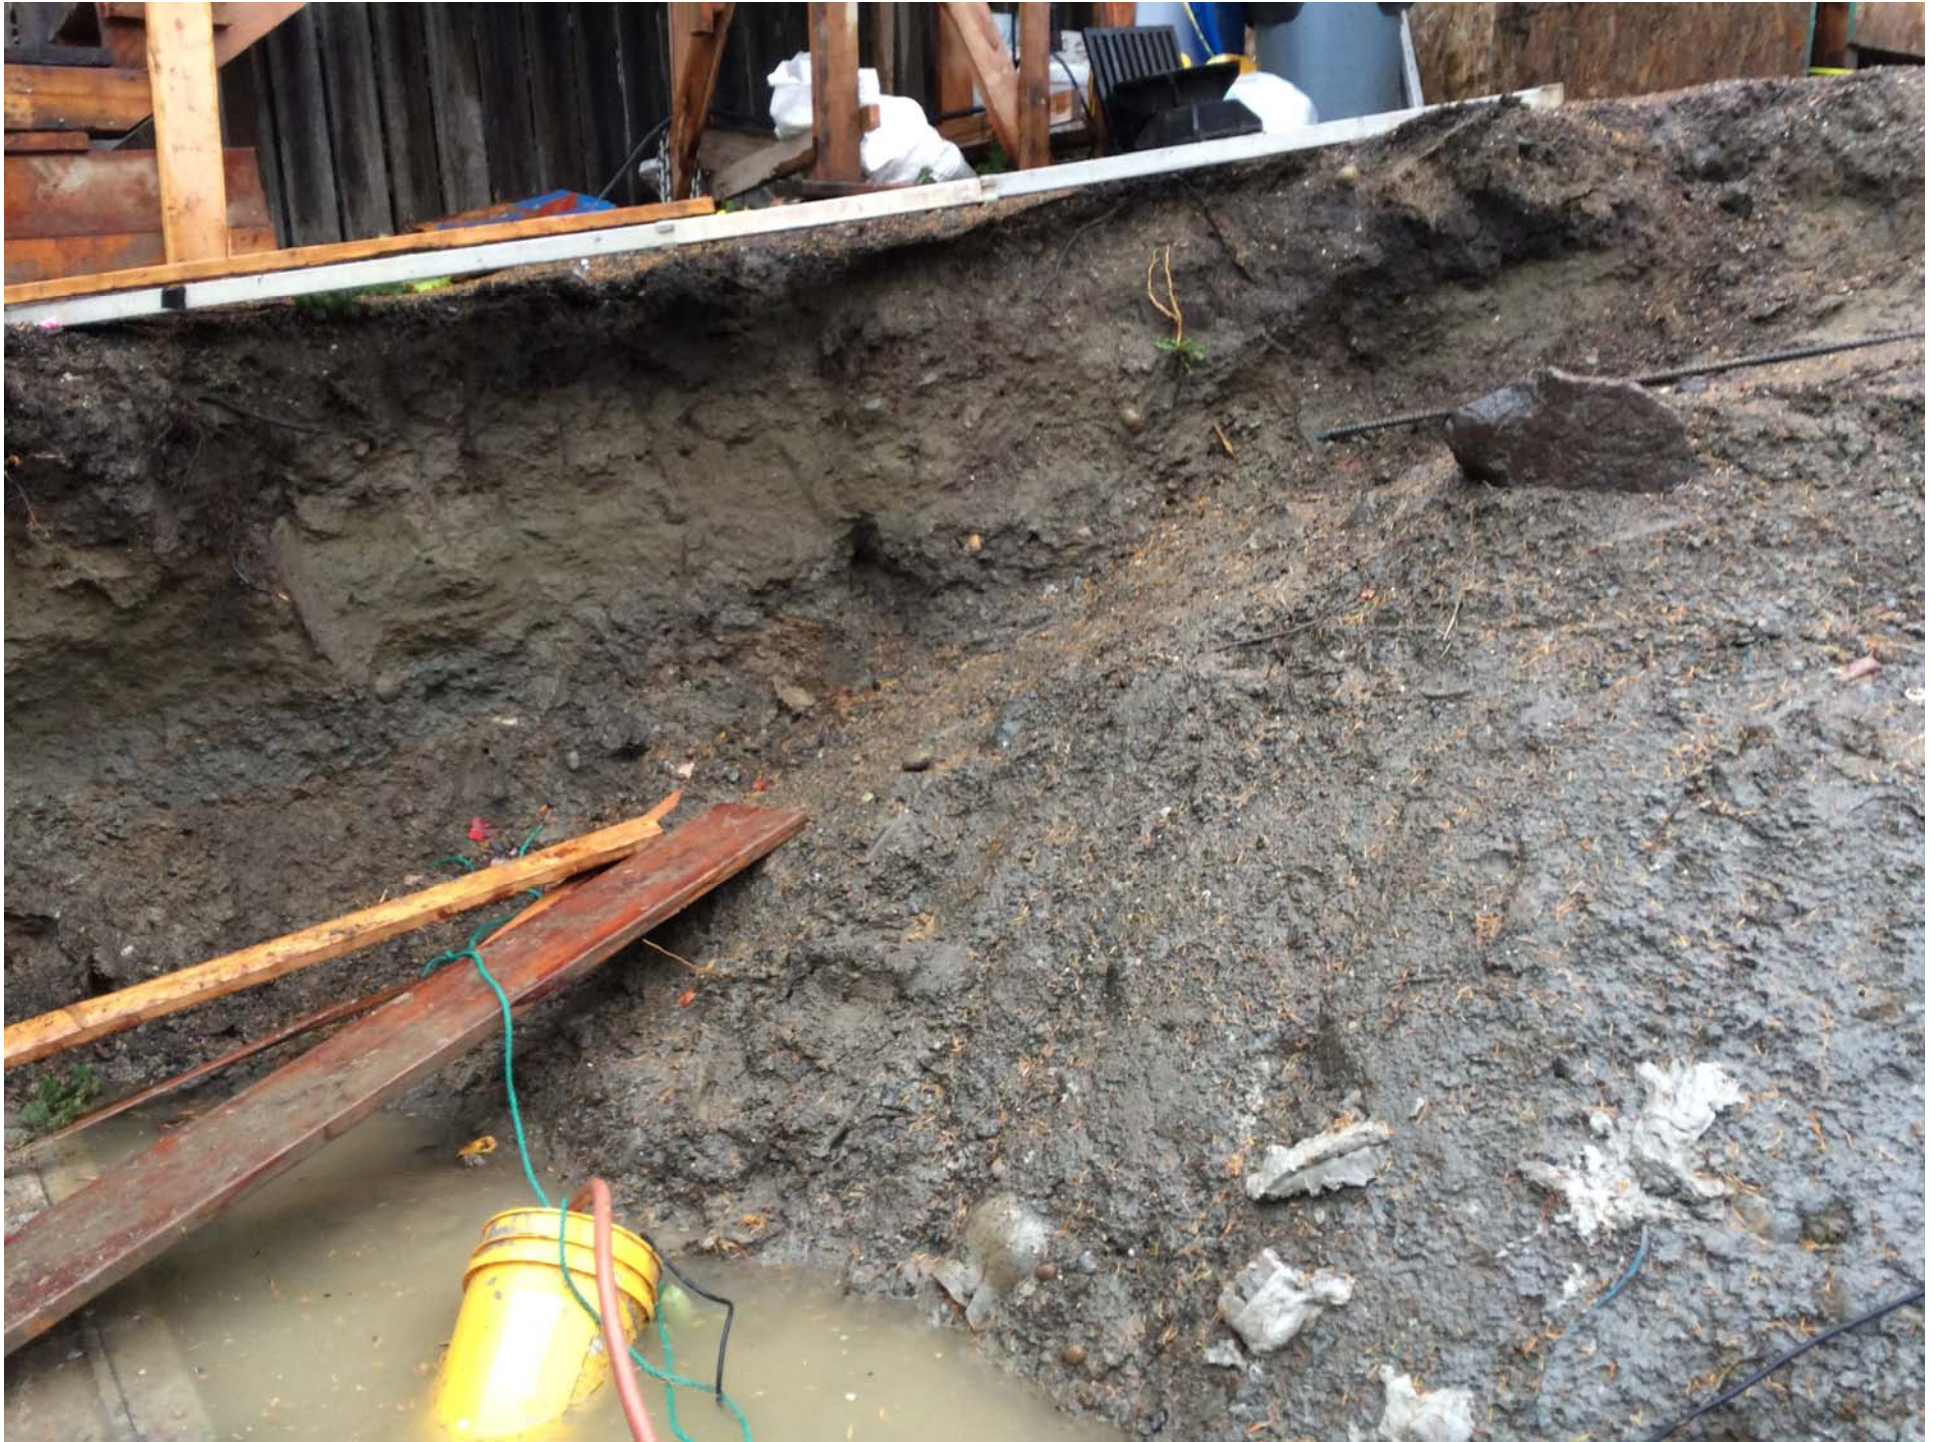
**FIGURE 2B:**  
Sample Location Diagram

OLD HOUSE

### Initial Samples

**Sample 1 NE: 3500 PPM;** Northeast corner of initial retaining wall footing trench

**Sample 2 Central: 2800 PPM;** Central area of initial retaining wall footing trench

**Sample 3 Southwest: 1800 PPM;** Southwest wall of initial retaining wall footing trench

### Verification Samples (Non detect or below MTCA)

C-4 south wall  
C-5 southeast wall  
C-6 south central floor  
C-7 east side wall  
C-8 east side wall

C-9 south wall  
C-10 northwest wall  
C-11 northwest floor  
C-12 northeast wall  
C-13 northeast floor
