RE: Final Report  
2011 Annual Performance Monitoring  
Black Sand Beach Project  
Stevens County, Washington  
**URS Job No. 36310105**

This letter report provides a summary of the October 3, 2011 Annual Performance Monitoring Event conducted at Black Sand Beach in Stevens County, Washington. This is the first Performance Monitoring Report following completion of the Black Sand Beach project in October 2010.

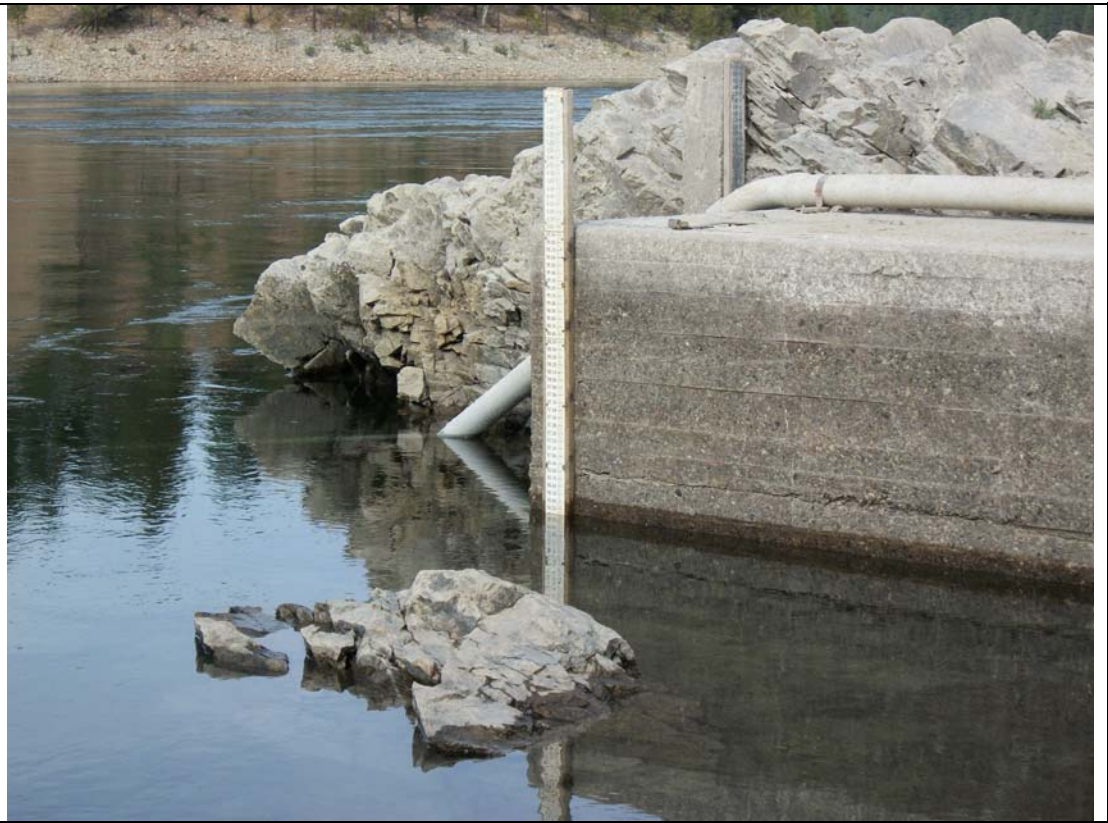
Gauging Station

Gauge reads  
approximately 96.25',  
which corresponds to  
river elevation of  
approximately 1299.2'  
NAVD88.
