RE: Oil Tank Removal at Sunset View Apartments; DBM Job No. 02023ie

UST Decommissioning Project  
Sunset View Apartments  
2101 Sunset Blvd.  
Renton, Washington

UST Decommissioning Project  
 Site Location & Topographic Map  
 2101 Sunset Blvd.  
 Renton, Washington

UST Decommissioning & Assessment  
Project Photographs  
2101 Sunset Blvd.  
Renton, Washington

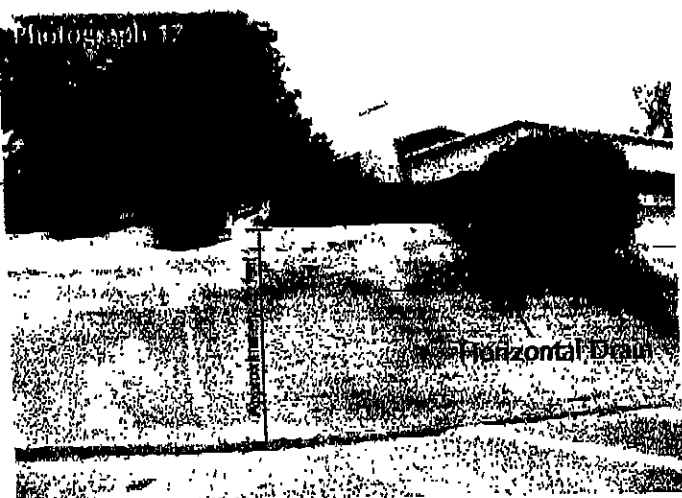
Wall south of UST location - View to the north
