Subject: Independent Remedial Action Summary Report
Talta Ballard Development Site
7500 to 7530 15th Avenue NW
Seattle, Washington

INDEPENDENT REMEDIAL ACTION SUMMARY REPORT

TALTA BALLARD PROJECT SITE
7500 - 7530 15TH AVENUE NW
SEATTLE, WASHINGTON

February 1, 2017
Project No. WES-1471A

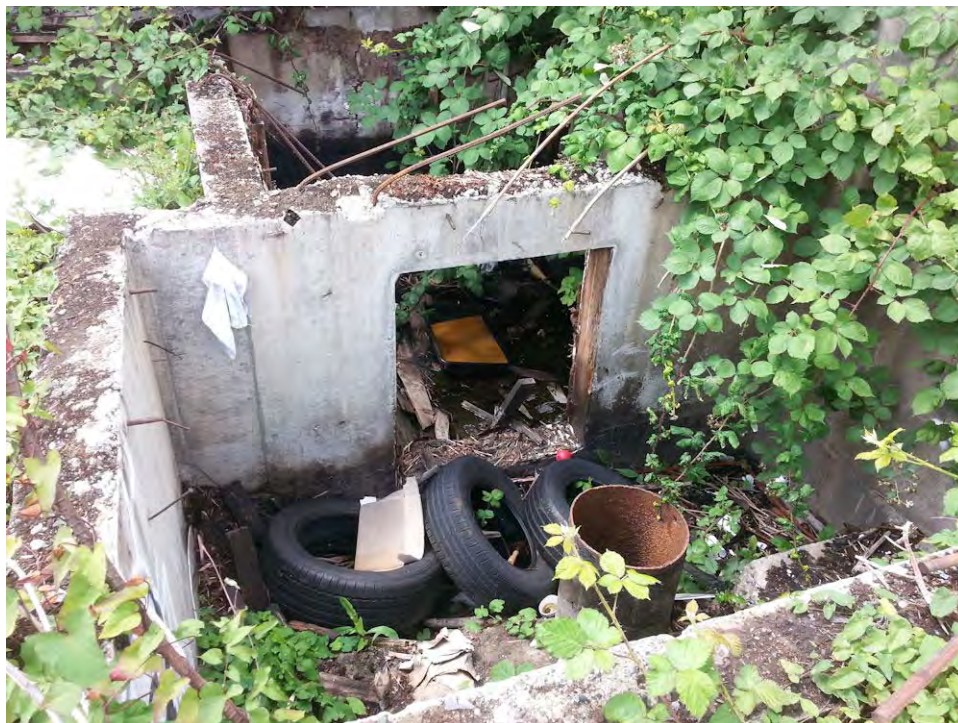
- 2.) View of the incomplete stairwell and elevator pit in the northwest corner of the building. The pit had standing water in it and debris. (June 24th, 2016)

The abandoned structure was a partially-built two-story concrete building that has no roof or floor slabs. By all appearances, construction had been halted abruptly. The structure was not in a useable condition, but was in place from about 1990 until removed as part of this redevelopment. The window and door openings had been boarded over to limit access, but it had become a disposal site for unwanted debris, tires, vehicles and containers, some in poor condition. There was an incomplete stairwell and elevator equipment pit located in the northwestern corner of the building, which contained debris and oily standing water.

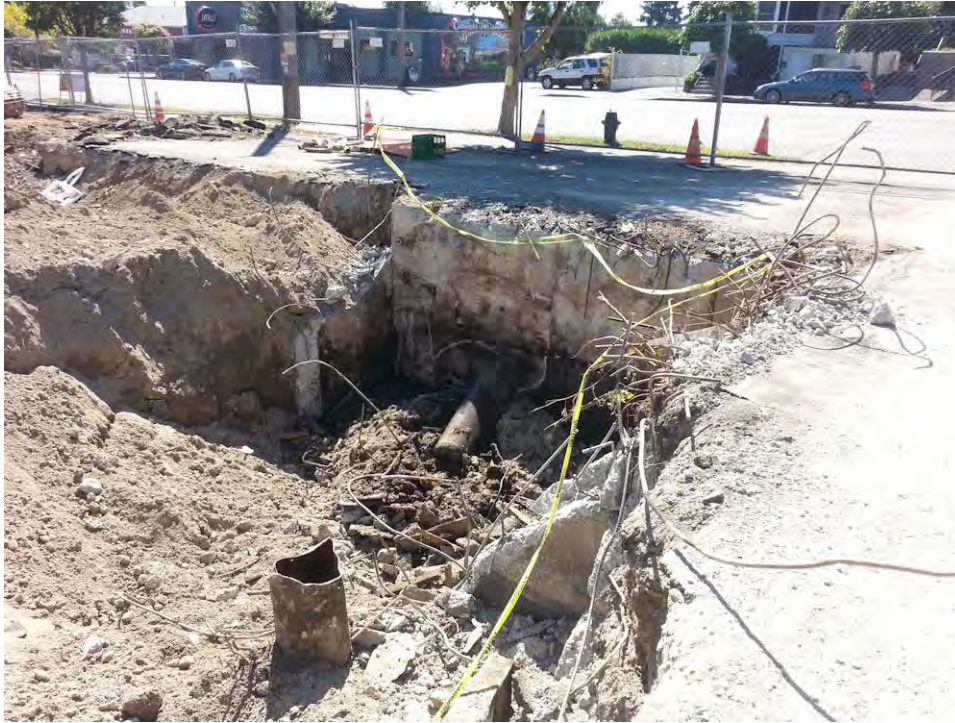
- 3.) View of the stairwell pit after the rest of the building had been removed. (August 11, 2016)

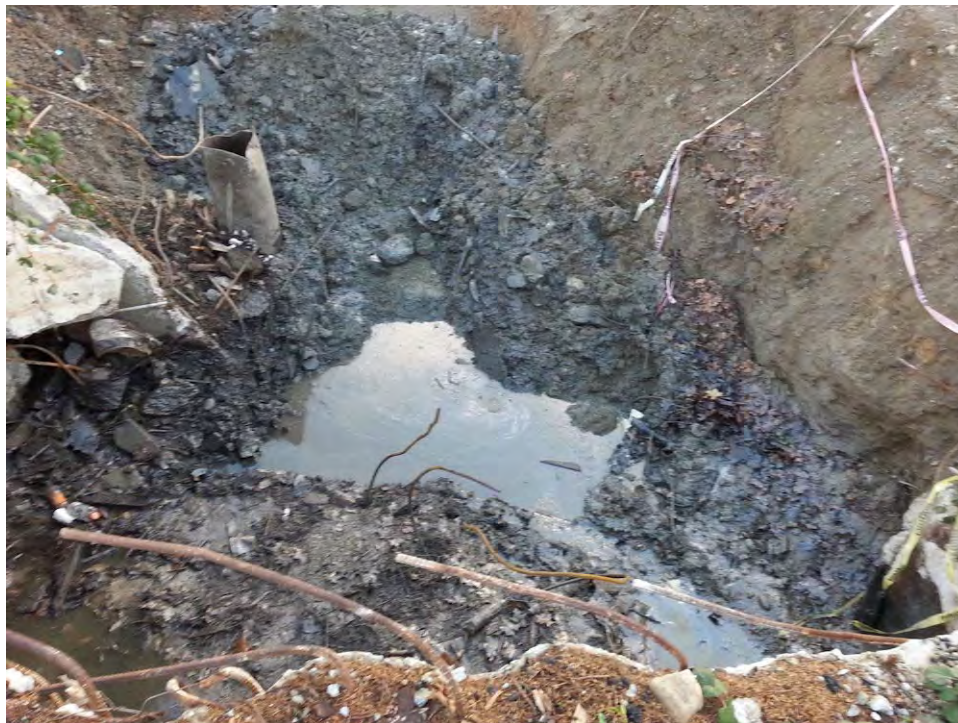
- 4.) View of the soil and standing water in the pit as excavation began. (December 13, 2016)

After the water was drained, Ryatt used a trackhoe to excavate the base of the pit to remove petroleum contaminated soil. Eight truck loads of soil totaling 122.01 tons of material were excavated and transported to Cemex, Inc. in Everett, Washington, for thermal treatment and disposal. Invoicing and truck weight tickets from Cemex for the materials they managed are included in Appendix D. Photographs of the cleanup actions and final conditions of the pit are included in Appendix A.

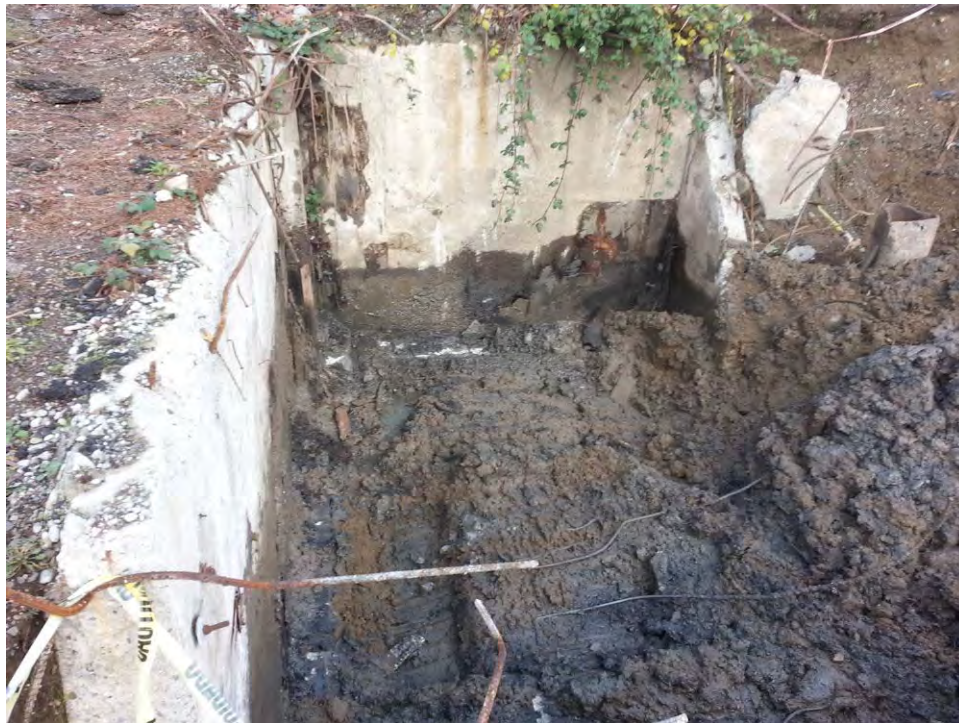
5.) View of the pit while excavating the base soil. (December 13th, 2016)

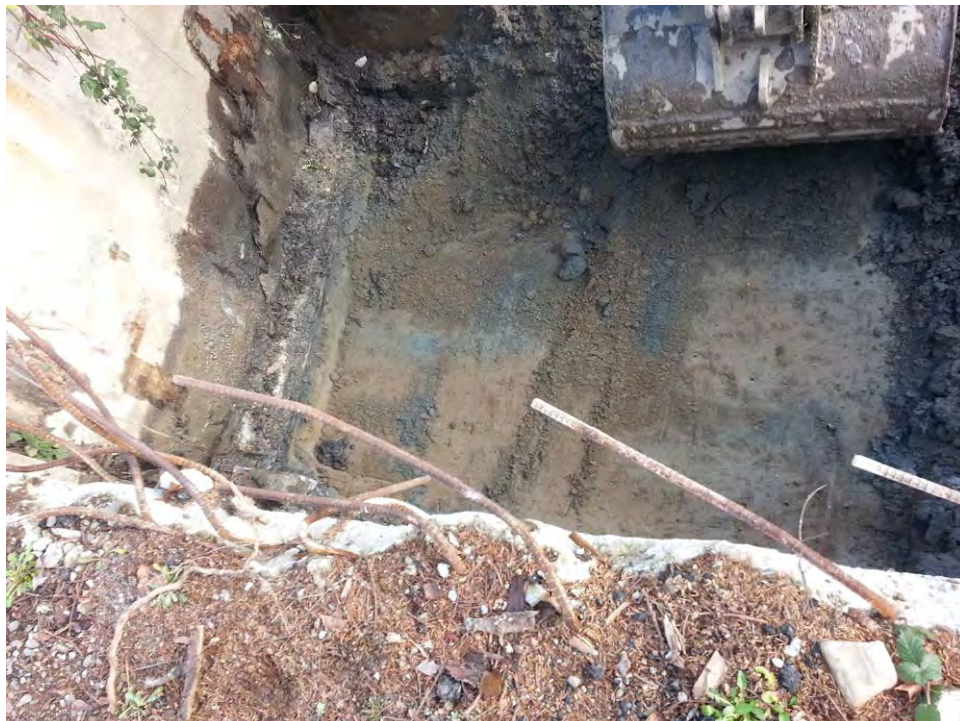
6.) View of clean soil in the excavation base, after removing about 1.5 foot of stained soil. (December 13, 2016)

The excavation found discolored and oily soil at the base of the pit, but it did not extend to appreciable depth. The excavation base was found to be a relatively clayey sand layer which limited infiltration of the standing water and contaminants. Digging confirmed that the water that had been standing in the pit was isolated from any underlying groundwater conditions. The excavation was continued until all visual evidence of discoloration or odors were removed, then four final confirmation samples were obtained from the excavation base. Figure 4 shows the extent of the excavated area and the locations of final confirmation samples.

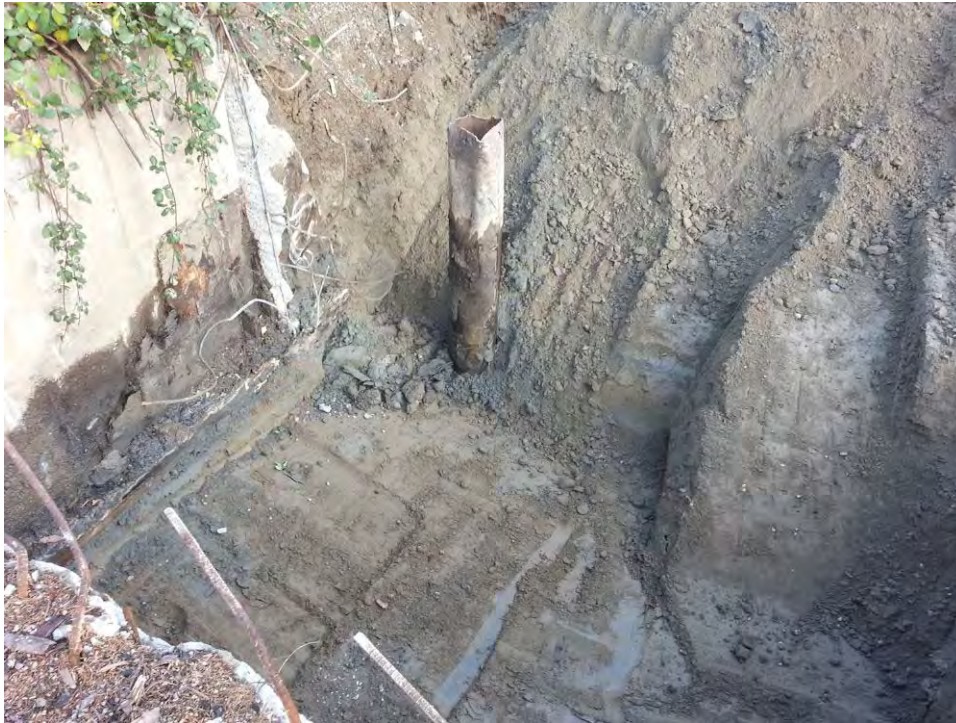
7.) View of the clean excavation base. (December 13th, 2016)

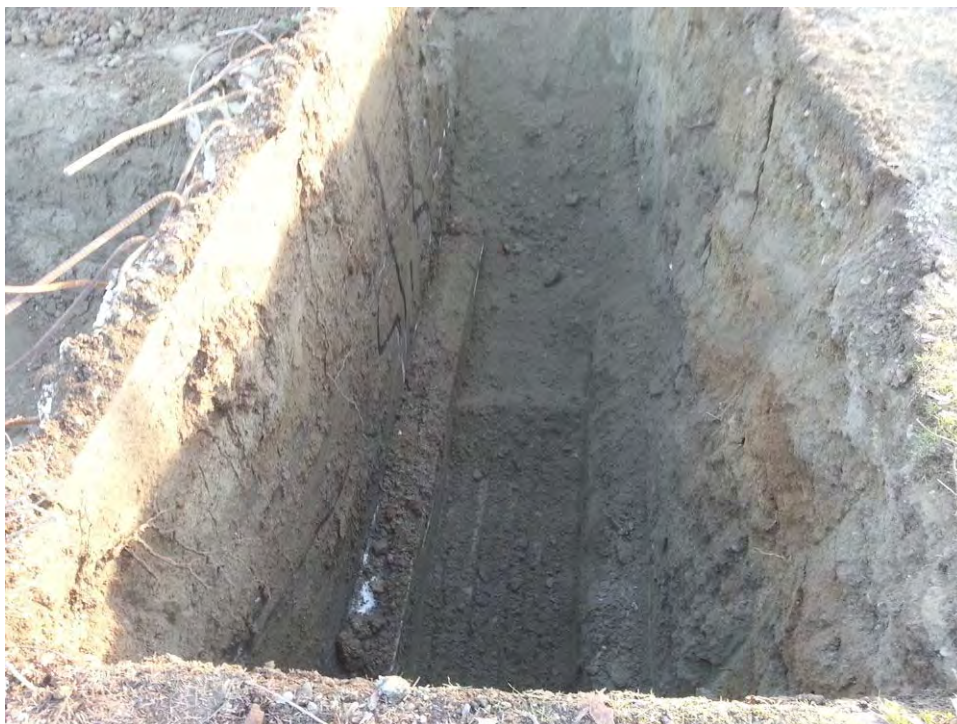
8.) View of the excavation outside the wall of the pit, to check if contaminants had seeped under the footing. West base sample taken from this area showed no detectable petroleum. (December 13th, 2016)

The sampling found no detectable concentrations of diesel or motor oil range petroleum hydrocarbons in any of the collected samples. Based on the work conducted, our observations of the excavation and this final confirmation sampling, no further action appears warranted.

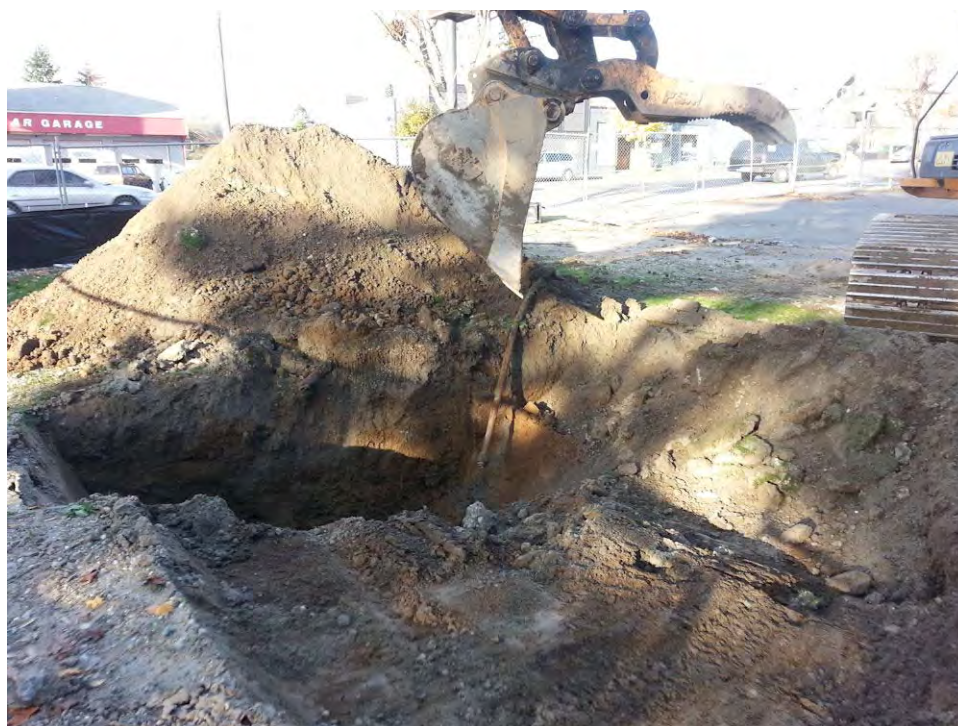
- 4.) View of the trackhoe digging a test pit at the location of the former pump island. Digging encountered product piping that extended to the east. (December 13th, 2016)

Once the Westernco donut shop building was removed, the area of the former gas station could be more thoroughly investigated. The work began on December 8th, 2016. Using a trackhoe, Ryatt Construction conducted test pit excavations at the approximate locations of former pump island areas, in the western and southwestern parts of the 7500 15th Avenue NW parcel. WES observed and documented the exploration. The test pits found no field detectable indications of petroleum contamination, such as odors, staining, sheens or discolored soil. The southern test pit encountered abandoned product piping which was traced to the east, where three underground storage tanks were found.

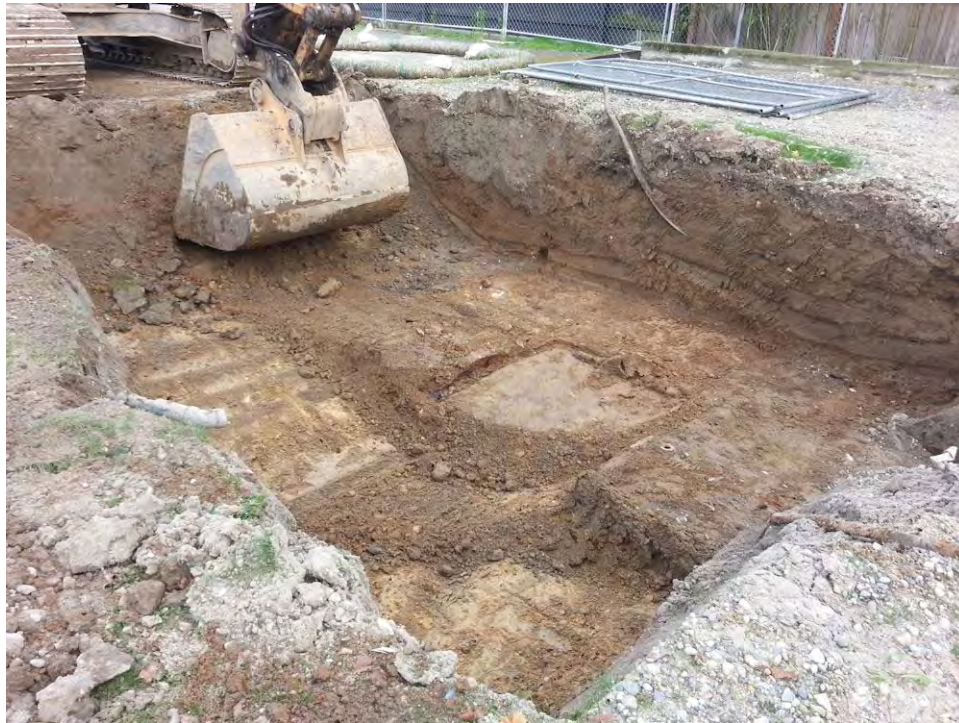
- 5.) View of the tank area, excavated to the level of the top of Tanks 1 and 2. Piping in the far wall extends to Tank 3, not yet excavated. (December 13th, 2016)

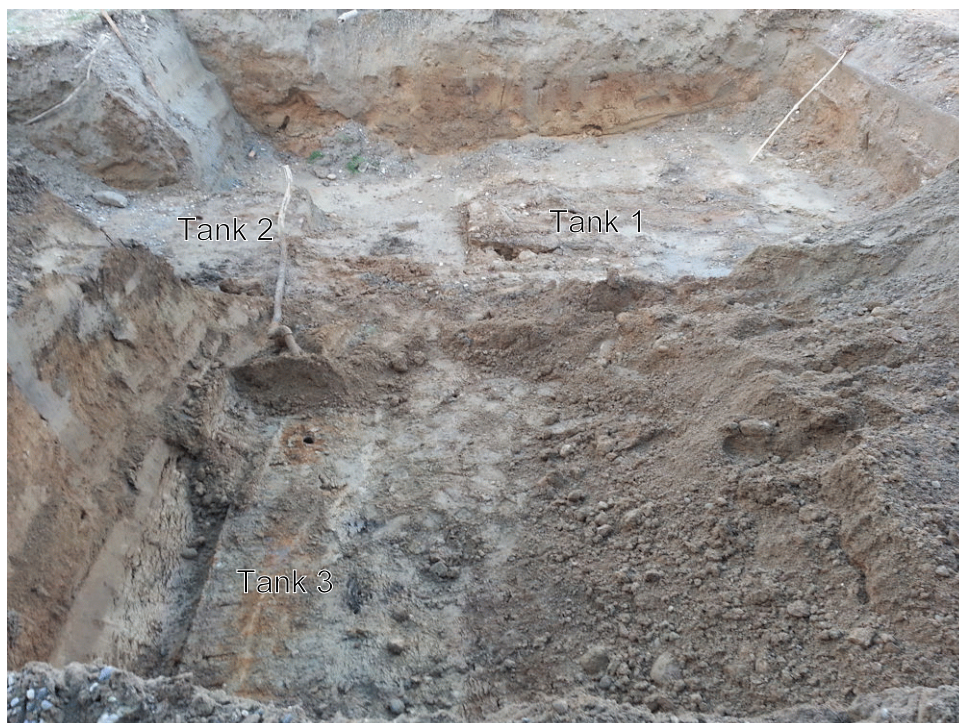
- 6.) View of the excavation with all three tanks exposed. (December 13th, 2016)

These tanks were approximately 1,500 gallons in capacity and were found to be empty, with the exception of small amounts of water. The tanks were buried at a depth of about three feet below the current site grade and the Westernco donut shop building had been constructed directly over them in 1964. The locations of the tanks, piping and excavations of the area are shown in Figure 3.

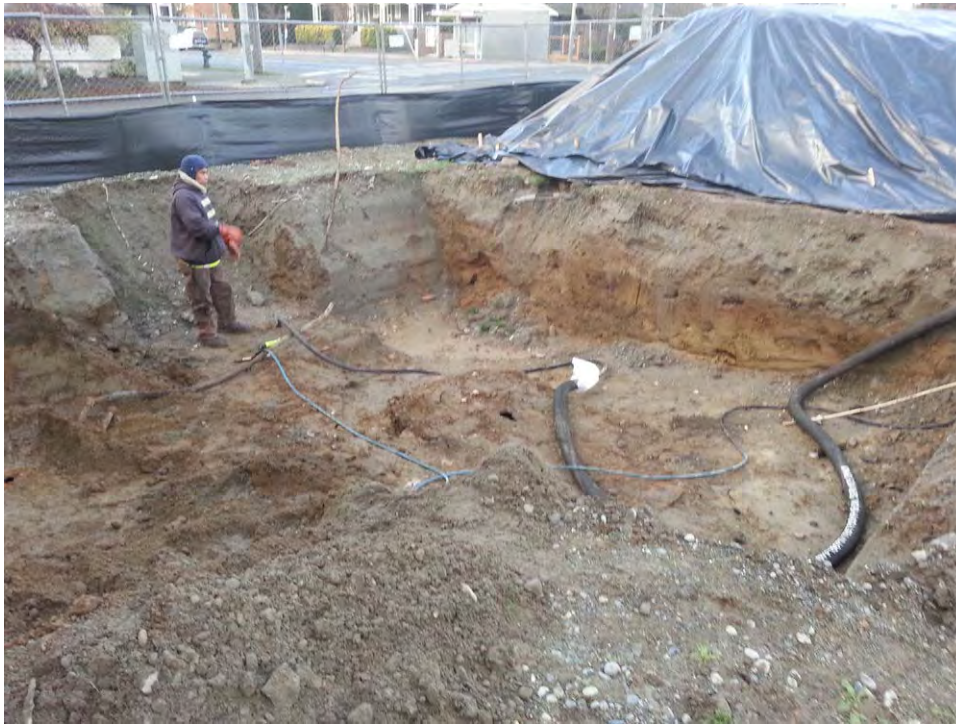
- 7.) View of the UST contractor pumping and rinsing the tanks before removal. (December 13, 2016)

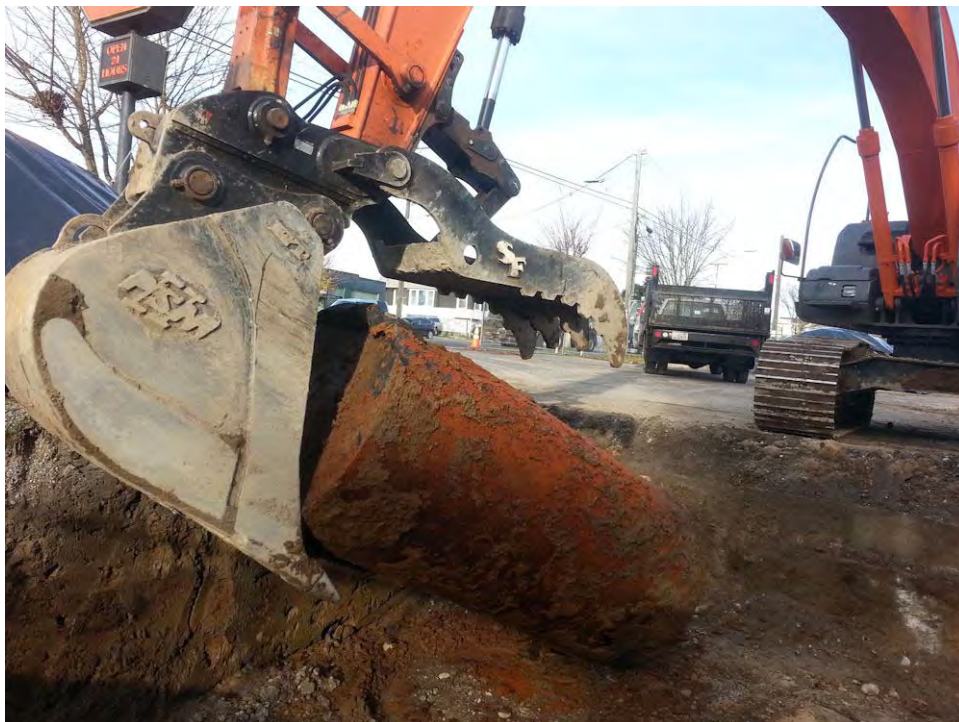
10.) View of Tank 2 after removal. The tank was heavily pitted, but there were no readily apparent holes. (December 14th, 2016)

Each tank was inspected after removal, then loaded onto a truck and removed from the site. All three of the tanks were in fair to good condition, with some areas of deep corrosion to the metal surface. All three tanks were damaged during the course of removal, but there were no readily visible holes and all appeared to have maintained their structural integrity while in the ground. The tanks were transported to MarVac's facility where they were destroyed, cleaned out and scrapped.

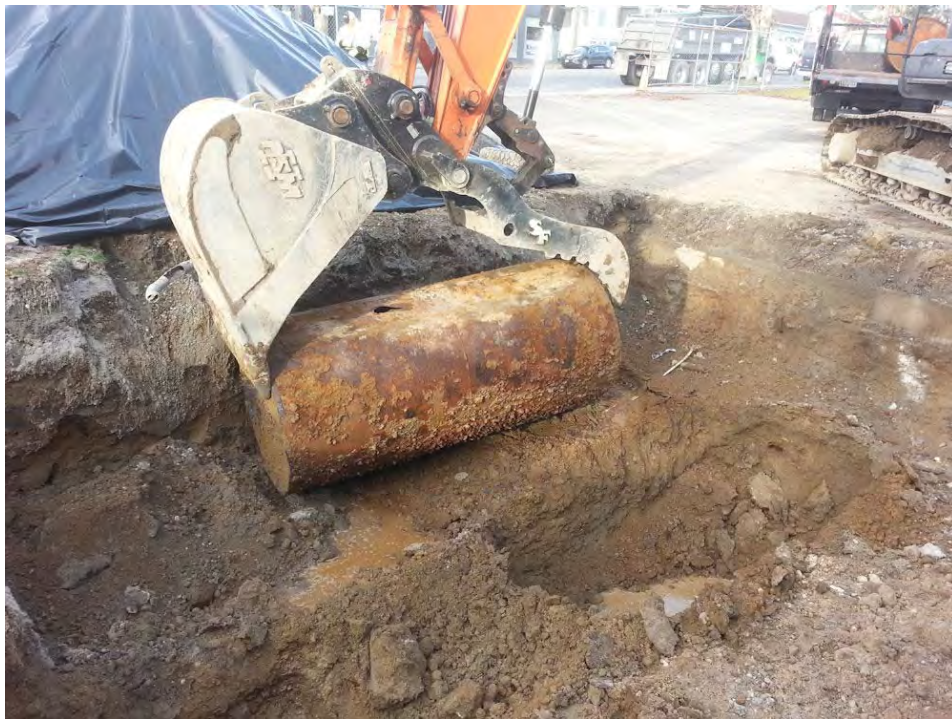
12.) View of Tank 1 after removal. The top of the tank had historically been partially cut open, but otherwise the tank was in good condition, with moderate corrosion. (December 14th, 2016)

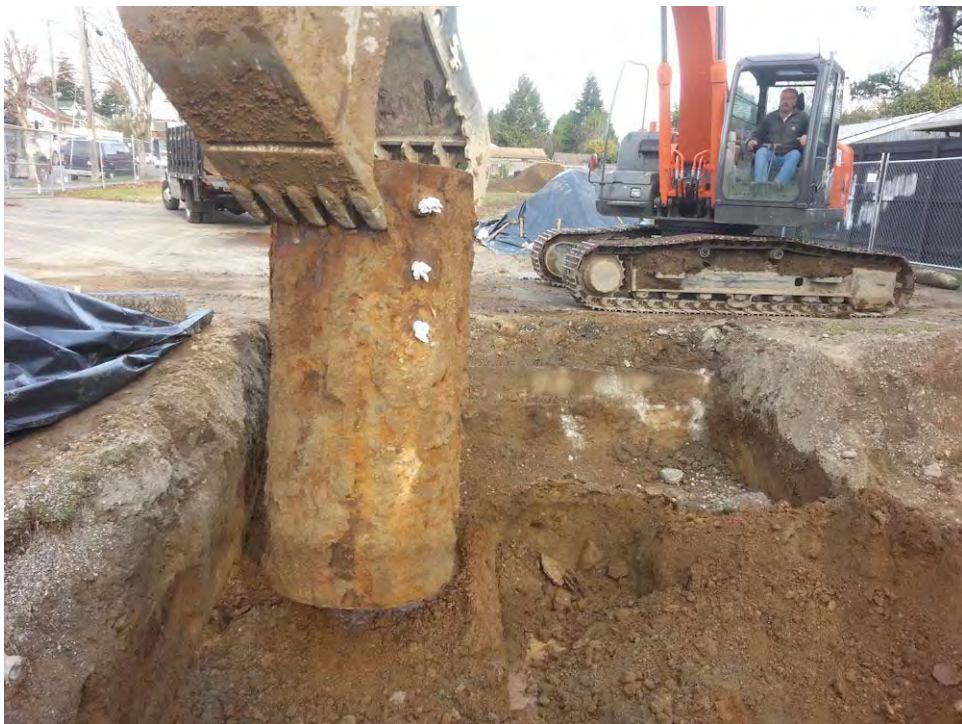
14.) View of Tank 3 after removal. The tank was in fair to good condition with moderate corrosion. (December 14th, 2016)

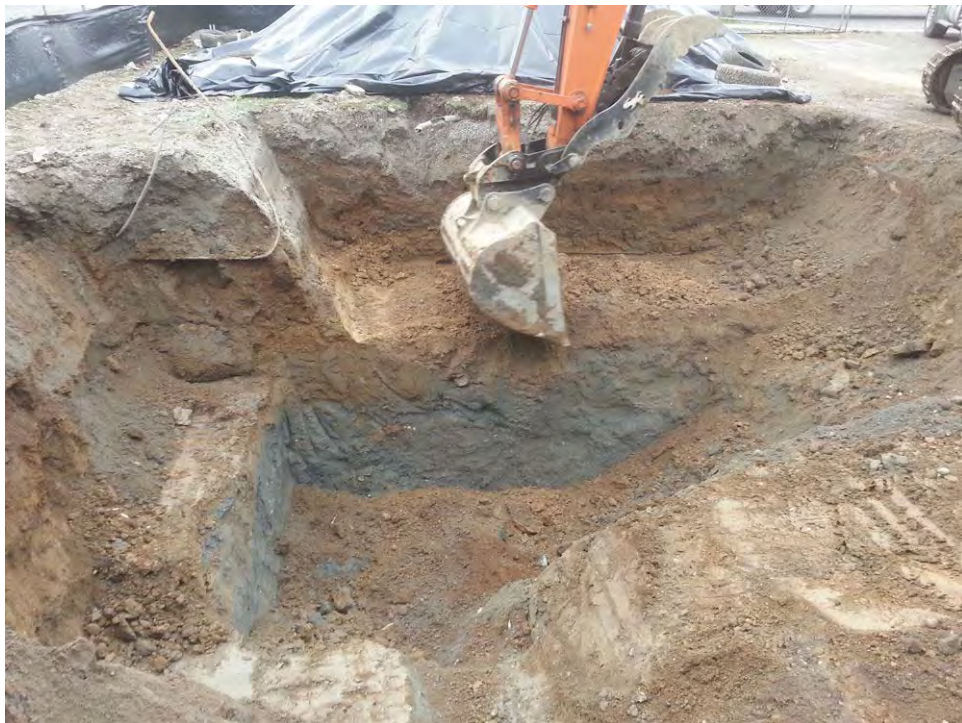
16.) View of excavation of petroleum contaminated soil. (December 15th, 2016)

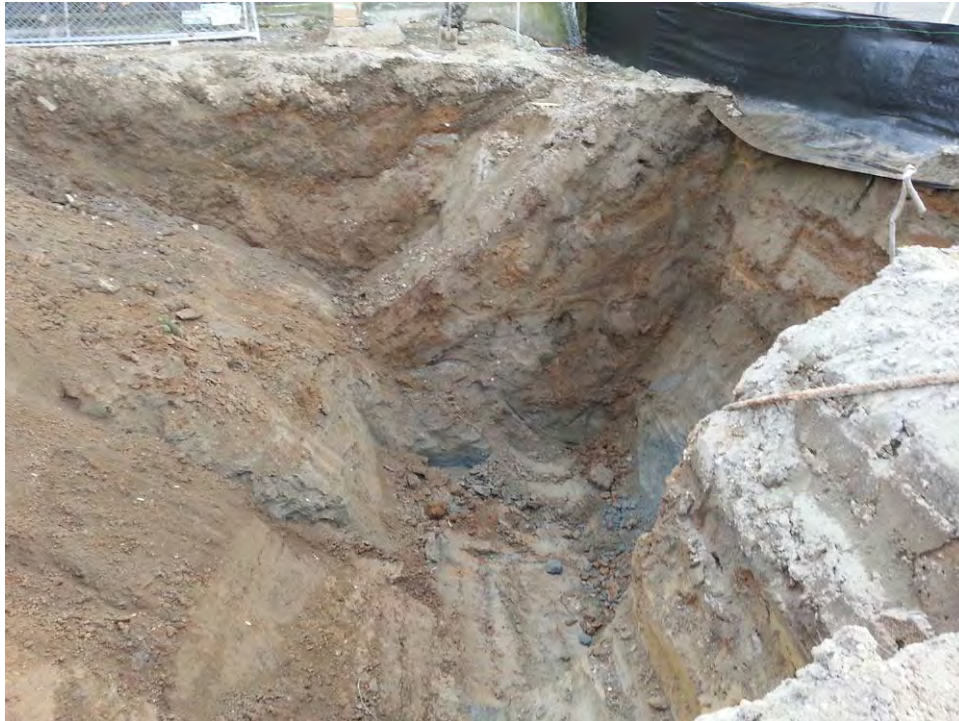
- 17.) View of excavation facing east after removal of discolored soil in the center and western part of the pit.

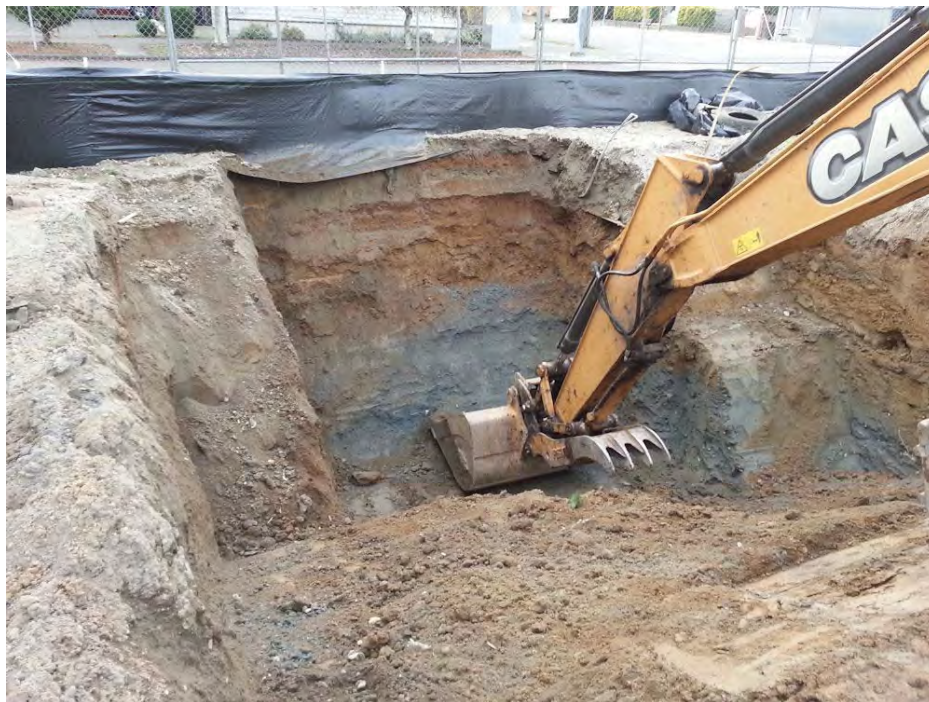
- 18.) View of excavation of the southern part of the pit, beneath Tank 2. (December 15th, 2016)

After removing the tanks, the surrounding loose soil was excavated to allow confirmation sampling. Discolored soil evidencing a strong petroleum odor was encountered directly beneath the southernmost tank (designated Tank 2, for the purposes of this assessment). The area was excavated over the course of the next two days, until field observations and laboratory testing of soil samples indicated all petroleum contaminated soil (PCS) had been removed. The extent of petroleum contamination was readily apparent based on the discoloration of the soil and obvious petroleum odors.

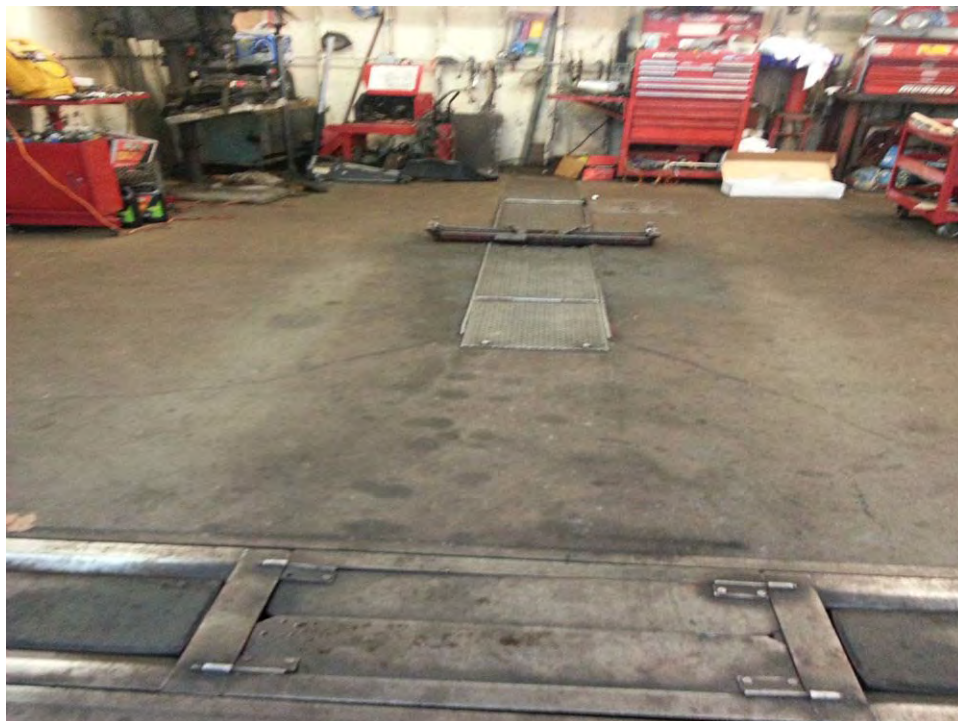
2.) View of one of two hydraulic lift systems in the muffler shop. Each lift had two hydraulic cylinders. (2014 photo)

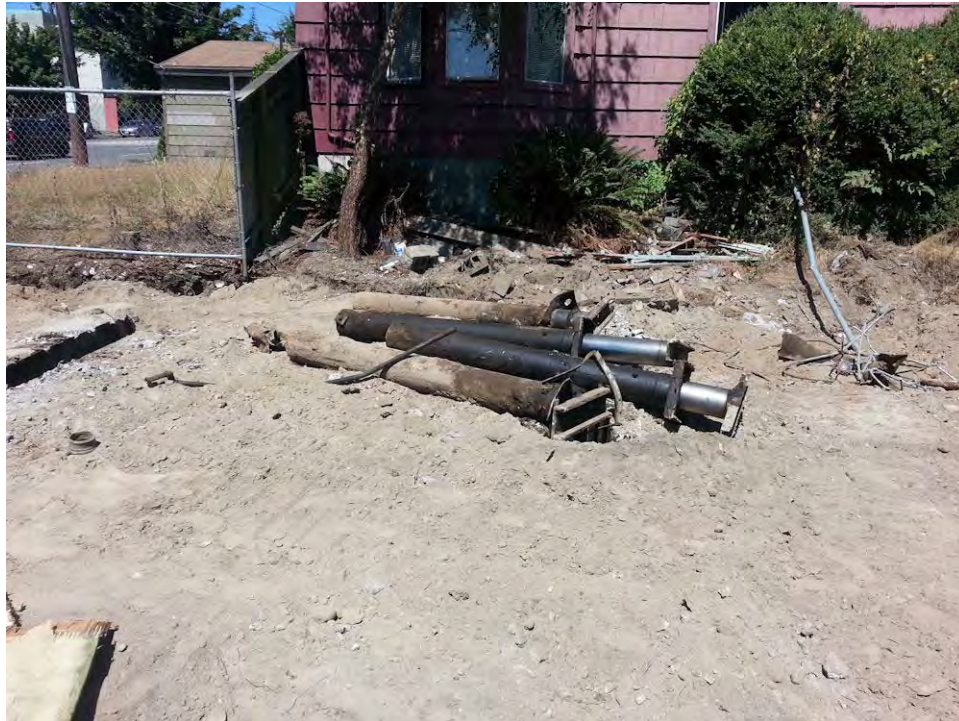
- 5.) View of the hydraulic lift cylinders and narrow concrete trenches after removing the floor slab and equipment. (August 5th, 2016)

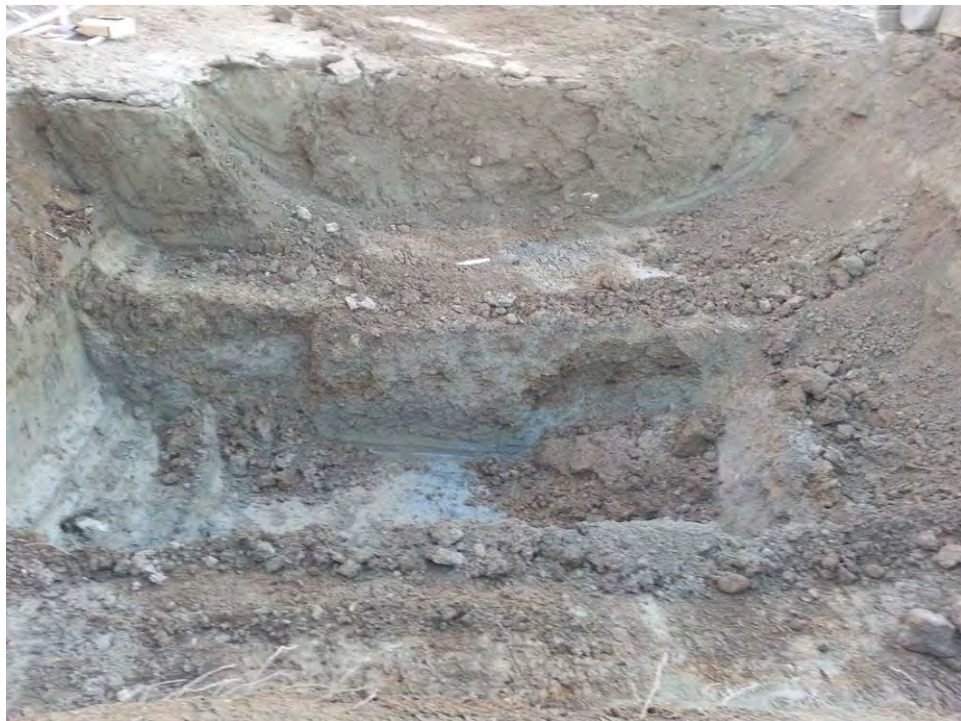
- 6.) View of the excavation of the western lift area, as dicolored soil was exposed. (January 3, 2017)

The excavation extended to a depth of about six feet, until discolored soil was observed in two areas that had been directly beneath the former concrete trenches that housed the lifts. The excavation was extended to a depth of about nine feet until these discolored areas were completely removed. A small amount of PCS was also removed extending to the north of the easternmost lift, then six final confirmation samples were obtained from the excavation sidewalls and base. Figure 5 shows the extent of the excavated area and the locations of final confirmation samples.

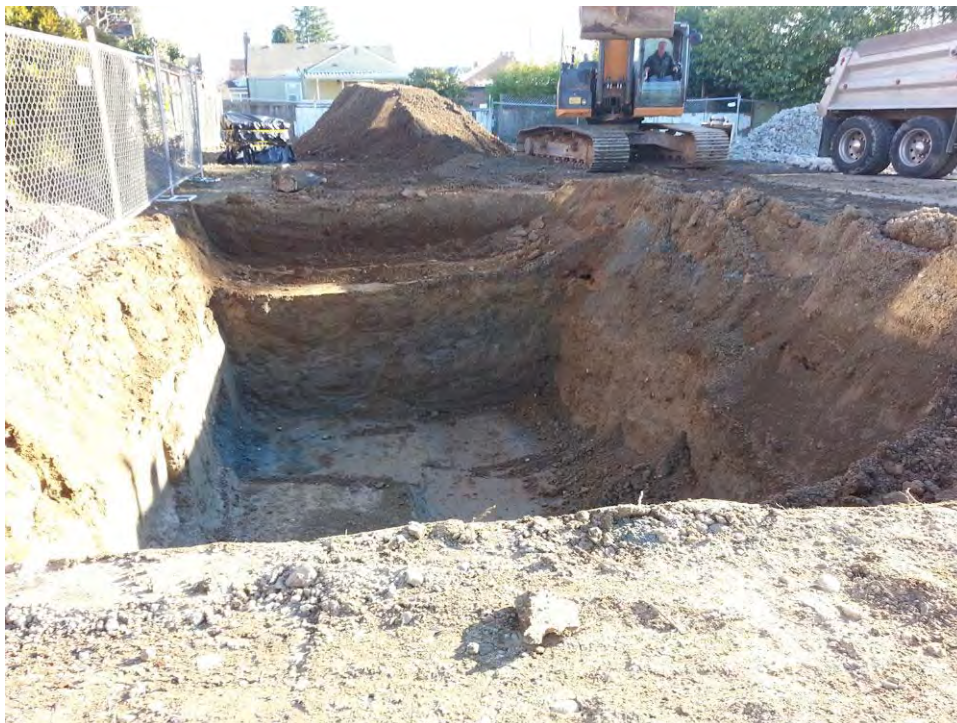
8.) View of the excavation of both lifts, nearing completion. A small zone of discolored soil remained at the north end of the eastern lift, on left. (January 3, 2017)

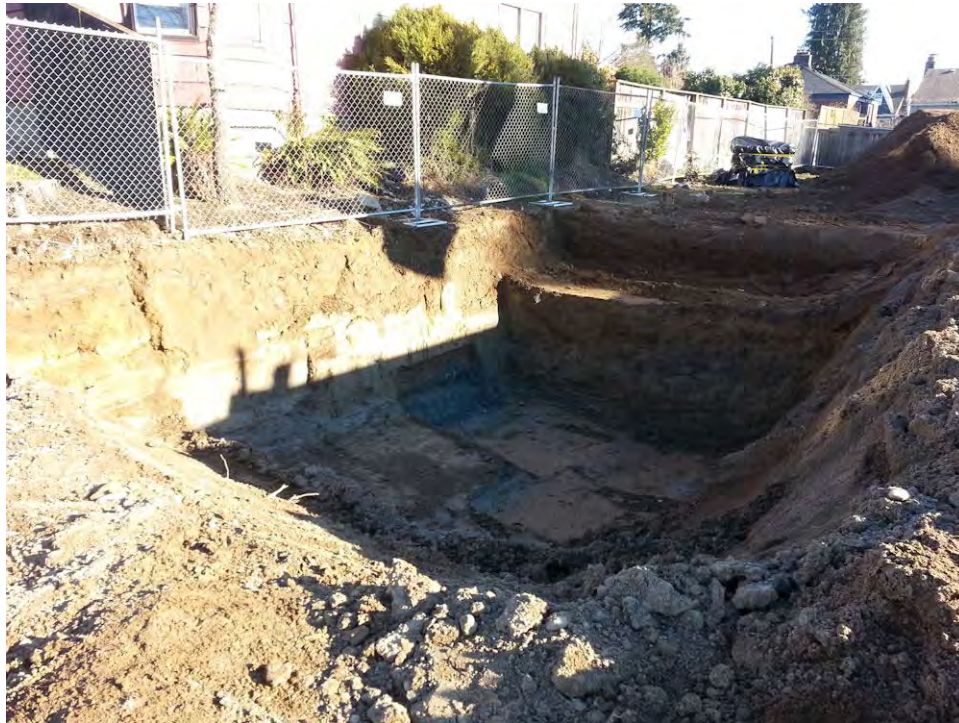
- 9.) View of the excavation while removing discolored area in the northeastern corner.
(January 3, 2017)

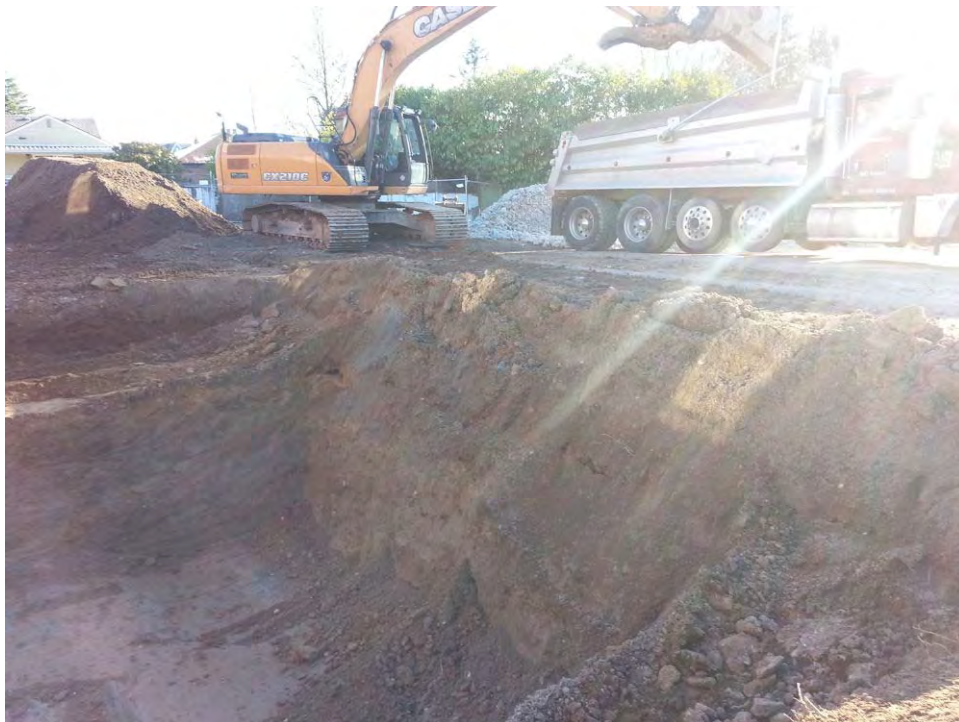
- 10.) View of the south end of the excavation and trackhoe loading petroleum contaminated soil to trucks for disposal. (January 3, 2017)

On January 3rd, 2017, WES and Ryatt returned to the north end of the site and excavated the location of the former hydraulic lifts. The soil that had been used to backfill the area was found to be saturated and unstable due to the heavy rains that had occurred in Fall and Winter. Some of the material was stockpiled for re-use, but much of it became mixed with PCS as the excavation proceeded, and was transported off-site for treatment and disposal. As a result, the volume of soil removed from this area was greater than required for environmental cleanup. Five truckloads of soil, totaling 80.77 tons were transported to Cemex for treatment and disposal.
