Subject: Environmental Site Investigation
7500 & 7510 15th Avenue NW
Seattle, Washington

Figure 1 - Site Map

Figure 2 - Site and Sampling Plan

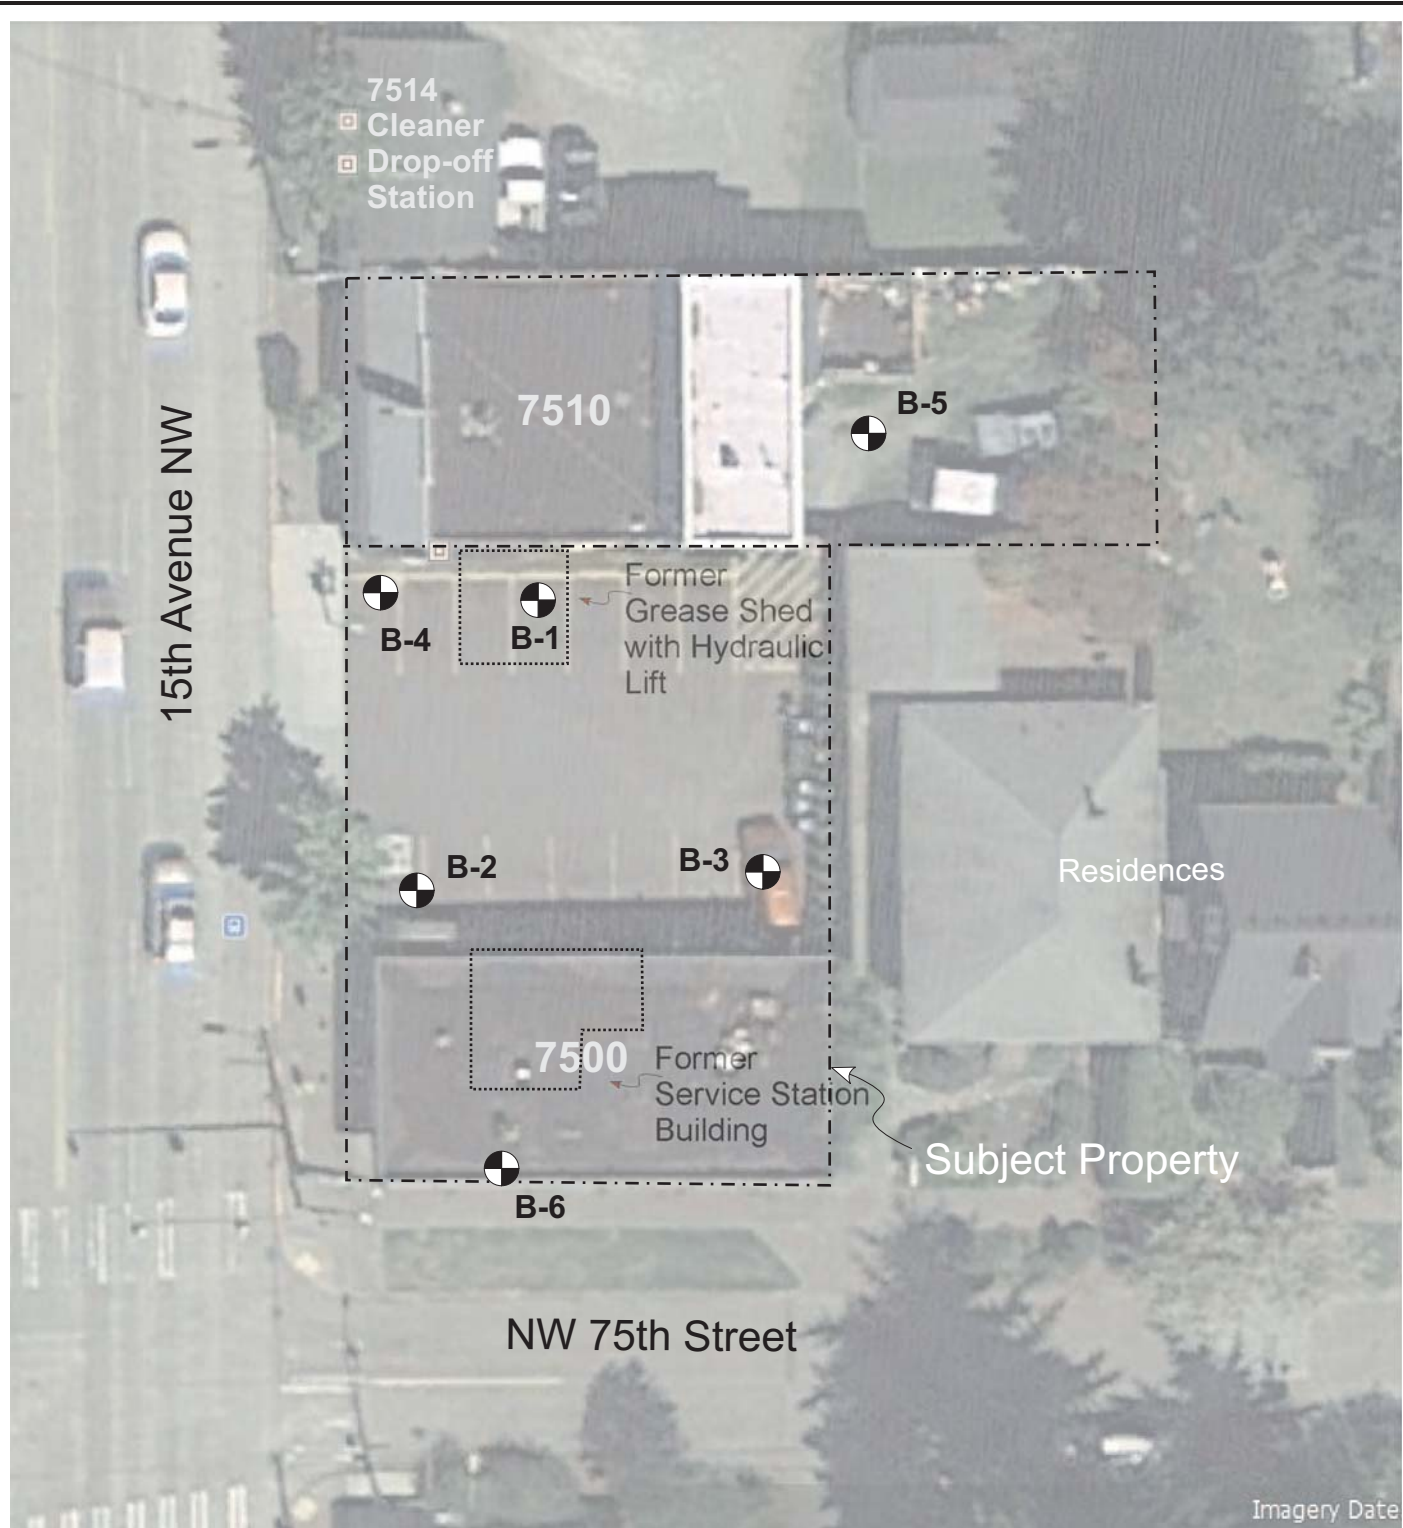
On September 8th, 2014, WES and ESN drilled six borings to obtain soil samples at accessible locations on the property that were at or near potential sources of recognized environmental conditions. The approximate locations of the borings are shown in Figure 2. Borings B-1, B-2, B-3

and B-4 were drilled in the parking lot on the north side of the 7500 15th building. Boring B-5 was located behind the 7510 15th building. Boring B-6 was drilled on the south side of the 7500 15th building, near the property line.

Boring B-1 was located near the former location of the grease shed. B-2 was located as far south as possible in the parking area, near the former location of the western pump island of the old service station. Boring B-3 was located in the southeastern part of the parking lot, in an area that may have originally held the station's underground storage tanks.

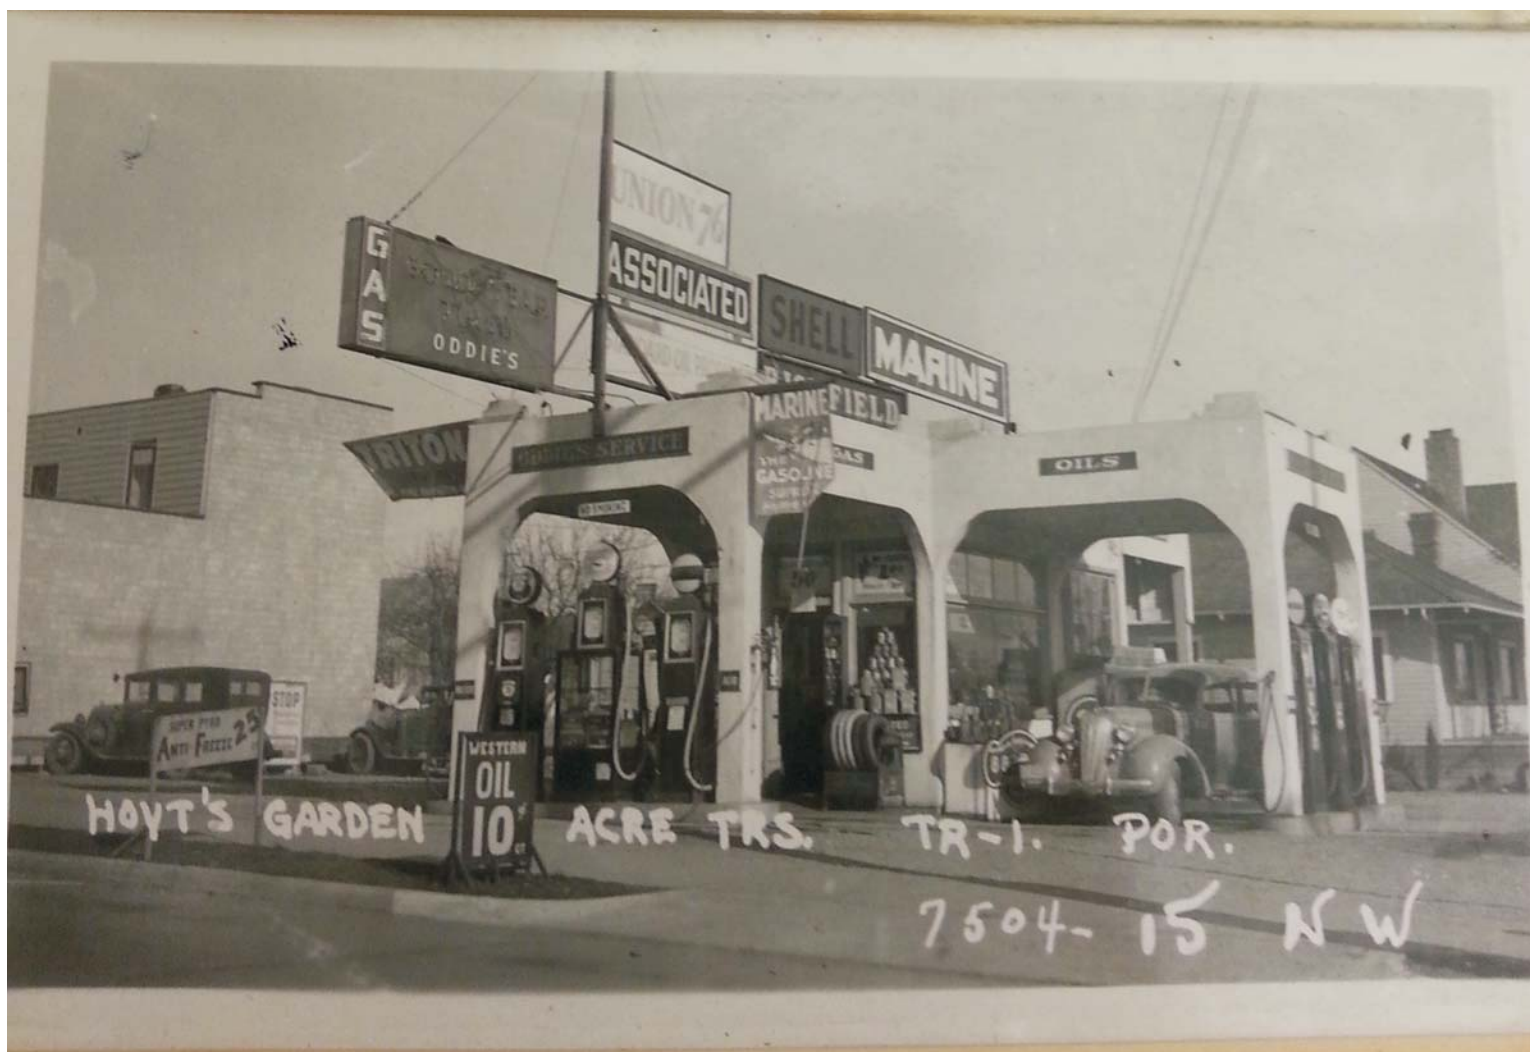
Historical Photograph - 1937

The service station was a relatively small structure with attached arches extending out from the building to two pump islands, located on the south and west sides of the building. Photographs of the building in historical Assessor's records show the fuel pumps on the islands, but the location of any underground storage tanks or vent lines can not be discerned. Historical references showing property details are included in Appendix A.

Former Service Station
7504 15th Avenue NW
Seattle, Washington
