INITIAL INVESTIGATION FIELD REPORT

<u>Site Name (Name over door):</u> Petrocard Woodinville	<u>Site Address (including City, State and Zip):</u> 24019 aka 24205 Snohomish-Woodinville Rd Woodinville, WA 98072	<u>Phone</u> <u>Email</u>
<u>Site Contact, Title, Business:</u> Yen-Vy Van, LHG Maul Foster & Alongi Inc	<u>Site Contact Address (including City, State and Zip):</u> 2815 2nd Ave, Suite 540 Seattle, WA 98121	<u>Phone</u> (206) 858-7620 <u>Email</u> yvan@maulfoster.com
<u>Site Owner, Title, Business:</u> Bristol Bay Petroleum Properties	<u>Site Owner Address (including City, State and Zip):</u> 111 W 16th Ave, Suite 400 Anchorage, AK 99501	<u>Phone</u> <u>Email</u>
<u>Site Owner Contact, Title, Business:</u>	<u>Site Owner Contact Address (including City, State and Zip):</u>	<u>Phone</u> <u>Email</u>
<u>Previous Site Owner(s):</u>	<u>Additional Info (for any Site Information Item):</u>	
<u>Alternate Site Name(s):</u>

Card Lock gas station - Caller reports his contractor uncovered petroleum contaminated soil (PCS) in an area around 40 feet while doing line upgrades. Caller advises he currently has his environmental consultant on site excavating the area and was told to report it

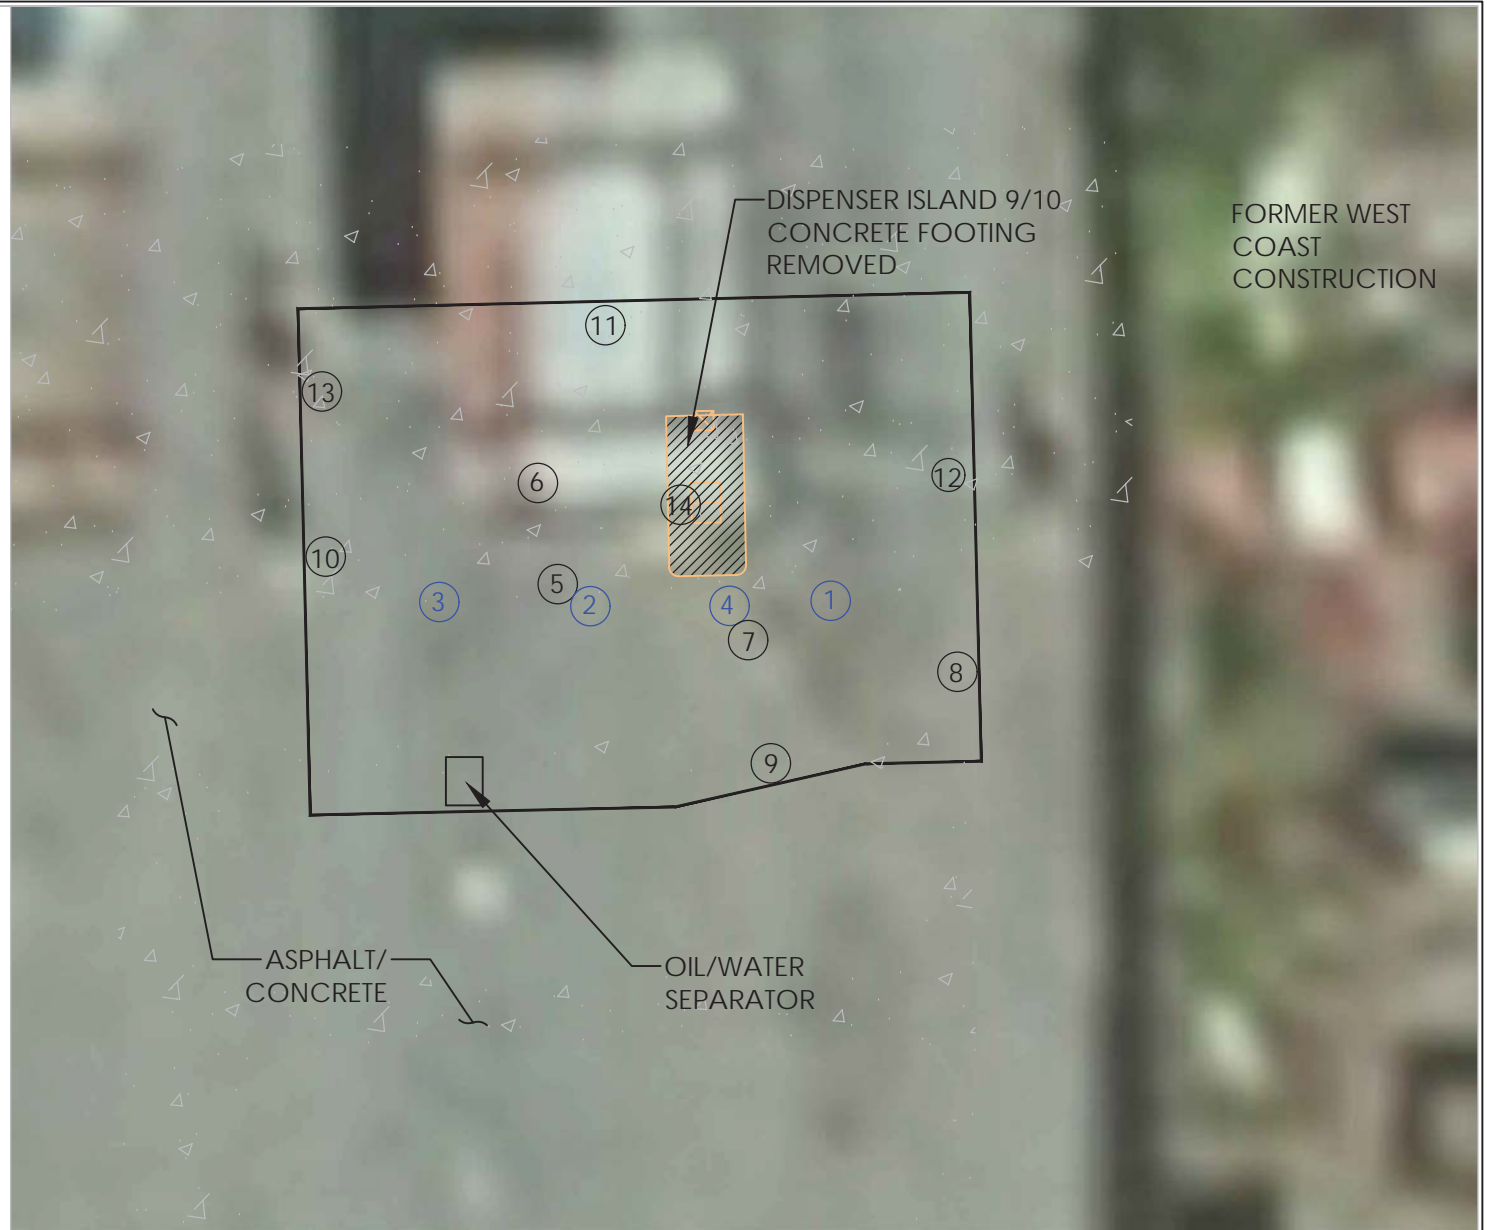
Figure 3
PCS Excavation Extent and
Soil Sample Locations

1. PCS = PETROLEUM CONTAMINATED SOIL
2. PCS EXCAVATION EXTENT AT DISPENSER ISLAND 9/10

SAMPLE	SAMPLE ID
1	WS1-B-9.0
2	WS2-SW-4.0
3	WS3-B-7.0
4	WS4-SW-3.0
5	WS5-B-9.5
6	WS6-SW-N-9.5
7	WS7-B-8.0
8	WS8-SW-E-5.0
9	WS9-SW-S-9.0
10	WS10-SW-W-7.0
11	WS11-SW-N-13.5
12	WS12-SW-E-12.5
13	WS13-SW-W-13.5
14	WS14-B-C-14.0

Contaminated area was over-excavated. Confirmation samples were below MTCA Method A cleanup levels. Approx 253 tons of PCS and 6 tons of material removed from the stormwater catch basins were transported off-site for disposal to CEMEX. Depth to groundwater ranges from 18 to 20 feet below ground surface (bgs), and groundwater was not encountered during excavation. Recommendation: No further action due to independent cleanup. This cleanup meets the criteria for Model Remedy No. 1.
