AS-BUILT REPORT FOR BUNKER C SOIL REMOVAL

Pulp and Tissue Mill Remedial Action Unit, Georgia-Pacific West Site, Bellingham, Washington

Prepared for: Port of Bellingham

Project No. 140298-001-13 • April 11, 2016

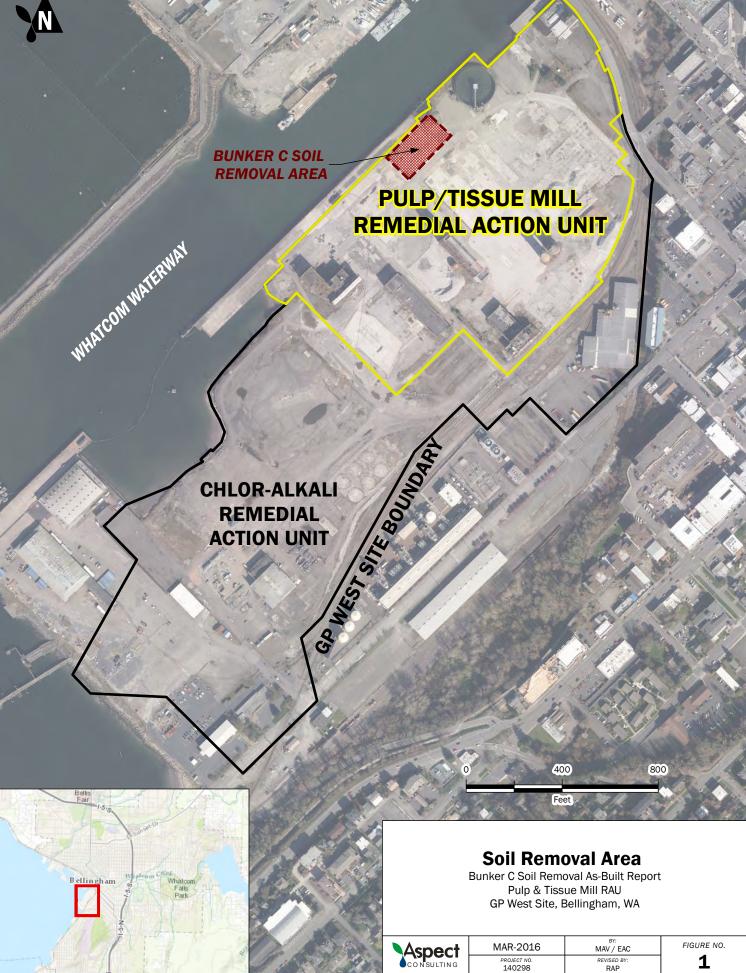
This report documents the soil removal action conducted within the Bunker C subarea of the Pulp and Tissue Mill Remedial Action (RAU) of the Georgia-Pacific West Site (Site) in Bellingham, Washington (Figure 1). This component of the Pulp and Tissue Mill RAU cleanup action permanently removed petroleum-contaminated soil that served as a potential source of contaminant migration to groundwater. The soil removal was conducted by the Port of Bellingham (Port) in accordance with the Cleanup Action Plan (CAP) (Washington State Department of Ecology [Ecology], 2014), which is Exhibit B to the 2014 Consent Decree No. 14-2-02700-8 between the Port and Ecology.

Based on information presented in the *Engineering Design Report for the Bunker C Soil Removal* (EDR; Aspect, 2015a), the excavation targeted TPH-contaminated soil under and around the footprint of the former Georgia-Pacific Mill Steam Plant, adjacent to the Whatcom Waterway (area denoted as Bunker C Soil Removal Area on Figure 1).

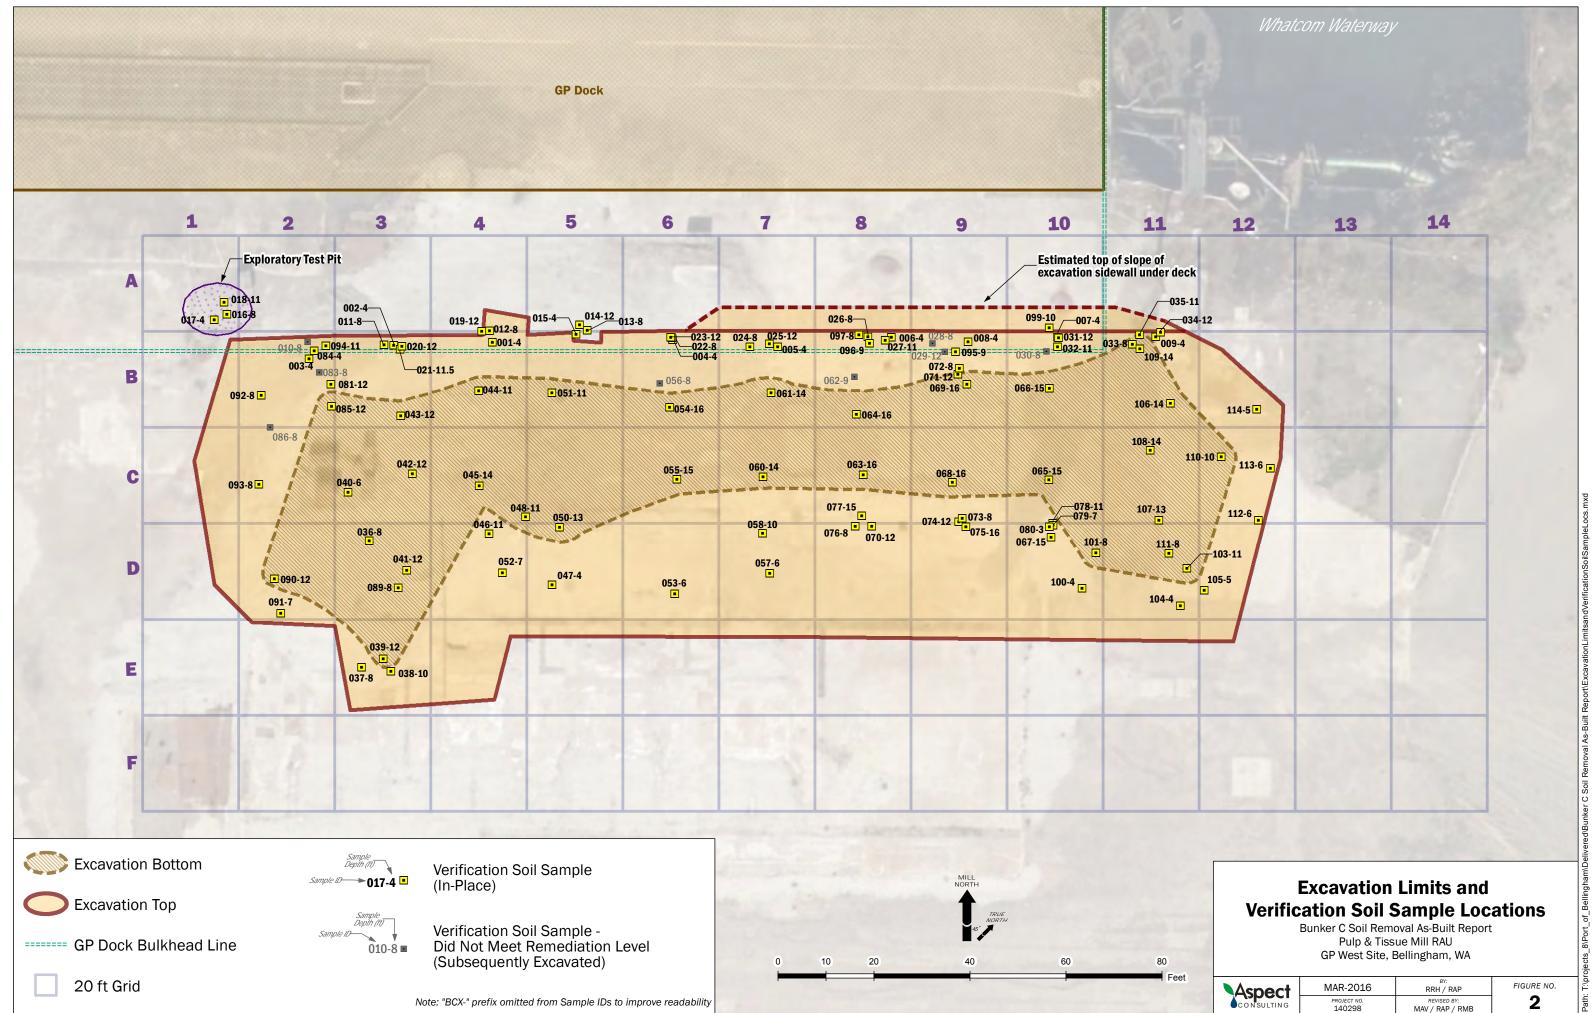
MAR-2016	BY: RRH / RAP	FIGURE NO.
CONSULTING	project no. 140298	REVISED BY: MAV / RAP / RMB	2

¹ Approximate extent of excavation under the deck is noted with a dashed line on Figure 2.

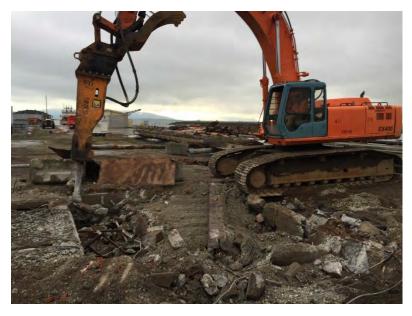
Photograph 1. Removal of surface slab and foundation elements.

The excavation area was in the footprint of the former Steam Plant and, because of that, the at-grade surface consisted of floor slabs, machinery stands and pedestals, and building foundation elements constructed of steel-reinforced concrete. The Contractor had to remove this concrete material, about 985 tons, from the excavation area to access the contaminated soil. Based on prior investigation results (Aspect, 2015a), uncontaminated (overburden) soil was estimated to occur to a depth of about 7 feet below the surface, and contaminated soil was estimated to occur at depths from about 7 to about 15 feet below the surface.

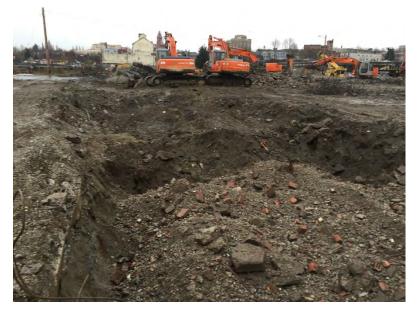
Photograph 2. Excavation of overburden.

The presumed-uncontaminated overburden soil encountered below the concrete structures was excavated and separately stockpiled. The overburden stockpile area was paved and bermed, just as the contaminated stockpile area was, in the event that it needed to be managed as contaminated soil based on sampling results. The Contractor covered the overburden stockpiles with a geomembrane when they were not in use. Aspect sampled the overburden stockpiles as described in Section 3.6.

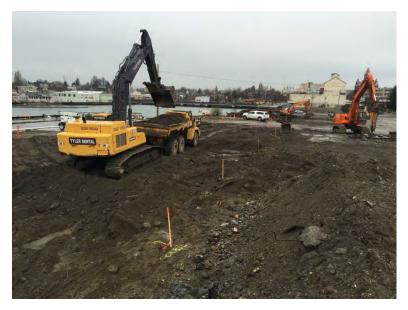
Photograph 3. Loading out of overburden to stockpile area.

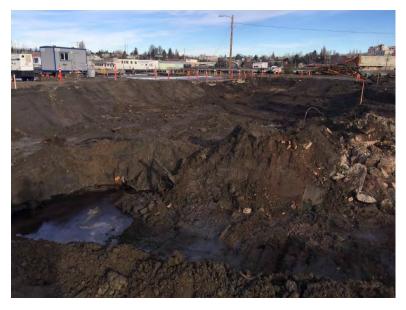
Photograph 4. Overburden removed, contaminated material encountered.

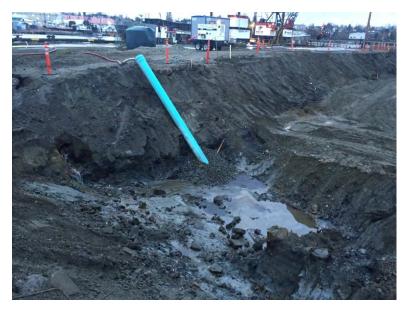
Photograph 5. Dewatering sump in operation.

During excavation, the Contractor pumped water from sumps within the excavation in order to achieve unsaturated conditions, in accordance with the Specifications. Dewatering water was pumped from the excavation sumps to the Contractor's water treatment system.

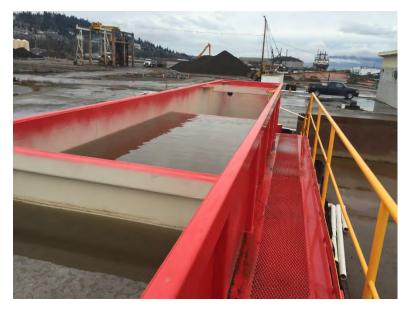
Photograph 6. Weir tank as part of water treatment system.

In total, approximately 154,000 gallons of water were pumped from the excavation, through the Contractor's water treatment system, and to the Port's Aerated Stabilization Basin (ASB) pump station during the project. In accordance with the Specifications, the water treatment system included a 10,000-gallon settlement tank with weirs, a 20,000-gallon settlement tank with weirs, and an oil-water separator rated at 300 gallons per minute. Water was pumped through the settlement tanks in series and then through the oil-water separator.

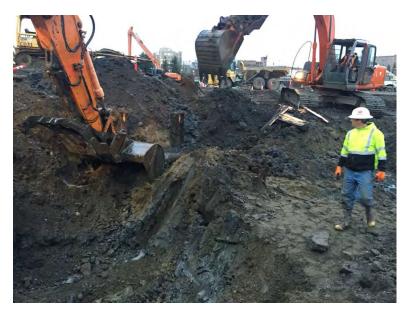
Photograph 7. Excavating contaminated material.

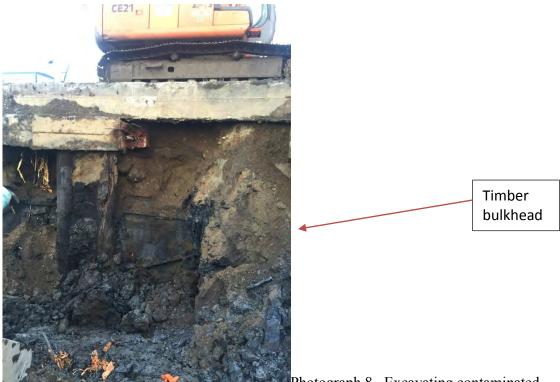
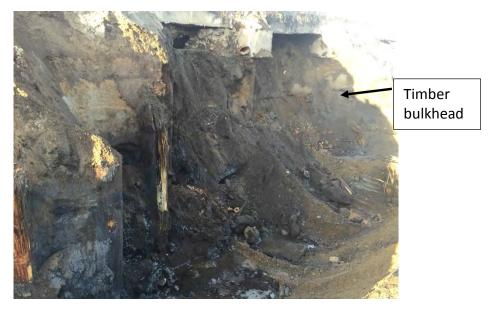
Photograph 8. Excavating contaminated material at bulkhead in NE corner of excavation.

Photograph 9. Excavating contaminated material at bulkhead in NE corner of excavation.

The bulkhead was encountered along much of the north edge of the excavation. The observed bulkhead included both a timber wall on the east side, and rip rap on the west side, of the excavation. The Contractor and Aspect devised construction methods that allowed removal of contaminated materials while protecting the function of the bulkhead. For example, excavation adjacent to the bulkhead was conducted at low tide to reduce the chance of influx of water from the Whatcom Waterway. On the east side of the excavation, contaminated soil was also successfully removed from between the top of the timber bulkhead and the bottom of the concrete deck¹. The proposed approach for excavation adjacent to the bulkhead was discussed in an on-Site meeting that Ecology participated in.

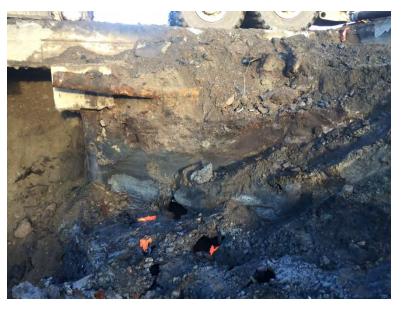
Photograph 10. Excavating contaminated material at bulkhead in NE corner of excavation. Orange flags mark locations of pipes that pierced bulkhead. No evidence of petroleum in pipes. Pipes were cut and capped.

During excavation, about 20 separate pipe sections were uncovered. Of these, two were found to contain oily residue; the rest appeared to have conveyed steam or water. The oily residue in the two pipe sections did not flow from the pipes. No indications of potential asbestos-containing material were observed. The pipe sections containing oily residue presumably had conveyed oil from the former Bunker C oil storage tank to the boilers in the Steam Plant. However, when the pipe sections were uncovered, they did not run all the way to the eastern sidewall of the excavation (nearest the storage tank), but were already broken or cut. The pipe sections with oily residue were removed from the excavation and recycled with other metal debris, as described below.

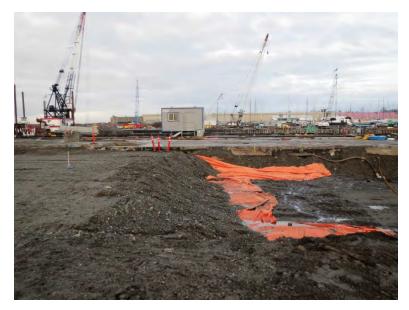
Photograph 11. High-visibility separation geotextile in process of being placed under 2-foot cap of clean import material.

- A layer of high-visibility separation geotextile on top of the overburden soil to distinguish it from the overlying imported capping material, in accordance with the CAP and the Specifications;
- Import gravel borrow from 4.5 to 0.5 feet below grade; and
- 6 inches of import permeable ballast at the surface.

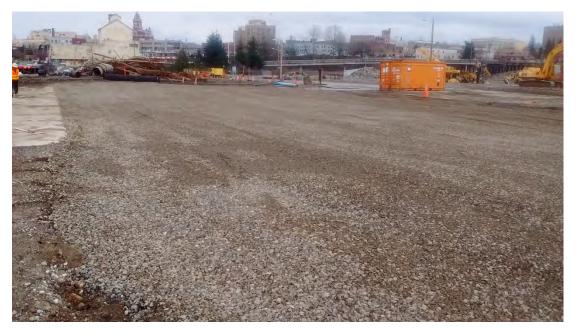
Photograph 12. Finished excavation with top dressing of imported permeable ballast.

The excavation was backfilled to the preconstruction grade with approximately 1,180 cubic yards of usable overburden soil, 6,341 tons of import gravel borrow, and 496 tons of import permeable ballast surfacing. From the bottom of the excavation up to surface grade, the excavation backfill sequence included placement of the following materials:
