**DRAFT APPENDIX C:
SPANAWAY LAKE WATERSHED-SCALE PLAN
WATERSHED CHARACTERIZATION**

AUGUST 2017

SPANAWAY LAKE WATERSHED-SCALE PLAN WATERSHED CHARACTERIZATION

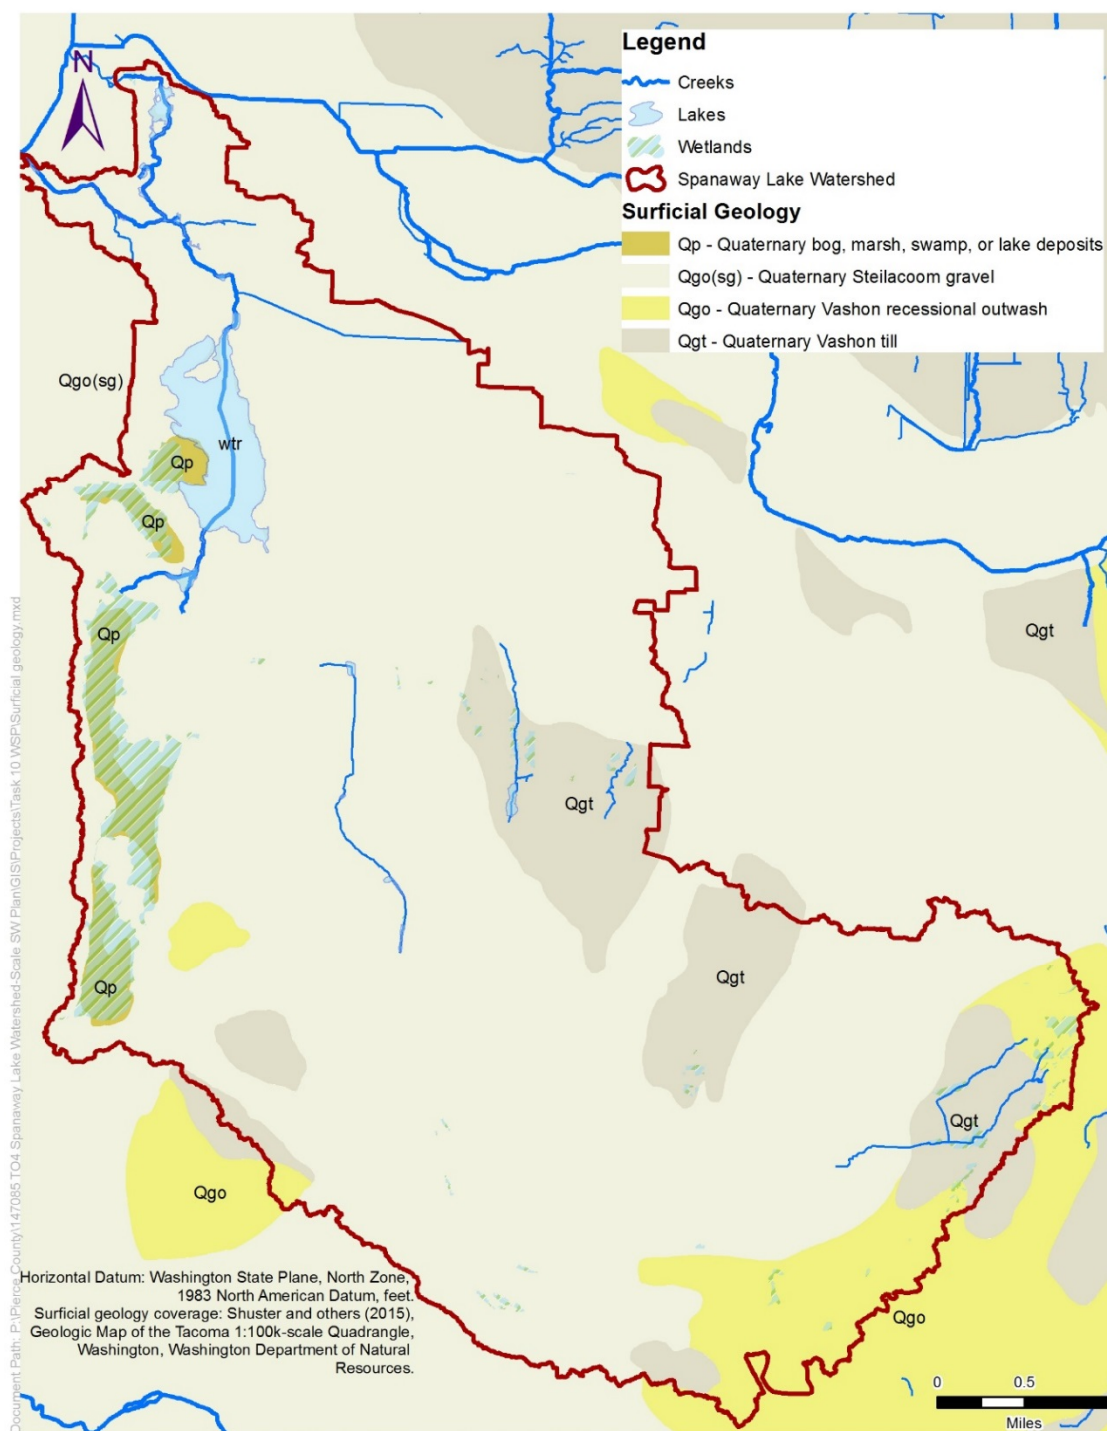
Figure 2-1. Surficial geology of Spanaway Lake WSP area

The Spanaway WSP area is underlain by northwest-thickening, unconsolidated, highly permeable glacial (till and outwash) deposits which overlie sedimentary and volcanic bedrock deposits (USGS 2011). Most unconsolidated deposits in the Spanaway Lake WSP area are referred to as the Steilacoom gravel, Qgo(sq) (Figure 2-1). The Steilacoom gravel is a porous gravel/cobble deposit 30-50 feet thick which offers little resistance to infiltration or rainwater and contaminants (Troost 2014). The gravel/cobble unconsolidated deposits in Pierce County and the Spanaway Lake WSP area are the result of repeated jökulhlaups, which is an Icelandic-term used to describe any large and abrupt release of water from a subglacial or proglacial lake/reservoir (Troost 2014). Attachment A includes geologic cross sections throughout Spanaway Lake as well as the boring logs and well construction details.

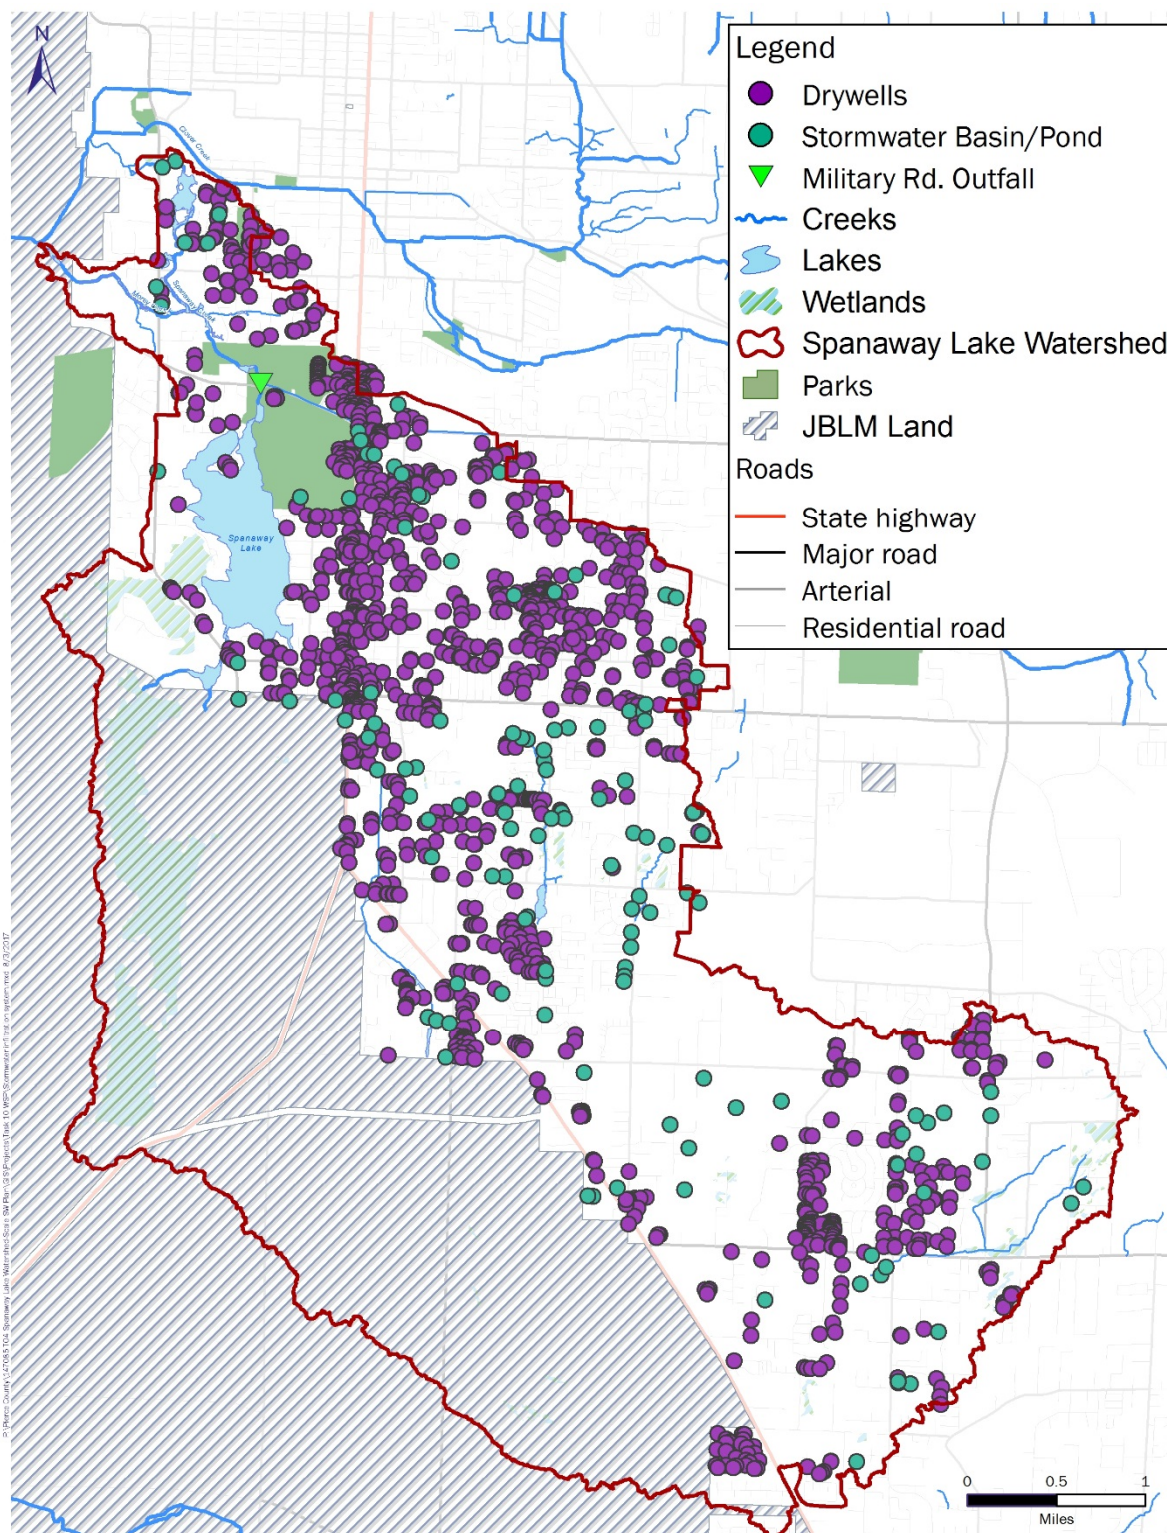
Figure 2-4. Stormwater infiltration systems and drywells in Spanaway Lake watershed

Nearly all stormwater runoff from impervious cover in the WSP area is infiltrated or dispersed onto adjacent pervious areas. The WSP area encompasses more than 1,400 infiltration facilities including drywells, infiltration basins, and infiltration trenches (Figure 2-4). Because of the highly permeable soils and ubiquitous infiltration facilities, the WSP area has only one significant MS4 conveyance system that discharges directly into a surface water body. This system receives stormwater runoff from approximately 176 acres and discharges into Spanaway Creek on the north side of Military Road. Numerous infiltration facilities have been installed in the catchment area for this outfall to reduce wet weather flows. The County recently installed a media filter just upstream of the outfall to treat the remaining flow prior to discharge.

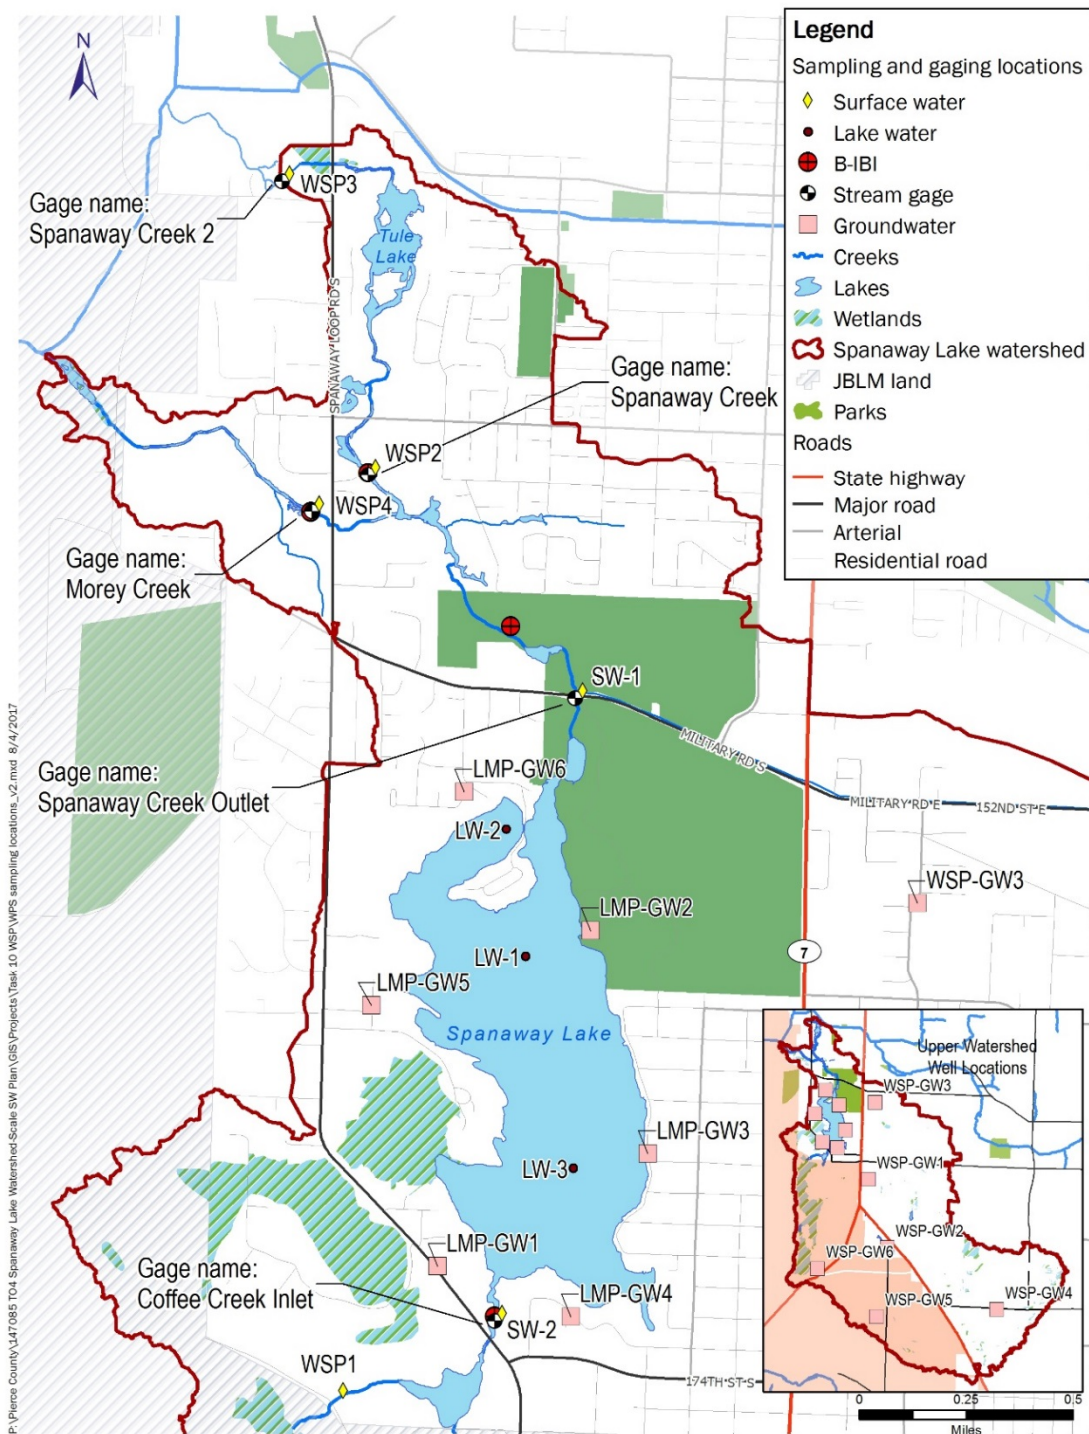
Figure 3-1. Spanaway Lake WSP sampling locations

The County collected streamflow data between summer 2014 and spring 2016 at four sites within the WSP Planning Area (SW-1, SW-2, WSP2, and WSP4), as shown in Figure 3-1 above. U.S. Geological Survey (USGS) flow data were also collected at the SW-1 site between September 2014 and November 2015, as shown in Figure 4-1 below.

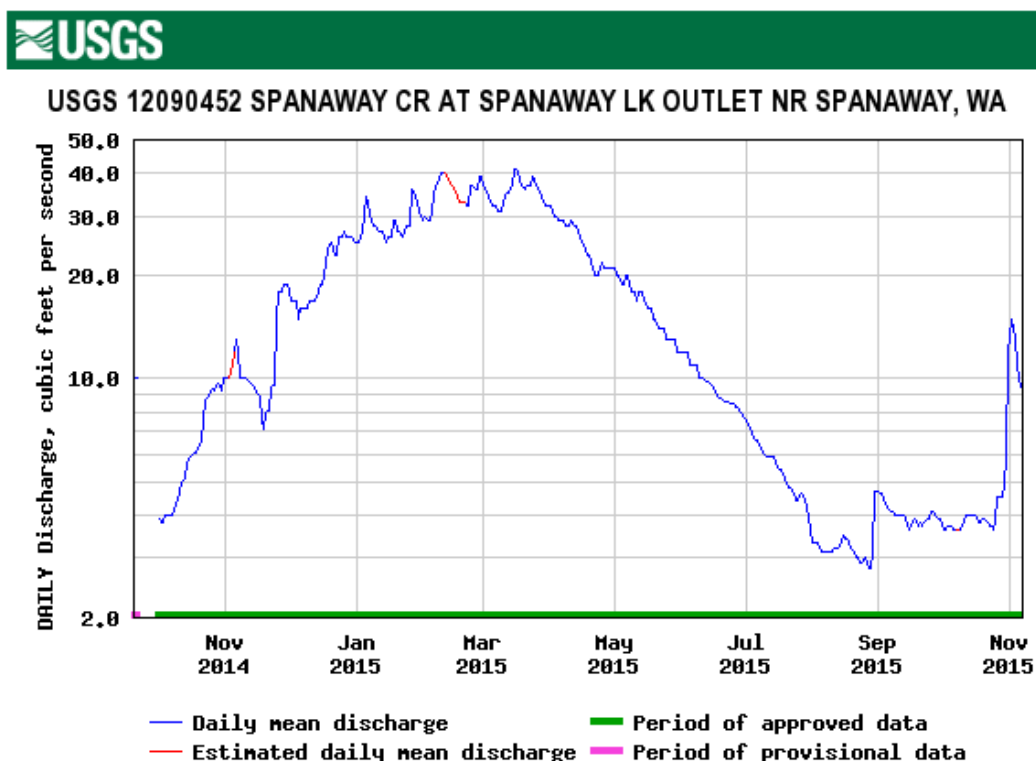
Figure 4-1. USGS flow data at SW-1 from September 2014–November 2015

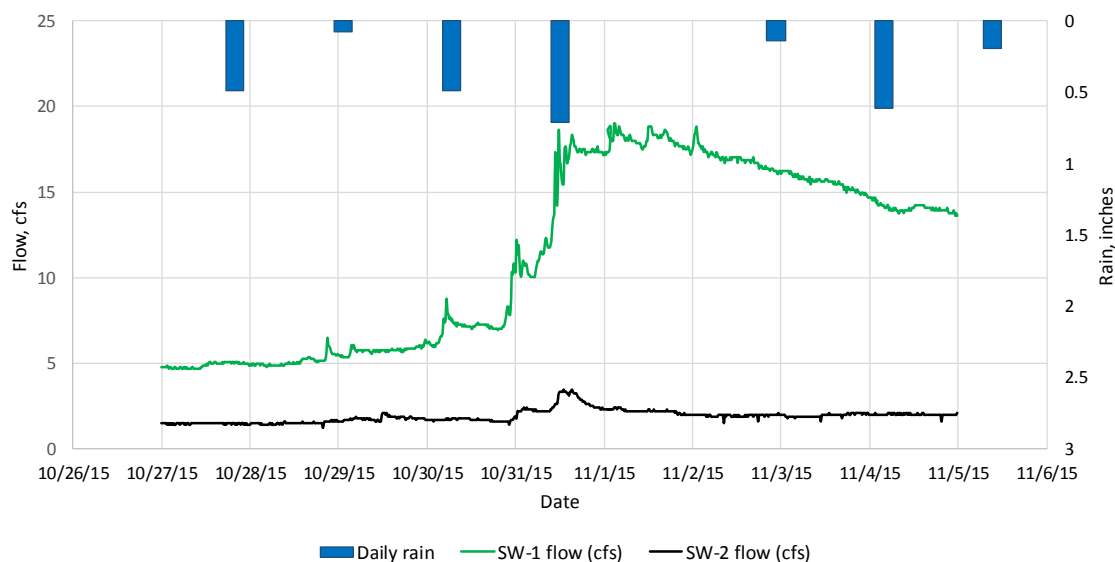
Figure 4-2. Flow patterns at SW-1 and SW-2 during October and November 2015 storms

Figures 4-2 and 4-3 show the flow patterns at locations SW-1 (Spanaway Creek below the lake) and SW-2 (Coffee Creek) during selected October, November, and December 2015 storms. As can be seen in these figures, flow at SW-2 at Coffee Creek coming into the lake is much more muted in response to rain events than flow leaving the lake at SW-1. This relatively small change in flow is expected for a stream system that is predominantly groundwater-fed and a tributary basin with significant storage in wetland and marsh areas. At SW-1, there was a substantial increase in winter baseflows, which would be expected based on the large amount of connection to the groundwater seen in Spanaway Lake.

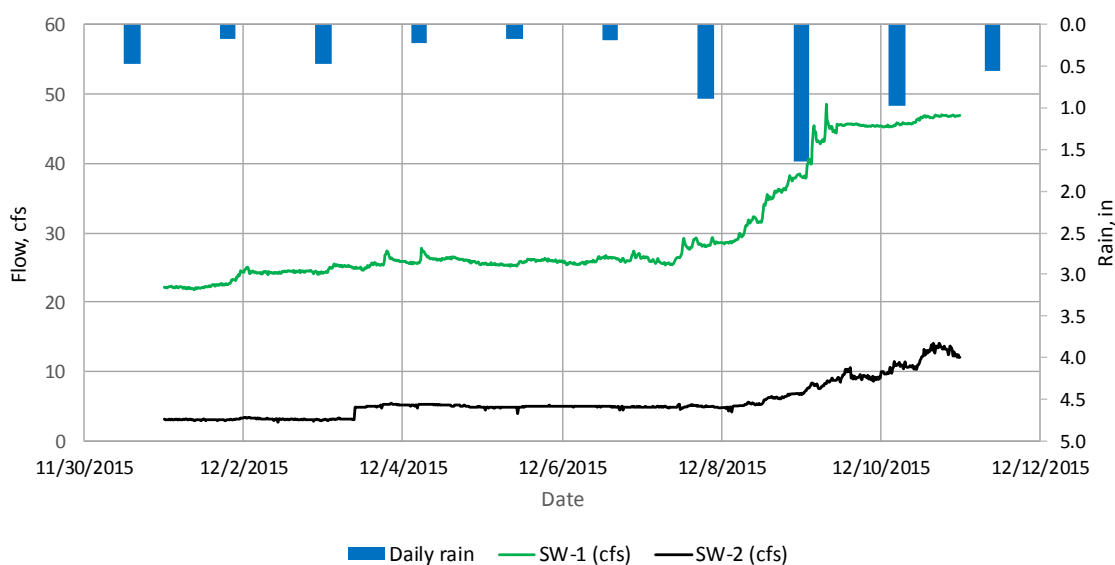
Figure 4-3. Flow patterns at SW-1 and SW-2 during December 2015 storms

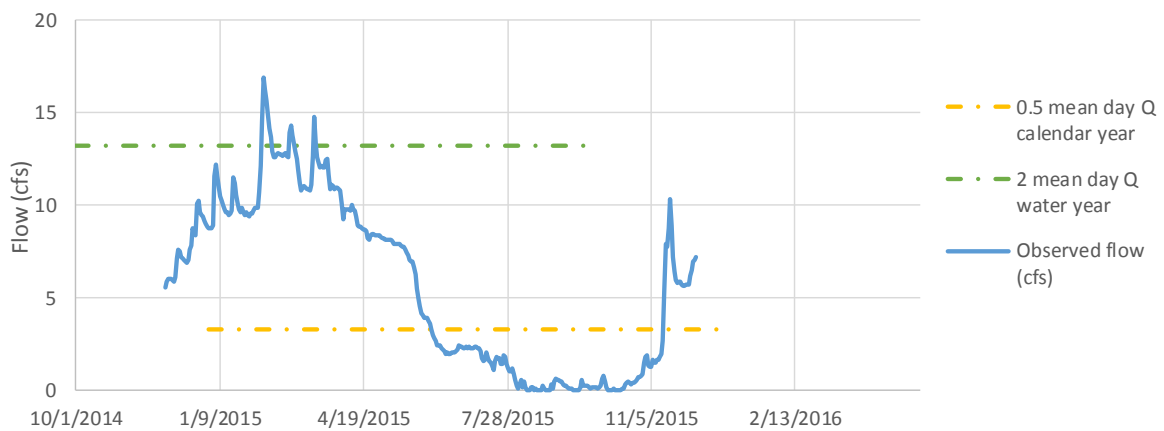
Figure 4-7. Flow pattern at WSP3

Unfortunately, the flow data collected from WSP3, the site downstream of Tule Lake on Spanaway Creek, proved to be unusable for model calibration because of equipment issues and impounded water conditions in the area around the gage. Flow data from the other four flow gages were used to calibrate the hydrologic and hydraulic (H&H) model for the Spanaway Lake WSP.

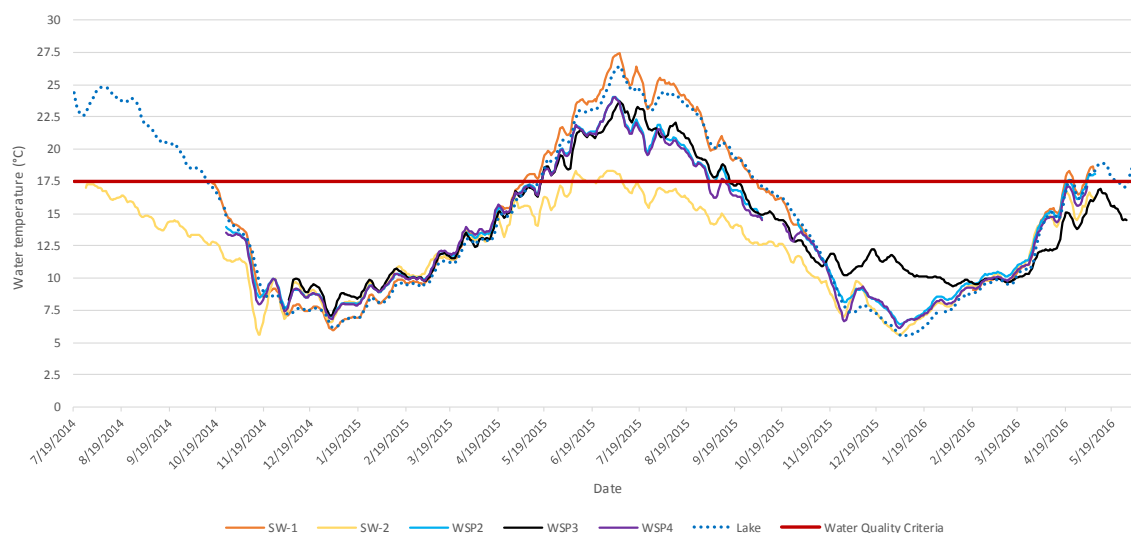
Figure 4-9. 7-day averages of daily maximum water temperatures in Spanaway Lake watershed

Instantaneous readings of temperature taken during the routine surface water sampling events ranged from 4.5°C to 31.3°C between the five creek sites (SW-1, SW-2, WSP2, WSP3 and WSP4). Table 4-2 provides a summary of the 7-DADMax water temperatures at each monitoring location during the monitoring period. Figure 4-9 shows the 7-DADMax temperature for each monitoring location, including the water quality criteria limit (red line).

As shown in Figure 4-9 above, the 7-DADMax at Coffee Creek (SW-2) was slightly above 17.5°C for about 29 days during the WSP monitoring period. Groundwater is the main source of flow in Coffee Creek during the summer months. It is possible that limited riparian shade contributed to the exceedances. Historical maps (Figure 2-3 above) indicate that prairie (rather than forest) covered the Coffee Creek area, so it is possible that riparian shade was limited under pre-developed conditions.

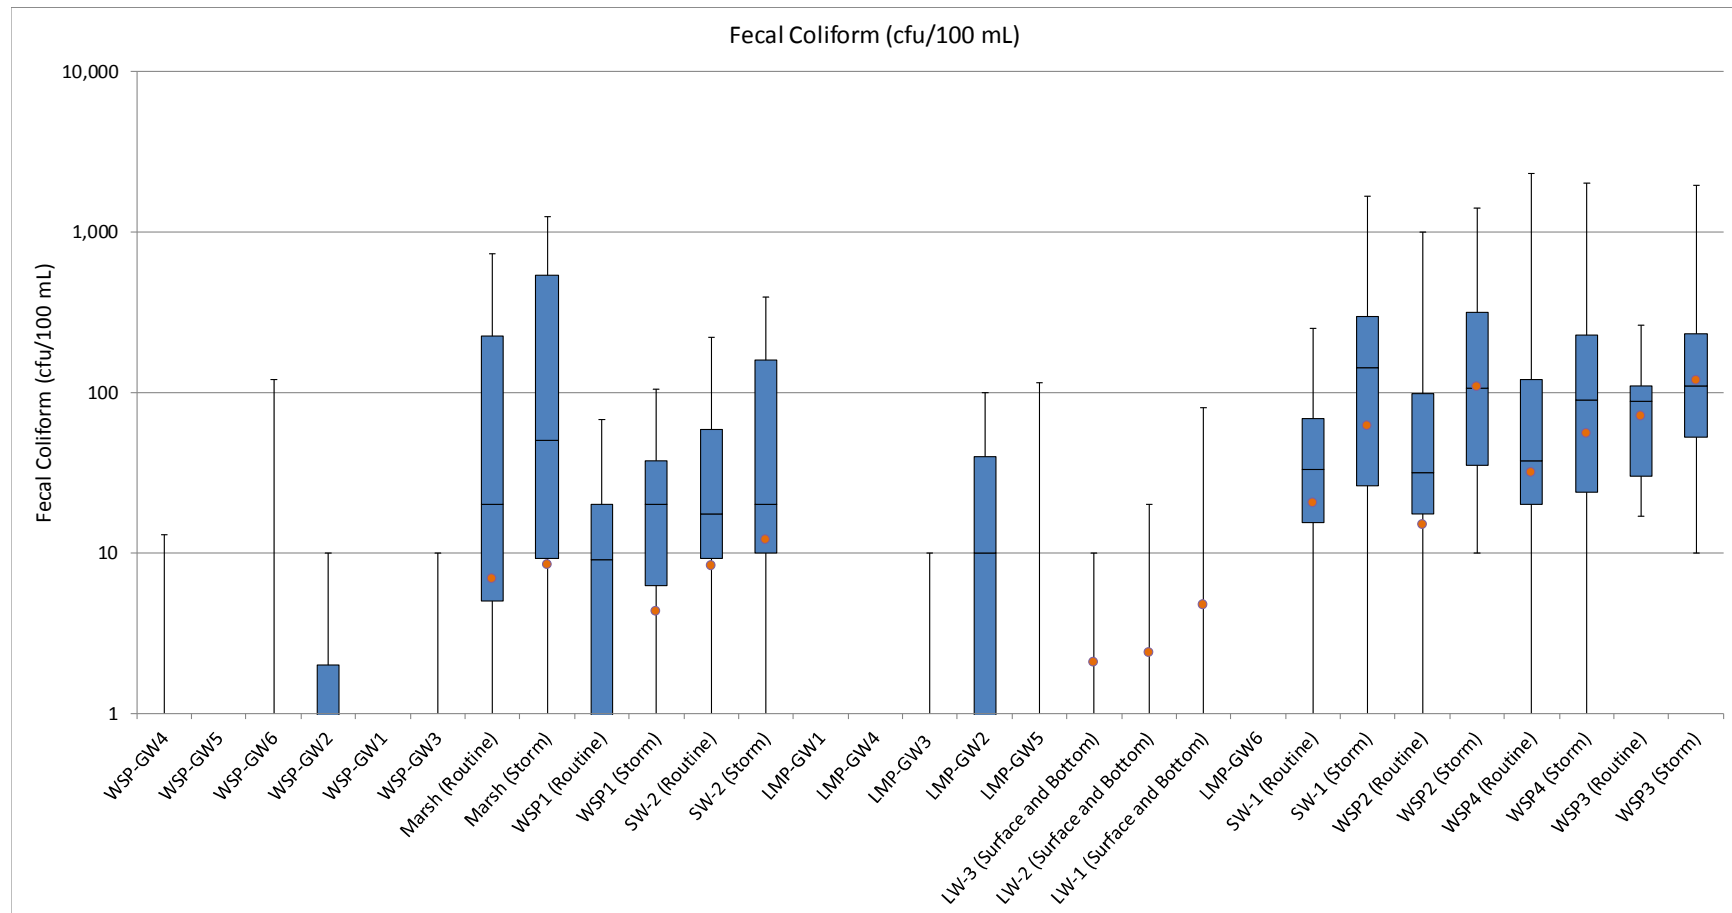
Figure 4-10. Fecal coliform concentrations in lake, creeks, and groundwater in Spanaway Lake watershed

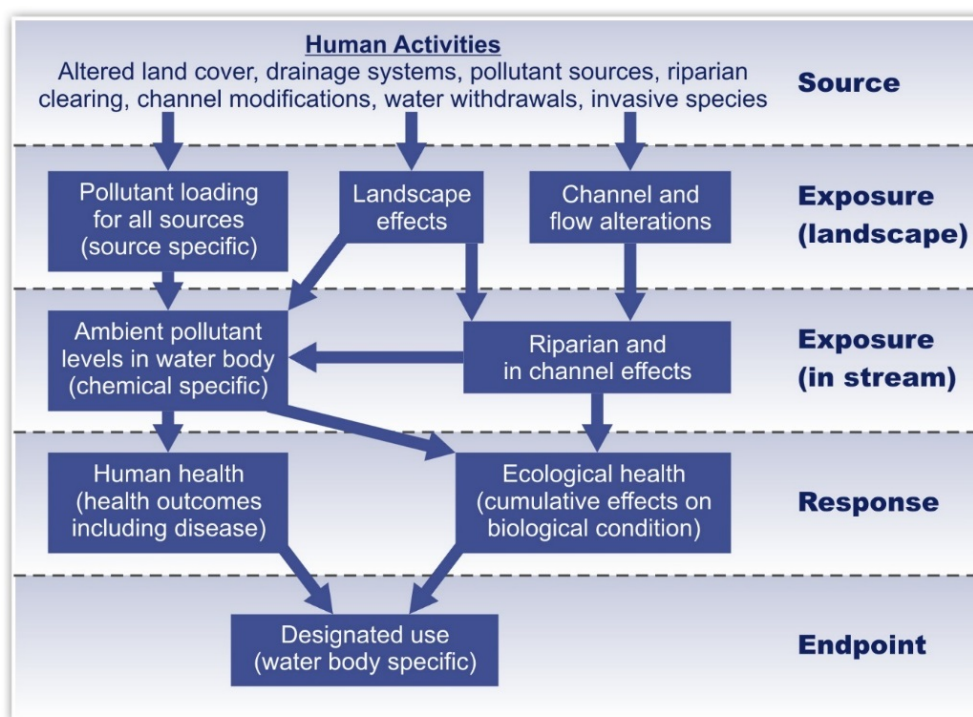
Figure 4-11. Causal sequence by which human activities affect receiving waters

The general “causal sequence” by which human activities can impair stream health is shown in Figure 4-11.

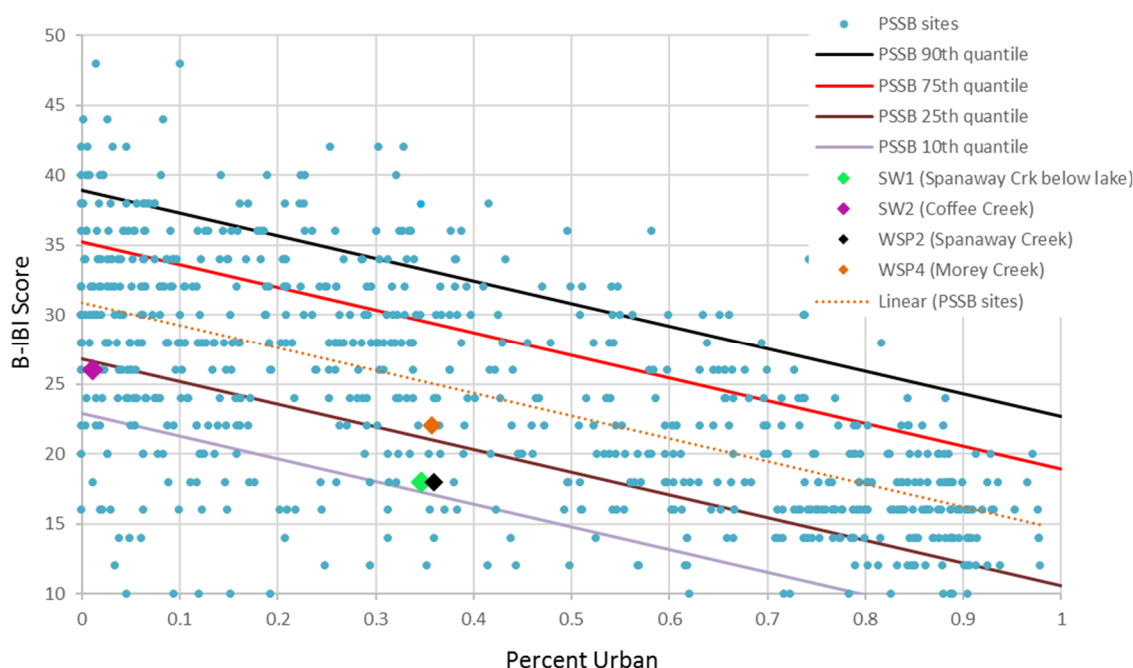
Figure 4-12. B-IBI score vs. percent urban in drainage area for Puget Sound Lowlands sites

Bioassessments, such as the B-IBI, identify the degree of impairment compared to pristine or least disturbed "reference" watersheds. They do not necessarily establish reasonable thresholds or criteria for watersheds that have been substantially altered by human activities. Urban development generally entails an array of landscape changes and in-stream stressors that can adversely affect watershed health (see Figure 4-12, below). It is rarely feasible to eliminate these stressors from existing urban areas, especially areas that developed prior to current land use codes and stormwater management regulations (Booth et al. 2007).

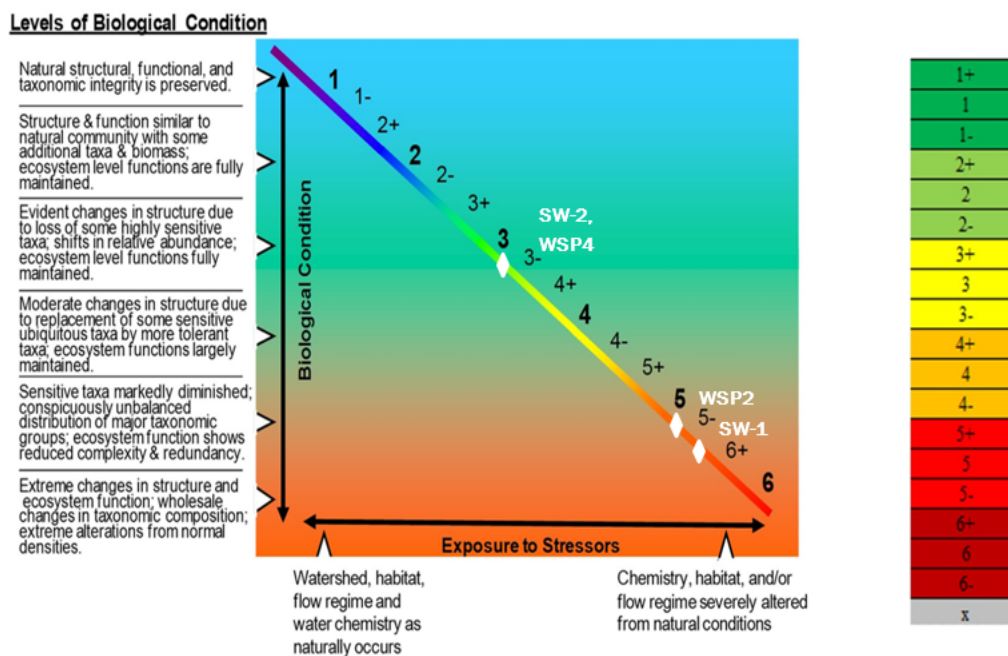
Figure 4-13. Biological Condition Gradient

The County sample sites were plotted on the BCG, an additional or alternative index to the B-IBI described in Section 4.1.5.1.2. As shown in Figure 4-13, the Spanaway Lake WSP sites range from biological condition 3 to 5-. Sites in this range show some disturbance to biotic integrity with fully intact ecological function (sites SW-2 and WSP4) to more serious disruption of the taxonomic balance at WSP2 and SW-1. A more complete evaluation of the site data and additional explanation of the BCG metrics is available in Attachment C.

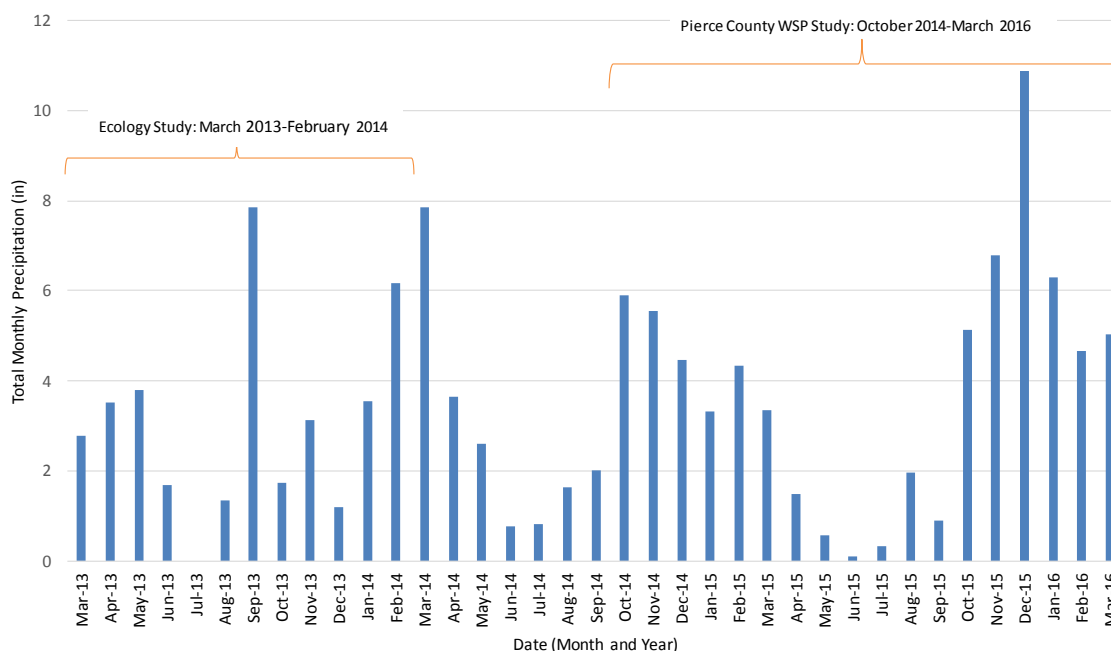
Figure 4-15. Total monthly precipitation during Ecology's and Pierce County's monitoring programs

The amount of precipitation received within the Spanaway Lake watershed during the two monitoring periods was very different, which could be a reason for differing results in some of the parameters, such as fecal coliform bacteria. The monitoring period for Ecology's Clover Creek monitoring program occurred from March 2013 to February 2014, a total of 14 months. During this monitoring period, a total of 48.3 inches of precipitation was recorded at the Spanaway Golf Course weather station. The Spanaway Lake WSP monitoring program occurred from October 2014 to March 2016, a total of 18 months, with a total of 71.1 inches of precipitation recorded at the Spanaway Golf Course weather station. As can be seen on Figure 4-15, the total monthly precipitation values are significantly different from both monitoring programs. The wet season months (October–April) during Ecology's study totaled 27.3 inches. The Spanaway Lake WSP had wet seasons in 2015 and 2016, with totals of 28.4 and 38.8 inches, respectively. The dry season months (May–September) during Ecology's study totaled 14.7 inches, whereas the Spanaway Lake WSP's dry season months totaled 3.9 inches—an exceptionally dry season.

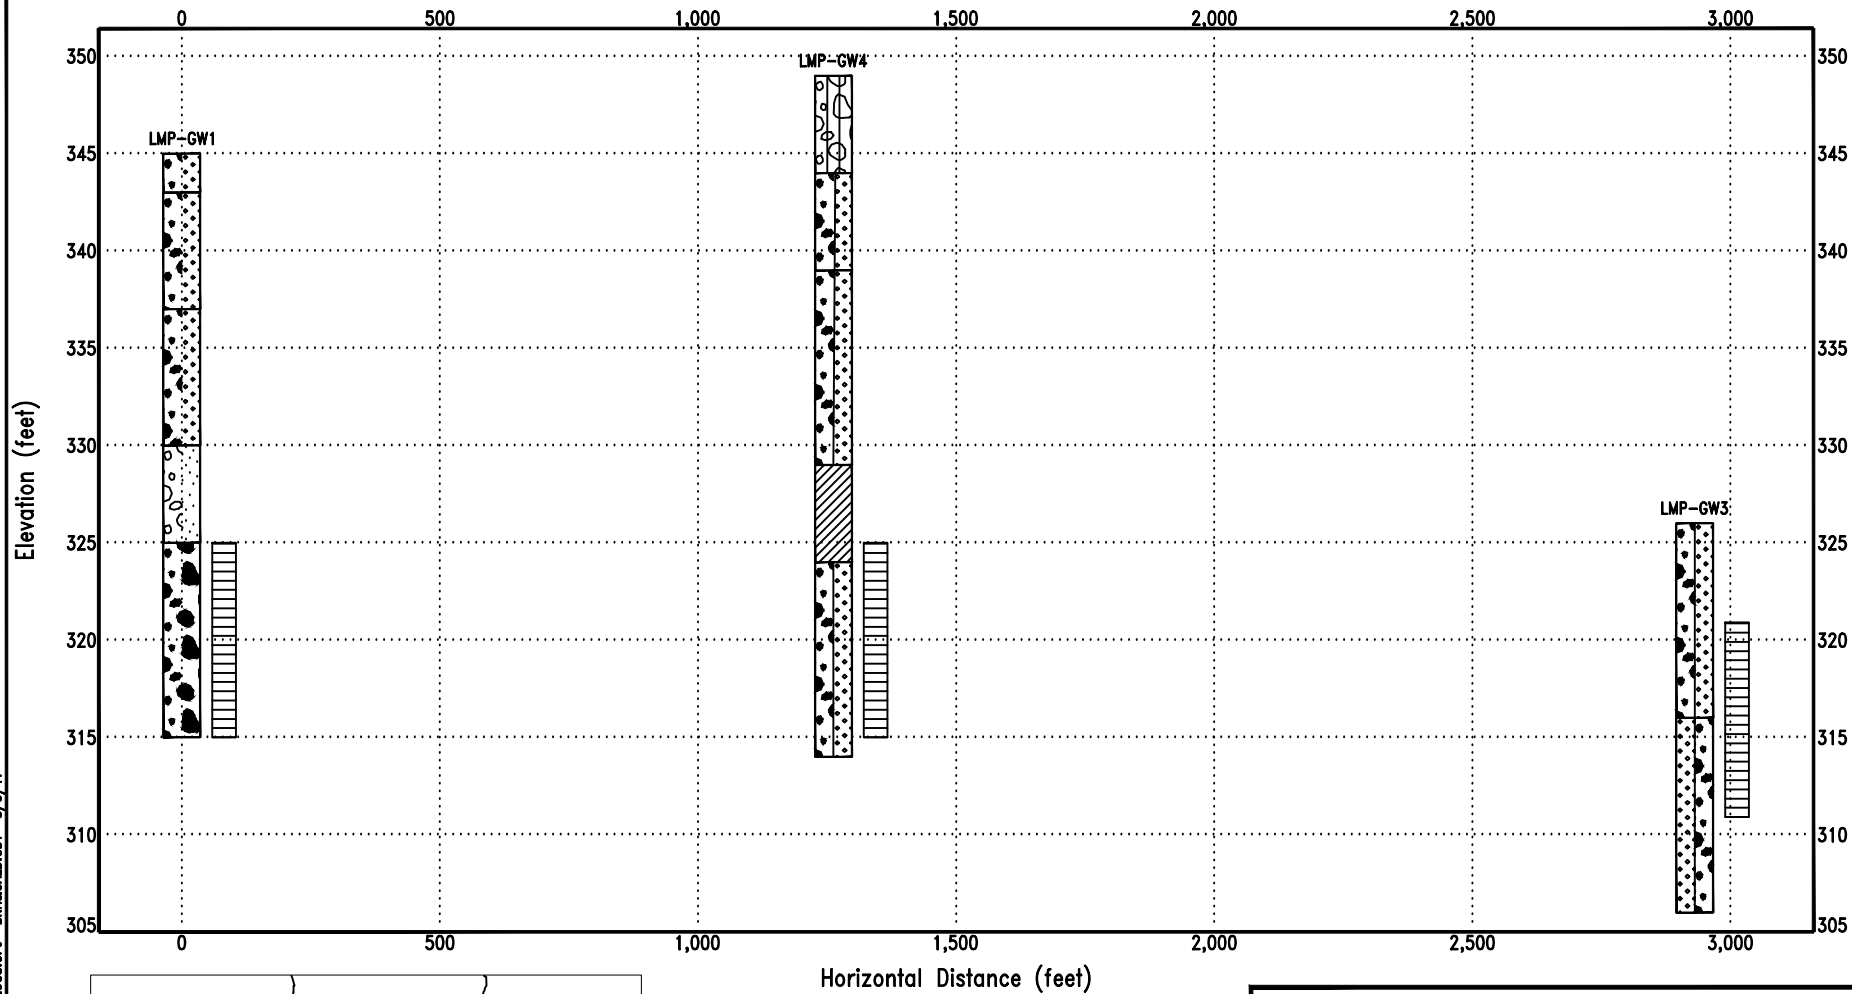
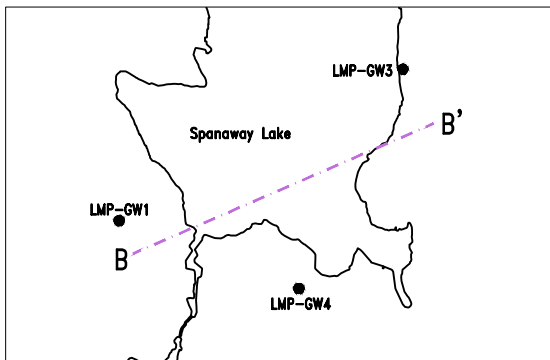
Cross Section B-B'

- Well-graded gravel (GP)
 - Poorly-graded gravel (GP)
 - Well-graded gravel, well-graded sand (GW/SW)
 - Silty gravel (GM)
 - Poorly-graded gravel with sand (GP)
 - Poorly-graded sand (SP)
- Well Screen Interval

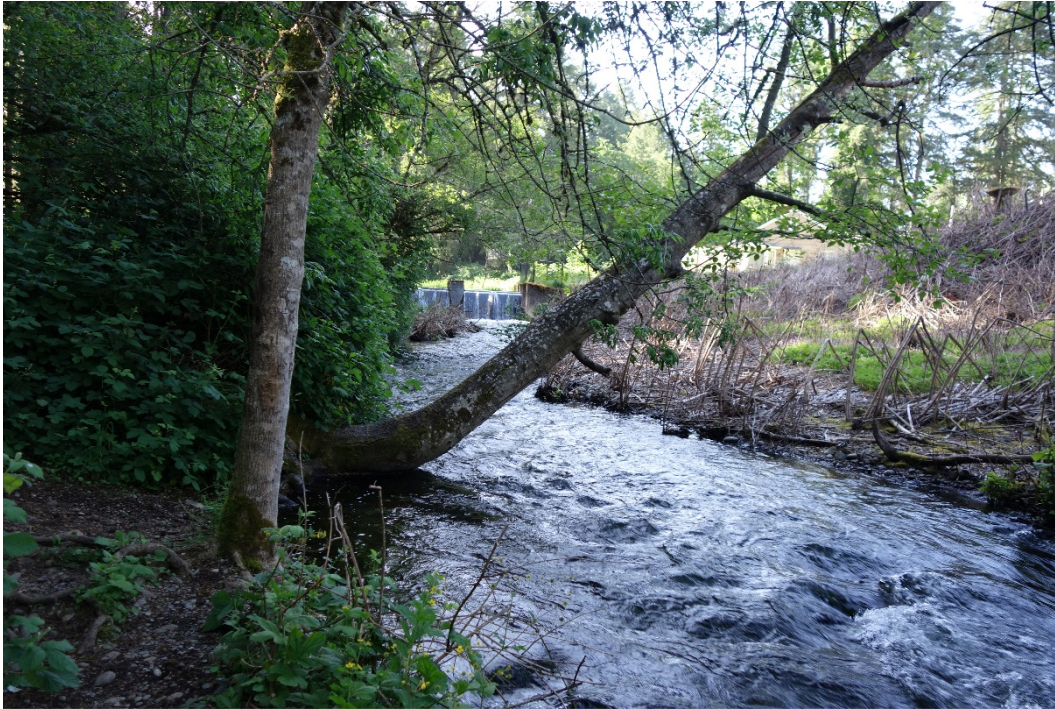
Figure C-1. SW-1 (Spanaway Creek) looking upstream, 5/25/2017

Habitat attributes: SW-1 is located several hundred meters (m) below the lake outlet. The low-to moderate-gradient stream outlet channel traverses a short, densely forested and shaded reach and empties into a small, more open pond created by a low dam, which then empties into a moderate-gradient outflow channel bounded on one bank by forest, and the other bank by suburban yard. Notes from May 25, 2017, field visit: The channel is 2–4 m wide; the width-to-depth ratio is moderate; sinuosity is low as it appears to have been straightened and channelized below the dam; water depth averages 20 cm; stream banks are rocky, stable, and with high coverage by vegetation and roots; shading from trees is moderate at and above the site; habitat is about 75 percent riffle and 25 percent glide; no pools, alcoves, or pocket water is found in this stream reach; no large woody debris is present; channel roughness is low; little substrate disturbance from high winter flows is evident; flow was strong from the wet spring; no turbidity was evident; cobble substrates dominate; cobbles were slick with abundant filamentous algal growth; embeddedness of riffle cobbles was estimated to be 25–50 percent; rocks were loosely consolidated, not armored; crevice space between cobbles was moderate to

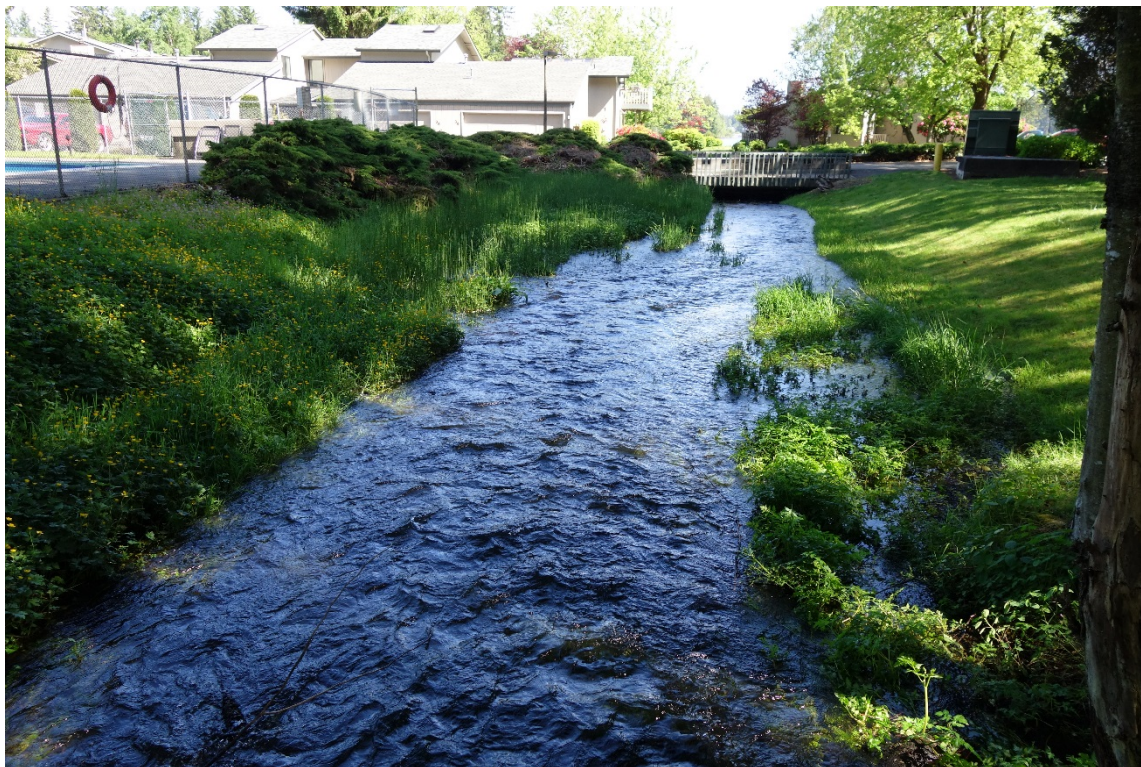
Figure C-2. SW-2 (Coffee Creek) looking downstream, 5/25/2017

Habitat attributes: The site is in a short stream segment of several hundred meters between Spanaway Lake and extensive wetlands found on Joint Base Lewis-McChord. The actual benthic sampling site is approximately 25 m above the lake in an apartment development. It is just below a more wooded reach near Spanaway Loop Road. Access to this wooded reach is blocked by a fence. There are a few scattered trees along the sampling reach, and lawn abuts both banks. The source water for the site comes from the extensive and minimally disturbed wetland across the Spanaway Loop Road on Joint Base Lewis-McChord property. This is a groundwater-fed system. Stream temperatures at the site are relatively cool year-round.

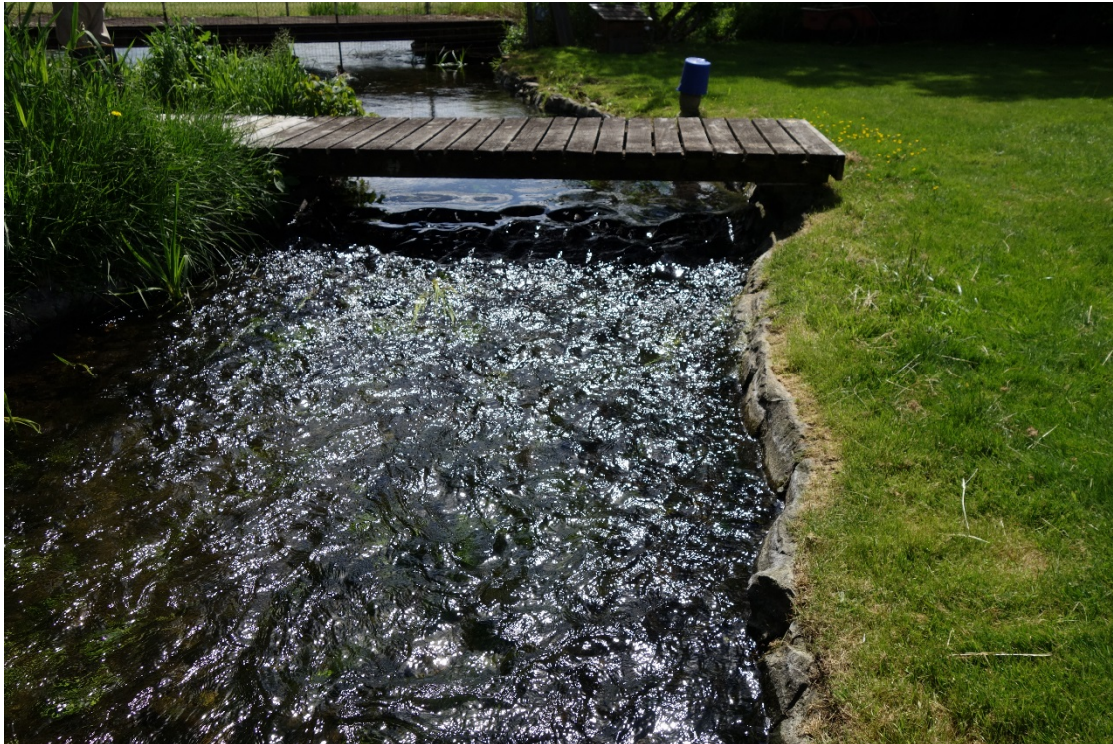
Figure C-3. WSP2 (Lower Spanaway Creek) looking upstream 5/25/2017

Habitat attributes: Spanaway Creek splits into two distributary streams (Spanaway and Morey Creeks) about 0.5 km above this site. The Morey Creek fork traverses a stream segment that appears to have an extensive riparian fringe of brush and trees and extensive beds of macrophytes in-channel. In contrast, the Spanaway Creek fork traverses a stream segment dominated by active pastureland that abuts the stream bank providing little or no riparian vegetation development. The stream is channelized, open, low-moderate gradient, and no macrophyte beds were evident as far upstream as could be seen. The site is in a small housing development at the downstream end of an extensive pasture area. Homeowners have channelized the stream, built a small island in the middle of the channel, and rip-rapped both banks with building stone. Semi-domestic ducks are found in the area. One bank is bordered by lawn, while the other bank and island have some trees that provide partial shade. Bottom substrates in the area are dominated by loosely consolidated sand and gravel with little entrained silt. Homeowners have built some riffle-glide habitat with paving stones.

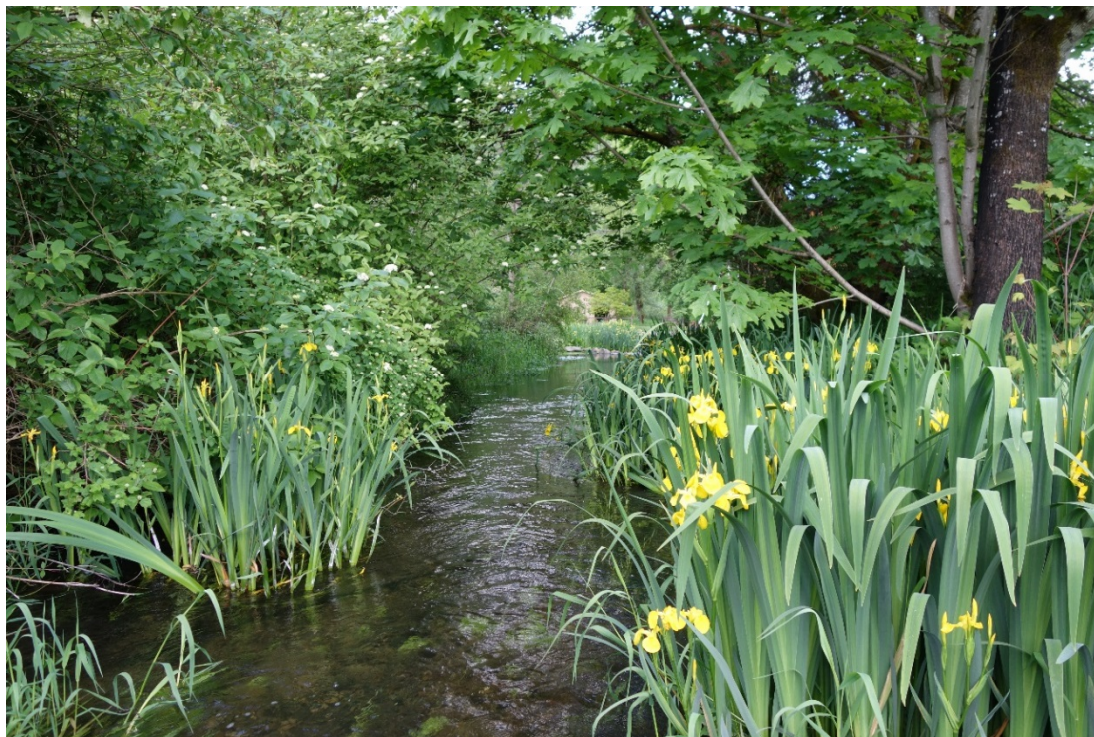
Figure C-4. WSP4 (Morey Creek) looking downstream, 5/25/2017

Habitat attributes: (Notes from May 25, 2017 field visit.) Stream flow was strong and the water clear after the exceptionally wet spring. The site is low gradient. Mid-channel substrates are dominated by sand and fine gravel. Emergent macrophytes line both shores. The site is located just upstream of a residence and about 50 m downstream of a road crossing. To the south, open inactive pasture encroaches the stream bank up to the line of emergent macrophytes, providing little shade. To the north, a riparian fringe of alder and other trees provides shading to about half the channel. Upstream of the road, a distinct riparian fringe of brush and trees is visible that may extend up to the Spanaway/Morey Creek fork. Extensive macrophyte beds (submergent and emergent) found in Morey Creek above the sampling site help to shade the stream, trap fine sediment and undoubtedly absorb nutrients being carried down from the Spanaway Lake area.
