# Current Conditions Assessment Report

November 2016

***Appendix A*** of the  
*Little Bear Creek Basin Plan,  
A Final Watershed-Scale Stormwater Plan  
Prepared in Fulfillment of Special Condition  
S5.C.5.c.vi of the Phase I Municipal  
Stormwater Permit*

## **CURRENT CONDITIONS ASSESSMENT REPORT**

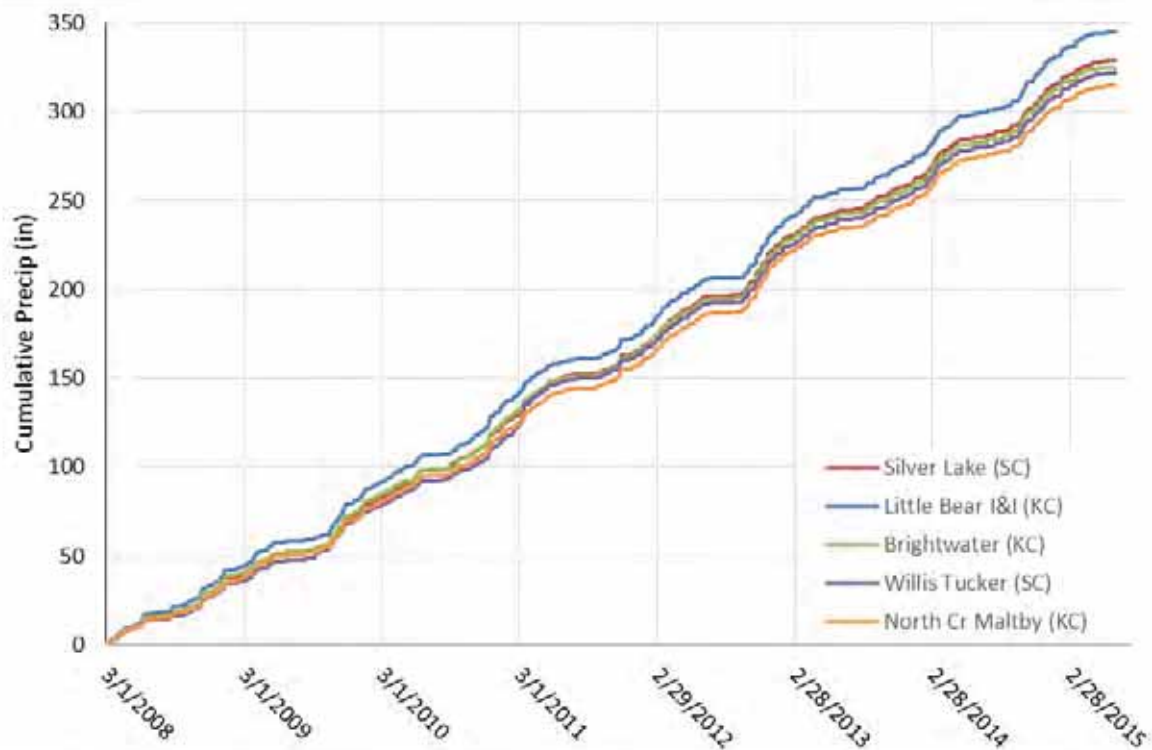
Figure 9 shows a cumulative precipitation plot for the same gages for the period from March 2008 through June 2015, when data for all five gages were available. The cumulative plot shows all but the Little Bear I&I gage tracking quite consistently; North Creek Maltby drops lower in spring 2011 but then resumes a consistent trajectory with the other three gages. The Little Bear I&I gage totals are distinctly higher than the other gages, including Brightwater, which is within half a mile. It is not clear why cumulative totals are higher at this site, but the result seems to be an anomaly given the otherwise fairly consistent totals in the area and the close day-to-day tracking with Silver Lake seen in Figure 8. Based on analysis of area gages, precipitation appears to be fairly consistent over the Little Bear watershed, though spatial patterns for individual storms vary.

Figure 9. Cumulative Precipitation (2008-2015) for Little Bear Area Precipitation Gages

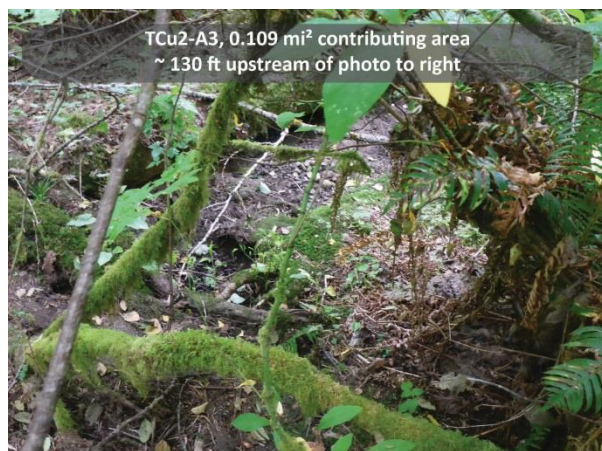
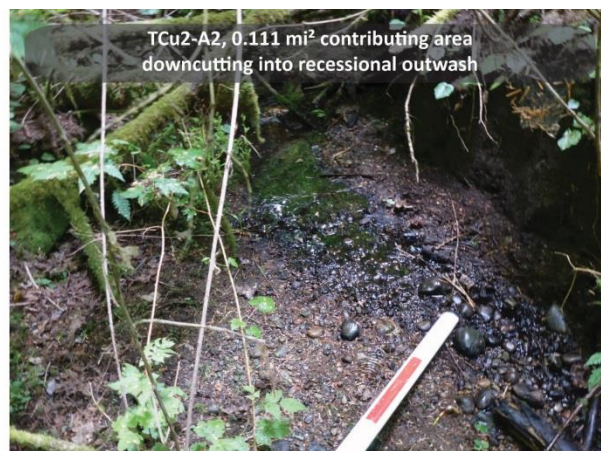
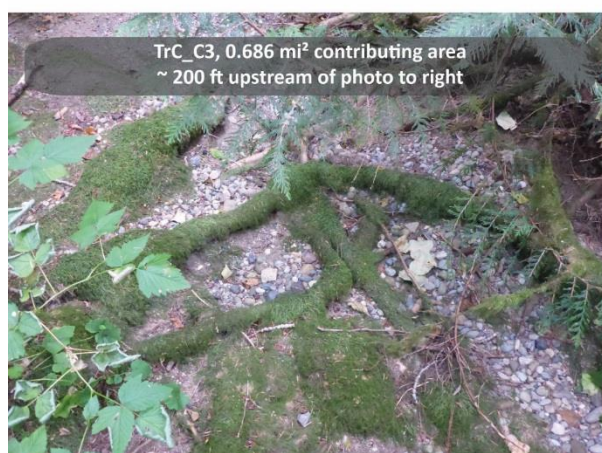
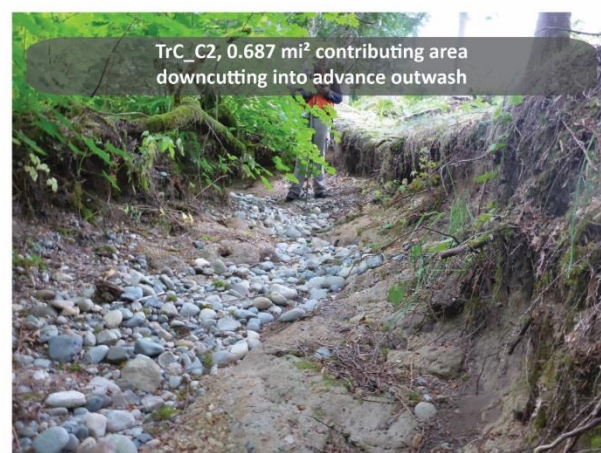
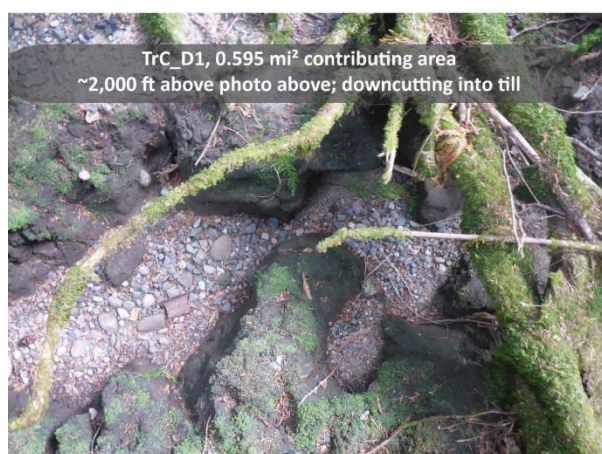
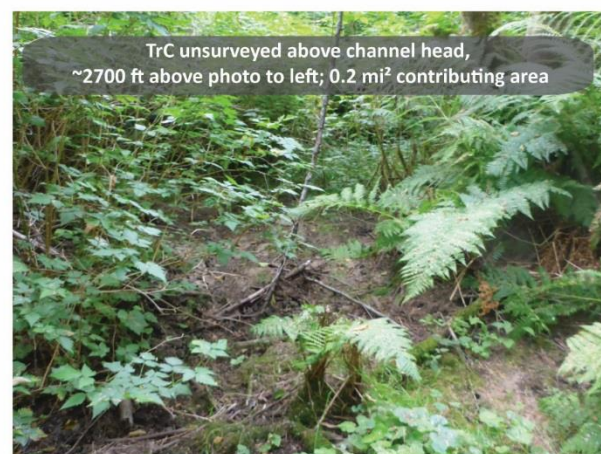
**Figure 12. Photos illustrating the important role of plant roots in stabilizing the soil surface near channel-head locations.**

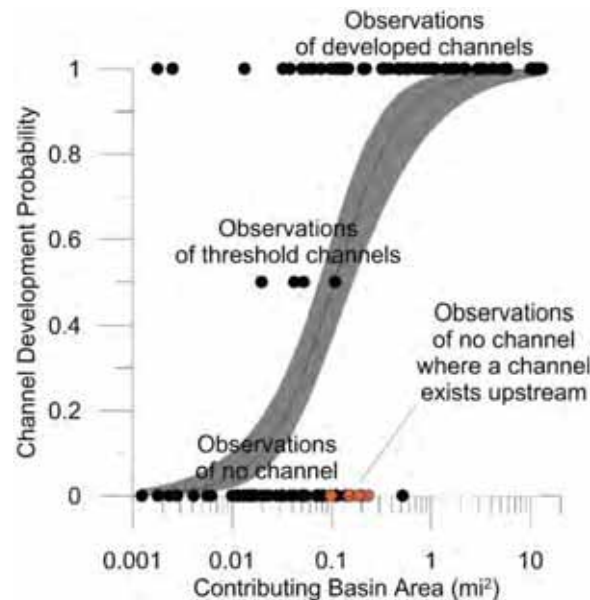
Figure 13 summarizes observations used to infer channel head locations and shows the results of a logistic regression<sup>1</sup> that predicts the probability of channel development by the contributing basin area. Although there is substantial overlap in the region of observed developed channels and observed absence of channels, the significant logistic regression ( $X^2 = .122$ ,  $df = 1$ ,  $p < 0.00001$ ) and observed threshold channels both indicate that most channels form around 0.1 square mile of contributing area, although some form at much smaller basin areas and channels may not be present at larger basin areas. Thus, it was possible to define the approximate drainage area where channelization typically begins in the Little Bear Creek study area basin.

**Figure 13. Observations of channel presence/absence and logistic regression predicting probability of channel presence. Gray shaded region represents the 95 percent confidence bounds for the results of the regression.**

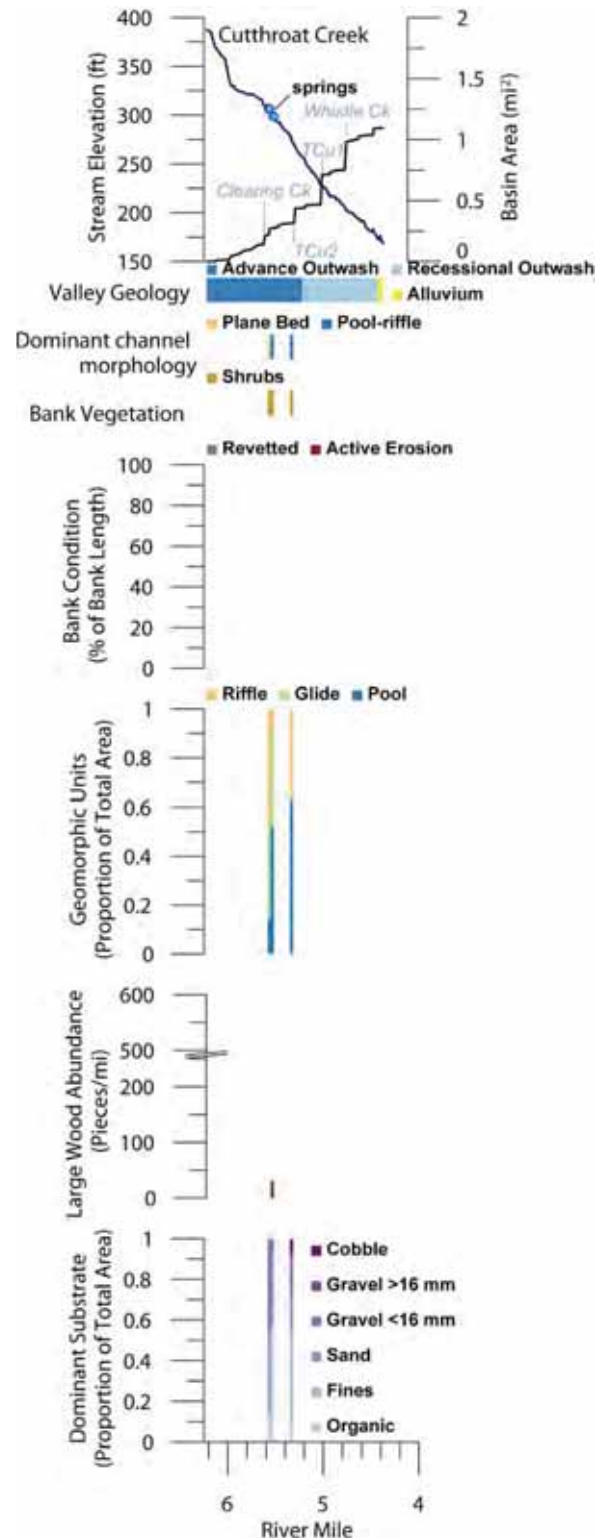
Only two reaches of Cutthroat Creek were surveyed, both of which are relatively close to the stream's headwaters. Both reaches have natural riparian conditions dominated by wet deciduous forest with a thick understory of mostly vine maple and salmonberry. Bed material is gravel- and sand- dominated with some cobble. Large wood in the active channel is relatively sparse. The narrow channel width means that most large wood spans the small creek channel. No areas of revetment or

**Figure 17. Stacked series of plots summarizing observed geomorphic condition along Cutthroat Creek.**

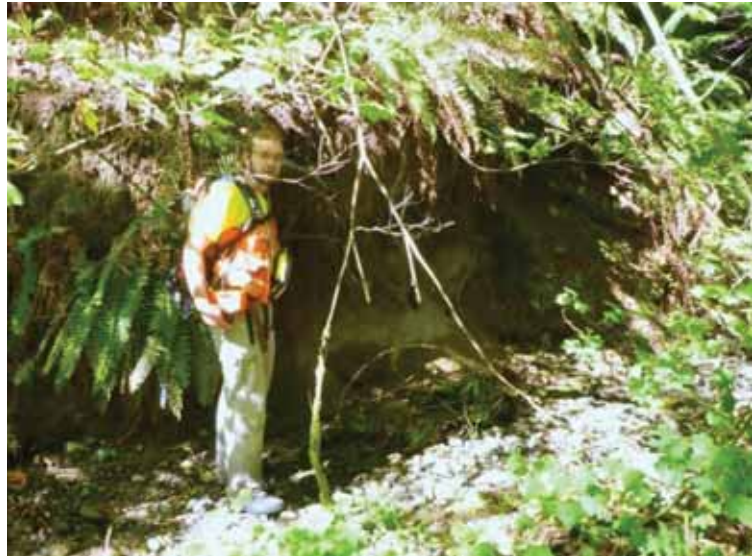
Approximately half a mile downstream, (Row C, RM 2.68-2.78), the vertical profile of the creek appears to be more stable, but meanders eroding the edge of the incised valley are undercutting the adjacent hillslope, initiating landslides, and indirectly mobilizing yet more gravel and sand (Photo 1). This reach is also the location where perennial springs feed the creek. The remainder of the ravine is quite steep (approximately four percent grade), relatively lacking in wood, and dominated by plane-bed morphology; that is long channel segments without distinct local changes in slope associated with pools and bars. Significant erosion is occurring in all reaches surveyed within the ravine, mobilizing both outwash sand and gravel and finer silt and sand deposited more recently as overbank alluvium.

**Photo 1. Lateral migration and vertical bank erosion at Row C.**

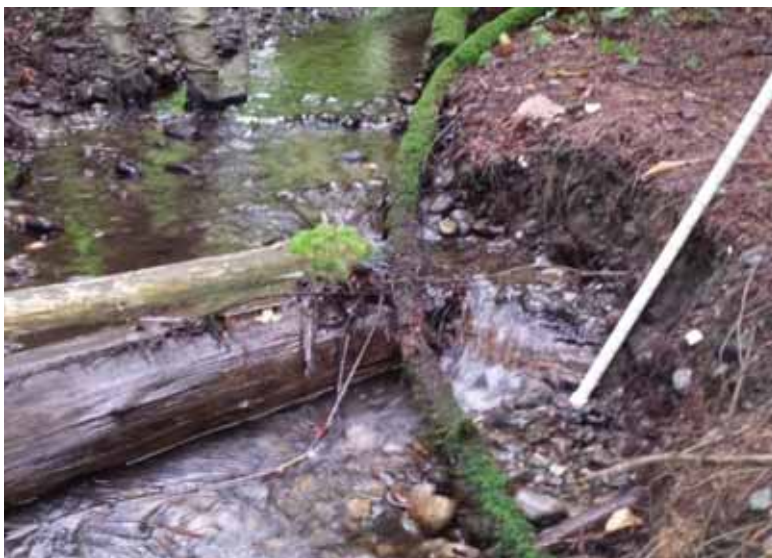
The entirety of the creek's alluvial fan was surveyed as a part of reach Row A (RM 2.21-2.35). Here the slope is slightly less (about three percent). Anomalously fine bed material in this reach indicates high bed

**Photo 2. Example of bed material aggradation on log weir in lower Rowlands Creek.**

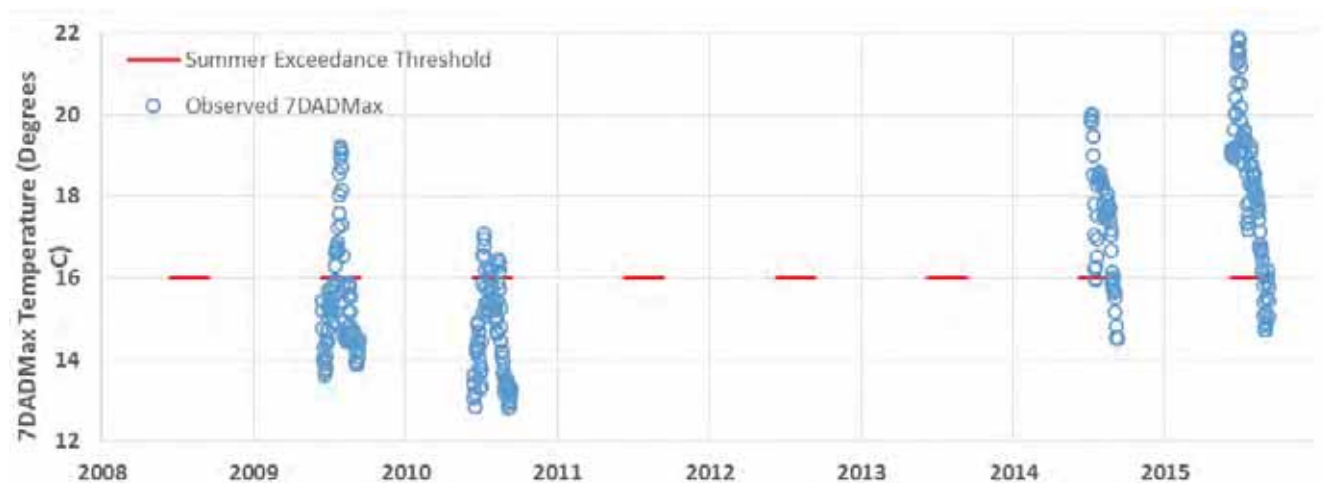
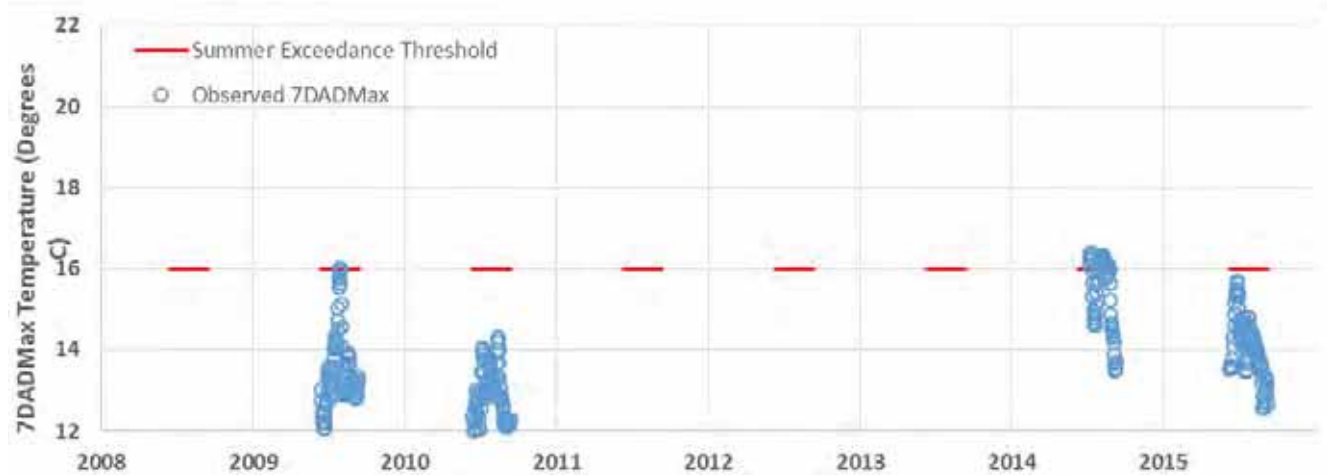
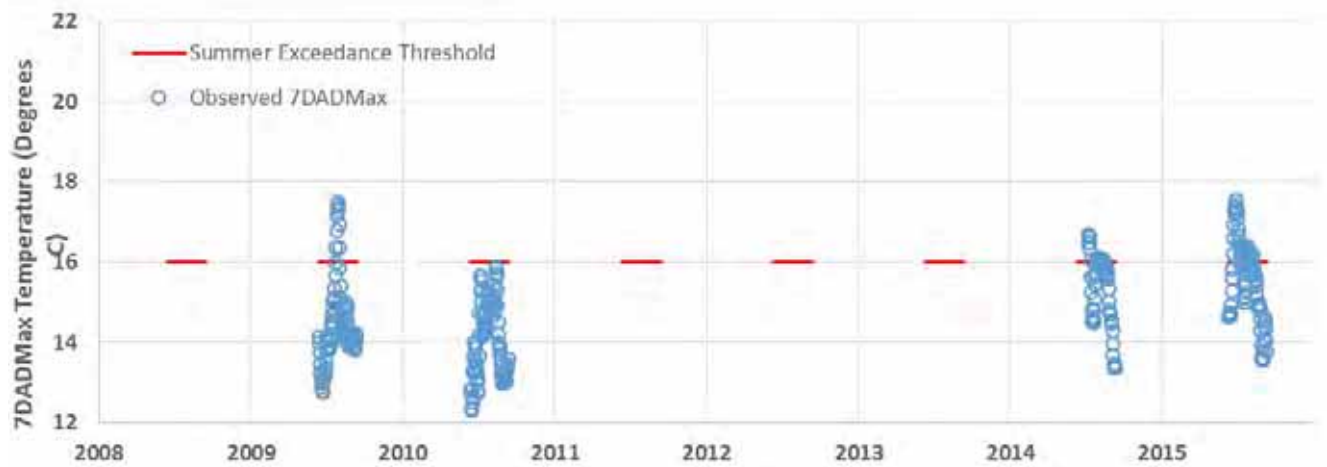
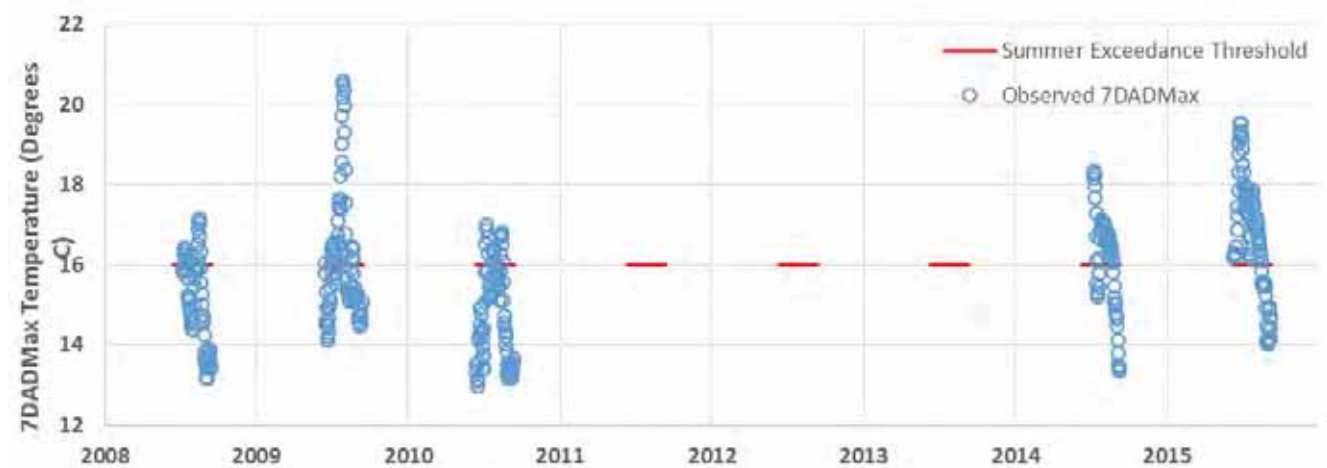
The summer temperature threshold was exceeded between 8 and 41 times per year on average. The number of exceedances was three to five times higher on the mainstem (LBLU and LBLD) than on the tributaries (DANE and CUTT). Time series plots in Figure 22 through Figure 25 show the 7DADMax temperature values computed from the observed data (in blue), and the exceedance thresholds representing the temperature criteria (in red). The highest observed 7DADMax temperatures occurred during the summers of 2009 and 2015. The summer 2009 7DADMax exceeded 20°C at the LBLD site and reached 18°C at the LBLU site. The summer of 2015 was warm and dry throughout the region, and high stream temperatures were common in many streams.

**Figure 22. Summer 7DADMax Temperature, Monitoring Site LBLU**

Figure 23. Summer 7DADMax Temperature, Monitoring Site DANE

Figure 24. Summer 7DADMax Temperature, Monitoring Site CUTT

Figure 25. Summer 7DADMax Temperature, Monitoring Site LBLD

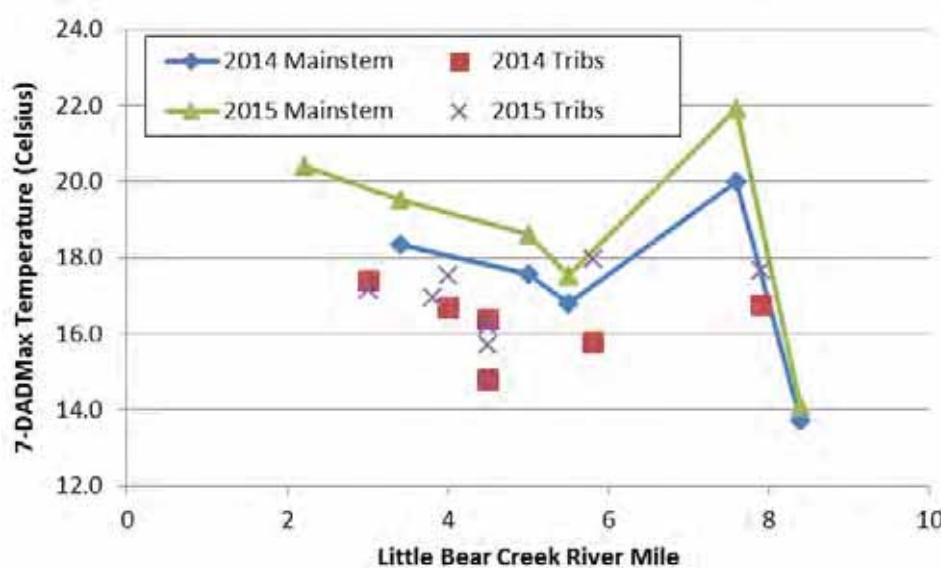
In addition to collection of temperature data for model calibration, new temperature data were collected as part of a stream metrics study conducted for the Little Bear Basin Planning project, providing additional locations for comparison of stream temperatures in 2014 and 2015. Summary results are plotted by year and location in Figure 26, displaying differences along the stream profile and between mainstem and tributary sites. Site LBLU at river mile 7.6 was the warmest among locations sampled in both years. The plot highlights that water temperature upstream from LBLU is relatively cooler before warming to the site. Then water temperature cools in a downstream direction to the middle portion of Little Bear Creek near Little Bear Creek Road. Tributaries are generally cooler overall and, except for one tributary at RM 5.5, did not increase in temperature as much as mainstem sites during the summer drought of 2015, either in degrees Celsius or relative percent difference.

Figure 26. Stream temperature plotted as the summer maximum 7DADMax (°C) by river mile for mainstem and tributary locations. Tributary values are plotted based on the confluence location along Little Bear Creek and not the location sampled on the tributary.

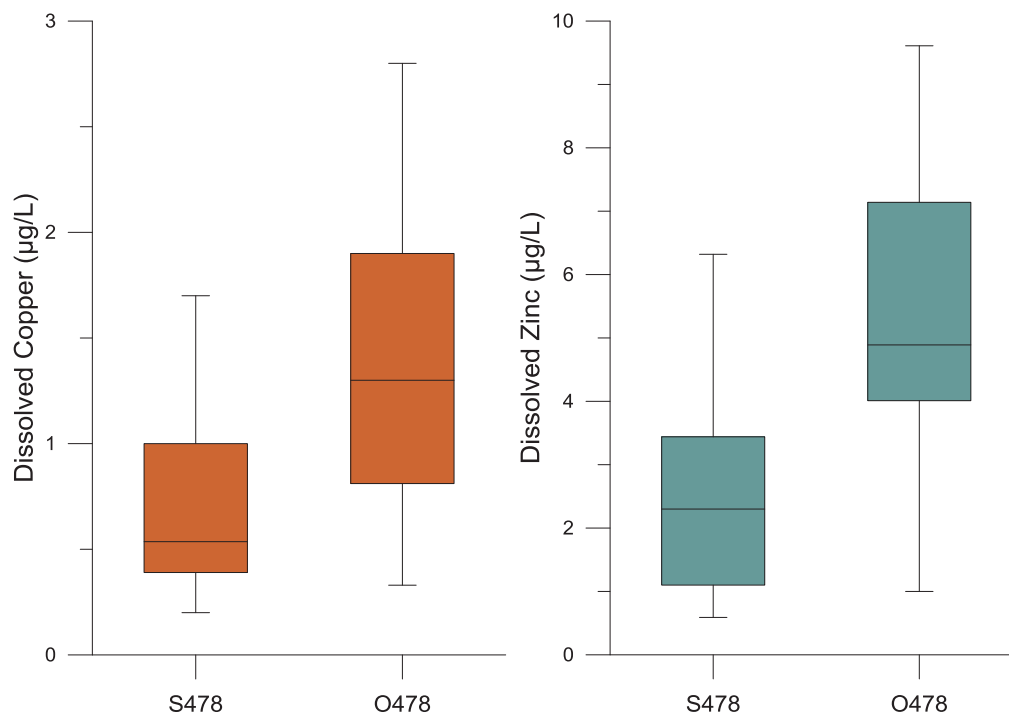
From **Table 19**:  
Dissolved Copper Standards (µg/L), Chronic = 4.3 – 8.0, Acute = 5.8 – 12  
Dissolved Zinc Standards (µg/L), Chronic = 40 – 73, Acute = 44 – 80

**Figure 27. Dissolved Copper (left) and Dissolved Zinc (right)**

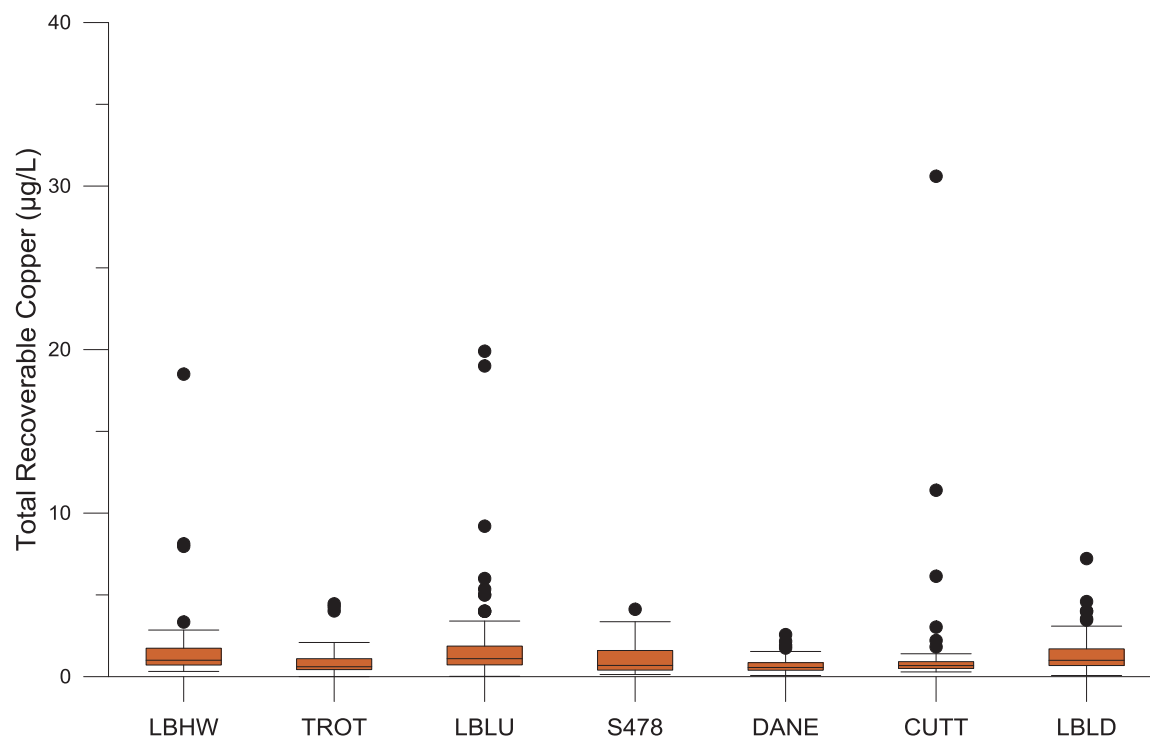
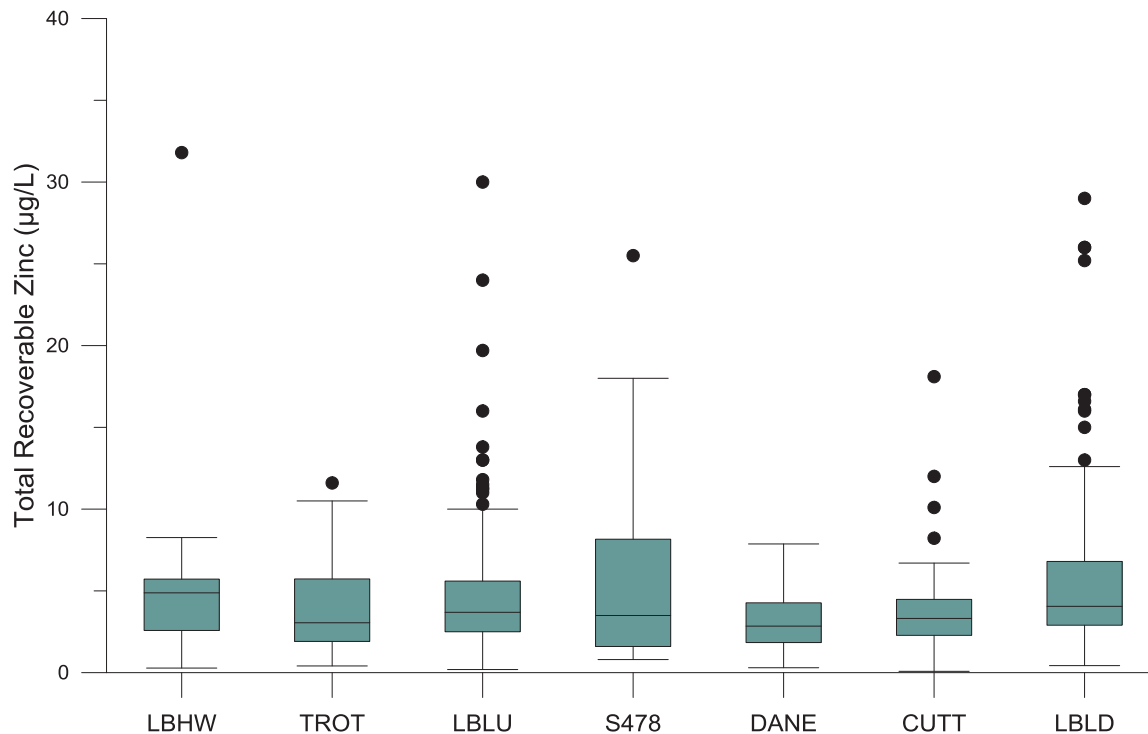
**Figure 28. Total Recoverable Copper, Ambient Monitoring Sites**

**Figure 29. Total Recoverable Zinc, Ambient Monitoring Sites**

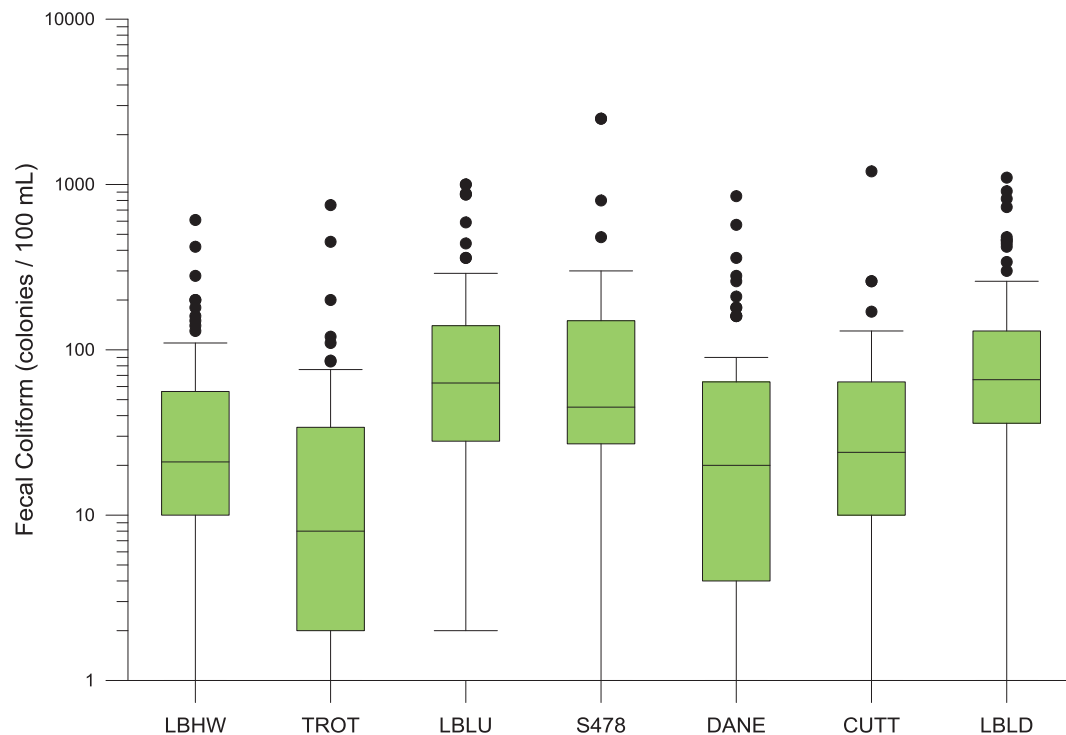
**Figure 30. Fecal Coliform Bacteria, Ambient Monitoring Sites**

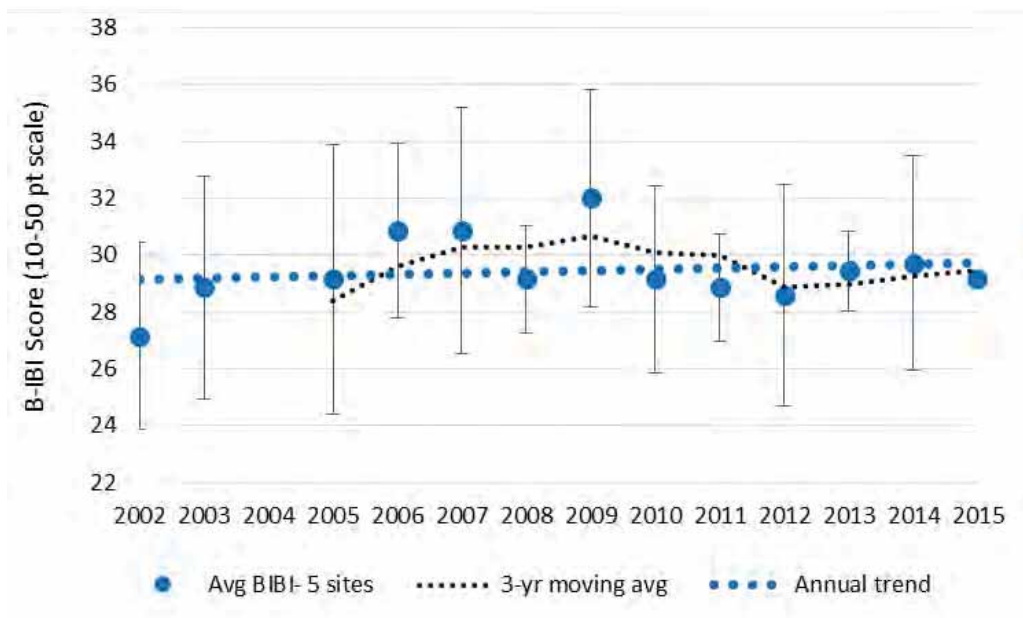
Table 29 shows that the highest average B-IBI score in Little Bear Creek (for these seven sites) was in 2009, followed by 2007. The lowest average scores were observed in 2002 and 2003 (no data were collected in 2004). A plot of the average B-IBI score (and standard deviation) by year is shown in Figure 33. Scores increase on average between 2002 and 2007 and decrease on average between 2009 and 2013. The largest increase in average score between years is from 2008 to 2009. The largest decrease in average scores between years is from 2009 to 2010.

**Figure 33. Average B-IBI score by year for all sites (with standard deviation). The linear relationship is plotted as a 3-year running average.**

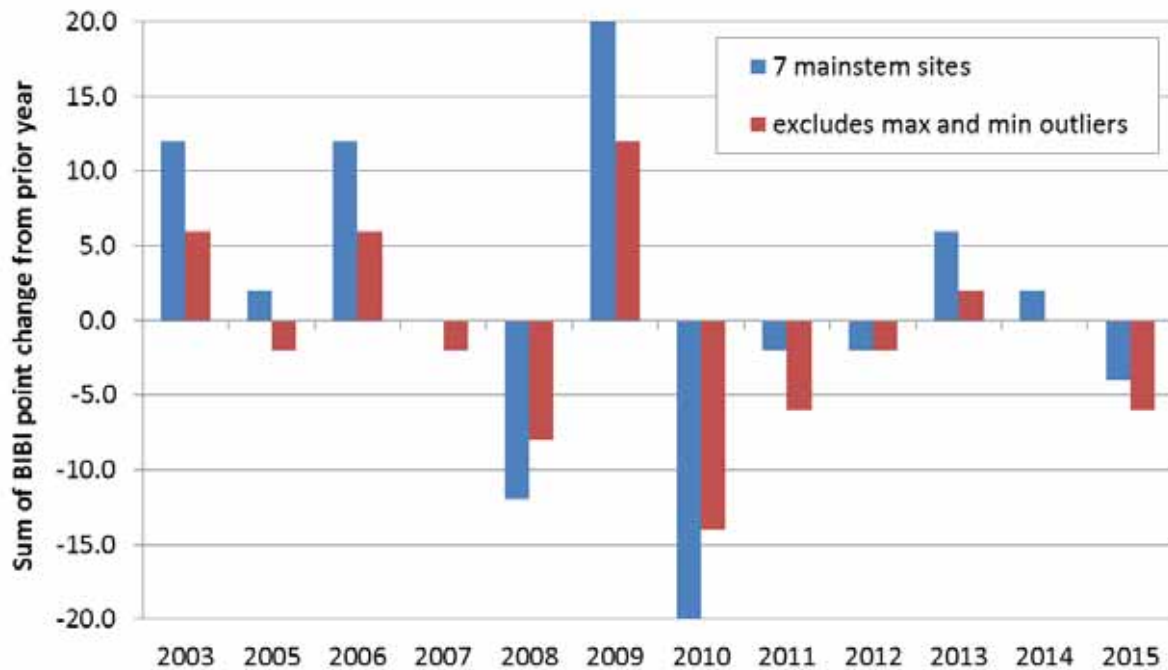
Figure 34 explores changes in site scores from year to year. For each of the same seven sites, the change in B-IBI point score (+/-) from the previous year was summed. The greatest observed changes were from 2007 to 2008 (negative sum), 2008 to 2009 (positive sum) and 2009 to 2010 (negative sum). Though individual site scores changed by up to  $\pm 12$  points between years, the sum of differences between these years was directionally compelling. Even when each of the largest positive and negative score changes per year were excluded from the analysis, the distinct shifts over this period were present. As a result, it may be worth investigating whether substantial differences in hydrology exist for this series of years (2008, 2009, and 2010) compared to any other series of three years.

**Figure 34. Year-to-year sum of B-IBI point change for seven sites. Values represent change from the previous year (i.e. 2008 value is the change from 2007 to 2008).**

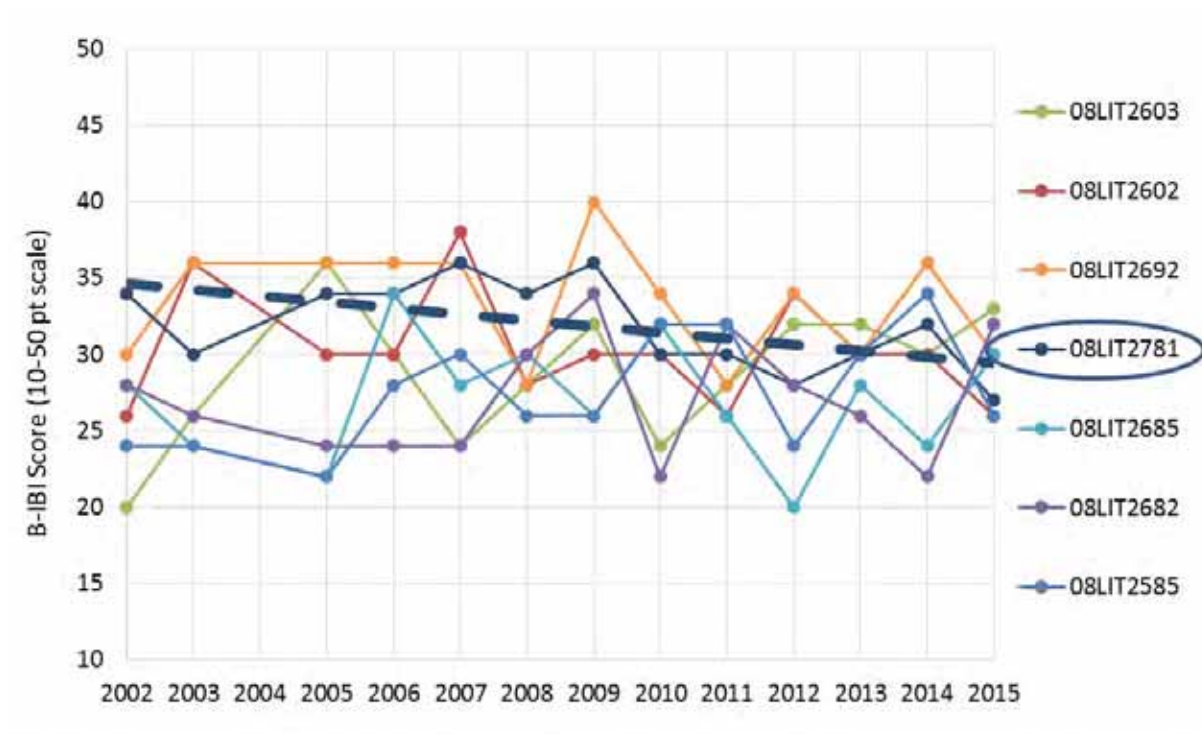
The data were tested for overall score trends among sites by year, despite the year-to-year variability. As highlighted by the line slope in Figure 35, only one site (circled legend item 08LIT2781) demonstrated either an increasing or decreasing score trend over time based on a simple test of the line slope ( $\alpha=0.05$ ). Even still, the significant negative slope is due to the decrease in B-IBI score in the final year in a range of years where increasing and decreasing score appears to be cyclical. Without the final year (2015), there is no significant line slope. The cyclical nature of increasing and decreasing B-IBI scores every few years (if persistent), suggests the statistically significant slope may not persist.

**Figure 35. Time series of site B-IBI scores. Statistically significant line slopes are shown with dashed regression line.**

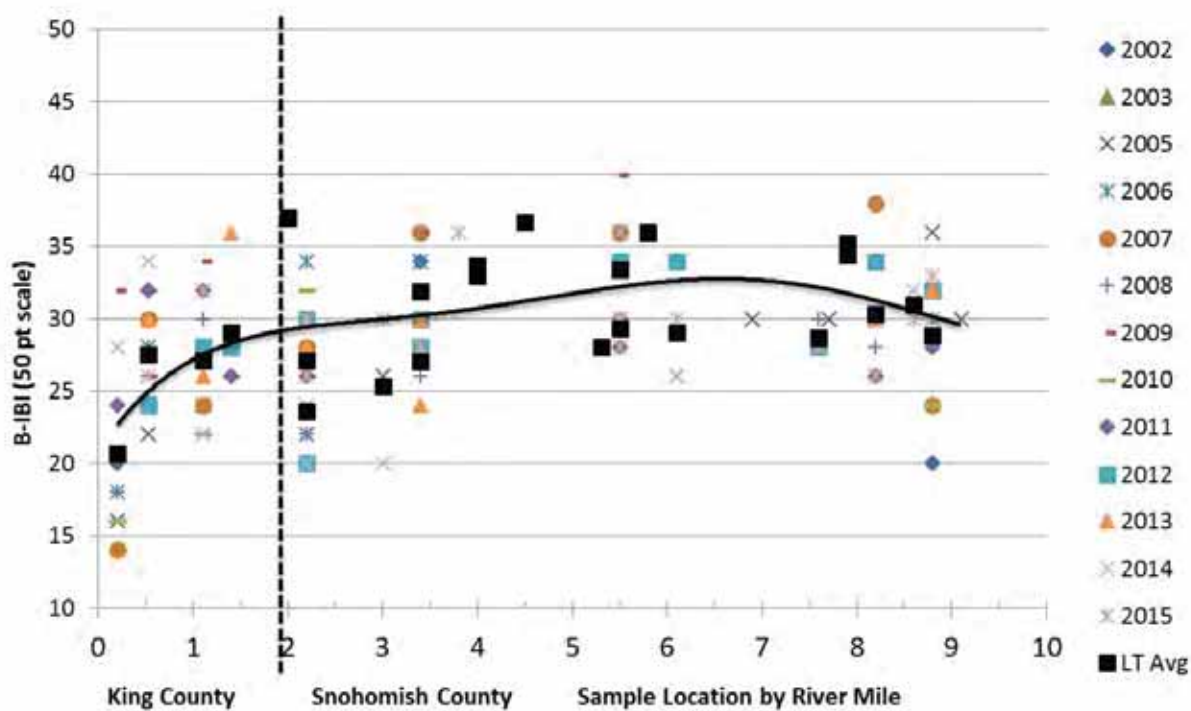
There does appear to be a more distinct spatial pattern in B-IBI scores along Little Bear Creek. B-IBI scores for all mainstem sites since 2002 are shown longitudinally by river mile in Figure 36. The plot shows that B-IBI scores increase in a downstream direction starting from the upper sampling sites at approximately river mile 9 and continuing to river mile 5.5 at Little Bear Creek Road. From there, B-IBI scores generally decline in a downstream direction to near the mouth of Little Bear Creek in Woodinville. A break in the decreasing trend in B-IBI score is observed near the Snohomish-King County line (RM 2.0). This was also observed in previous studies (Morley, 2000; McBride, 2002) based on data collected prior to 2002. A downstream improvement in the forested buffer condition and the physical stream condition were noted by these authors.

**Figure 36. Longitudinal plot of all B-IBI scores (2002-2014) by river mile. Heavy dashed line represents Snohomish-King County line. Line fit through years is approximated to long-term average by site.**
