State of Washington Department of Ecology
**WASTEWATER TREATMENT PLANT
 COMPLIANCE INSPECTION REPORT**

Compliance Inspection

Name, Location, and Phone of Facility Inspected Cashmere POTW 2 Riverfront DR, Cashmere, WA 98815 509-782-3513	Entry Time 9:05	Permit Effective Date 12/1/2010
	Exit Time 16:00	Permit Expiration Date 11/30/2015
Name(s)/Title(s) of On-Site Representative(s) Bruce Germain, Lead Tony Griese, Wastewater Operator Randy Low, Wastewater Operator Steve Croci, Public Works Director	Ecology Staff On-Site Donna Smith Erik Van Doren Heather Simmons	
Name, Address, Title, Phone, and Fax Number of Responsible Official Jim Fletcher City of Cashmere, Mayor 101 Woodring St, Cashmere, WA 98815	Other Facility Data None	
Phone Number 509-782-3513 Fax 509-782-2840 Contacted? <input type="checkbox"/> Yes <input checked="" type="checkbox"/> No

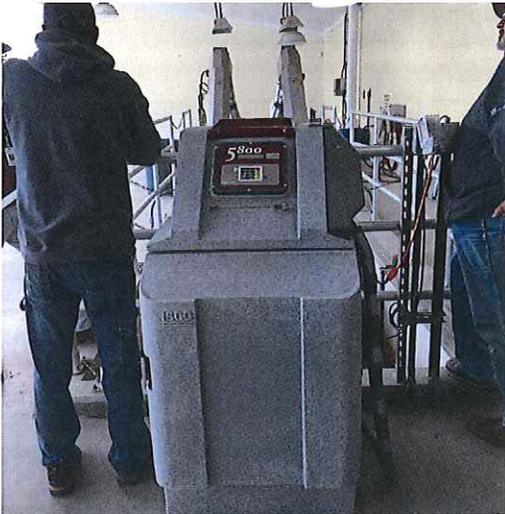
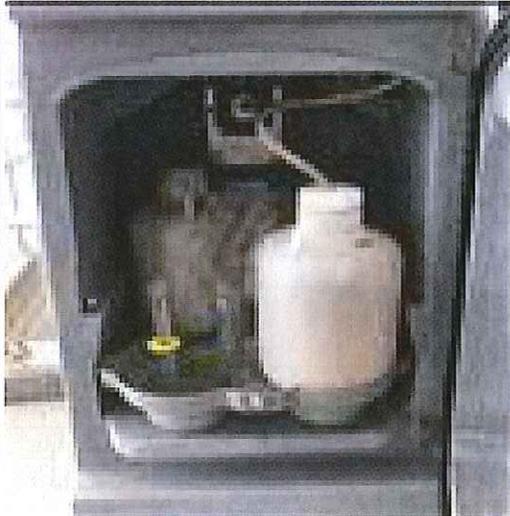
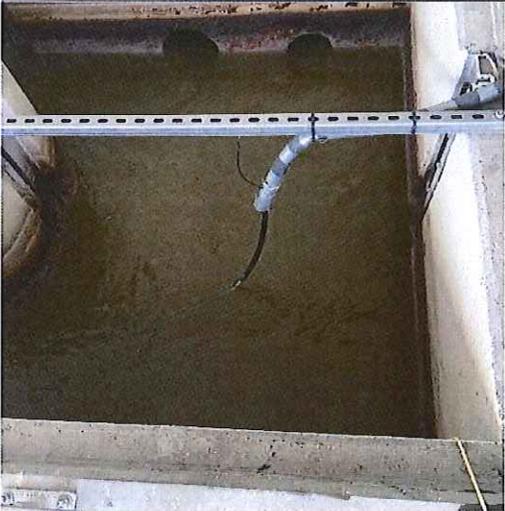
Influent Sampler, Inside Sampler, Sampler Hose

- All participants observed the MCC room, mechanical room, screenings room, and upper level of headworks building.
- A 300 gal tote approximately 1/2 full with product previously used in the treatment process was stored in the mechanical room. Ecology recommended putting a camlock cap on it to prevent a spill.
- The screenings room was clean, orderly and equipment functioning properly.
- The influent sampler was located prior to any screening. It may be better to have the sampler located post screening. The sampler did not have a certified thermometer inside. It is important to ensure samples collected are preserved at the proper temperature (4 degrees C).

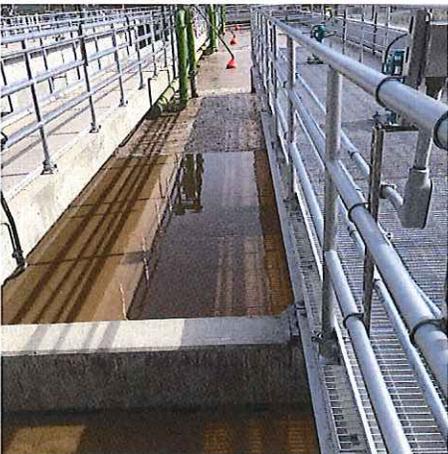
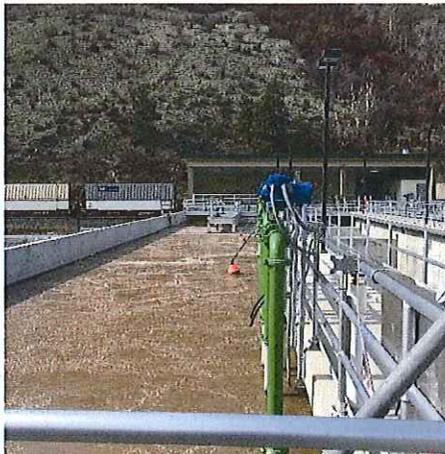
Basin

- There are two AB's at the Cashmere POTW. The east AB was online. Activated sludge looked good in color, odor, and a uniform aeration pattern on the surface. The operators perform maintenance on the AB equipment (gear box oil changes, greasing, etc) when they take one AB offline and put the other online.
- The EQ basin is located between the two AB's. The EQ is broken into three cells. It is to be utilized during high influent flow rates which are likely to occur during large storm events. Most equalization will only require the use of one cell.

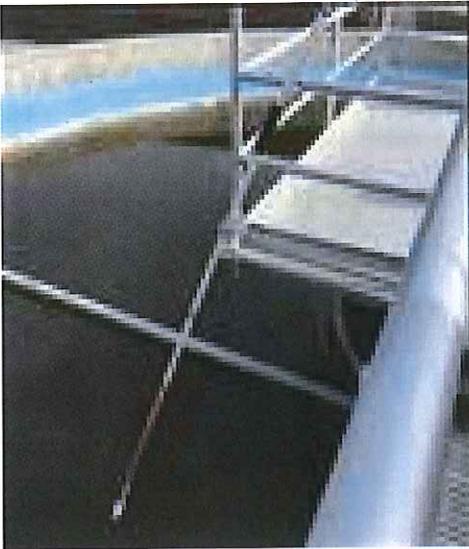
Secondary Clarifier

- There are two secondary 40ft diameter clarifier tanks. Only of the two clarifiers were online during our visit. The water secondary effluent looked a bit hazy but the operators informed us that the water quality was within permit limits and likely a bit hazy due to seasonal change.

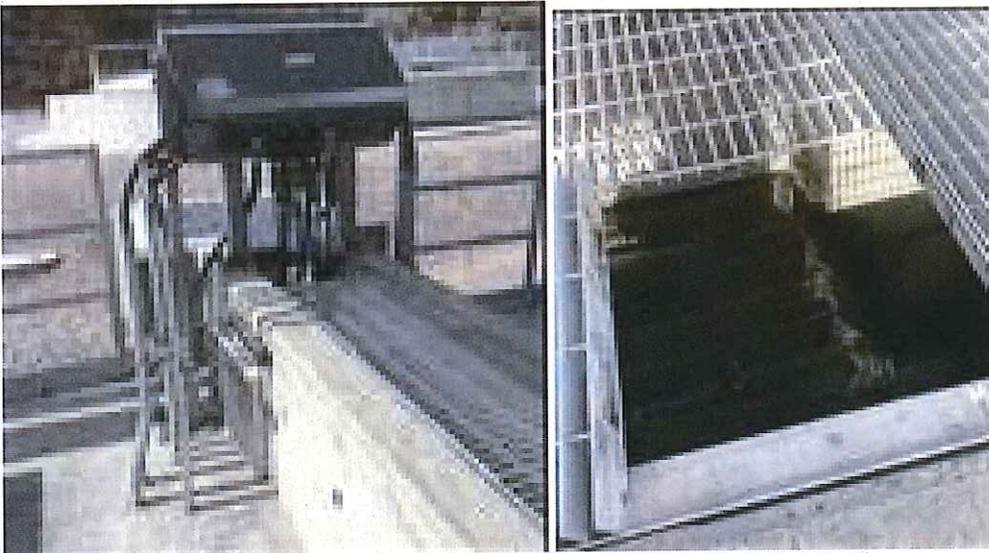
UV disinfection, Effluent Post UV

- The UV system was operational and the area looked mostly clean. A composite sampler was located post UV disinfection. The sampler was without a certified thermometer. The operators informed me that they would be purchasing one for each of the composite samplers. The tubing was similar to the influent tubing.

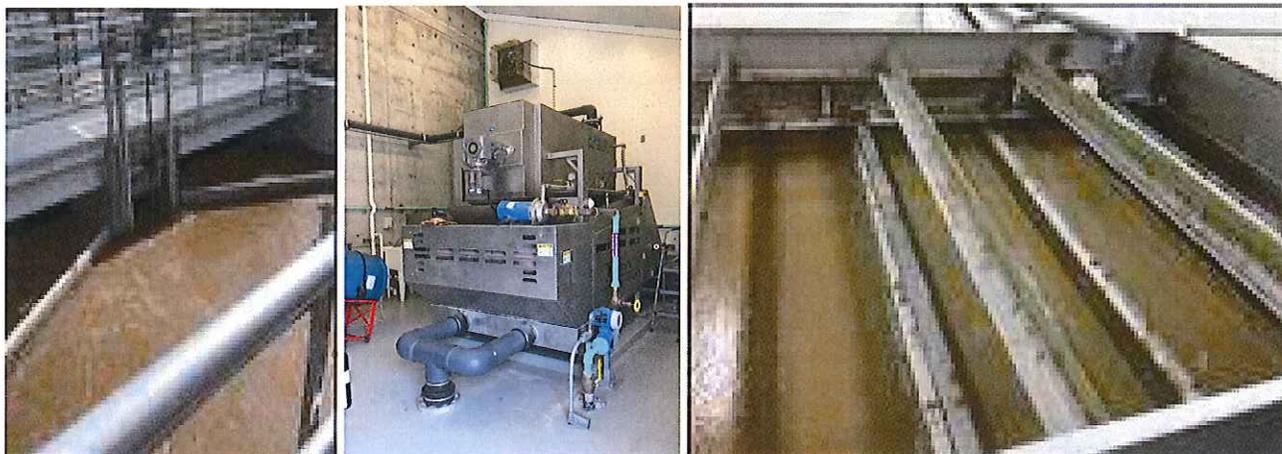
Surface Wasting, Belt Filter Press (BFP), Dissolved Air Flotation (DAF)

- We observed the surface wasting from the AB, the Dissolved Air Flotation (DAF), and belt filter press. All equipment appeared to be functioning properly. The operators explained that recent citizen complaints regarding the odors of biosolids is preventing them from turning solids during the hot summer months. The idea is that by not turning solids it will limit the biosolids odor. In reality, not turning biosolids during the summer can create unfavorable odors, especially after sitting for long periods. The odors would be most unpleasant when contract haulers have to load the biosolids. Additionally, solids that are not turned and dried limit biosolids storage capacity due to a lack of evaporation, can attract vectors, and can be costly hauling wet.

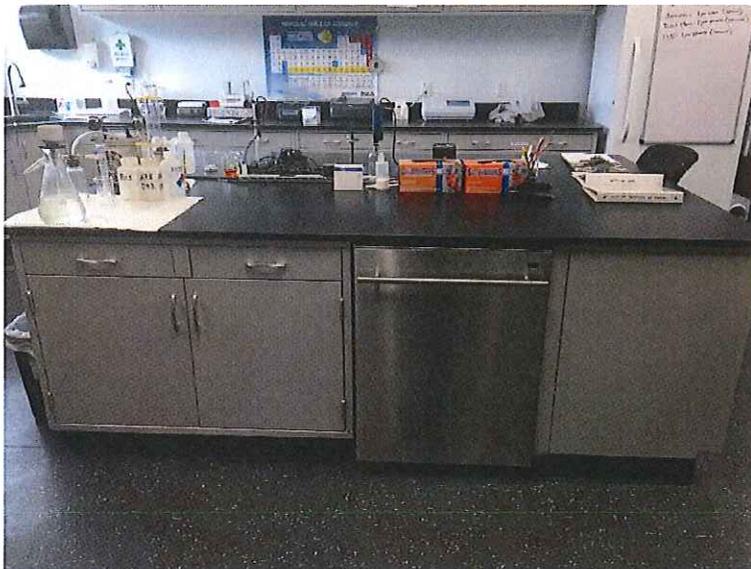
Laboratory

- Clean and orderly
- Bench sheets: Operators purchased NCL BOD bench sheets. The Cashmere POTW lab is accredited for BOD. Although they take BOD samples to Cascade Analytical for weekly analysis. Randy mentioned he plans to do BOD's in-house again when time allows. The DO probe used for measuring dissolved oxygen looked dirty. Additionally, the LDO membrane cap appeared scratched. The BOD bottle, used for storing the probe, had algal growth in it. I recommended replacing the dirty BOD bottle with a clean one with clean DI water too.

- The operators stated they were working on SOP's for all laboratory procedures but had not finished them.
- TSS analysis is performed at the Cashmere POTW lab. I noted an empty NCL TSS standard vial next to the scale. I asked Randy if he was still using the NCL TSS standard. Randy stated they do order TSS from NCL but did not have any more in the lab. I recommended they purchase TSS standard for their weekly analysis and if needed, send their samples to Cascade until they obtained new standard.

- The water bath used for fecal coliform analysis was observed to be 44.9 degrees C. The standard methods temperature range is 44.5 +/- 0.2 degrees C. The operators were informed to check their thermometer against a certified thermometer and record the values. An adjustment would likely need to be made to keep within temp range.

- I suggested to date and initial laboratory supplies.
