State of Washington Department of Ecology WASTEWATER TREATMENT PLANT COMPLIANCE INSPECTION REPORT			Northwest Regional Office PO Box 330316 Shoreline, WA 98113 ph: (206) 594-0000 (rev. 5-28-21)	
Section A: General Information						
Report Version	PERMIT #	mm/dd/yy	Inspection Type	Inspector Code	Facility Type	
<input checked="" type="checkbox"/> New <input type="checkbox"/> Changed <input type="checkbox"/> Deleted	WA0002470	08/10/23	I	S	<input checked="" type="checkbox"/> 2 Industrial	
Remarks						
Inspection work days	Facility Self-Monitoring	Photos Taken	Samples Taken	BI	QA

Section D: Summary of Findings/Comments

Maia Hoffman, Department of Ecology permit manager, conducted a site visit at Darigold Inc. Lynden Plant (Darigold Lynden). The site visit was arranged via email with Mike Jaynes. The purpose of the site visit was to review operations of the newly installed and operating condensate of whey (COW) water treatment system prior to discharge to the Nooksack River.

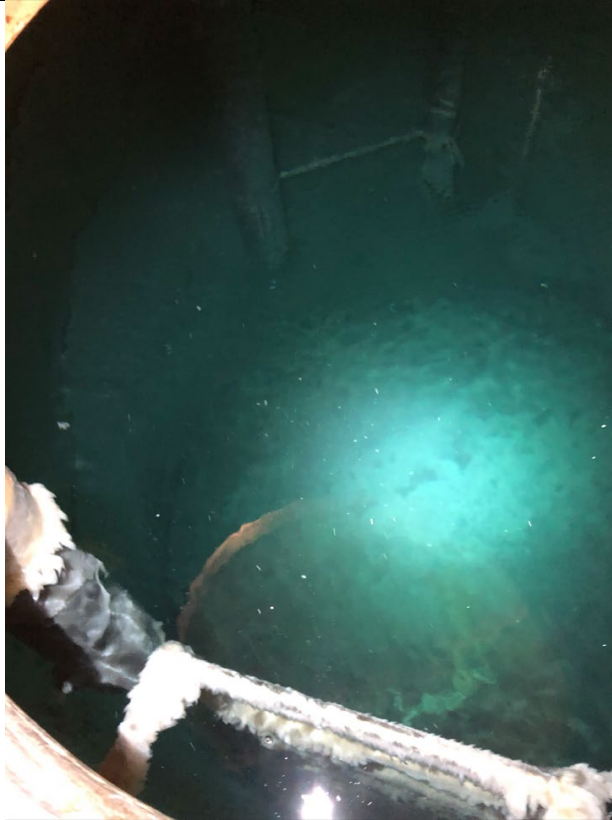
M. Jaynes said the system is operating well. There has been a noticeable decline in the growth of the biofilm and personnel have been able to reduce the tank cleaning frequency. Photo 1 shows the inside of the COW water treatment tank and the biofilm. At the time of the site visit, the tank had not been pressure washed in about 2 months.

Photo 1: View inside COW water treatment tank. Biofilm is the white material forming on the surfaces of the tank.

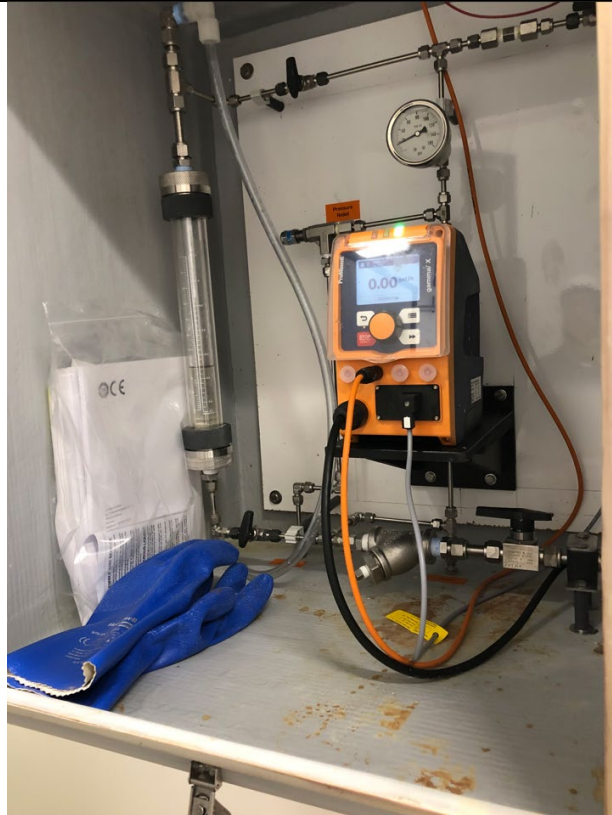
We viewed the caustic tank storage area and dosing system as well as the PAA storage area and dosing system (Photos 2, 3, 4, and 5). The caustic is stored indoors while the PAA is stored outdoors within containment. The odor from the PAA was slightly noticeable, particularly from the dosing pump cabinet. M. Jaynes had a carbon filter installed on the tank to minimize the odor.

Photo 2: Caustic dosing pump cabinet

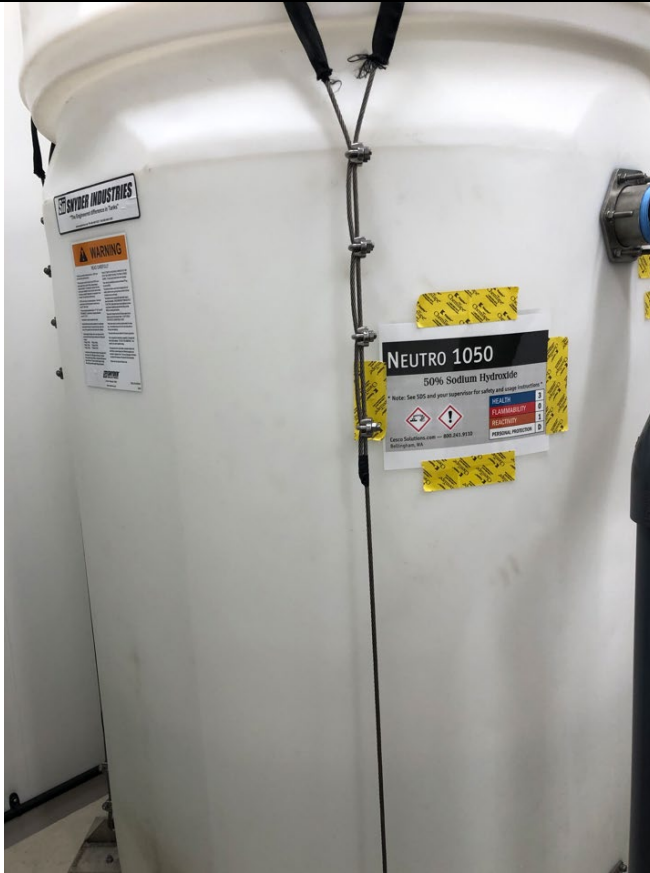
Photo 3: Caustic storage tank

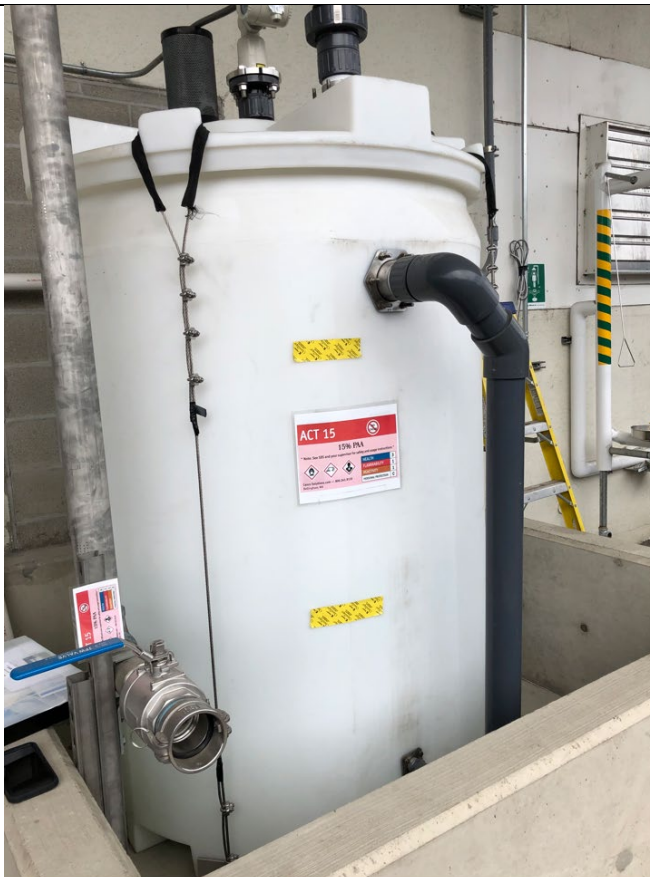
Photo 4: PAA storage tank located outdoors. The carbon filter is located on the top of the tank.

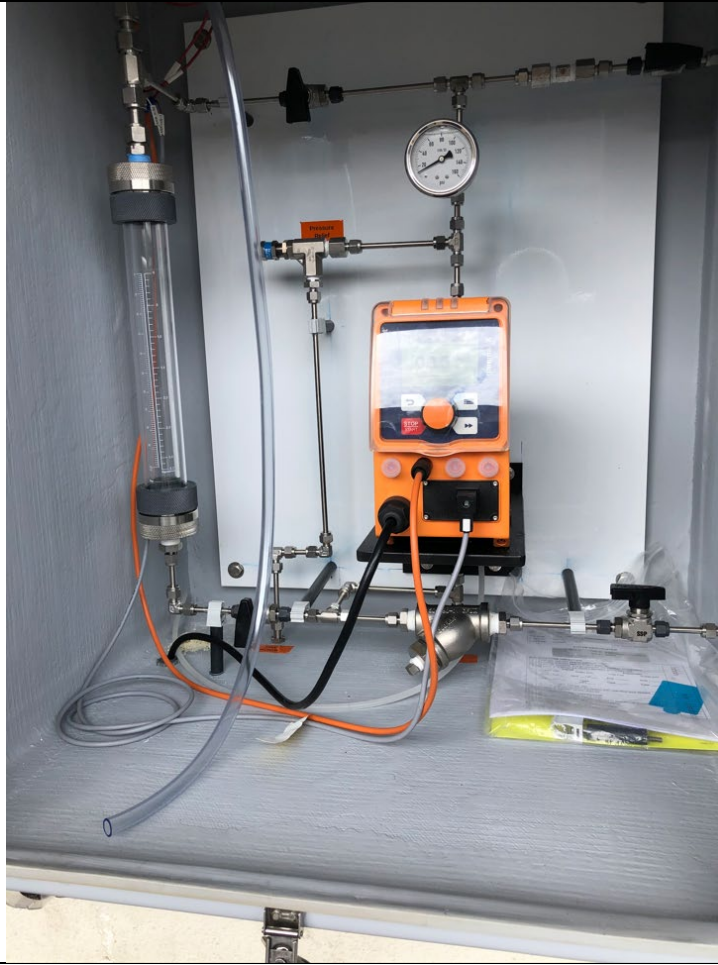
Photo 5: PAA dosing pump cabinet.

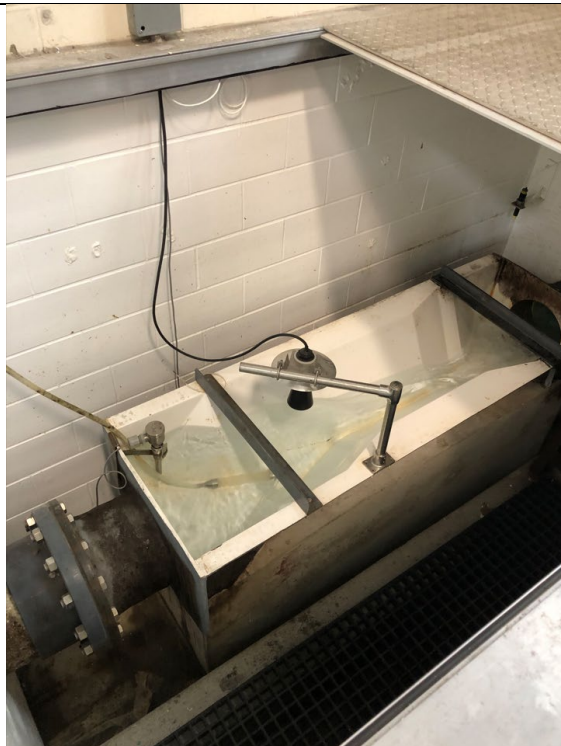
We then viewed the COW water effluent discharge point from the facility (Photo 6). The outfall is cleaned once per week with a brush. At the time of the visit, the effluent flow was about 233 gallons per minute. A new sampler was installed to take flow proportional composite samples.

Photo 6: COW water effluent flow meter and discharge point from facility.
