**STATE OF WASHINGTON
DEPARTMENT OF ECOLOGY**

Re: National Pollutant Discharge Elimination System (NPDES) Class Compliance
Inspection, NPDES Permit Number WA0041971

Enclosures: Ocean Companies National Pollution Discharge Elimination System Permit No.
WA0041971 Inspection Report August 8, 2023
Inspection Photo Log

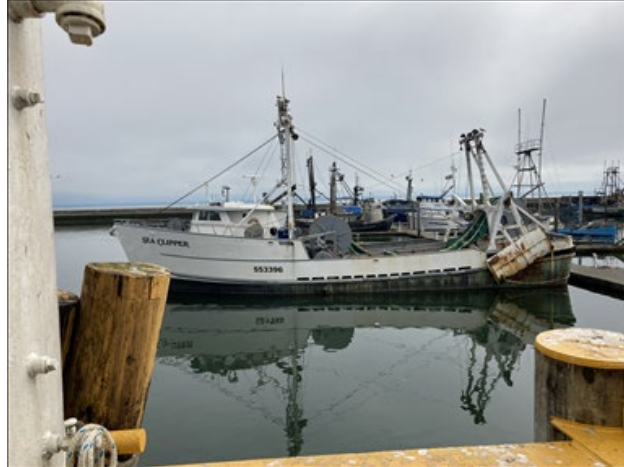
Photo 3. Sea Clipper - One of the vessels that delivers fish.

We started our tour at the Dock. This is the area where product is offloaded from the fishing vessels (Photo 3). Pacific whiting is kept in a refrigerated tank on the ships. The first part of the process is on the dewatering tank/block (Photos 1, 2, and 5). The fish are pumped off the boat through a large tube (Photo 4). The fish must be lubricated with seawater to flow through the tube. It is important that the fish are kept in seawater, so their biology/taste doesn't change. When the fish are separated from the water it generates lots of TSS etc. The fish are separated by size and then sent into respective totes for transportation to the processing building (Photo 6). Most of the water is returned to the boat. Spills are collected on the concrete pad which provides secondary containment for the dewatering process. There are two pumps, East and West. The water that is collected from the dewatering process is sent via sump (Photo 7 and 8) to the hydro-core in the "Goo House".

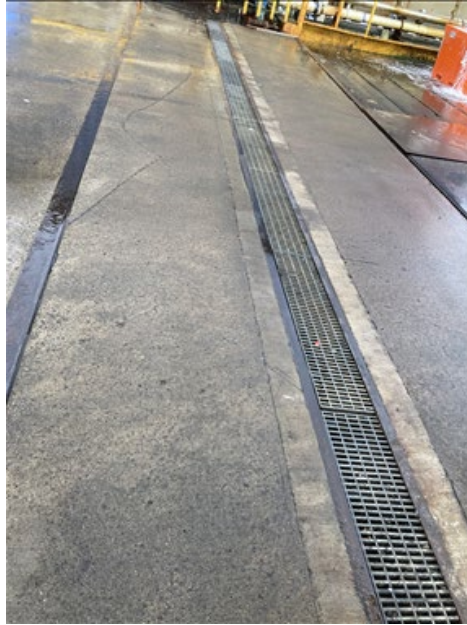
Photo 9. Drain in tote washing area that collects water that is sent for treatment.

We then move on to see the Goo House. As we walked from the dewatering block to the Goo House, Greg pointed out a "kicker" that was recently installed (Photo 11). This kicker was a BMP implemented to ensure all water from the dewatering process was collected in the appropriate drain (Photos 9 and 10). Greg informed me that they have a "no drip" policy and work hard to make sure all process water is going to the correct drains. During the walk to the Goo House, I observed two streams of continuously flowing water that was discharging into an orange tote and onto the Dock (Photo 12) Greg explained that they store live crab on the Dock, and they recirculate water from the bay. The water is not altered and thus is safe to flow back into the bay.

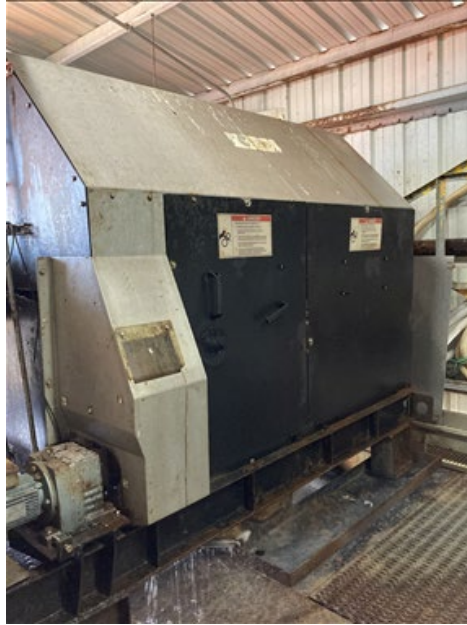
Photo 13. Rotary hydro-core screen. Upgrade that replaced a series of 5 sieves.

We entered the Goo House and Greg showed me the rotary hydro-core (Photo 13). The large hydro-core uses a 10 µm mesh to screen the water from the offloading of fish from the boats and the process water from the dewatering/sorting area. Greg explained that they recently upgraded to the large hydro-core and took 5 screens offline. Greg said that they are working on updating the O&M manual with this change and submitting it to Ecology. We looked at holding tanks T1 and T2 (Photo 14). These tanks hold pretreated water from the hydro-core which is then pumped through two 6-inch pipes to the treatment facility at Firecracker Point.

- 1) Ecology recommends improving secondary containment BMPs to ensure that all chemicals/other discharge will be captured in case of a spill.
- 2) Submit updated O&M manual reflecting the new hydro-core that replaced 5 screens.

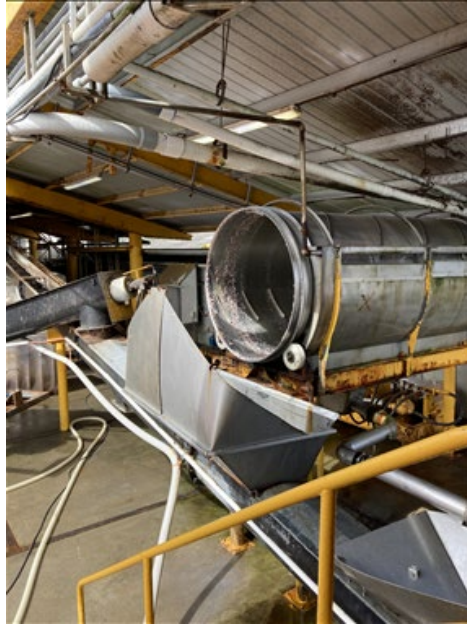
Photo 15. Second hydro-sieve that treats water from blue building.

Process water from the Blue Building (Photo 16) is pretreated through the large outdoor hydro-core (Photo 15). Currently the Blue Building is processing shrimp. The outdoor hydro-core is rated for 1000 gallons per minute (GPM) but they only process about 600 GPM. They have extra capacity to ensure treatment of process water and for potential expansion in the future. Previously they had problems meeting limits due to overcapacity. I asked if the birds were a problem and they said yes, at one point they had to overcome the "Great Pelican Invasion!"

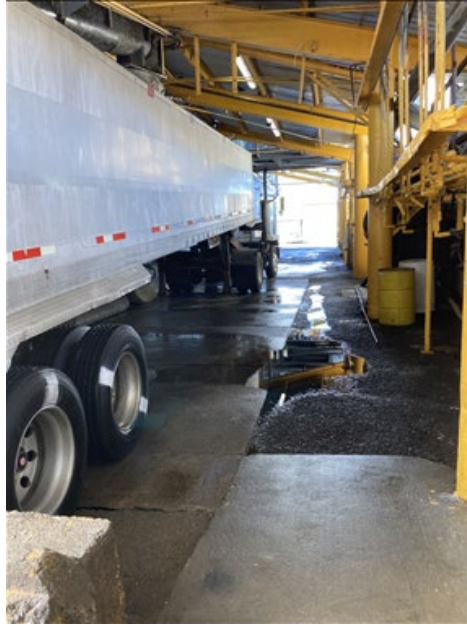
Photo 19. Loading bay for trucks that transport solid waste. Pavement collects water and it is collected in a drain for treatment.

The fish and seafood solid waste is collected in what they call "gut wagons" – large semi-trucks (Photo 18 and 19). Water from the truck pad is collected in the appropriate drain for treatment (Photo 20). The trucks transport the solid waste to Ocean Protein, an Ocean Companies facility in Hoquiam, WA. The French drain water (Photo 26 and 27) from the Blue Building goes to yellow vault (Photo 24) which is then pumped to outdoor hydro-sieve for screening (Photo 15).

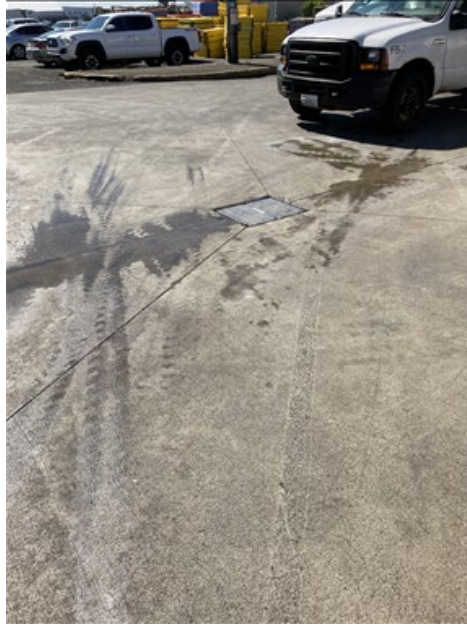
Photo 29. Relatively new cement pad for wet storage of totes. The drains collect runoff for treatment.

They also have a wastewater circuit (Photo 29) for wet tote storage where they implemented a large concrete pad with drains (Photo 30). In summary, the screened water flows to the new pipeline they installed under Dock/new concrete pour which runs to

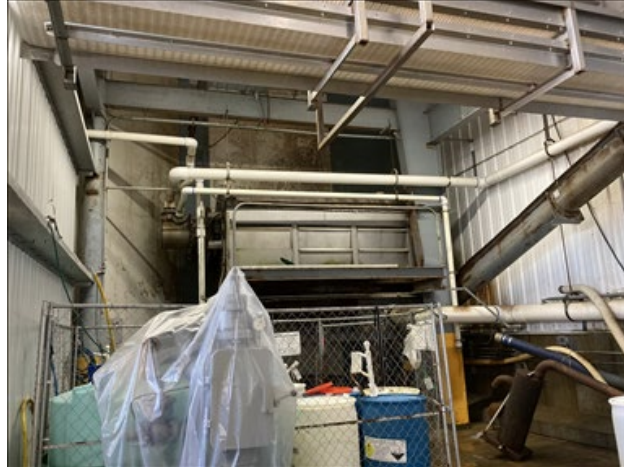
Photo 37. Hydro-sieve in Clear Ocean building.

The Clear Ocean facility is processing pacific whiting. Flat beds bring totes of fish from the Dock to the processing area (Photo 32 and 34). Pacific whiting is the main product at Clear Ocean (Photos 35 and 36). There is a large hydro-core in the Clear Ocean building that screens the process water (Photo 37). The large cement pad in front of the building has drains which are designated wastewater and are collected for treatment (Photo 33). I observed a large gut wagon on site (Photo 39). Greg explained that the first rain is a big problem. To help mitigate the bird guano outside they contract a sweeper to come quarterly. For stormwater, they have another vendor who comes and sucks out the waste vaults, so they do not get overwhelmed. Additionally, after first rain they always have the vaults cleaned. We briefly consulted with Mike who happened to be walking by. Greg called him over and Mike said that the wastewater has enough flow that first rain and bird guano does not cause a problem/upset for treatment.

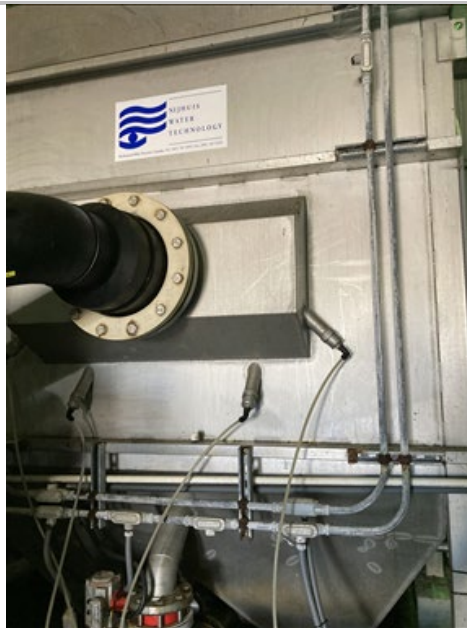
Photo 44. DAF Unit.

We met with Alan Fletcher (Treatment Facility Manager) and Brenda Belgado (Assistant). I chatted with them about the treatment process. They use various polymers and flocculants (Photos 49) to treat the process water, which are aluminum chloral hydrate, starch polymer, and peracetic acid. Greg prefers the starch polymer as it breaks down better in the water creating less secondary contamination. After chemical dosing, the process water goes into the DAF unit (Photo 44) for final treatment and discharge. The DAF unit is rated for 1,200 GPM, and they usually about 600 GPM.

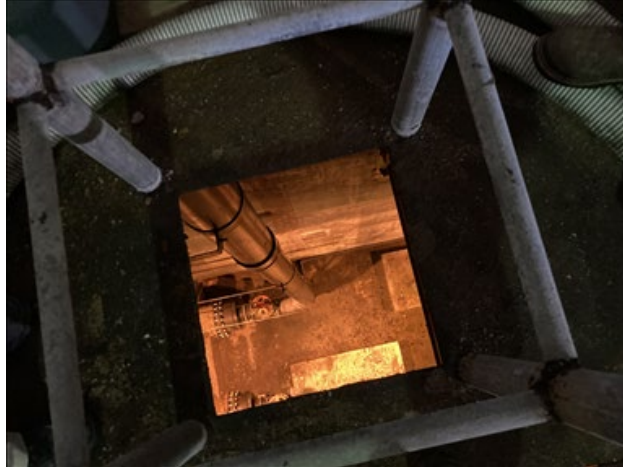
Photo 47. 30' deep vault. No longer holds water. There are sumps to pump water out in case of spills

The cement pad covering the 30-foot vault has openings in the floor (Photo 47). It is assumed that any spills will drain into the vault which is equipped with sumps. I asked Alan about the BOD₅ exceedance (which was the fecal coliform exceedance – my mistake). He stated that the lab had some problems with a bad plate. They used to use Dragon Labs, but it closed. They now use Spectra in Tacoma, but it is hard to get samples completed there and he often must drive to Poulsbo and deliver them himself. I mentioned that they need shore up their secondary containment for the chemicals (Photos 49). While the chemicals are on a cement pad that has openings to the vault below, there is no defined sloping for collecting a spill, and there are sections around the building where the berms are missing (Photo 50). The treatment building does not have a unique spill control plan; they use the one for the whole facility.
