Subject: Outfall Evaluation for NPDES Permit No. WA0040967  
Vancouver, Washington

**Annual Outfall Inspection - 2013****TOC Holdings Co. - HANDY ANDY #8**

**HANDY ANDY #8 - TOC Holdings No. 01-115**  
**Vancouver, Washington**

**NPDES Permit No. WA0040967**

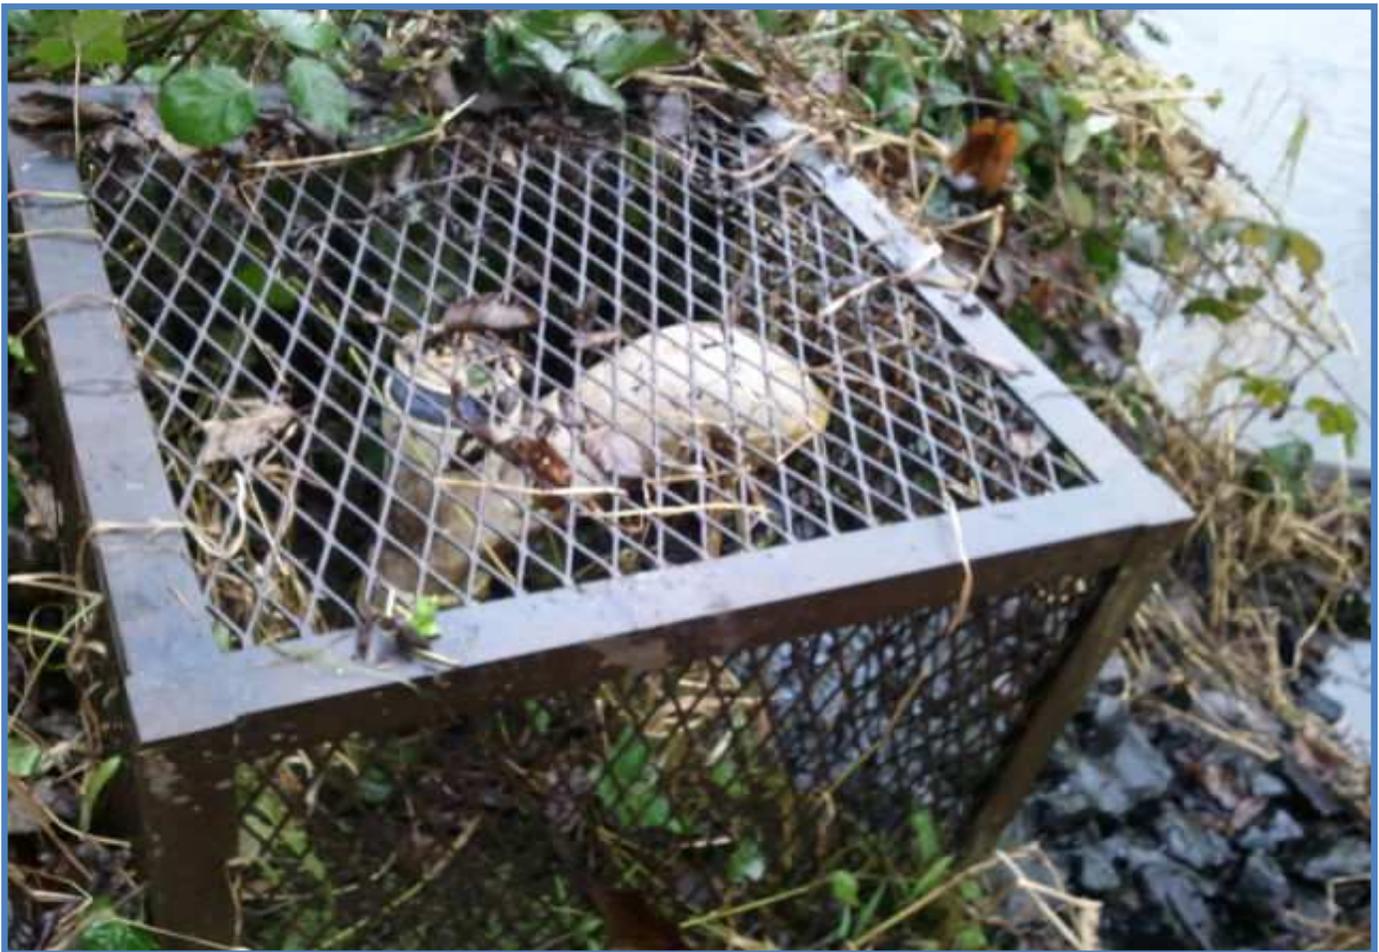
**Site Inspection Photograph**

On December 20, 2013, AMEC staff inspected the outfall pipe, its integrity and continued function in accordance with the NPDES waste discharge permit. An evaluation sheet and photograph taken of the outfall structure are attached. The physical condition of the outfall structure, including the P-trap (U-turn) at the top of the discharge pipe, the surrounding protective cage, concrete foundation, and diffusing rock arranged below the outfall pipe all appear to be in good condition and functioning as designed. There is no evidence of sediment accumulation inside the discharge pipe, in the P-trap and on the surrounding splash block/rock. The discharge pipe, P-trap and diffusing rock appear to be free of obstructions and are allowing uniform flow.

**Photograph Note:** Photo of the outfall during the inspection. Note that vegetation has been removed and structures is clear and draining normally (out to the right of the photo).
