<b>Notice of Violation (NOV)</b>	13337
<b>Docket #</b>	
<b>Project/Site Name</b>	Tom Crabtree Farm located in Whatcom County
<b>Project/Site Location</b>	9331 Hammer Road Lynden, WA 98264

Re: Notice of Violation

Attachment A – Photo Log

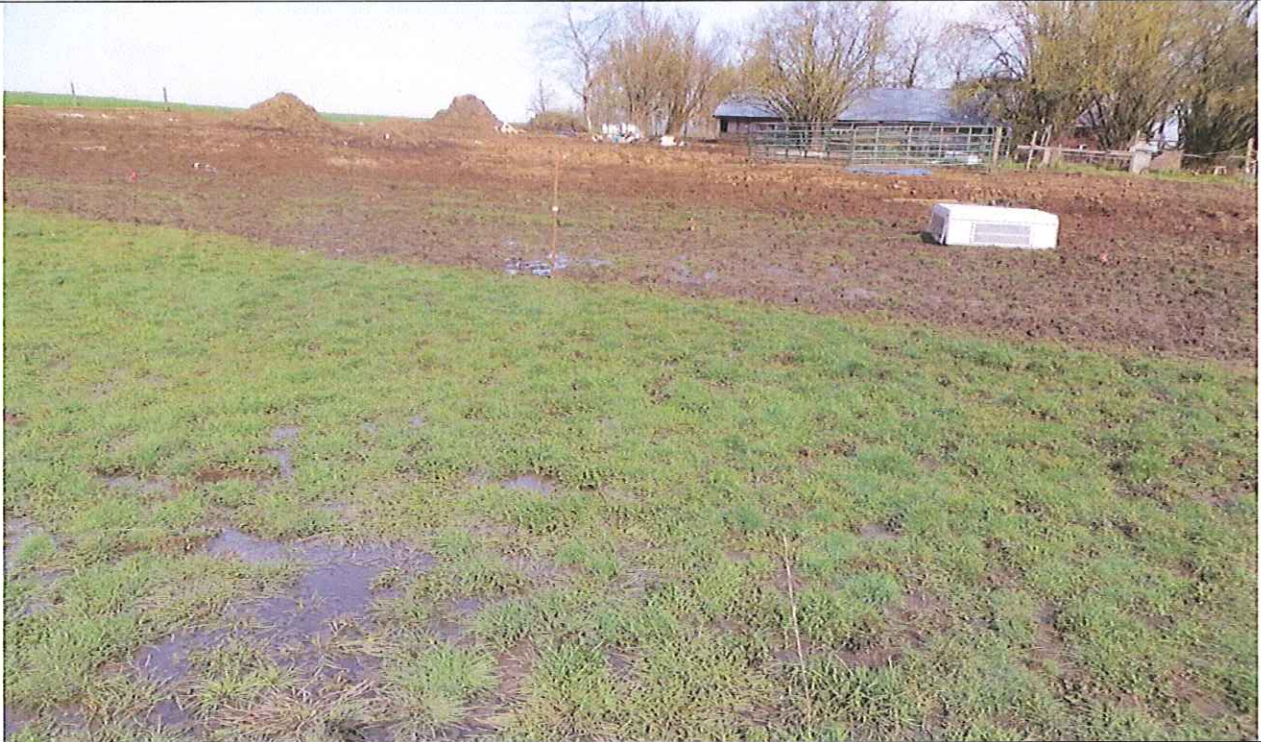
Photo 1 – March 26, 2013. This photo shows the horse confinement area on the south part of the property. The piles of manure are visible in the upper left. Groundwater was actively discharging through the manure contaminated confinement area and into a culvert that discharges to Pangborn Creek.

- Large piles of manure are stored, uncovered, on the ground in the horse confinement area. This area slopes towards a tributary of Pangborn Creek. See Photos 1 and 2 on Attachment A.

- The horse confinement area, which slopes to a tributary of Pangborn Creek, has heavy accumulations of mud and manure. The ground here is saturated for much of the year, and actively discharges manure contaminated water into a tributary of Pangborn Creek. See Photos 1-4 on Attachment A.

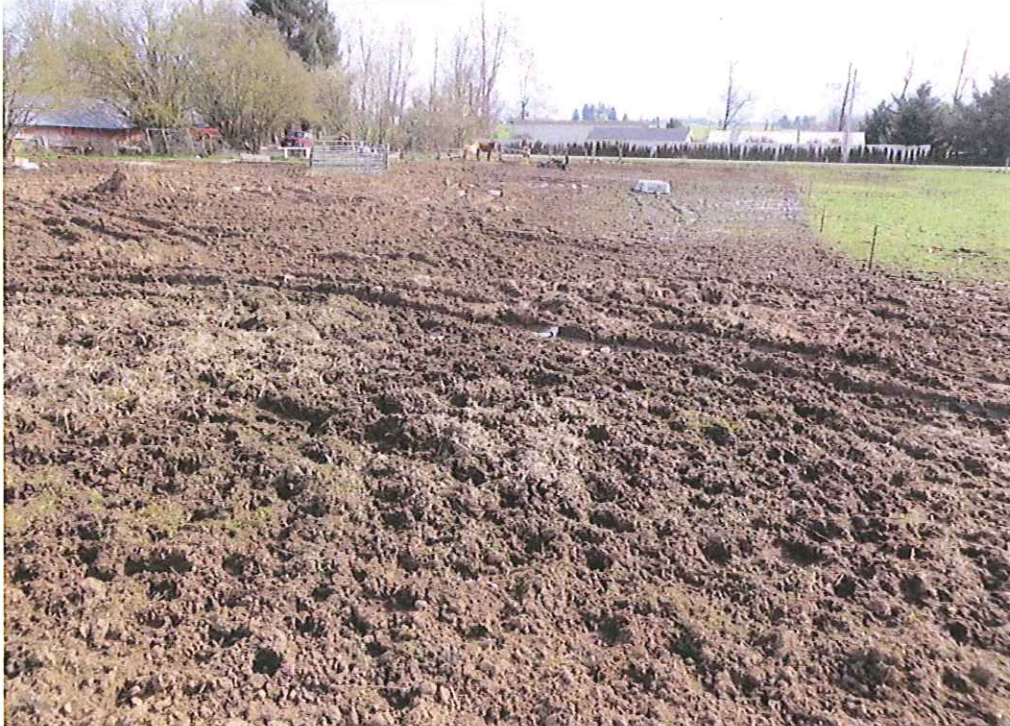
Photo 2 – March 26, 2013. This photo shows the horse confinement area. There is no vegetation and heavy accumulations of manure. The area slopes towards a culvert that discharges into Pangborn Creek.

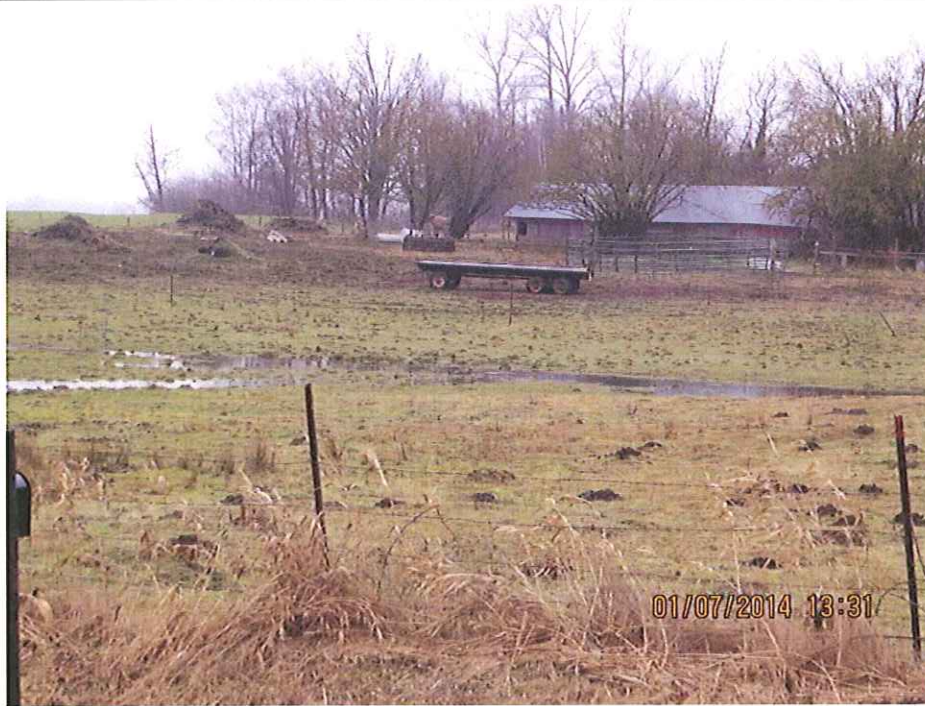
Photo 3 – January 7, 2014. This photo shows the horse confinement area. The surface water in the middle of the picture discharges through a culvert into Pangborn Creek.

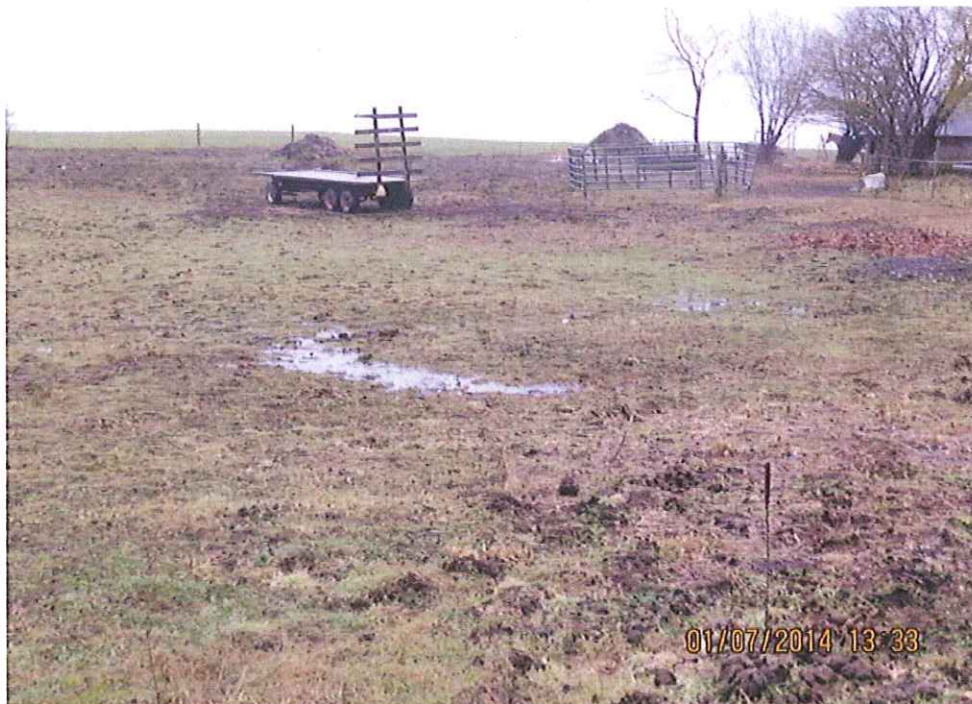
Photo 4 – January 7, 2014. This photo shows the horse confinement area. The area is not large enough to support a pasture, is overgrazed, has accumulations of manure, was saturated, and slopes towards the culvert that discharges into Pangborn Creek. The two mounds in the background are piles of manure.

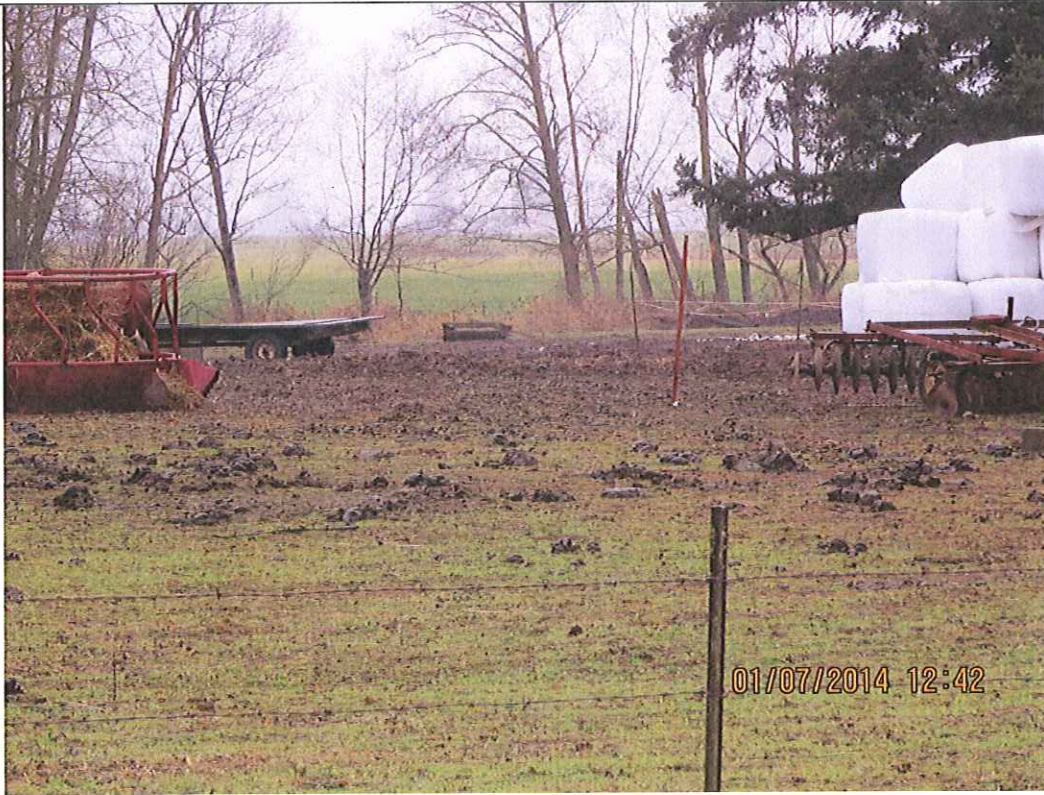
Photo 5 – January 7, 2014. This photo shows the cattle confinement area on the north side of the property. This area is adjacent to Pangborn Creek. The area is not large enough to support a pasture, was overgrazed, and had accumulations of mud and manure.

- Large portions of the cattle confinement area on the north side of Pangborn Creek are denuded of vegetation by cattle kept there over the winter. Manure accumulations were observed in portions of this field throughout the winter. Most of this confinement area slopes toward Pangborn Creek. See Photos 5, 6, and 8 on Attachment A.

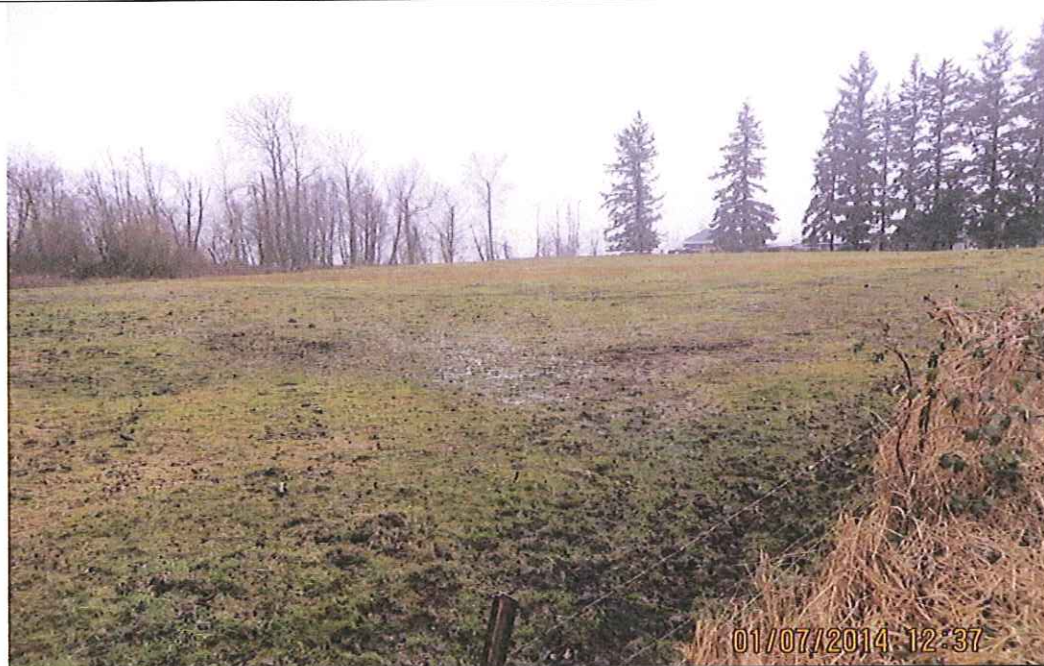
Photo 6 – January 7, 2014. This photo shows the cattle confinement area on the north side of Pangborn Creek. This area has sparse vegetation, accumulations of mud and manure, and is saturated during winter.

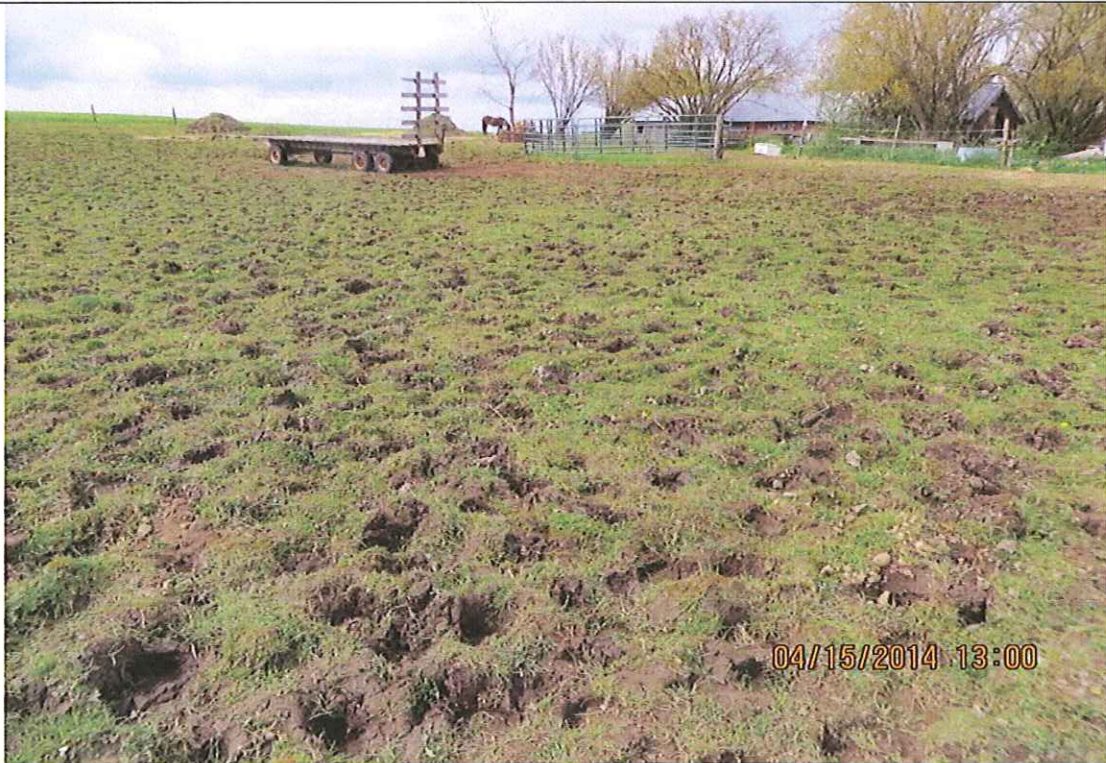
Photo 7, April 15, 2014. This photo shows the horse confinement area. The piles of manure are stored on the ground, and are not protected from precipitation. The horse confinement area has very sparse vegetation, is saturated, and has accumulations of manure.

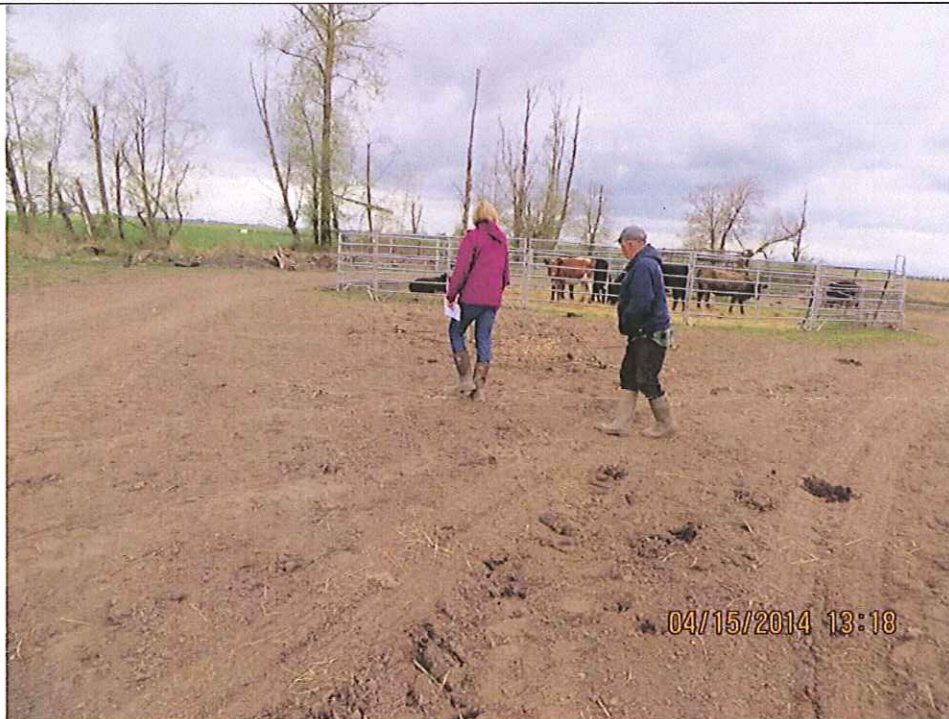
Photo 8 – April 15, 2014. This photo shows the cattle confinement area on the north side of the property. The cattle were allowed to trample the areas outside of the metal pen shown in the photo during the winter, as shown in Photo 5. This area generally slopes towards Pangborn Creek, visible in the upper left of the photo.
