State of Washington Department of Ecology
Northwest Regional Office
WATER COMPLIANCE INSPECTION REPORT

Name and Location of Facility Inspected (For industrial users discharging to POTW, also include POTW name and NPDES permit number) Hughes Farms 1325 Farm to Market Road Mount Vernon, WA 98273	Entry Time/Date 10:10 am 06/09/14	Permit Effective Date
	Exit Time / Date 12:50 pm 06/09/14	Permit Expiration Date

UNANNOUNCED Inspection

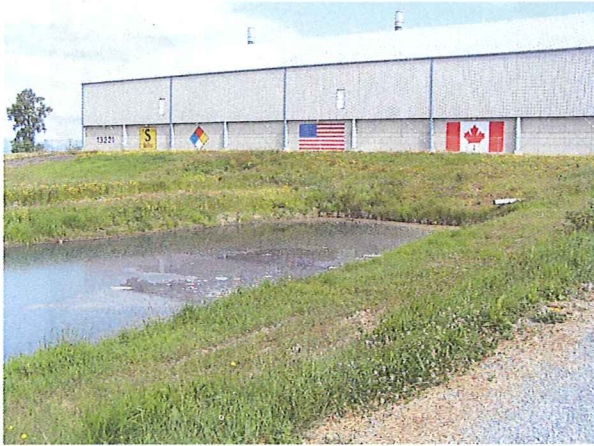
PHOTO #:01 DATE: 06/09/14 TAKEN BY: JEANNE TRAN
DESCRIPTION: A VIEW OF THE SETTLING POND THAT IS SHARED BY MULTIPLE NEARBY FACILITIES. HUGHES FARMS IS THE MAIN DISCHARGER TO THIS POND.

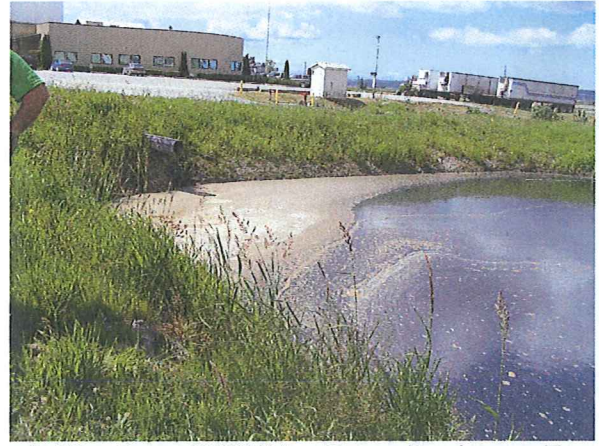
PHOTO #: 02 DATE: 06/09/14 TAKEN BY: JEANNE TRAN
DESCRIPTION: THIS PICTURE SHOWS HUGHES FARMS' OUTFALL PIPE. THE DISCHARGE COMING FROM HUGHES FARMS HAD A SLIGHT BROWN COLOR.

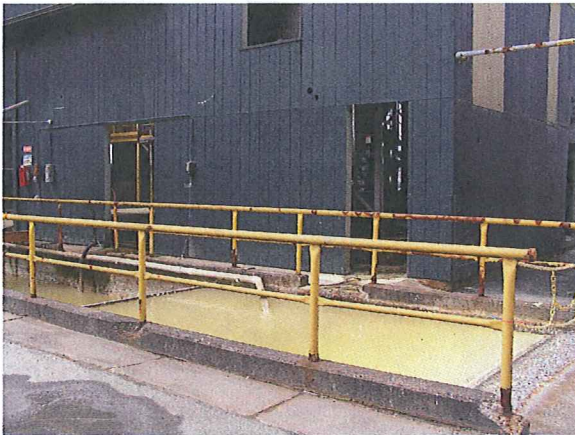
PHOTO #: 03 DATE: 06/09/14 TAKEN BY: JEANNE TRAN
DESCRIPTION: A VIEW OF THE CONCRETE TROUGH LOCATED IN THE BACK OF CHEMTRADE SULEX'S PLANT. THIS TROUGH IS USED FOR COLLECTING PRILLED SULFUR CONTACT WATER FOR REUSE.

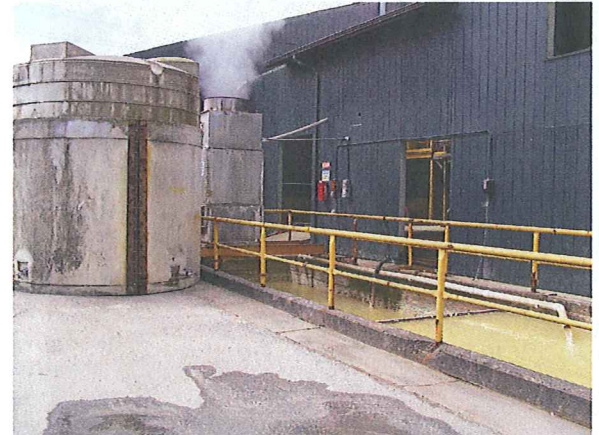
PHOTO #: 04 DATE: 06/09/14 TAKEN BY: JEANNE TRAN
DESCRIPTION: ANOTHER VIEW OF THE CONCRETE TROUGH AND WATER STORAGE TANK AND A COOLING TOWER.

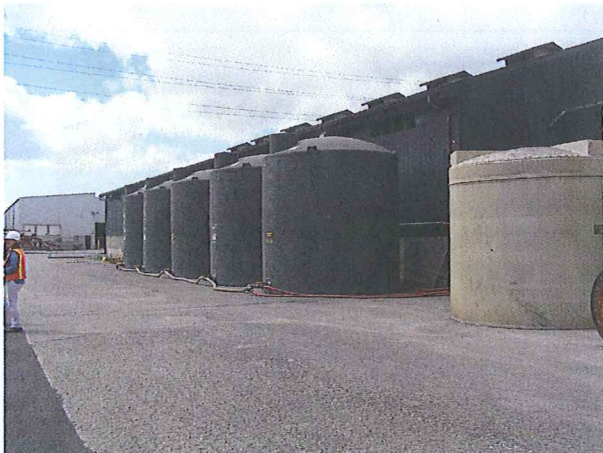
PHOTO #: 05 DATE: 06/09/14 TAKEN BY: JEANNE TRAN
DESCRIPTION: SIX NEW STORAGE TANKS WERE RECENTLY INSTALLED TO HOLD ALL WATER COLLECTED FROM THE SITE, INCLUDING STORMWATER, FOR REUSE PURPOSES.

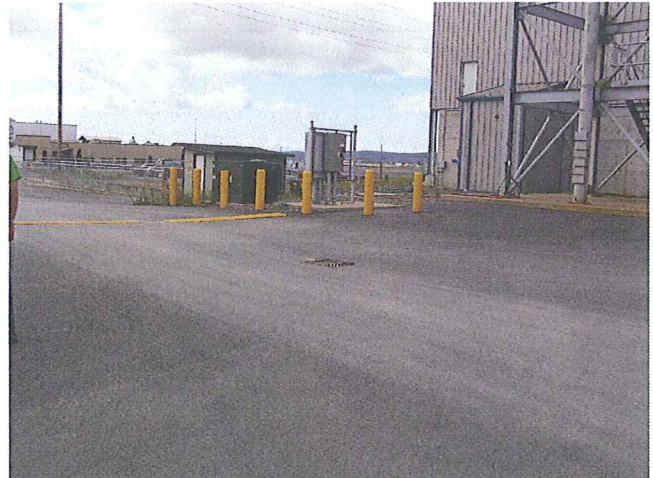
PHOTO #:06 DATE: 06/09/14 TAKEN BY: JEANNE TRAN
DESCRIPTION: A VIEW OF THE BACK OF THE SULFUR STORAGE SHED. THE GROUND APPEARED TO BE CLEAN WITH NO NOTICEABLE SULFUR DUST.

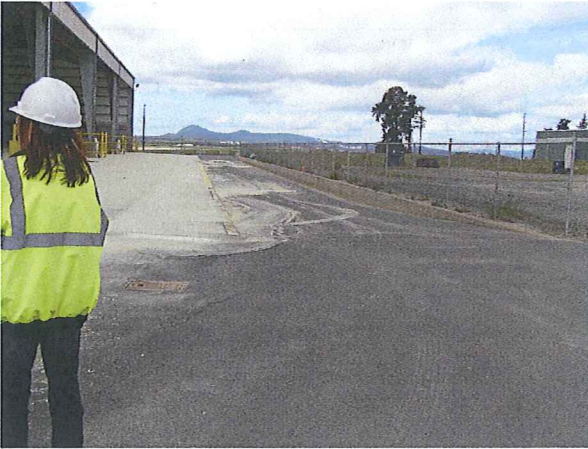
PHOTO #:07 DATE: 06/09/14 TAKEN BY: JEANNE TRAN
DESCRIPTION: CHEMTRADE'S SECOND LOADING RACK. SULFUR WAS FOUND OUTSIDE THE STORAGE SHED AND ON THE LOADING AREA. JEANNE SUGGESTED THE FACILITY TO INCREASE THE SWEEPING FREQUENCY TO REDUCE AND PREVENT TRACK OUT.

Inspection at Chemtrade Sulex: At approximately 10:55 am, Chemtrade's staff assisted us in a walk through inspection of their plant. The plant was generally clean with little yellow sulfur dust on the ground. We walked through the back of the plant and looked at their concrete catch basin and water storage water tanks (See photos 3,4, and 5). We continued on and walked around the back of the roofed prilled sulfur storage shed. This area was generally clean. At this roofed sulfur storage shed, we observed some sulfur dust in the truck loading area immediately adjacent to the shed. This area is approximately 350 feet away from the settling pond. Pat informed us that the truck loading area is swept frequently. Then, we walked to the settling pond. The water in the pond was black with bubbles rising to the surface of the pond. We observed the discharge from Hughes Farms, and the discharge has a brown color. We also detected a sewage odor like, but not a rotten egg odor. Next, we walked to the new roofed storage shed, north of the site. In this area, we observed sulfur product on the truck loading area, outside of the storage shed (see photo #7). Jeanne encouraged the facility to increase housekeeping frequency in this area. Stormwater from this site is collected and it does not drain to the settling pond. We also noticed a muddy draining path coming from the neighboring facility to Chemtrade's storm drain (See photo 8), since the land is slightly sloped toward Chemtrade's premises. This suggested that stormwater draining from the neighboring facility to this storm drain was somewhat muddy, leaving a muddy draining path in the area. Jeanne encouraged Chemtrade's staff to work with the neighboring facility to keep the area clean.

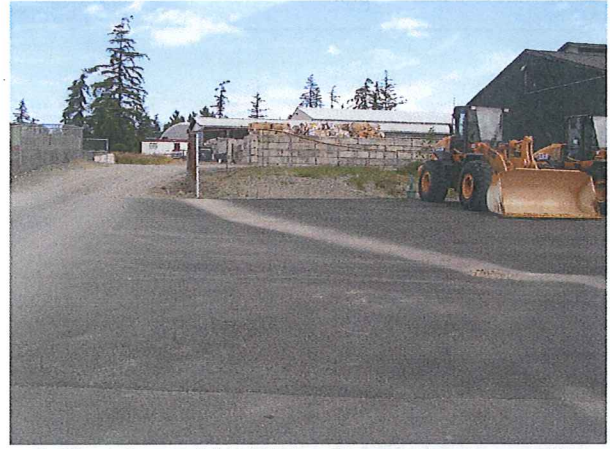
PHOTO #:08 DATE: 06/09/14 TAKEN BY: JEANNE TRAN
DESCRIPTION: THIS PICTURE SHOWS A PATH OF MUDDY STORMWATER FROM THE NEIGHBORING FACILITY WHICH HAD BEEN FLOWING TO CHEMTRADE'S STORMWATER DRAIN.

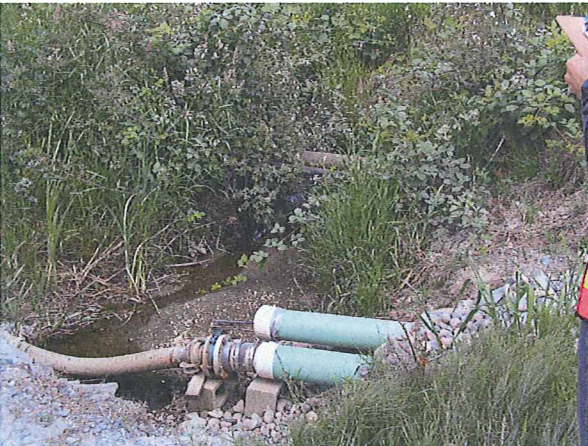
PHOTO #:09 DATE: 06/09/14 TAKEN BY: JEANNE TRAN
DESCRIPTION: HUGHES FARMS PIPED THE WATER FROM THE SETTLING POND TO THE FARM FIELD LOCATED ACROSS THE STREET FROM THEIR PLANT.

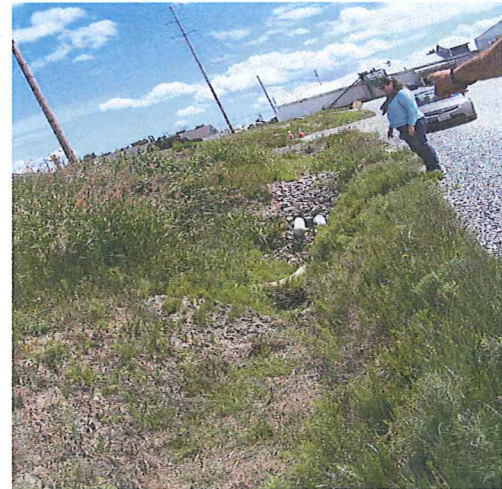
PHOTO #:10 DATE: 06/09/14 TAKEN BY: JEANNE TRAN
DESCRIPTION: ANOTHER VIEW OF THE SETTLING POND'S OUTLET PIPE CONNECTING TO A HOSE WHICH CARRIES THE WATER TO THE FARM FIELD.

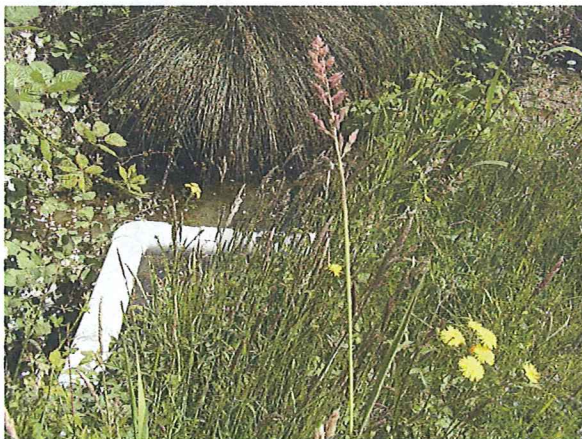
PHOTO #:11 DATE: 06/09/14 TAKEN BY: JEANNE TRAN
DESCRIPTION: A VIEW OF THE PVC PIPE TRANSPORTING THE WATER TO THE FARM FIELD. THE PVC PIPE RUNS UNDERNEATH THE ROAD, ACROSS THE STREET TO THE FARM FIELD.

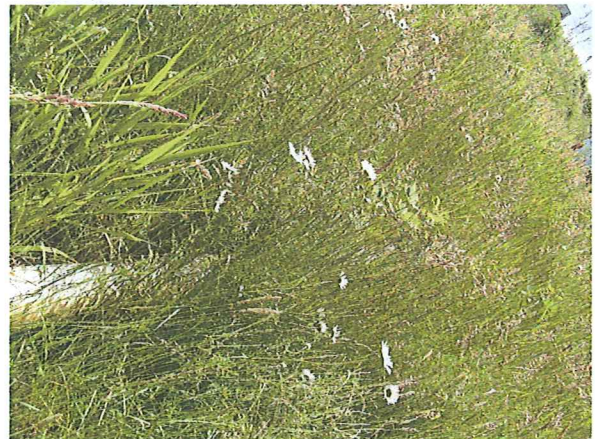
PHOTO #:12 DATE: 06/09/14 TAKEN BY: JEANNE TRAN
DESCRIPTION: THE PVC PIPE WAS TRACED TO THE FARM FIELD.

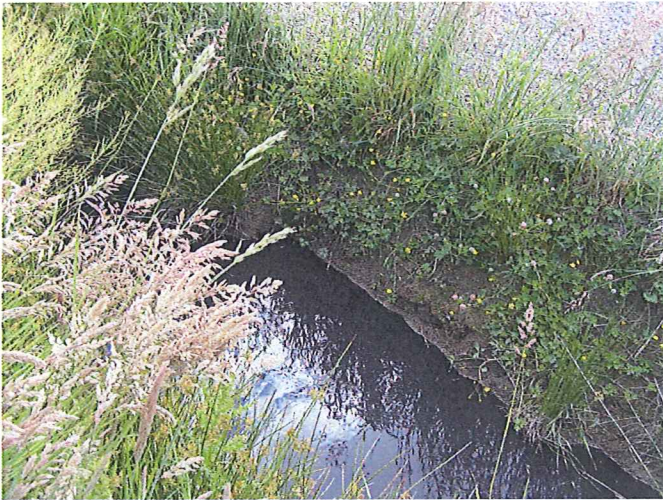
This inspection was prompted by a complaint received from Skagit County Public Works Department regarding discharge from the settling pond shared by Hughes Farms, Chemtrade Sulex, and other nearby facilities. Cheryl Thompson and Jeanne Tran met with Pat Murphy, Renee Westlund, and Lisa Trevino from Chemtrade Sulex, and Steve Kramar and Lori Wight from Skagit County Department of Public Works at 10:10 am in Chemtrade's conference room. Steve and Lori expressed concerns regarding the discoloration and the odor of the water in the settling pond and in the field ditch (See photos 13 through 17).

PHOTO #:13 DATE: 06/09/14 TAKEN BY: JEANNE TRAN
DESCRIPTION: WATER IN THE FIELD DITCH WAS BLACK.

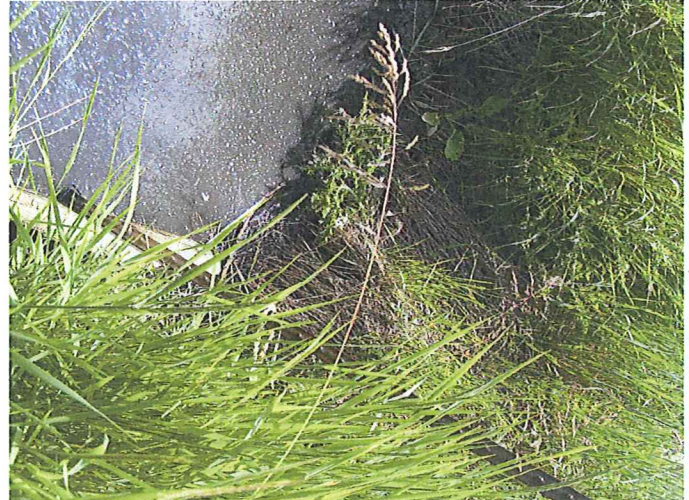
PHOTO #:14 DATE: 06/09/14 TAKEN BY: JEANNE TRAN
DESCRIPTION: BUBBLES WERE OBSERVED RISING TO THE SURFACE OF DITCH.

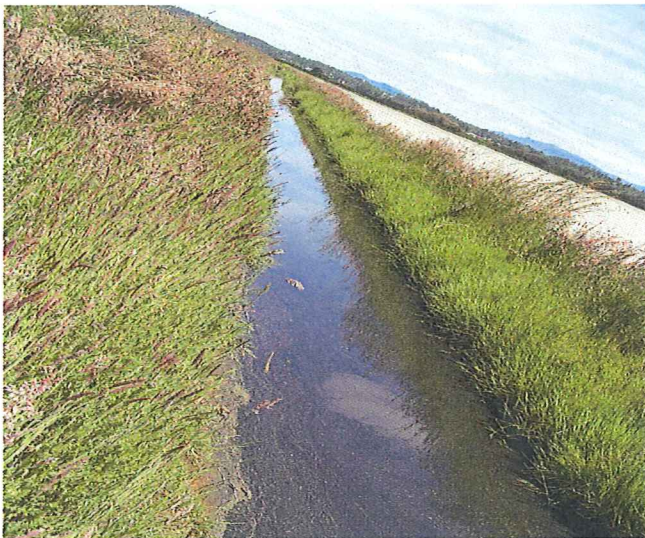
PHOTO #:15 DATE: 06/09/14 TAKEN BY: JEANNE TRAN
DESCRIPTION: THE FIELD DITCH WAS LONG.

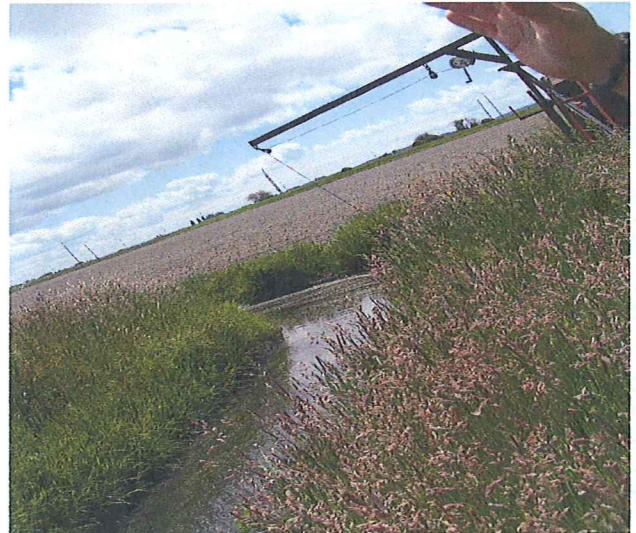
PHOTO #:16 DATE: 06/09/14 TAKEN BY: JEANNE TRAN
DESCRIPTION: ANOTHER VIEW OF THE FIELD DITCH.

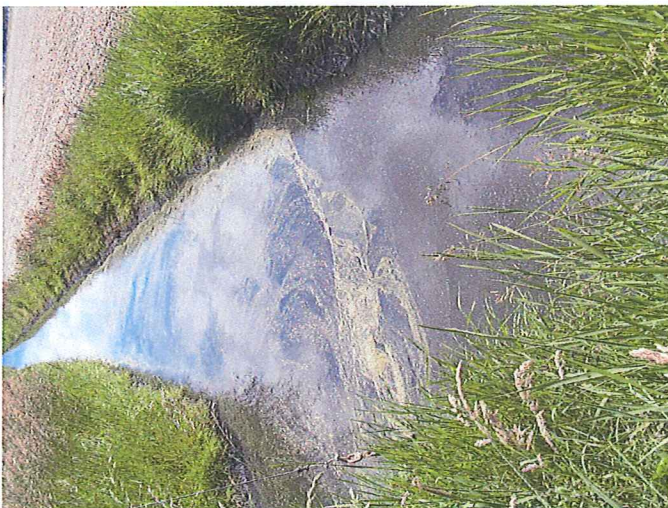
PHOTO #:17 DATE: 06/09/14 TAKEN BY: JEANNE TRAN
DESCRIPTION: A CLOSE UP VIEW OF THE WATER.

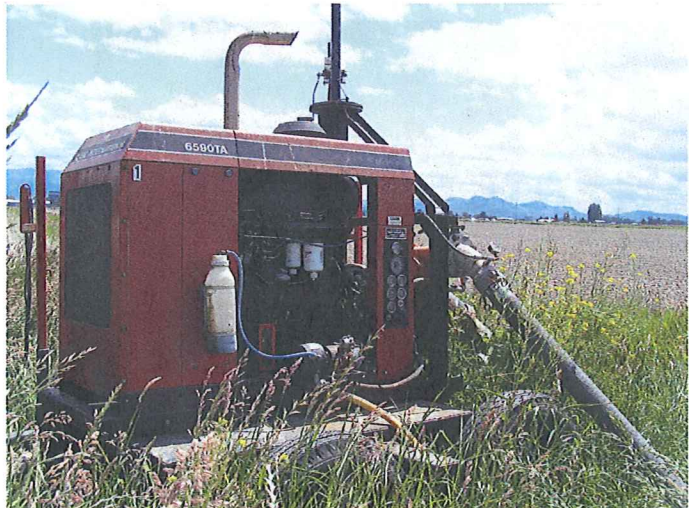
PHOTO #:18 DATE: 06/09/14 TAKEN BY: JEANNE TRAN
DESCRIPTION: WATER FROM THE DITCH WAS WITHDRAWN BY THE FIELD PUMP FOR IRRIGATION.

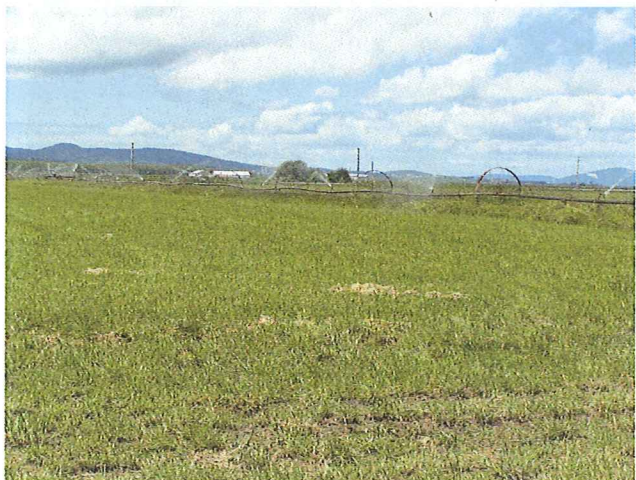
PHOTO #:19 DATE: 06/09/14 TAKEN BY: JEANNE TRAN
DESCRIPTION: A VIEW OF THE IRRIGATION SYSTEM AND FARM FIELD.

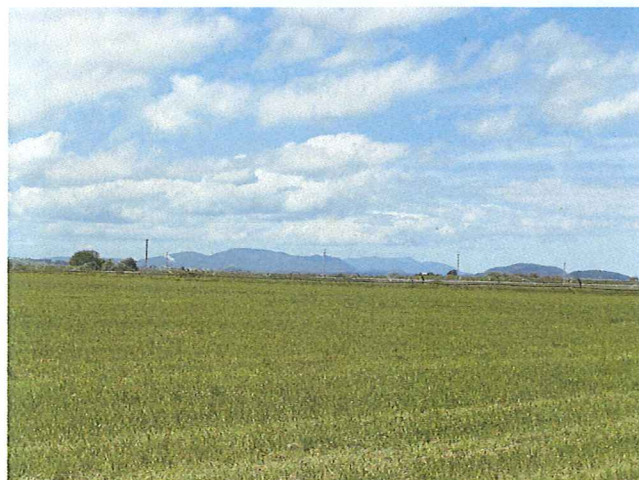
Inspection at Hughes Farms' Farm Field: We drove to the farm field where Hughes Farms uses it as their land application site. This field is located across the street from the plant, on Farm to Market Road (See photos 19 through 21). The water from the settling pond is routed to the field ditch. The water in the ditch was then withdrawn (See photo 18) and applied to the farm field through an irrigation system. The field ditch was long and it branched off and divided. Each end except for the receiving end was blocked off with a plywood covered with plastic material. Since the plywood does not provide a 100% seal, water travels around the plastic covered plywood and through the soil column to the other side. We noticed the water on the other side of the plastic covered plywood had a brownish color rather than black. After a short distance, the water was cleared up and the odor disappeared. Jeanne informed Steve and Lori that she will follow up with sampling to investigate the source of the discoloration.

PHOTO #:20 DATE: 06/09/14 TAKEN BY: JEANNE TRAN
DESCRIPTION: ANOTHER VIEW OF THE FARM FIELD.

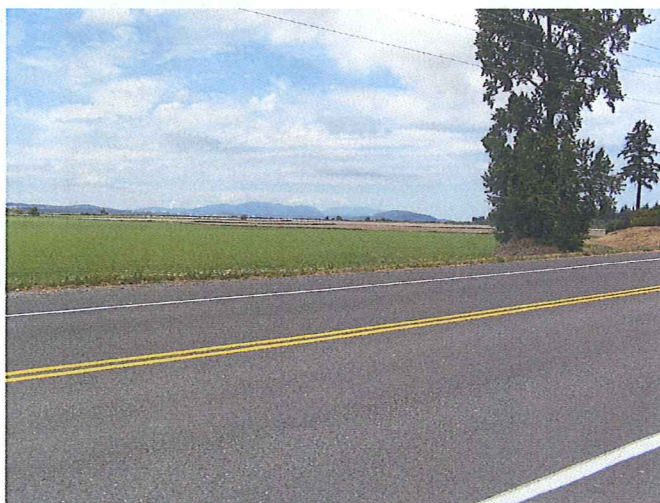
PHOTO #:21 DATE: 06/09/14 TAKEN BY: JEANNE TRAN
DESCRIPTION: A VIEW OF THE FARM FIELD TAKEN ACROSS THE STREET.

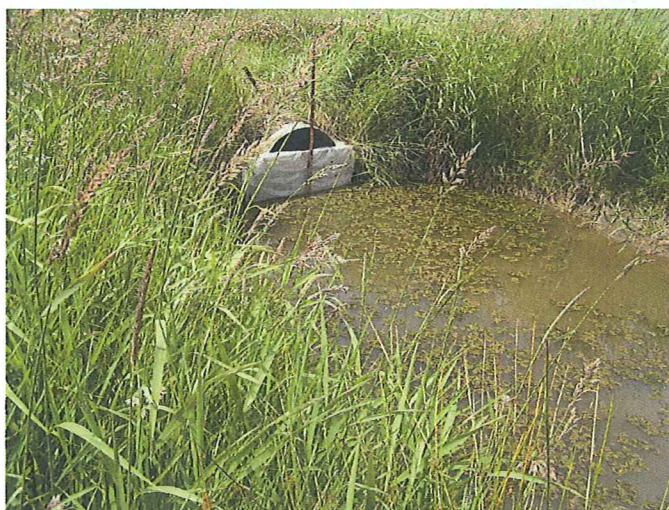
PHOTO #:22 DATE: 06/09/14 TAKEN BY: JEANNE TRAN
DESCRIPTION: A MAN-MADE PLYWOOD COVERED WITH PLASTIC TO ISOLATE THE WATER IN THE FIELD DITCH.

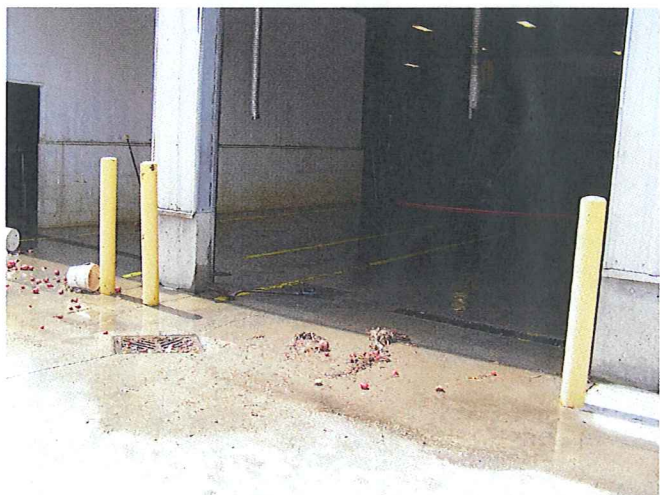
PHOTO #:23 DATE: 06/09/14 TAKEN BY: JEANNE TRAN
DESCRIPTION: A VIEW AT THE POTATO OFF-LOADING AREA. FLOOR WASH WATER IS DRAINED TO THE UNDERGROUND VAULT.

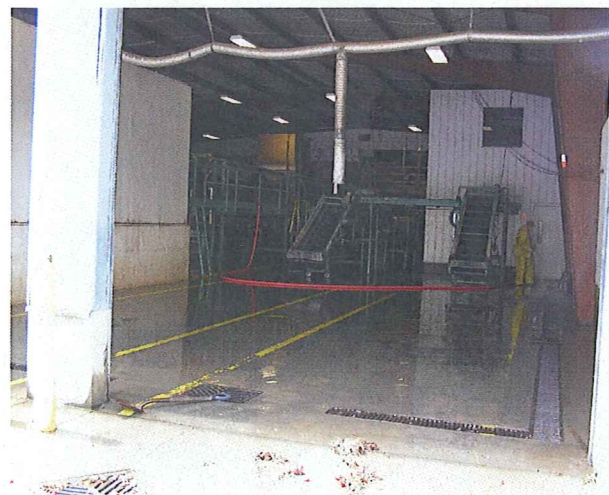
PHOTO #:24 DATE: 06/09/14 TAKEN BY: JEANNE TRAN
DESCRIPTION: THE POTATO WASHER LINES. THE SHIFT WAS OVER WHEN WE INSPECTED PLANT.
