State of Washington Department of Ecology  
Northwest Regional Office

**WATER COMPLIANCE INSPECTION REPORT**

**PHOTO ADDENDUM – BLAU OYSTER CO., INC. WA002926-2**

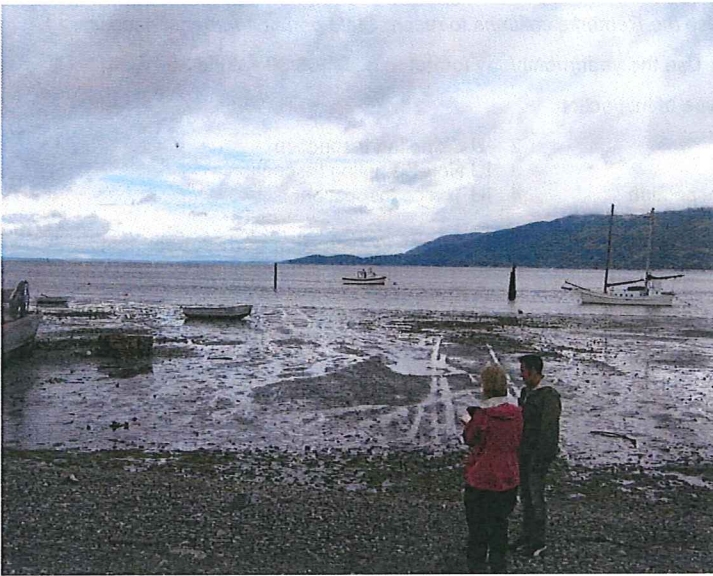
PHOTO #:01 DATE: 05/05/2015  
TAKEN BY: SHAWANNA TUFONO  
DESCRIPTION: SAMISH BAY, OUTFALL #001 DISCHARGES OUT PIPE TO BEACH.

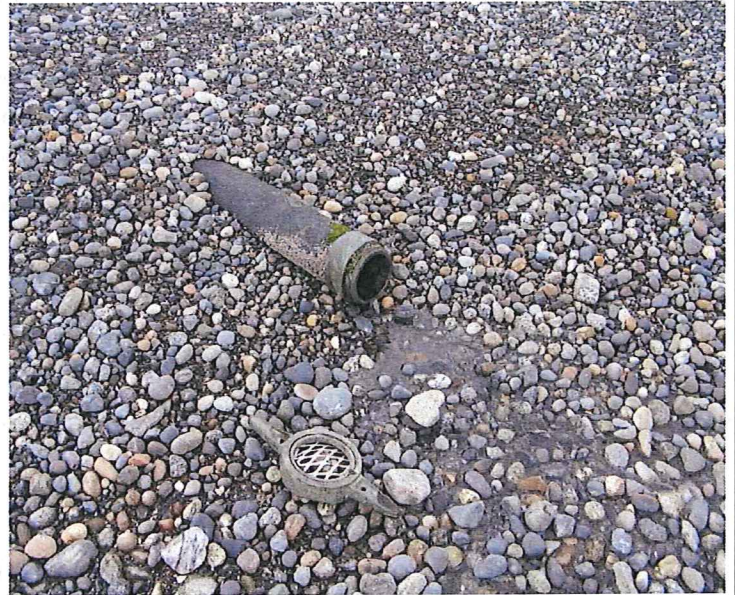
PHOTO #:02 DATE: 05/05/2015  
TAKEN BY: SHAWANNA TUFONO  
DESCRIPTION: CLOSE UP OF OUTFALL #001. SAMPLE TAKEN HERE.

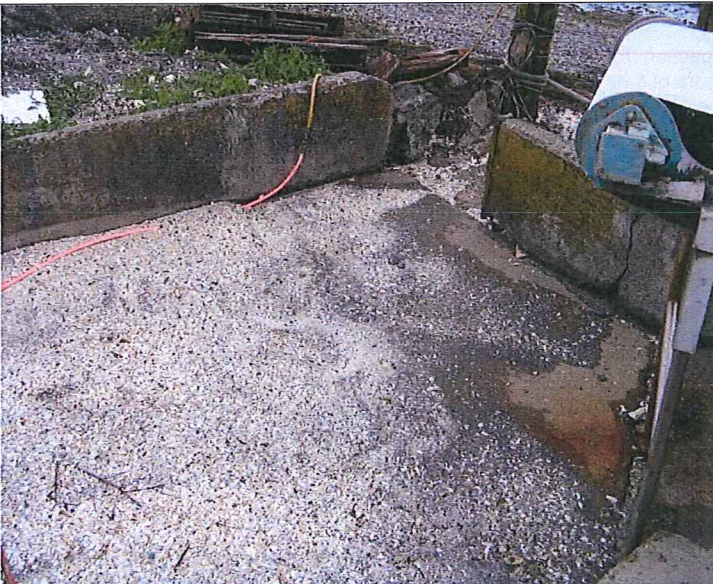
PHOTO #:03 DATE: 05/05/2015  
TAKEN BY: SHAWANNA TUFONO  
DESCRIPTION: OUTFALL #002, COMPOSED PRIMARILY OF SHELL WASHWATER PRIOR TO ENTERING FACILITY.

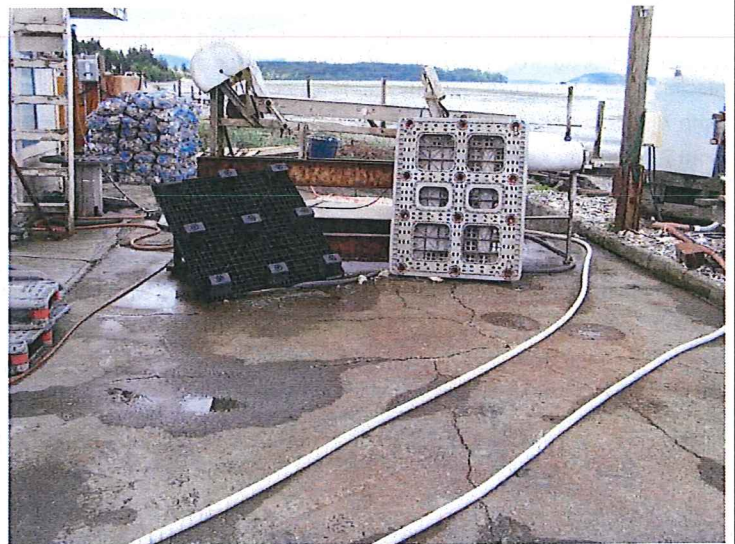
PHOTO #:04 DATE: 05/05/2015  
TAKEN BY: SHAWANNA TUFONO  
DESCRIPTION: SOURCE OF DISCHARGE TO OUTFALL #002 IS WASH WATER FROM INCOMING SHELLFISH FROM BAY.

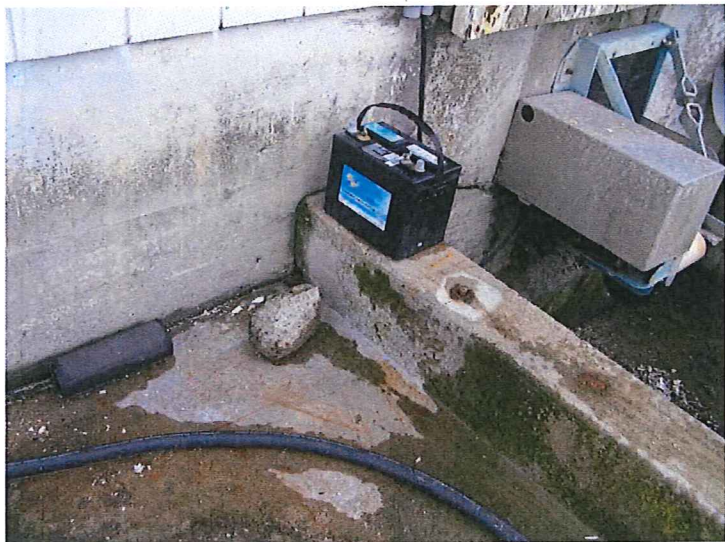
PHOTO #:05 DATE: 05/05/2015  
TAKEN BY: SHAWANNA TUFONO  
DESCRIPTION: BATTERY, NEEDS TO BE STORED IN SHED.

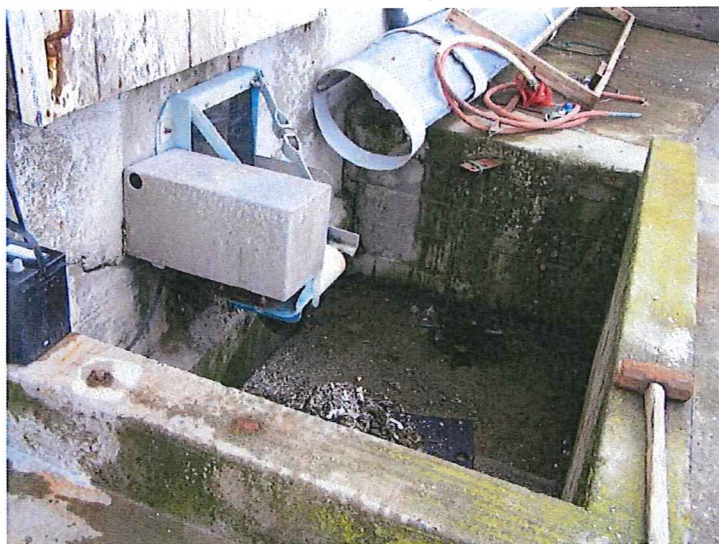
The conveyor belt that usually takes the shells from the shucking table, to a truck that then drives to the shell piles is not operational. Until the belt is replaced, shells are placed into baskets and manually put in trucks and taken to the piles.

PHOTO #:06 DATE: 05/05/2015  
TAKEN BY: SHAWANNA TUFONO  
DESCRIPTION: SOLIDS FROM SHELL TABLE CONVEYED TO THIS OUTSIDE SUMP THEN TO TRUCK FOR LAND DISPOSAL, WHEN CONVEYOR WORKING. WATER DISCHARGES OUT #002.

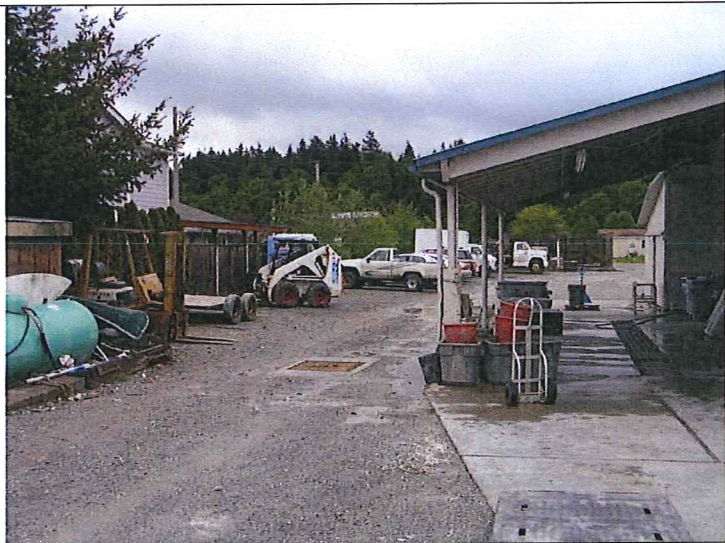
Solids cleaned out of the sump leading to outfall #001 and the shucking room are put in totes and taken to the shell pile. Solids from the cleaning room are bagged and picked with other garbage by a contract hauler for disposal.

PHOTO #:07 DATE: 05/05/2015  
TAKEN BY: SHAWANNA TUFONO  
DESCRIPTION: GRATED SUMP IN DRIVEWAY, FLOWS TO OUTFALL #001. SOLIDS CLEANED OUT WEEKLY AND SENT TO SHELL PILE.

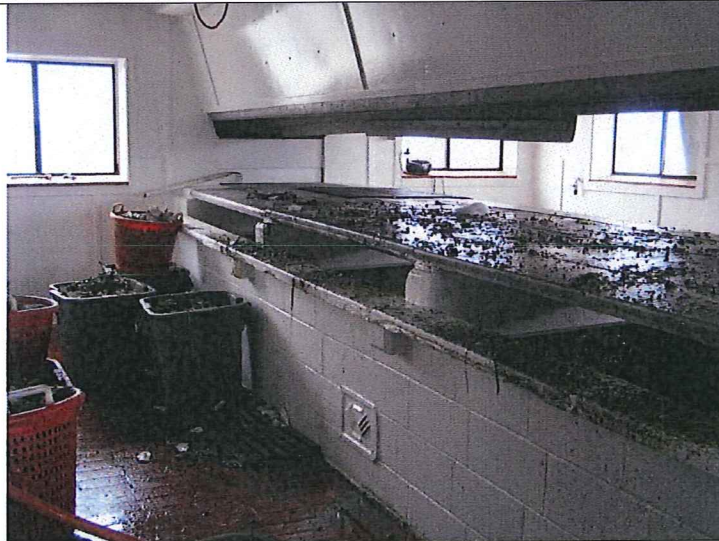
PHOTO #:08 DATE: 05/05/2015  
TAKEN BY: SHAWANNA TUFONO  
DESCRIPTION: SHUCKING TABLE. WASHED SHELLS DROPPED ON TABLE FROM UPPER HOPPER. SOLIDS CONVEYED OUTSIDE AND TRUCKED TO SHELL PILE. WASHWATER FLOWS OUT #001.

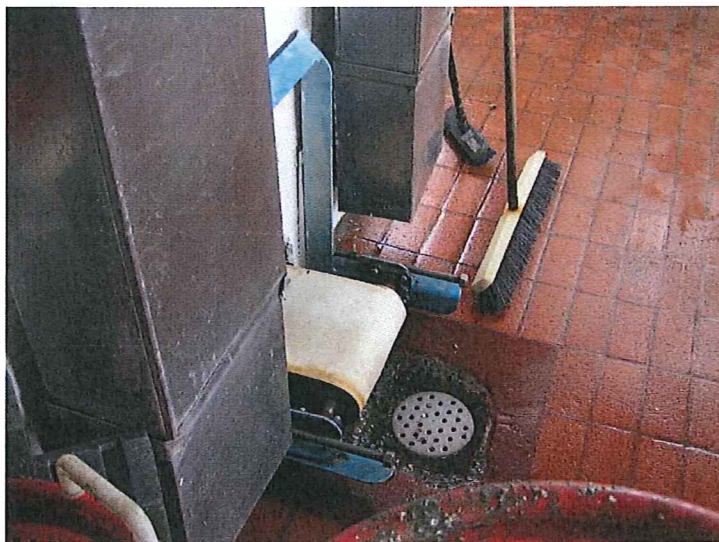
PHOTO #:09 DATE: 05/05/2015  
TAKEN BY: SHAWANNA TUFONO  
DESCRIPTION: SCREENED OUTFALL BY SHUCKING TABLE. FLOW GOES TO OUTSIDE SUMP THEN OUT OUTFALL #001.

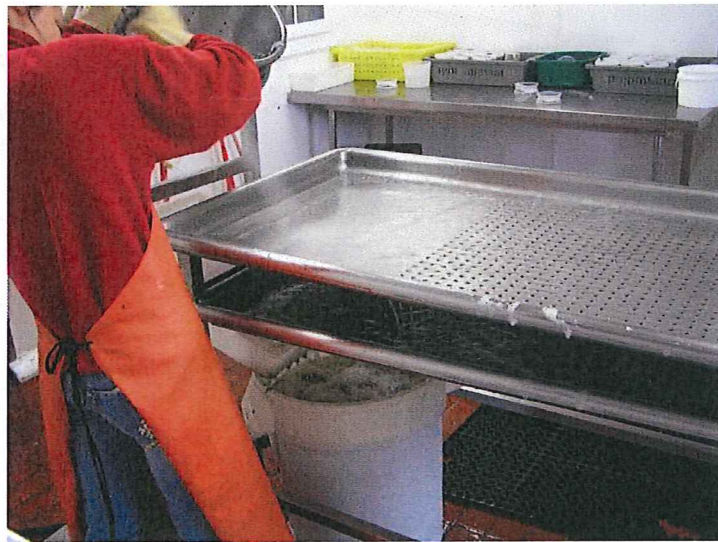
PHOTO #:10 DATE: 05/05/2015  
TAKEN BY: SHAWANNA TUFONO  
DESCRIPTION: OYSTER MEAT WASH TABLE. BUCKET UNDER TABLE COLLECTS SOLIDS, WHICH ARE DEWATERED AND PUT INTO DUMPSTER FOR REMOVAL.

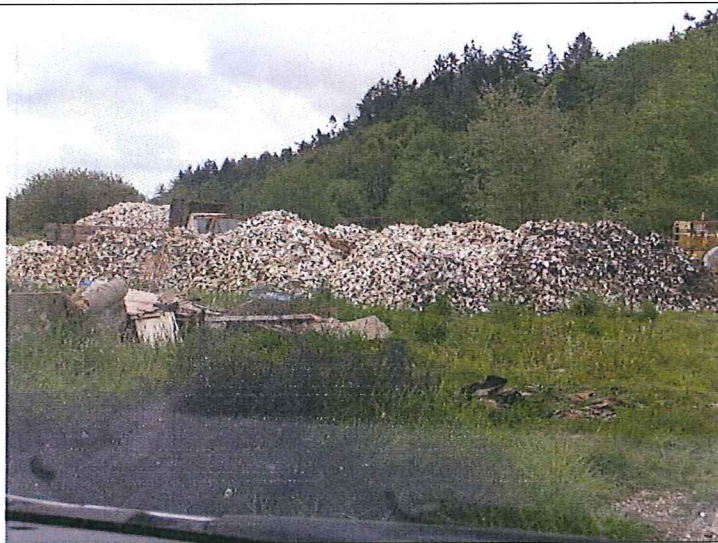
PHOTO #:12 DATE: 05/05/2015  
TAKEN BY: SHAWANNA TUFONO  
DESCRIPTION: UPLAND SHELL PILE STORAGE.
