WATER COMPLIANCE INSPECTION REPORT

Name and Location of Facility Inspected (For industrial users discharging to POTW, also include POTW name and NPDES permit number) Icicle Acquisition Subsidiary LLC, dba American Gold Seafoods Site 2, Deepwater Bay Bellingham Channel, Skagit County	Entry Time/Date 10:35 hrs, 07/17/2015	Permit Effective Date 06/26/07
	Exit Time / Date 11:15 hrs, 07/17/2015	Permit Expiration Date 10/26/2012 Admin. extended

PHOTO ADDENDUM – AMERICAN GOLD SEAFOODS, SITE 2, CYPRESS ISLAND

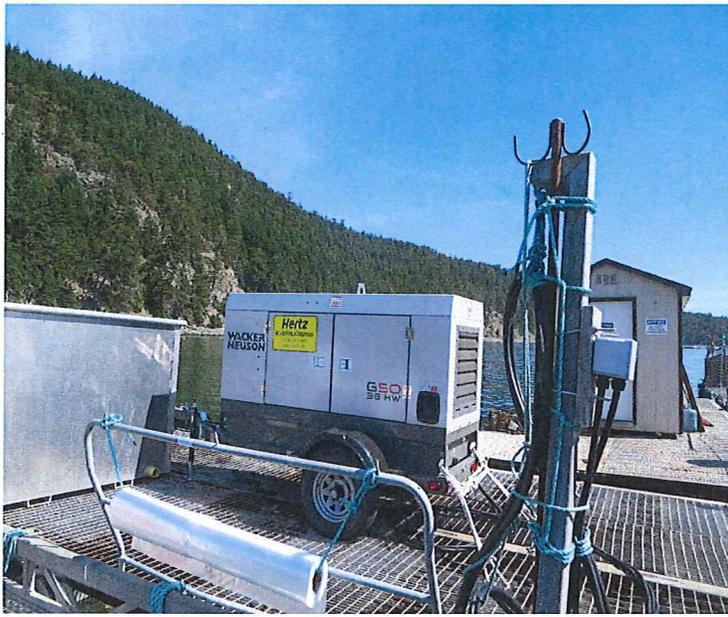
Double walled diesel tank is on site for operating the 125 kw generator and for the boats. New, quieter compressors have been installed on the pens to aerate the cages when needed, and with minimal sound impacts (photo #01). The tank is refueled as needed from a mobile contractor. Booms, pads and sorbents are available on site as part of the spill kit. Iodine footbaths use is required when entering and leaving the site.

PHOTO #:01 DATE: 07/17/2015
 TAKEN BY: LORI LEVANDER
 DESCRIPTION: NEW, QUIETER GENERATOR.

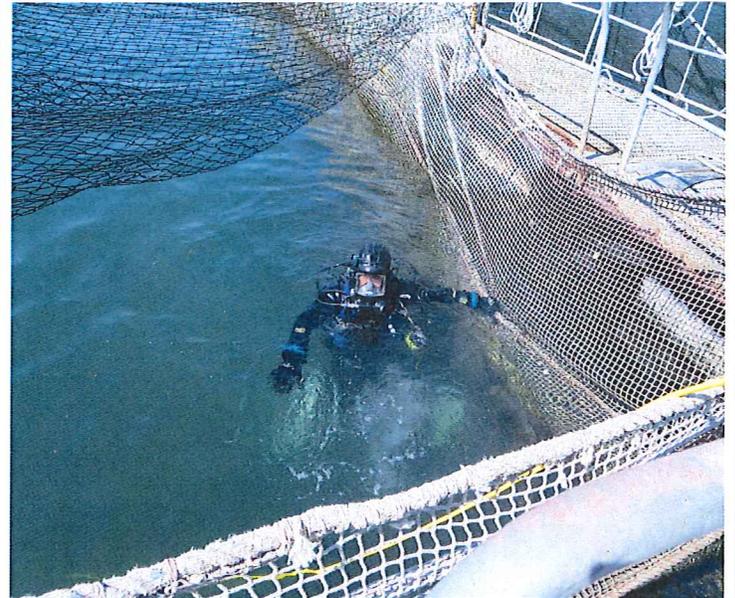
Divers inspect the pens a few times a week, checking the integrity of the nets and collecting dead fish (photo #02). Any dead or dying fish are brought to the surface, placed in plastic-lined totes with lids. The totes are hauled away weekly by a contracted vessel and taken to a composting facility. The company has an emergency plan in place in the event of catastrophic losses. AGS worked with WDFW to develop and implement a Reportable Finfish Pathogen Plan that outlines a rapid reporting and emergency response strategy in the event there is a positive confirmation for a reportable finfish pathogen on site.

PHOTO #:02 DATE: 07/17/2015
 TAKEN BY: LORI LEVANDER
 DESCRIPTION: DIVERS ASSESS MORTALITY AND NET PEN INTEGRITY A FEW TIMES A WEEK.

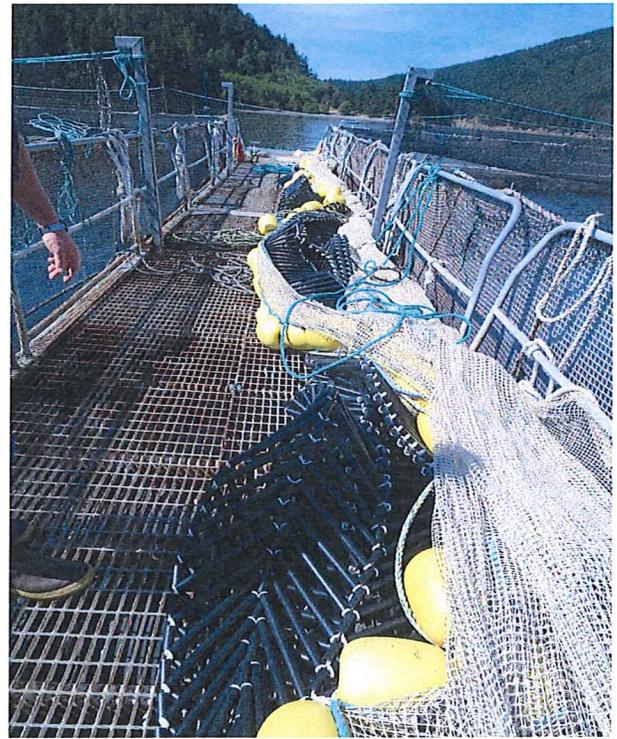
PHOTO #:04 DATE: 07/17/2015
 TAKEN BY: LORI LEVANDER
 DESCRIPTION: NEW CROWDING "NETS" AND SYSTEM FOR HARVESTING AND SIZING FISH.
