State of Washington Department of Ecology
Northwest Regional Office

WATER COMPLIANCE INSPECTION REPORT

Name and Location of Facility Inspected (For industrial users discharging to POTW, also include POTW name and NPDES permit number) Hughes Farms 1325 Farm to Market Road Mount Vernon, WA 98273	Entry Time/Date 11:30 am 11/04/15	Permit Effective Date
	Exit Time / Date 1:00 pm 11/04/15	Permit Expiration Date
Name(s) of On-Site Representative(s)/Title(s)/Phone and Fax Number(s) Jose Velazquez Plant Manager 360-424-3772	Other Facility Data	
Name, Address of Responsible Official/Title/Phone and Fax Number. David Hughes Owner Phone Number: (360) 424-3772 Fax: Contacted? <input checked="" type="checkbox"/> Yes <input type="checkbox"/> No

PHOTO ADDENDUM – HUGHES FARMS, WA0501489

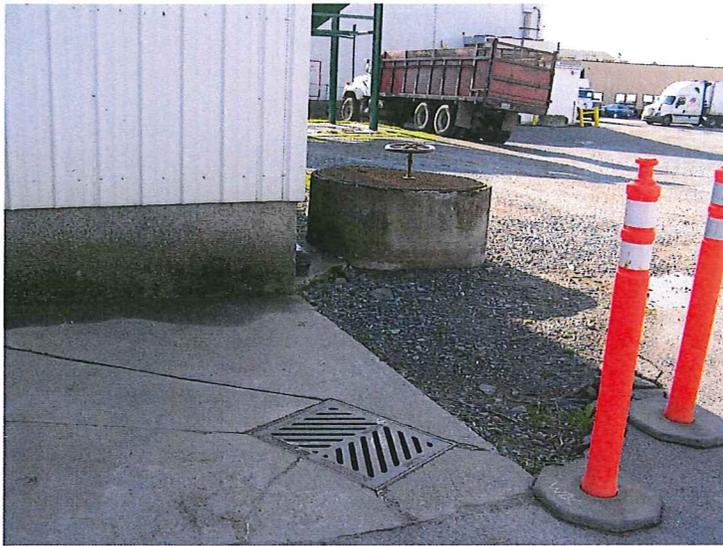
PHOTO #:01 DATE: 11/04/15
 TAKEN BY: JEANNE TRAN
 DESCRIPTION: PICTURE SHOWS AN UNDERGROUND COLLECTION SUMP FOR WASHWATER; THIS SUMP IS DRAINED INTO THE UNDERGROUND VAULT THAT HAS A MANUAL CONTROL VALVE. THE WASH WATER IS CURRENTLY DRAINED TO THE SHARED FILTRATION POND, BUT WILL BE ROUTED TO THE LINED PONDS WHEN CONSTRUCTION IS COMPLETED. IT IS ANTICIPATED TO START OPERATION IN DECEMBER 2015.

- 1) As we walked toward the plant, I observed the washwater collection sump which drains toward the underground vault (See photo 1). The water from the vault is currently discharged to the shared pond, but as soon as the new treatment system is completed, the water will then be pumped to the newly constructed settling pond for treatment. It is anticipated that the treatment system will be started in the next 3 weeks.

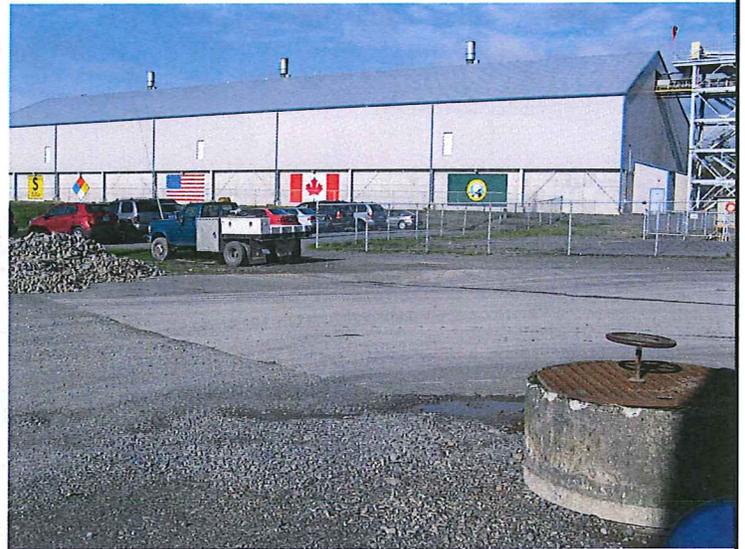
PHOTO #:02 DATE: 11/04/15
 TAKEN BY: JEANNE TRAN
 DESCRIPTION: PICTURE SHOWS THE TRUCK ENTRANCE ROAD IS PARTIALLY PAVED. DAVE HUGHES INFORMED JEANNE THAT THEY HAVE PLANS TO PAVE IT BY NEXT SUMMER.

- 2) Stormwater from the plant will continue to discharge to the shared pond (See photo 5). Dave Hughes informed me that the parking area and the access road to the plant will be paved next year (See photos 2 and 3).

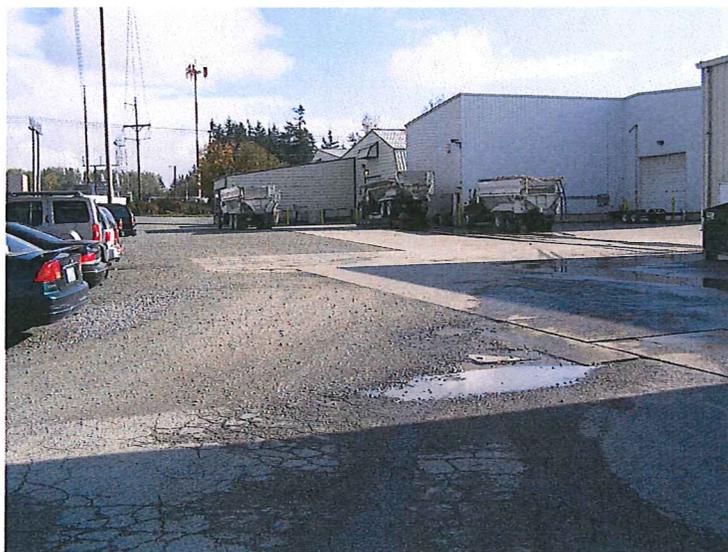
PHOTO #:03 DATE: 11/04/15
 TAKEN BY: JEANNE TRAN
 DESCRIPTION: ANOTHER VIEW OF THE YARD, SHOWING THAT A PORTION OF THE YARD HAS BEEN PAVED.

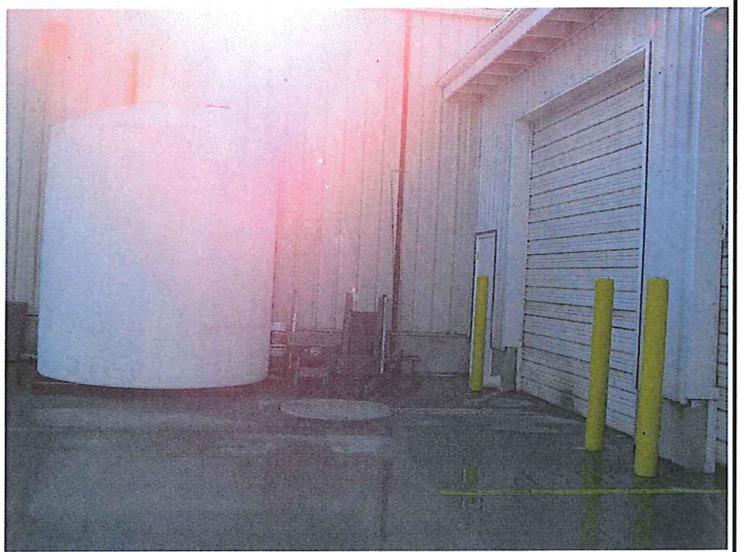
PHOTO #:04 DATE: 11/04/15
 TAKEN BY: JEANNE TRAN
 DESCRIPTION: A POLYETHYLENE STORAGE TANK HAS BEEN ADDED AS PART OF THE TREATMENT SYSTEM TO STORE TREATED WATER FOR REUSE.

- 3) I observed the soil removed from the potato sorting operation being shoveled back onto the truck, and being delivered back to the field.
- 4) I observed a temporary storage tank (approximately 6000 gallons in capacity) stored outside of the processing plant (See photo 4). Pat informed me that the storage tank is new and will be used as a holding tank for treated water for reuse.

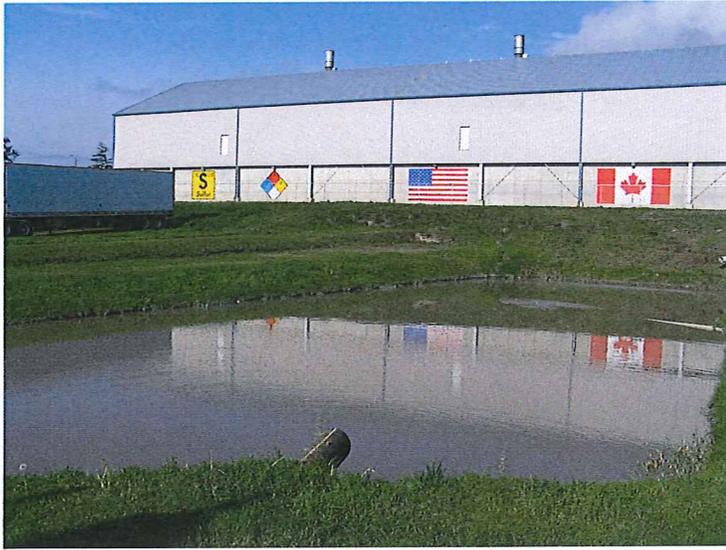
PHOTO #:05 DATE: 11/04/15
 TAKEN BY: JEANNE TRAN
 DESCRIPTION: PICTURE SHOWS THE SHARED INFILTRATION POND. NO DISCHARGE WAS GOING TO THE POND DURING THE INSPECTION. THE COLOR OF THE WATER WAS LIGHT BROWN.

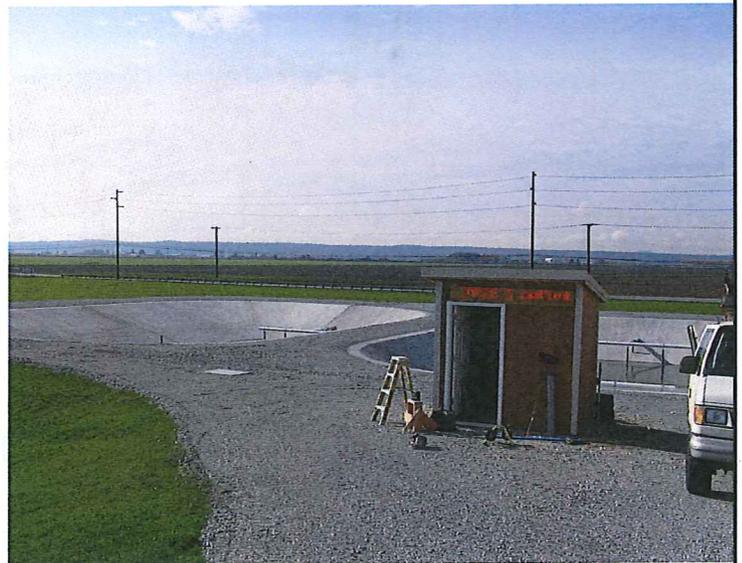
PHOTO #:06 DATE: 11/04/15
 TAKEN BY: JEANNE TRAN
 DESCRIPTION: PICTURE SHOWS TWO NEWLY CONSTRUCTED LINED PONDS, AND AN EQUIPMENT CONTROL SHED.

5) The construction work for the two lined settling ponds has been completed. At the time of the inspection, the contractor was doing electrical work for the pumps, and the pH and flocculent injection meters (See photos 6 through 10). Each pond has bottom dimensions of 15'x45' with interior and exterior 3:1 side slopes with a 12' wide drivable surface around each pond. One of the ponds will receive silty water from the potato processing plant and will act as the primary settling pond. A flocculent agent is to be injected into the line that carries the silty water and delivered through a perforated pipe for uniform distribution into the primary pond. The pretreated water from the first pond will then enter the second pond for further settling. The treated water is either recycled back to the plant for reuse or discharged to Little Indian Slough via an existing man made ditch. Bill informed me that Wesmar Chemical Company will be supplying the flocculent agent and conducting water sampling for Hughes Farms. Jose will manage the treatment system once it is in operation.

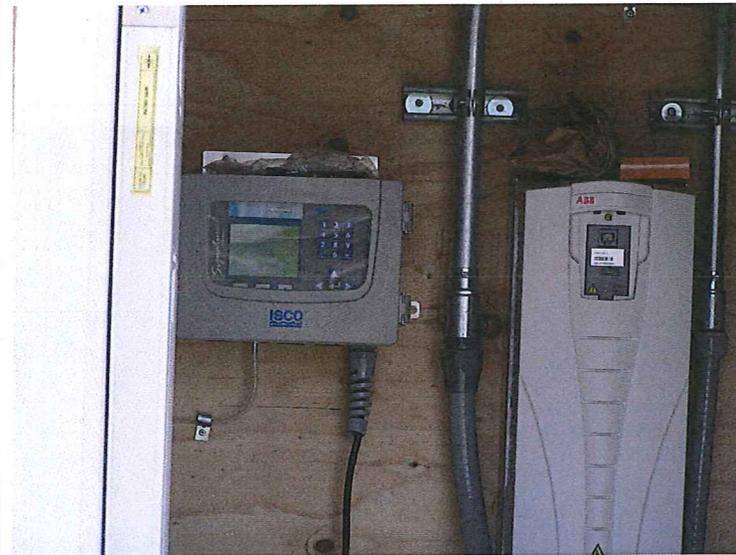
PHOTO #:07 DATE: 11/04/15
 TAKEN BY: JEANNE TRAN
 DESCRIPTION: CONTROL PANEL FOR FLOW AND PH METERS IN THE SHED.

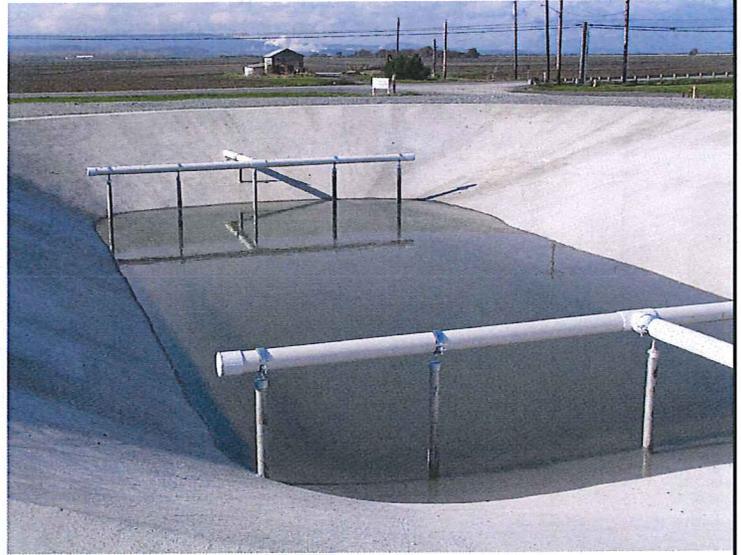
PHOTO #:08 DATE: 11/04/15
 TAKEN BY: JEANNE TRAN
 DESCRIPTION: WASHWATER WILL ENTER THE PRIMARY SETTLING POND THROUGH THE PERFORATED PIPE. FLOCCULENT AGENT WILL BE INTRODUCED INTO THE INCOMING LINE BEFORE ENTERING THE POND.

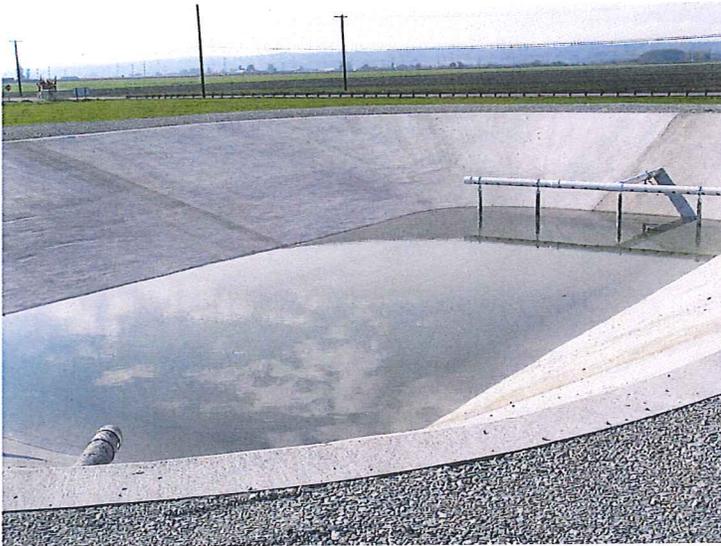
PHOTO #:09 DATE: 11/04/15
 TAKEN BY: JEANNE TRAN
 DESCRIPTION: PRETREATED WATER FROM THE FIRST POND IS THEN PUMPED TO THE SECONDARY POND FOR FURTHER SETTLING. THE WATER IS THEN EITHER PUMPED BACK TO THE PLANT FOR REUSE OR DISCHARGED TO THE DITCH.

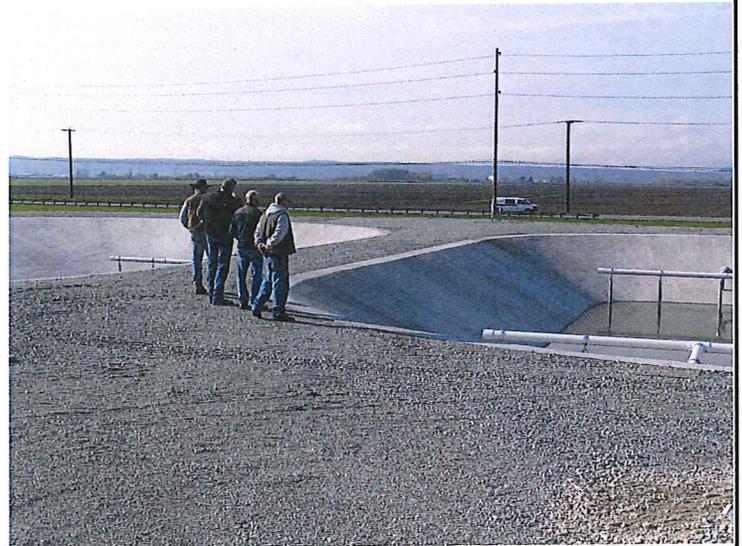
PHOTO #:10 DATE: 11/04/15
 TAKEN BY: JEANNE TRAN
 DESCRIPTION: A VIEW SHOWING BOTH PONDS.

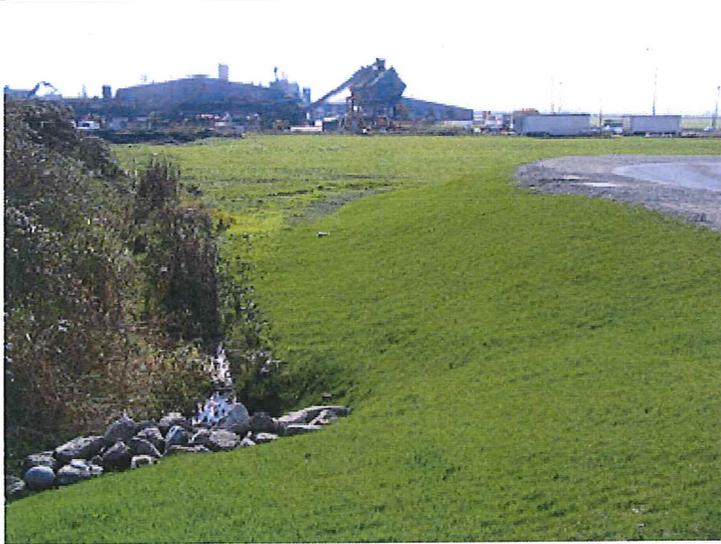
PHOTO #:11 DATE: 11/04/15
 TAKEN BY: JEANNE TRAN
 DESCRIPTION: EXISTING DITCH ADJACENT TO THE PLANT, IS DRAINED TO LITTLE INDIAN SLOUGH.

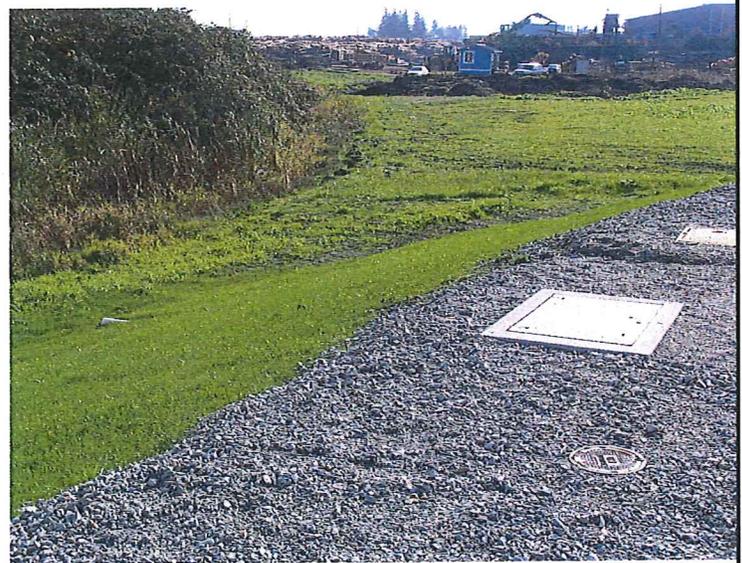
PHOTO #:12 DATE: 11/04/15
 TAKEN BY: JEANNE TRAN
 DESCRIPTION: PICTURE SHOWS AN UNDERGROUND PUMP CHAMBER WITH DISCHARGE METER. THE WHITE PIPE SHOWN IN THE GRASSY AREA IS THE DISCHARGE PIPE INTO THE DITCH WHICH DRAINS INTO LITTLE INDIAN SLOUGH.
