STATE OF WASHINGTON
DEPARTMENT OF ECOLOGY

IN THE MATTER OF PENALTY)	NOTICE OF PENALTY
ASSESSMENT AGAINST)	INCURRED AND DUE
Sarbanand Farms LLC)	PENALTY DOCKET #10455
)

Attachment A – Sarbanand Farms Photo Log

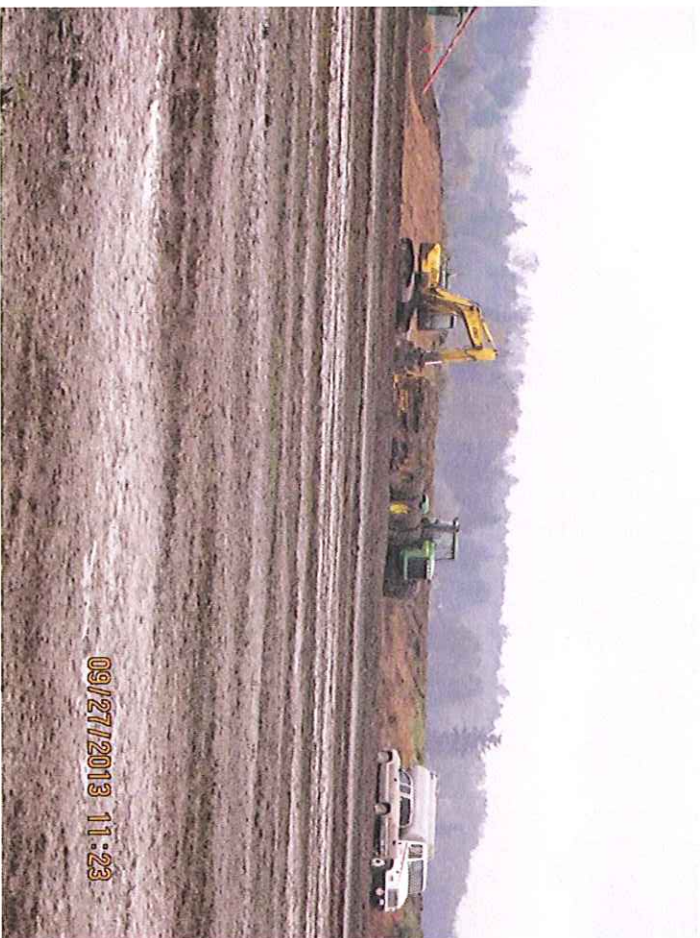
Photo 1 – September 27th, 2013: Photo from Rock Road of Sarbanand Farms' manure lagoon decommissioning project. Note the heavy application of manure solids to Field A. This manure application was 1 to 2 inches thick in this location. Some dead grass stubble can be seen covered by the application. The grass had been mostly killed prior to application. The weather forecast predicted 100% chance of heavy rains over the next three days on the day this photo was taken.

A significant amount of the manure-contaminated material that was observed on the field bordering Rock Road on September 27th (see Attachment A, Photo 1) appeared to have been washed off of the field on this September 30th visit (see Attachment A, Photo 2). At the time of the inspection, the fields were being planted with grass. Inspector Kirkpatrick observed and photo-documented (see Attachment A, photos 7-12) evidence of sediment discharge from these fields into adjacent ditches. Suspended sediment is known to degrade the quality of salmonid spawning habitat. The receiving stream, Saar Creek, has documented presence of several species of salmonids.

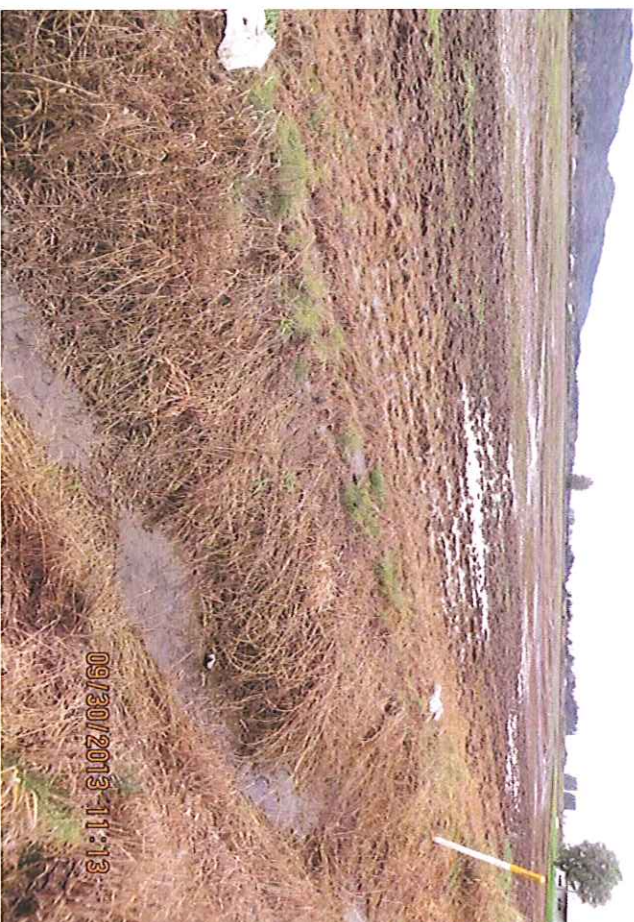
Photo 2 – September 30th, 2013: This photo shows the same field shown in Photo 1, after three days of heavy rain. Note that some vegetation is now visible on the field, and the absence of the thick layer of manure visible in photo 1. The water flowing off of this field into state waters contained 3,800 fecal coliform colonies per 100 mL of water. Prior to the application the field had been treated with an herbicide and very little living vegetation remains. Also shown is the surface roughening measure that Sarbanand Farms implemented on a 15 foot wide strip after being contacted by Ecology. Stormwater runoff is visible discharging through this strip.

Inspector Kirkpatrick observed manure-contaminated water discharging from the field bordering Rock Road into the Rock Road roadside ditch, a tributary to Saar Creek. Inspector Kirkpatrick collected a sample of water from the field runoff, and laboratory analysis confirmed that the sample was contained 3,800 f.c.u. per 100 mL of water (see Attachment B for the laboratory report). This concentration is 19 times greater than the state water quality standard for fecal coliform bacteria for Saar Creek, which is 200 f.c.u. per 100 mL. WAC 173-201A-200(2)(b). State water quality standards for fecal coliform bacteria are set at a level determined to be protective of human health (WAC 173-201A-200). The discharge to surface waters of runoff containing levels of fecal coliform bacteria above the state standard is a violation of RCW 90.48.080.

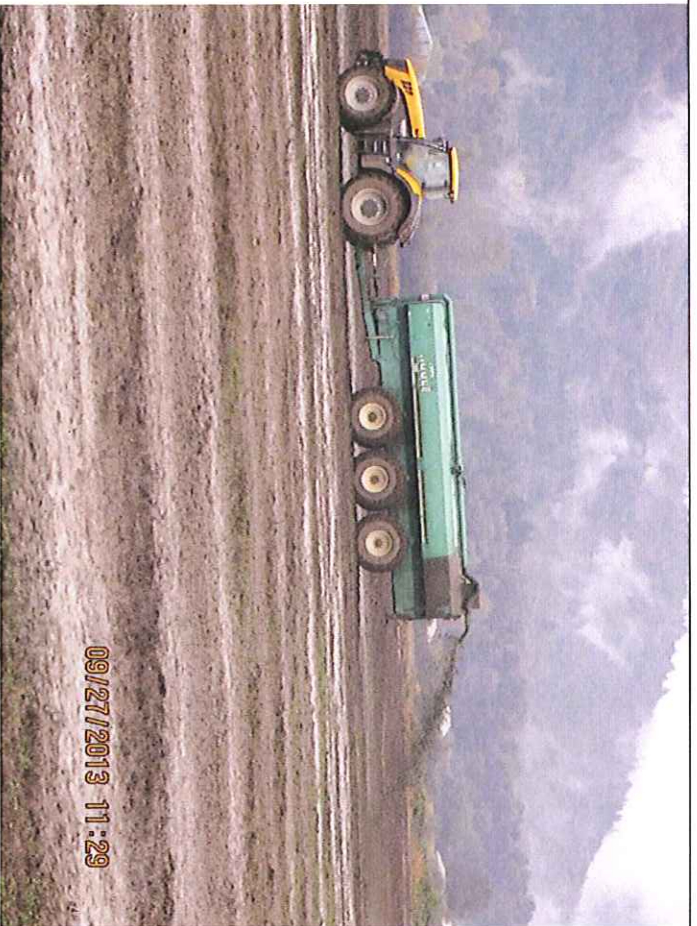
Photo 3 - September 27, 2013: Equipment operated by Pacific Pumping LLC applying manure lagoon contents to a Field A. The manure application to the part of Field A visible from Rock Road was between one to two inches thick.

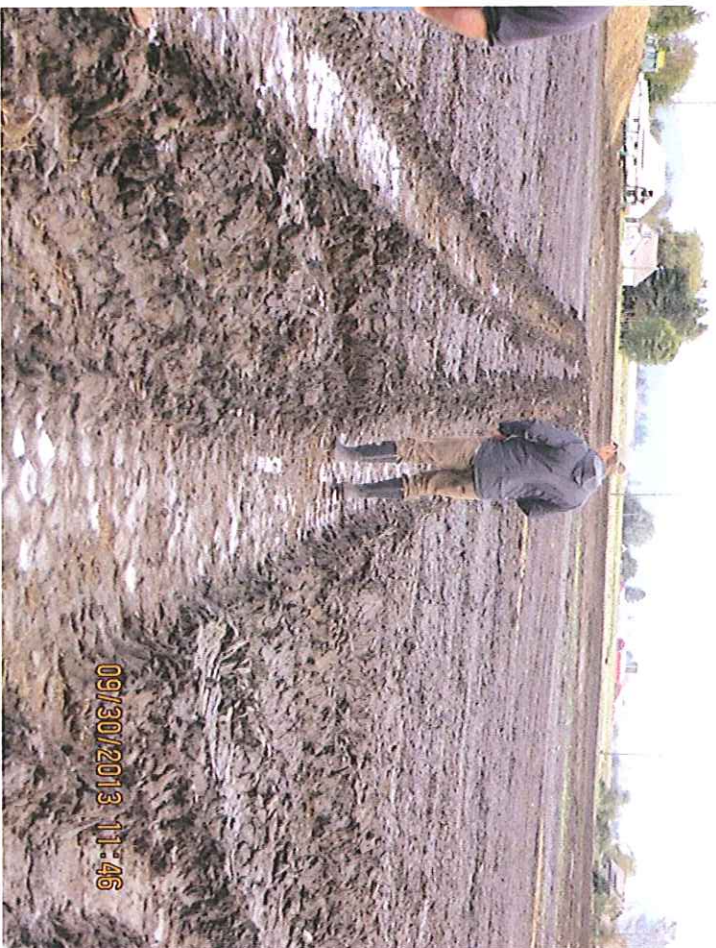
Photo 5 – September 30th, 2013: Immediately south of Lagoon 2, solids had been scraped out and spread on the field approximately 4 to 6 inches thick. This material is mostly dried manure that had been scraped out of the lagoon, mixed with a small amount of sand the inside of the lagoon.

Western Refinery Services Inc., hired by Sarbanand Farms LLC, spread solid manure mixed with dairy cow bedding sand from one or more of the lagoons between 4 and 6 inches deep on a small

portion of Field A in its southwest corner. See Attachment A, Photos 5 and 6 for photos of this area.

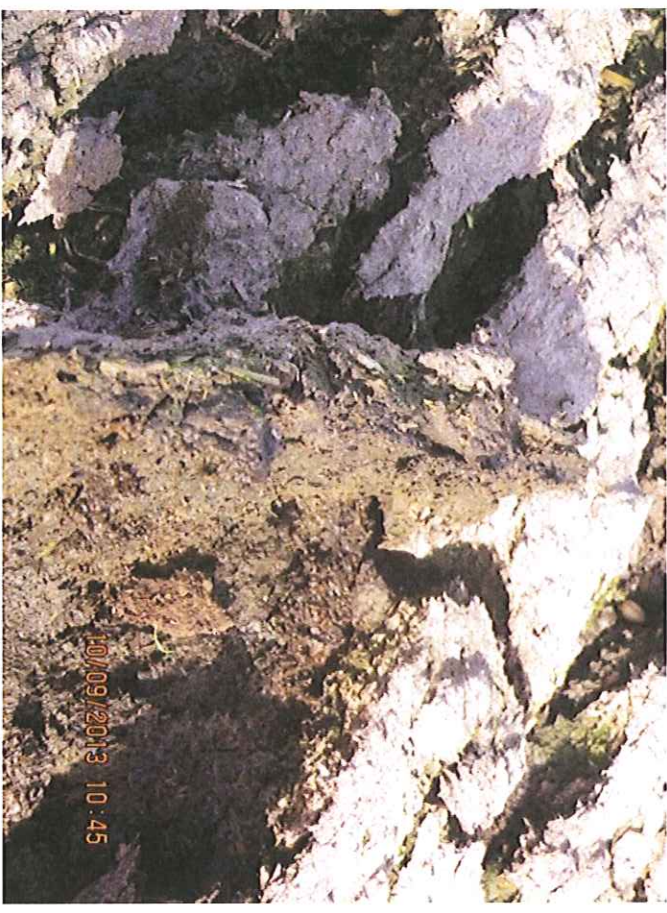
Photo 6 – October 9th, 2013. This photo shows a close-up of the material from the lagoons spread four to six inches thick on a smaller part of Field A immediately south of Lagoon 2 in Photo 3. Close inspection of this material indicated that it was mostly manure solids.

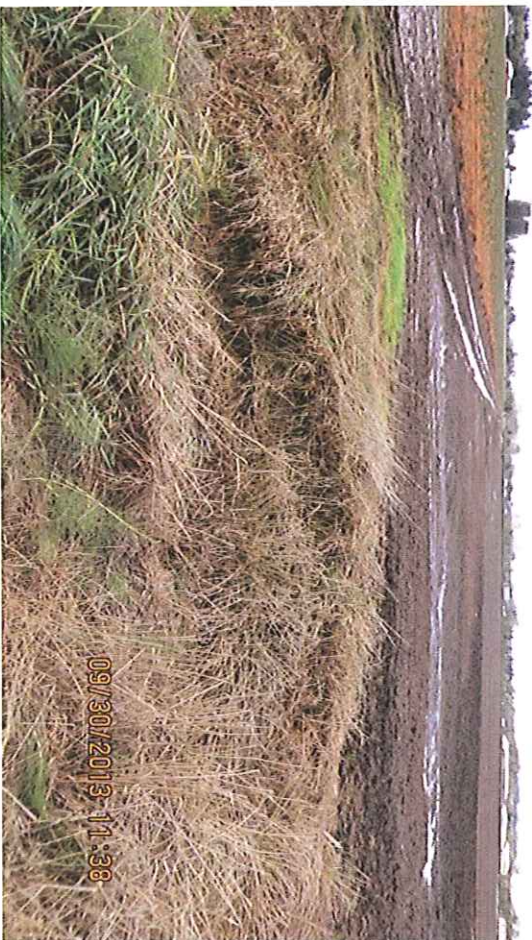
Photo 7 – September 30th, 2013 This photo shows Field B. It was leveled and spread with manure. No BMPs had been implemented to prevent sediment or manure from discharging into the drainage ditch in the foreground of the photo.

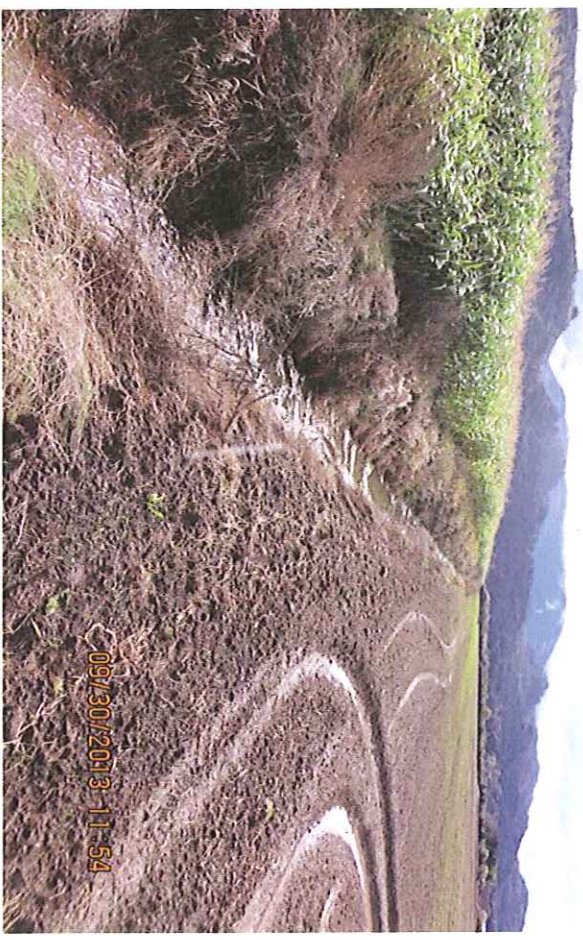
Photo 8 – September 30, 2013 This photo shows Field C. The contents of the lagoons had been applied to this and other fields prior to September 27th. Evidence of sediment discharge into the stream pictured in the center of the photo was observed along the border of this field.

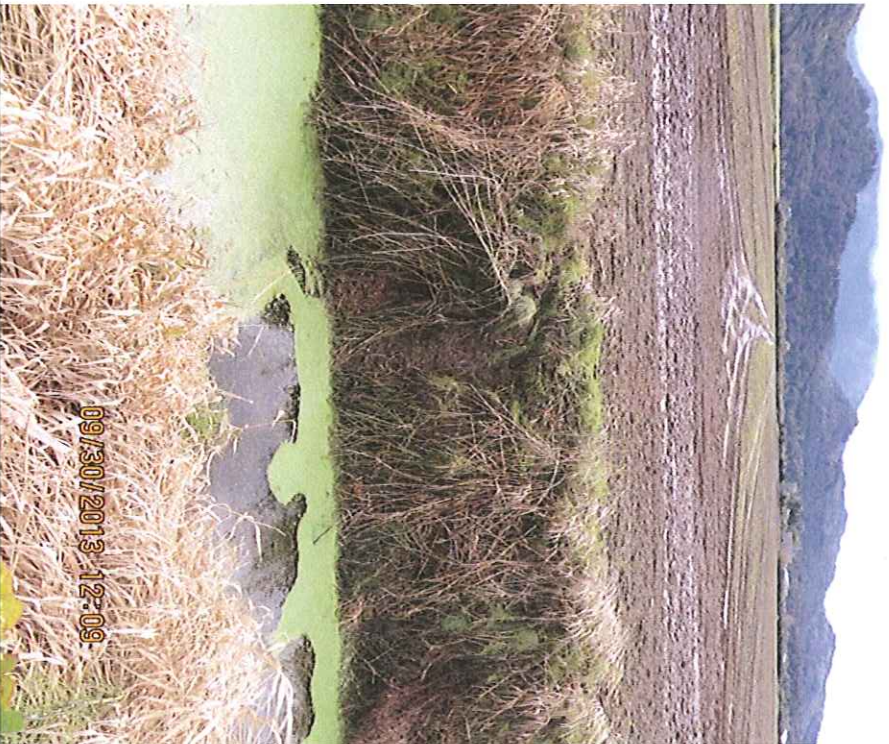
Photo 9 – September 30th, 2013 This photo shows Field C and its border with a drainage ditch between Field A and Field C that drains to Saar Creek. Field C has been disturbed to the top of the bank and the contents of the manure lagoons spread on the field. There were many places along its border with the ditch where evidence of runoff contaminated with sediment entering the ditch was observed.

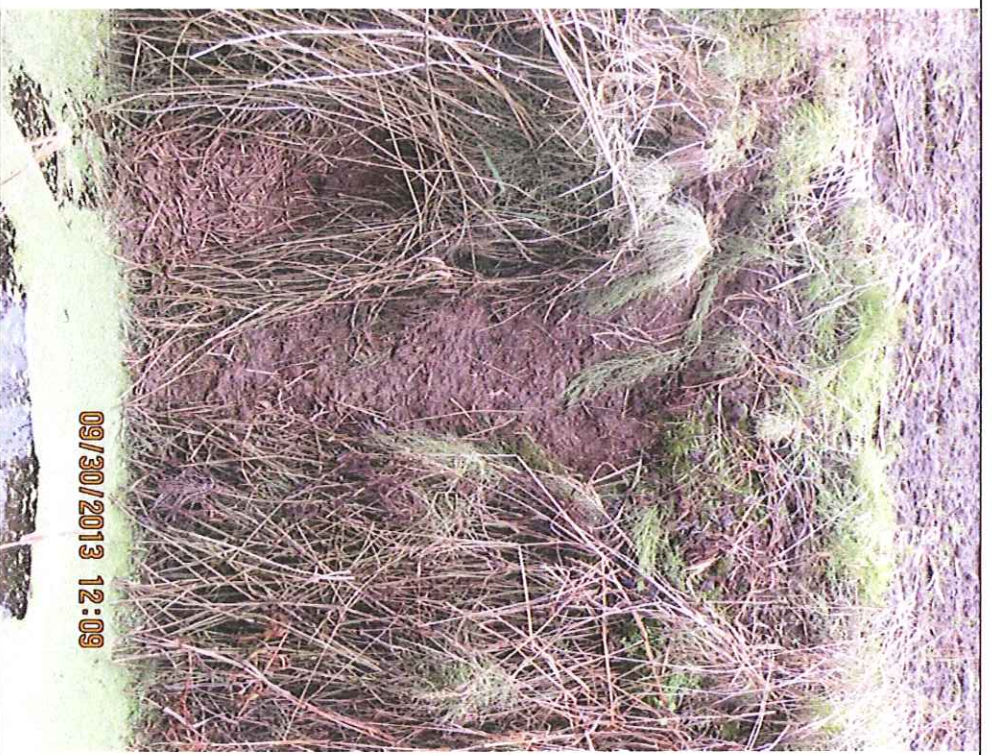
Photo 10 – September 30th, 2013 This photo shows a close-up of the area in Photo 5 where visual evidence of contaminated runoff was observed.

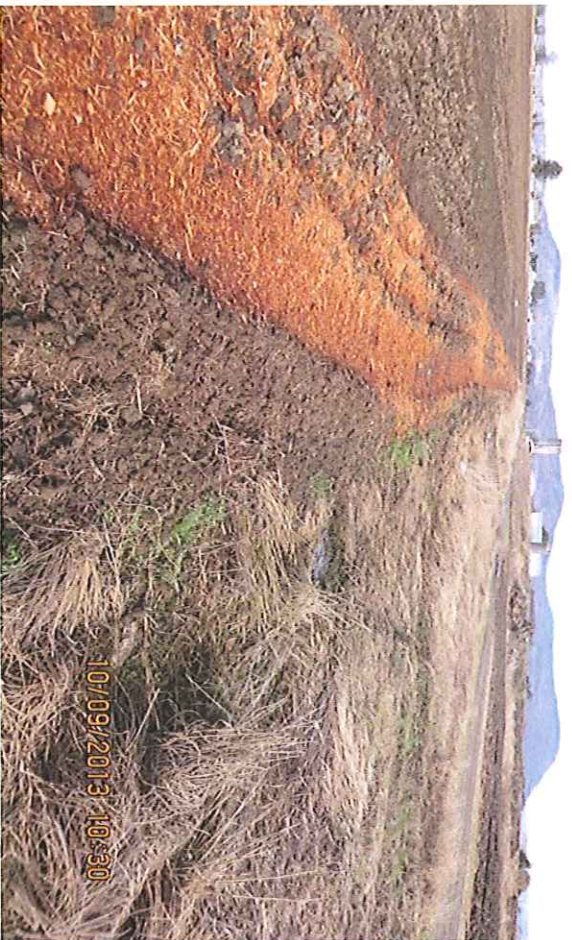
Photo 12 – October 9th, 2013 This photo shows Field B. A strip of wood chips has been laid on the edge of this field, between the field and the drainage ditch.

Additional wood chip and sawdust mulch had been applied to the border of the fields in some places (see Attachment A, Photo 11) since the visit on October 2nd. Grass previously planted in the north field was beginning to sprout, but was not yet sufficiently established to prevent erosion (see Attachment A, Photos 13 and 14).

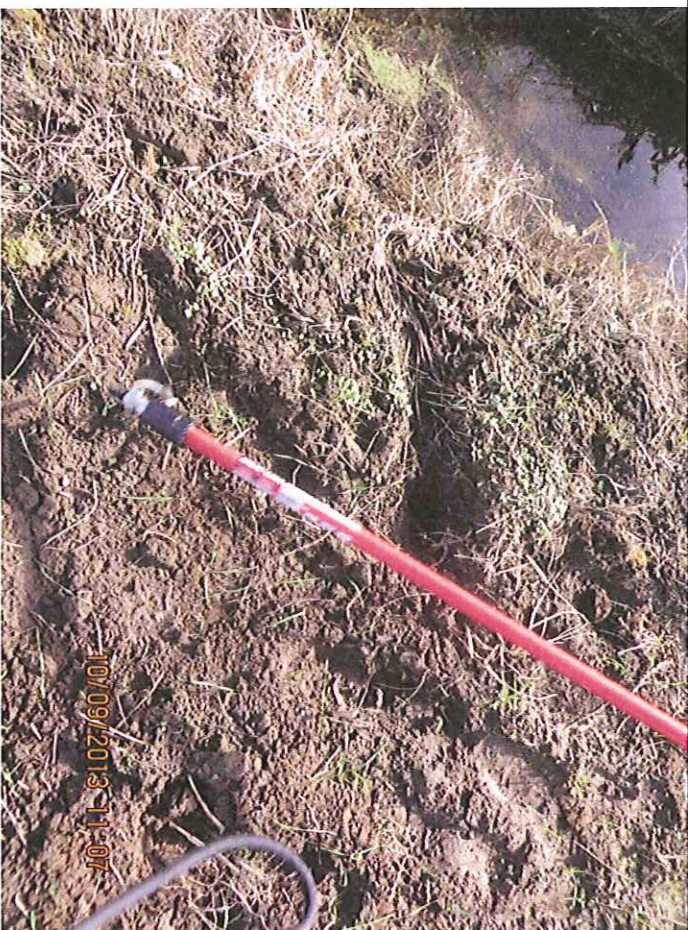
Photo 13 – October 9th, 2013 This photo shows rills in the bank and sediment deposited on the bottom of the ditch along the east edge of Field C. This ditch is a tributary to Saar Creek.

Inspectors Chris Luerkens and Jessica Kirkpatrick conducted an inspection of this property. Kathy Heriot, an employee of Sarbanand Farms, met us in the office and gave permission for us to access the property. During the inspection, Inspector Kirkpatrick observed evidence of previous erosion from Field C and A and resultant sediment deposition into the drainage ditches bordering Field C and Field A that drain to Saar Creek (see Attachment A, Photo 12). This is likely a violation of 90.48.080 for the discharge of pollutants into state waters.

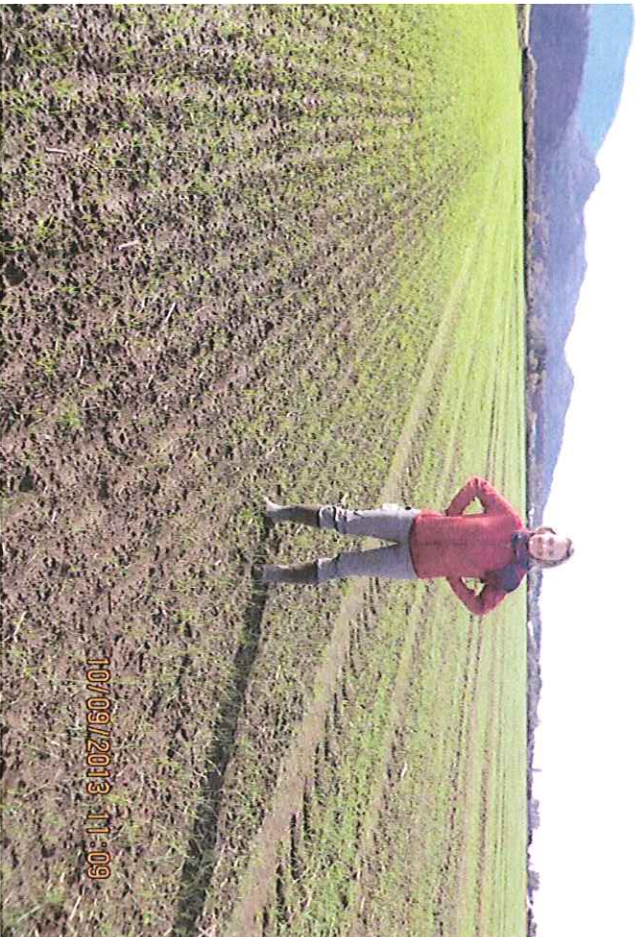
Photo 13 – October 9th, 2013 This photo shows the shoots of new grass starting to grow in Field C. Inspector Kirkpatrick is standing for scale reference.

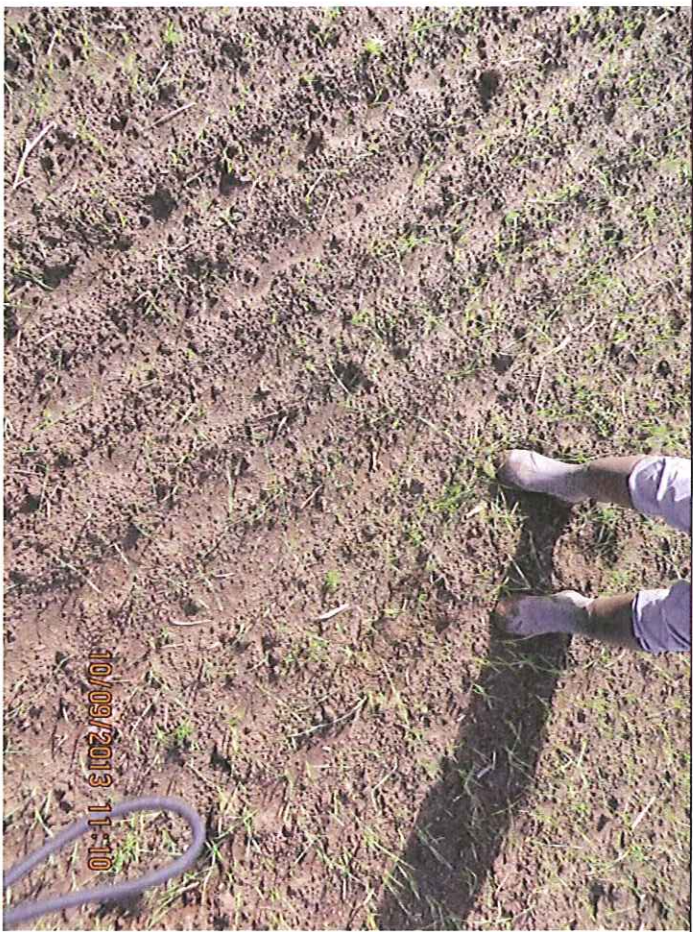
Photo 14 – October 9th, 2013 This photo shows that although Field C looks green from an oblique angle, the grass is very new and is not established enough to prevent erosion. Inspector Kirkpatrick's boots are in the same position as in Photo 12.

Inspector Kirkpatrick advised Ms. Heriot that additional measures should be implemented to prevent erosion from the bare fields and fields where vegetation was not sufficiently established to prevent erosion. Inspector Kirkpatrick further advised Ms. Heriot that Sarbanand Farms had a responsibility to implement the BMPs to prevent and control the pollution of the waters of the state.
