Re: Administrative Order
Notice of Penalty

NOTICE OF PENALTY
INCURRED AND DUE
PENALTY DOCKET #13096

IMMEDIATE ACTION
ORDER
DOCKET # 13260

Appendix A— Photo Log

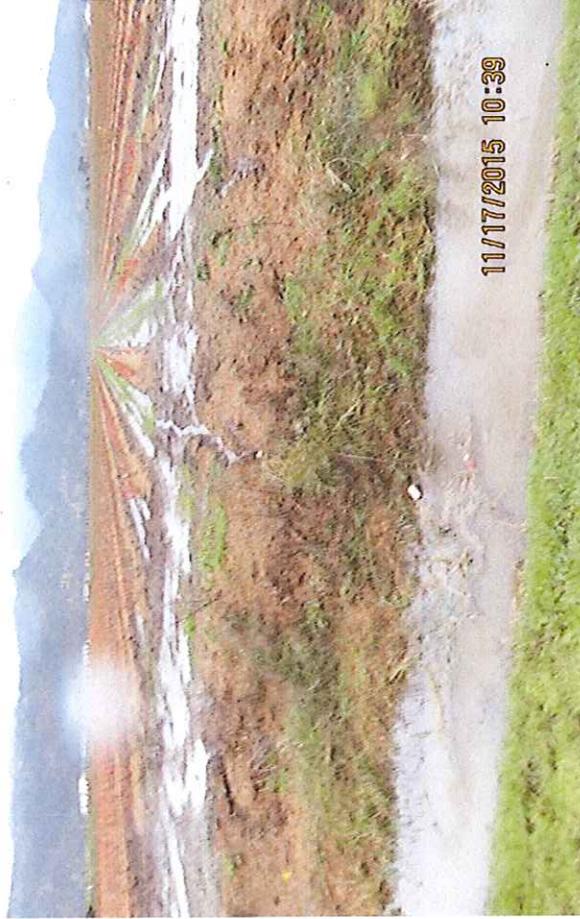
1) November 17th, 2015 – This photo shows water draining off of Sarbanand Farm's blueberry field into the Rock Road roadside ditch. The concentrated flow visible in the middle of the photo is a hand-dug trench. Manure and sawdust is visible on the berry rows, and on the banks of the ditch.

Ecology responded to a report received (Environmental Report Tracking System #660799) regarding pollution discharges from Sarbanand Farm's operation into a tributary of Saar Creek. Ecology photographed water discharging in multiple locations from Sarbanand Farms' operation into the tributary of Saar Creek along Rock Road at 4721 and 4775 Rock Road east of Sumas, Washington (see Appendix A Photos 1-2). Ecology observed mulch material including manure in and around the Rock Road roadside ditch. Ecology collected the following two water quality samples. See map in Appendix B for discharge locations. See Appendix C for the laboratory report documenting these sample results:

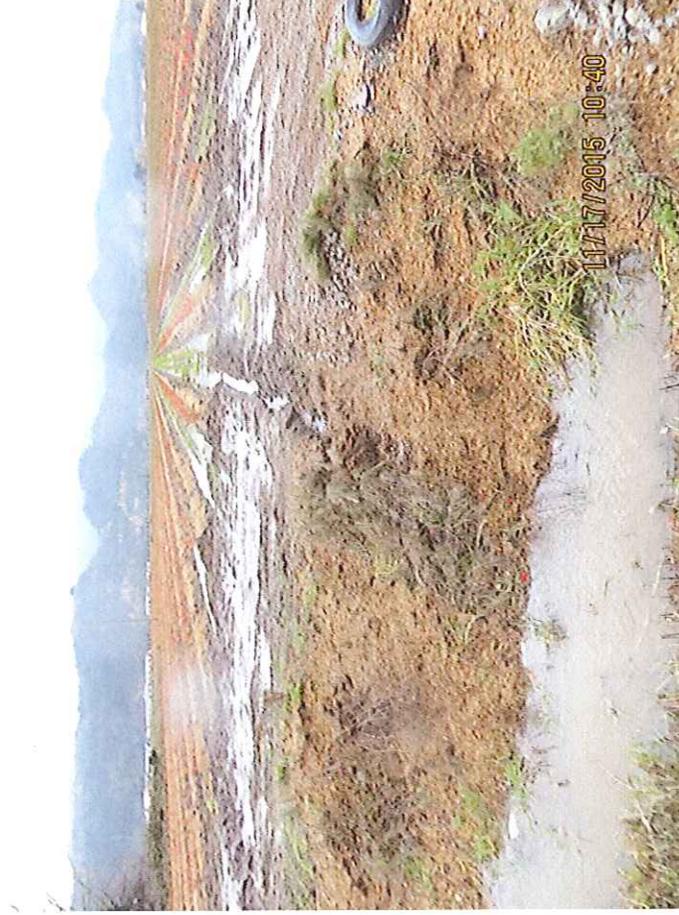
2) November 17th, 2015 – This photo shows water draining off of Sarbanand Farm's blueberry field into the Rock Road roadside ditch. The concentrated flow visible in the middle of the photo is a hand-dug trench. Manure and sawdust is visible on the berry rows, and on the banks of the ditch.

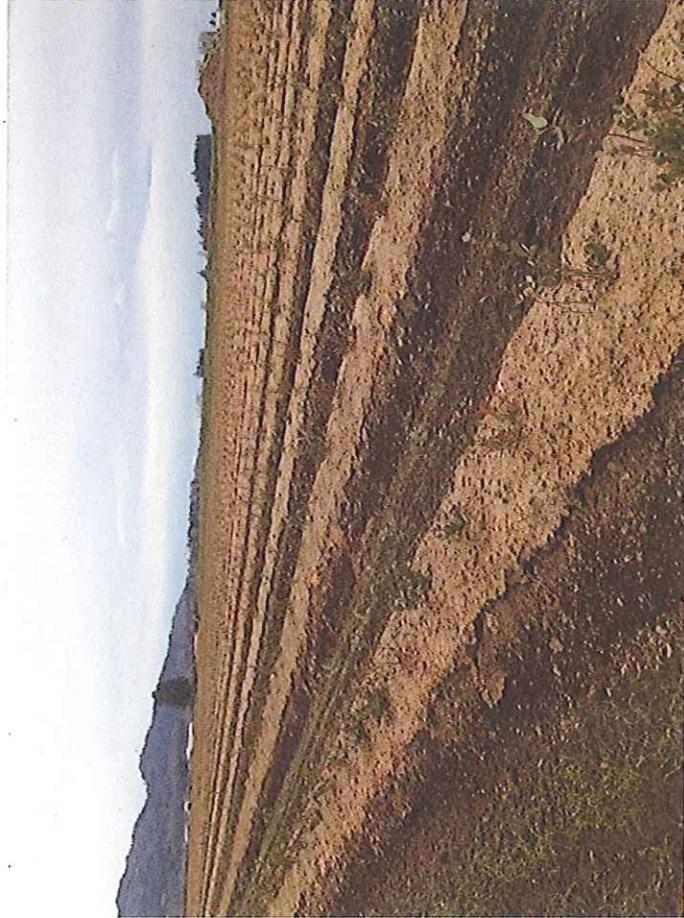
3) December 1st, 2015— This photo shows manure solids applied to the tops of berry rows on Sarbanand Farm's field south of Rock Road. This field drains into the Rock Road roadside ditch.

Ecology observed water discharging through berry rows covered in manure into the tributary of Saar Creek along Rock Road at multiple locations (see Appendix A, Photos 3-5). BMPs had not been implemented to prevent water contaminated with manure from discharging from the berry operation into the tributary of Saar Creek along Rock Road. Ecology collected the following two water quality samples (see Appendix B for a map of sample locations and Appendix D for the laboratory report documenting these sample results):

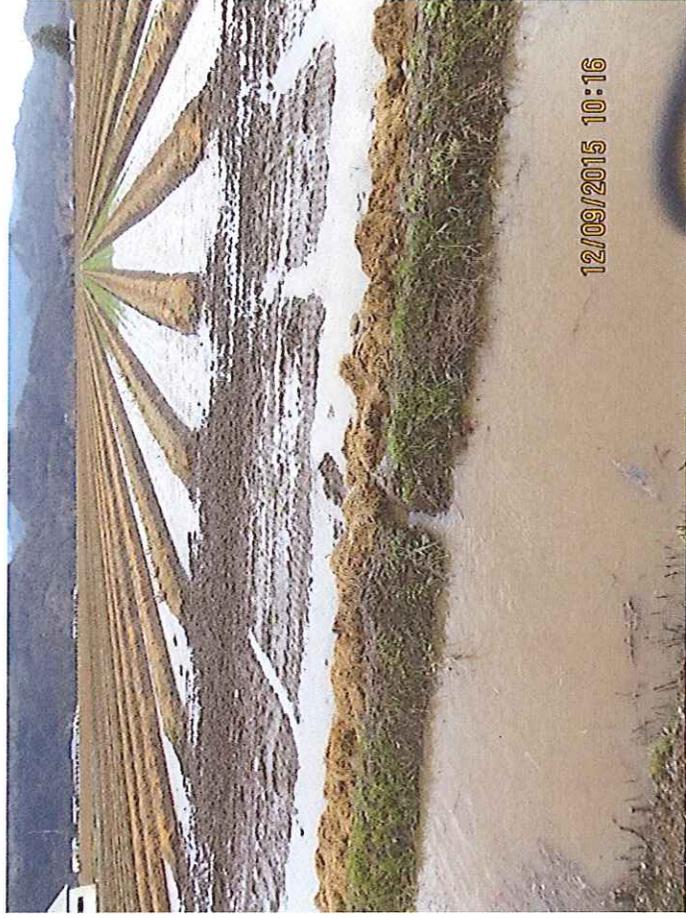
4) December 9th, 2015 — This photo shows water flowing over and through berry rows covered with manure into the Rock Road roadside ditch.

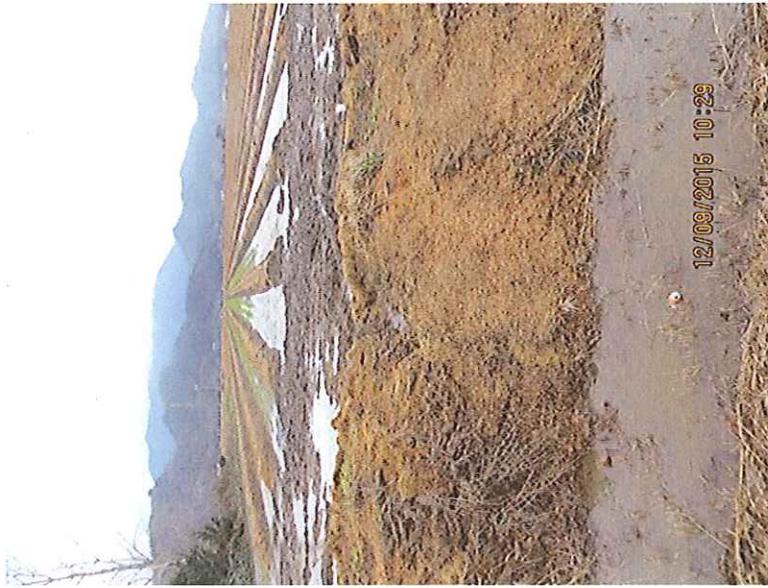
3) December 9th, 2015– This photo shows water draining through manure solids and saw dust applied to the tops of berry rows on Sarbanand Farm's field south of Rock Road.

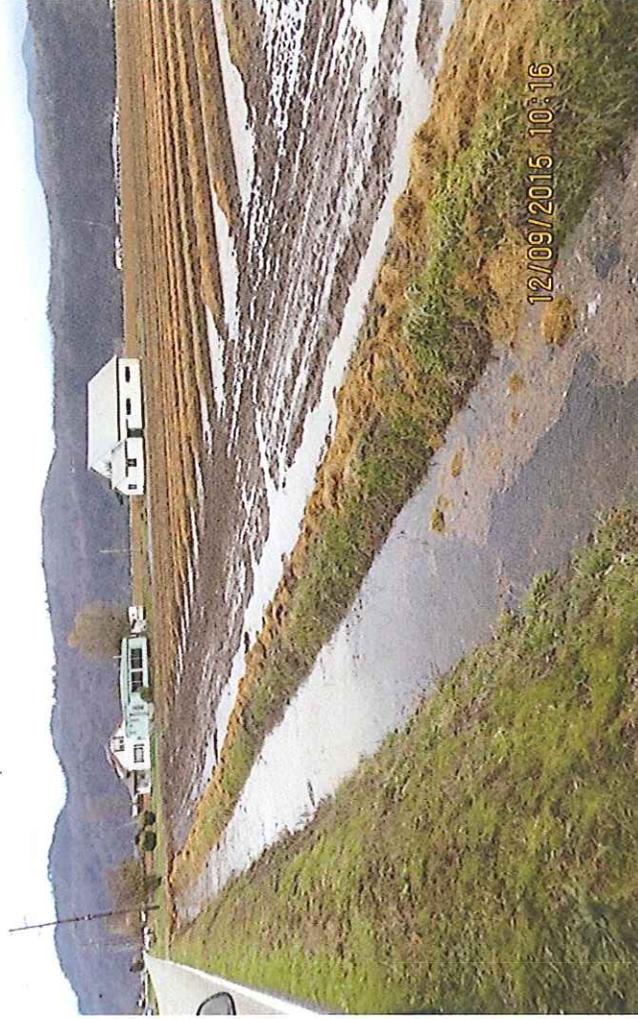
4) December 9th, 2015 – This photo shows water running over and through berry rows covered with manure into the Rock Road roadside ditch.
