Re: City of Camas Water Treatment Plant National Pollutant Discharge Elimination System (NPDES)
Inspection to Determine Termination of the General Permit

Water Compliance Inspection Report

CAMAS WATER FILTRATION PLANT PHOTOS
AUGUST 23, 2016

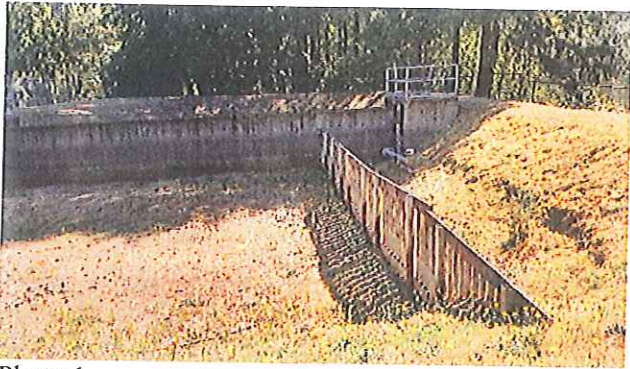
Photo 1

Mr. Stevens then drove Carl and me to the old Water Filtration Plant. Photos 1 and 2 show the Settling Ponds. The Settling Ponds have vegetation and does appear to have sediment from when they were in use. Mr. Stevens explained how the backwash discharged to the lake from the Settling Ponds (Photo 3).

Mr. Stevens showed us around the plant a little more and then drove us back to the Operations Center. I recommend that if the pipes are raised so there is not a possible discharge to the lake and the Settling Ponds are able to infiltrate/percolate in order to handle normal rain events, that the permit gets terminated.

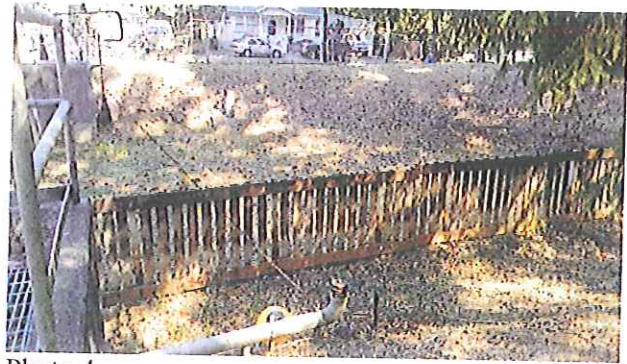
Photo 4

We discussed our concerns that if the rain in ponds are not able to infiltrate, the possibility of a discharge to the lake through the current pipes (Photo 4). Mr. Stevens suggested raising the pipes so rainwater would not be able to discharge to the lake. His only concern is the gate (Photo 5) above the pipes. I suggested that if there is a major storm event, that they go and check to see if the rainwater reaches the gate.

Carl suggested that Mr. Stevens fill the ponds with a couple feet of water to test to see if it infiltrates. Mr. Stevens said he would do that and he will take pictures of the raised pipes and send them to us. I suggested that if the water test infiltrates that he should also send the request for termination letter along with the pictures and the results of their test.
