State of Washington Department of Ecology
Northwest Regional Office
WATER COMPLIANCE INSPECTION REPORT

Name and Location of Facility Inspected (For industrial users discharging to POTW, also include POTW name and NPDES permit number) Hughes Farms 1325 Farm to Market Road Mount Vernon, WA 98273	Entry Time/Date 10:45 am 09/08/16	Permit Effective Date
	Exit Time / Date 11:40 am 09/08/16	Permit Expiration Date

PHOTO ADDENDUM – HUGHES FARMS, WA0991008

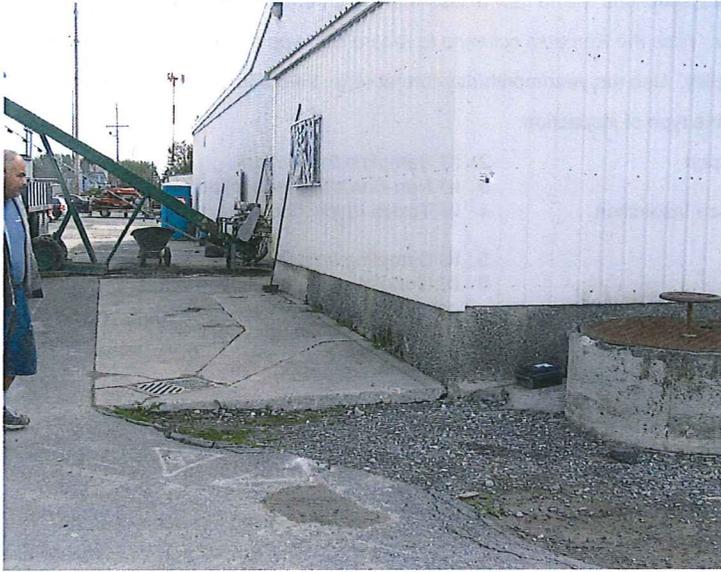
PHOTO #:01 DATE: 09/08/16
TAKEN BY: JEANNE TRAN
DESCRIPTION: PICTURE SHOWS AN UNDERGROUND COLLECTION SUMP FOR THE PLANT. THIS SUMP HAS BEEN PLUMBED TO DRAIN TO THE TWO NEWLY CONSTRUCTED LINED PONDS FOR TREATMENT.

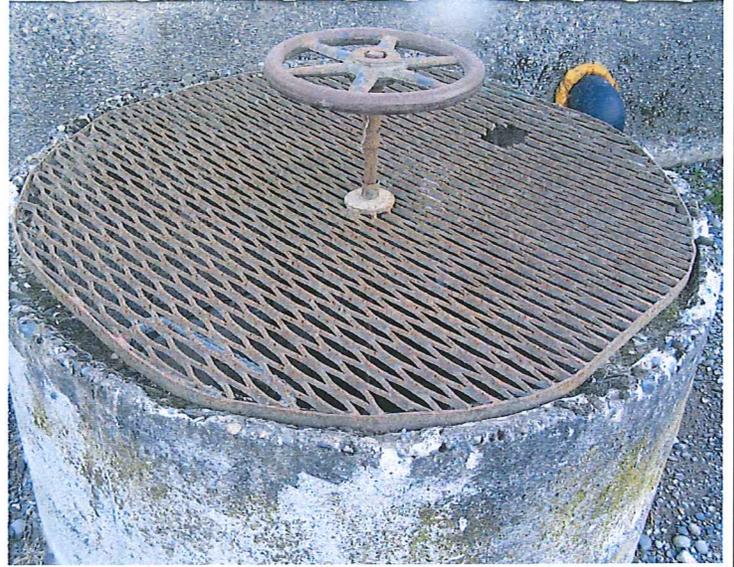
PHOTO #:02 DATE: 09/08/16
TAKEN BY: JEANNE TRAN
DESCRIPTION: A CLOSED UP PICTURE OF THE UNDERGROUND SUMP, WHICH HAS A MANUAL VALVE TO CONTROL THE DISCHARGE TO THE PONDS.

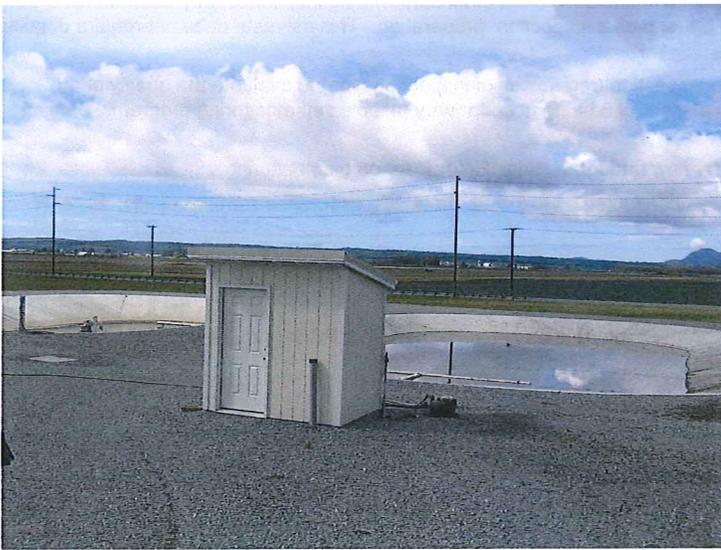
2) The facility has been routing wastewater to the new ponds for treatment with a flocculent agent to aid with solids settling. The pretreated water from the first pond enters the second pond for further settling. The total settling time is approximately 13 hours. The treated water has been recycled back to the plant for reuse. No discharge has actually occurred since startup of the new treatment system. The design flow rate of the treatment system is 130 gpm, but the facility has been operating at approximately 42 gpm (60,000gpd). Solids built up in the primary pond has been removed once since the startup of the treatment system in August.

PHOTO #:03 DATE: 09/08/16
TAKEN BY: JEANNE TRAN
DESCRIPTION: A VIEW OF THE TWO NEWLY CONSTRUCTED LINED PONDS CONNECTED IN SERIES. ONE SERVES AS A PRIMARY POND, THE SECOND SERVES AS THE SECONDARY POND TO POLISH THE TREATED WATER FROM THE FIRST POND.

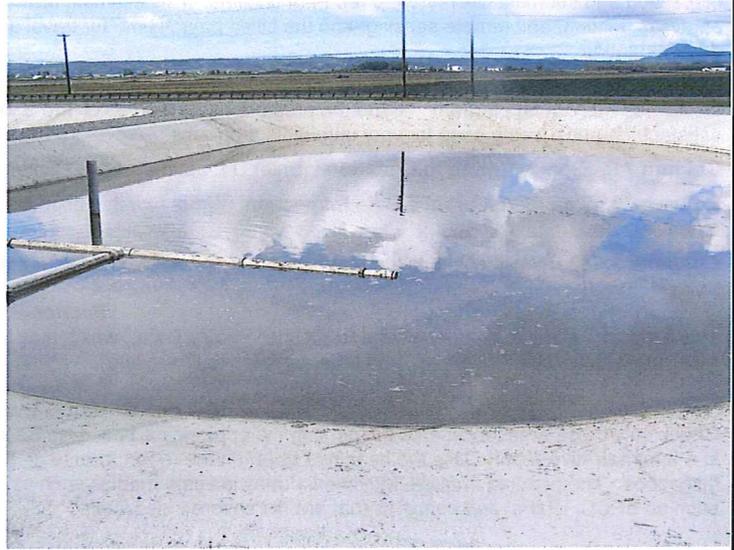
PHOTO #:04 DATE: 09/08/16
TAKEN BY: JEANNE TRAN
DESCRIPTION: A CLOSED UP PICTURE OF THE FIRST POND. EACH POND IS DESIGNED TO HANDLE A FLOW RATE OF 130 GPM WITH 13 HOUR SETTLING TIME AFTER DOSING WITH A FLOCCULATING AGENT TO AID IN THE SEDIMENTATION OF THE WASTEWATER.

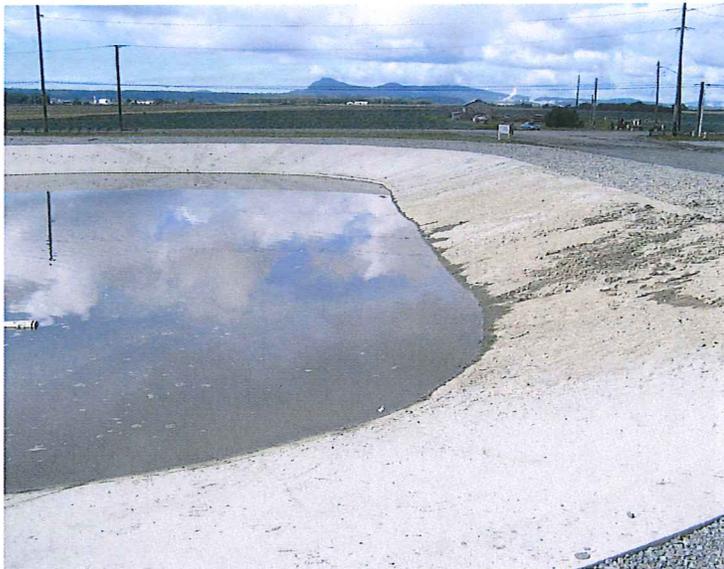
PHOTO #:05 DATE: 09/08/16
 TAKEN BY: JEANNE TRAN
 DESCRIPTION: A CLOSED UP PICTURE OF THE PRIMARY POND. BOTH PONDS HAVE BOTTOM DIMENSIONS OF 15X45' WITH INTERIOR AND EXTERIOR 3:1 SIDE SLOPES WITH A 12' WIDE DRIVABLE SURFACE AROUND EACH POND.

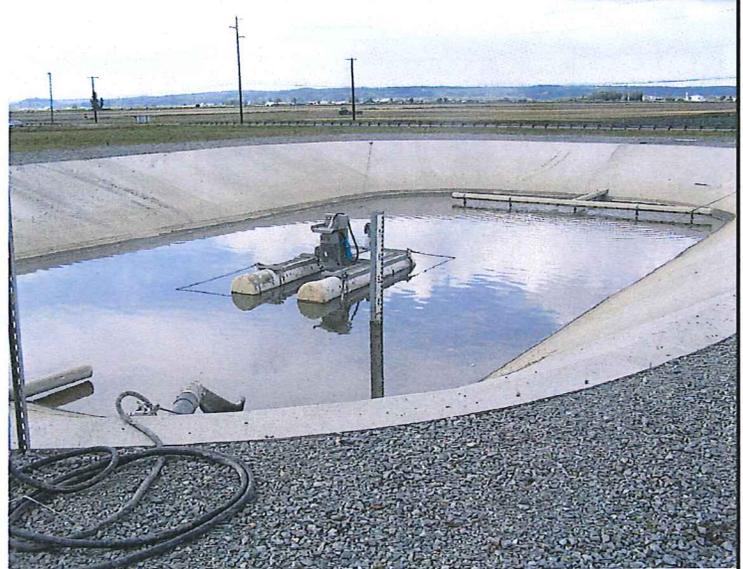
PHOTO #:06 DATE: 09/08/16
 TAKEN BY: JEANNE TRAN
 DESCRIPTION: A VIEW OF THE SECONDARY POND. EACH POND HAS A STORAGE CAPACITY OF 24,000 CFT. CURRENTLY, THE FACILITY IS OPERATING ONLY 1/3 OF THE DESIGN FLOW RATE, AND THE TREATED WATER IS RECYCLED FOR REUSE AT THE PLANT.

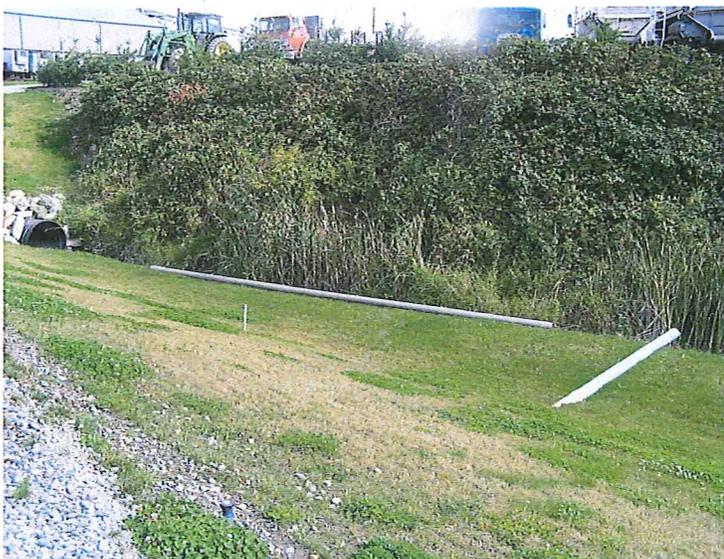
PHOTO #:07 DATE: 09/08/16
 TAKEN BY: JEANNE TRAN
 DESCRIPTION: A VIEW OF THE DISCHARGE PIPE FROM THE SECONDARY POND TO THE DITCH WHICH DRAINS TO LITTLE INDIAN SLOUGH.

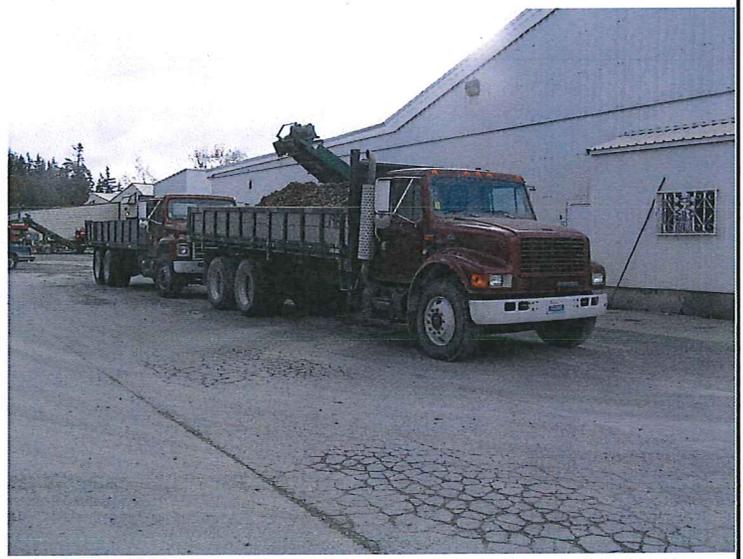
4) The soil removed from the potatoes was conveyed out of the building and dropped off onto an awaiting truck which parked outside of the building. Jose informed me that once the truck is full, the soil would then be taken back to the field. I

observed two trucks parked outside the processing building (See photo #8), waiting to be loaded. I observed that most of the facility is paved including this truck loading area. Jose indicated that Hughes Farms has retained a contractor to install a trench in the perimeter of the truck loading area to collect and route the stormwater to the new ponds for treatment. I observed spray painted lines on the pavement for the plumbing work. Jose informed me that the work is expected to be completed by October this year.

PHOTO #:08 DATE: 09/08/16
 TAKEN BY: JEANNE TRAN
 DESCRIPTION: SOIL REMOVED FROM THE HARVESTED POTATOES WAS COLLECTED AND TRUCKED BACK TO THE FIELDS. STORMWATER FROM THE ACTIVE PAVED AREA WAS CURRENTLY DRAINED INTO THE UNLINED POND WHICH IS SHARED WITH OTHER NEIGHBORING FACILITIES IN THE AREA.

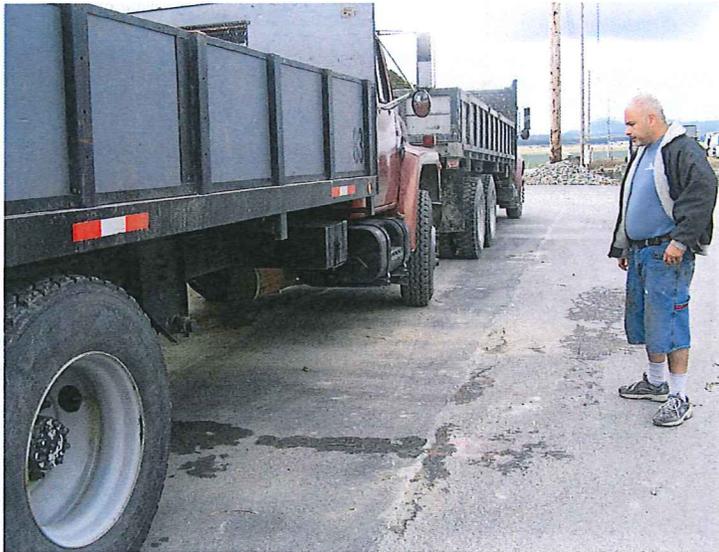
PHOTO #:09 DATE: 09/08/16
 TAKEN BY: JEANNE TRAN
 DESCRIPTION: A CLOSED UP VIEW OF THE SOIL TRUCK LOADING AREA. JOSE INDICATED THAT THE FACILITY WILL BE INSTALLING A PERIMETER TRENCH ALONG THE TRUCK LOADING AREA, AND THE STORMWATER IN THIS AREA WILL BE ROUTED TO THE NEW PONDS.

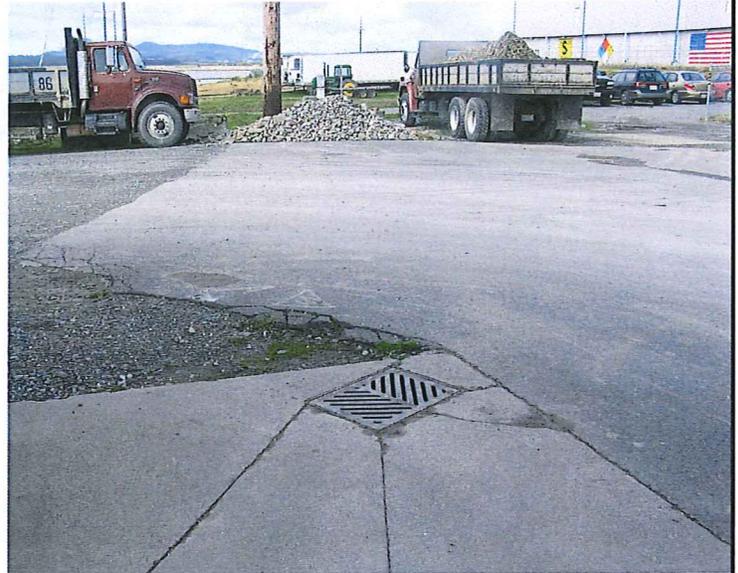
PHOTO #:10 DATE: 09/08/16
 TAKEN BY: JEANNE TRAN
 DESCRIPTION: A VIEW OF THE LAST CATCH BASIN WHICH DRAINS TO THE UNLINED SHARED SETTLING POND. AFTER THE PERIMETER TRENCH IS INSTALLED IN THE SOIL TRUCK LOADING AREA, AND THE LINE IS TIED IN WITH THE UNDERGROUND SUMP, STORMWATER WILL BE DISCHARGED TO THE NEW PONDS.

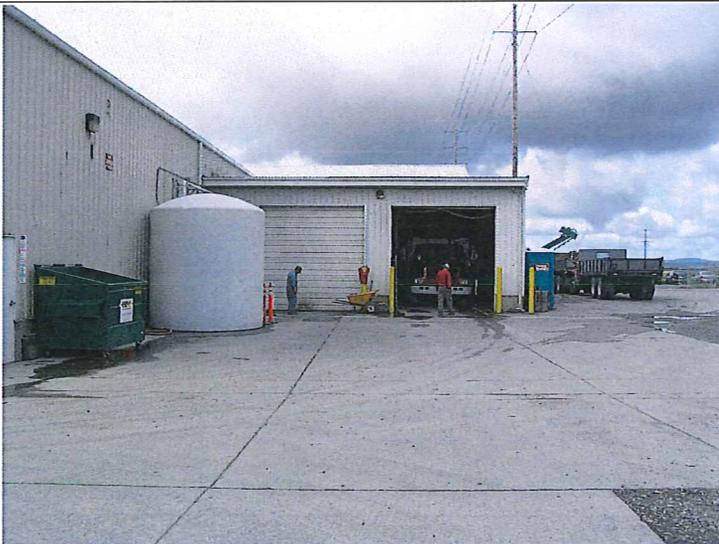
3) Potatoes harvested from the fields were trucked to the plant for processing. The truck was parked inside the building (See photo 11) where potatoes were dropped off onto conveyance belts for sorting, washing, grading, and packaging. Jose indicated that once unloading is done, the staff would hose down the unloading area. The washwater is collected and combined with the potato washwater for treatment and reuse. The quality potatoes are packed into boxes or bags to be stored in the refrigerated cooler awaiting for shipment. The imperfect potatoes are trucked to cattle farms for feed.

PHOTO #:11 DATE: 09/08/16
 TAKEN BY: JEANNE TRAN
 DESCRIPTION: A VIEW OF THE BACK OF THE PROCESSING PLANT BUILDING. NOTE A POTATO TRUCK WAS PARKING INSIDE THE BUILDING TO UNLOAD POTATOES JUST HARVESTED FROM THE FIELDS.

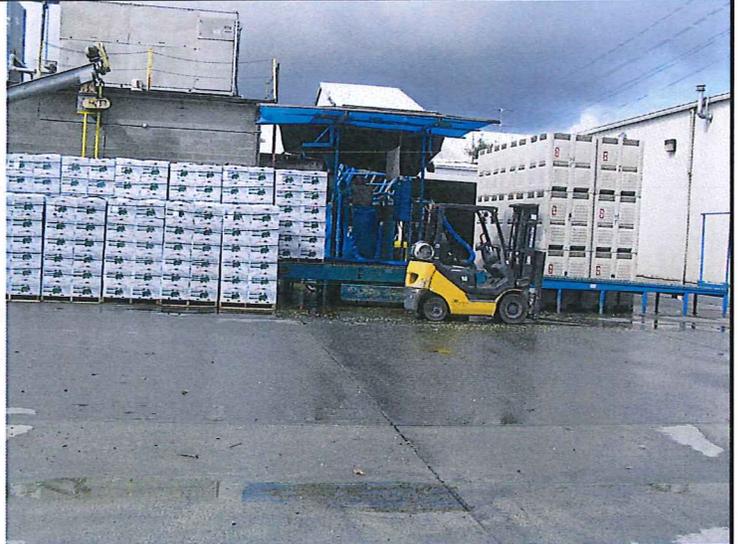
PHOTO #:12 DATE: 09/08/16
 TAKEN BY: JEANNE TRAN
 DESCRIPTION: BROCCOLI IS CUT AND PACKED IN THE FIELD AND TRANSPORTED TO THE PLANT TO BE STORED IN THE REFRIGERATED STORAGE COOLER. THE COOLED BOXES ARE MAINTAINED IN THE REFRIGERATED STORAGE UNTIL SHIPMENT.

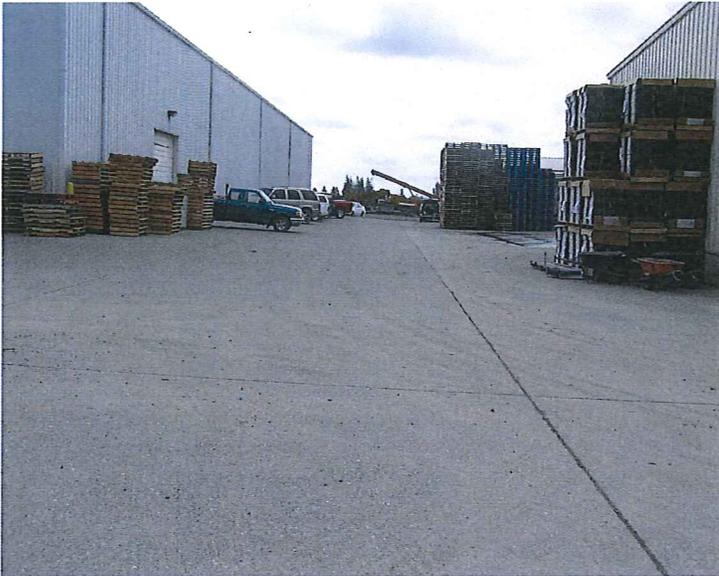
PHOTO #:09 DATE: 09/08/16
 TAKEN BY: JEANNE TRAN
 DESCRIPTION: WALKING TOWARD THE BACK OF THE FACILITY, I OBSERVED EMPTY DRUMS STACKED UP ON PALLETS. JOSE INDICATED THEY ARE WAITING TO BE SHIPPED OUT.

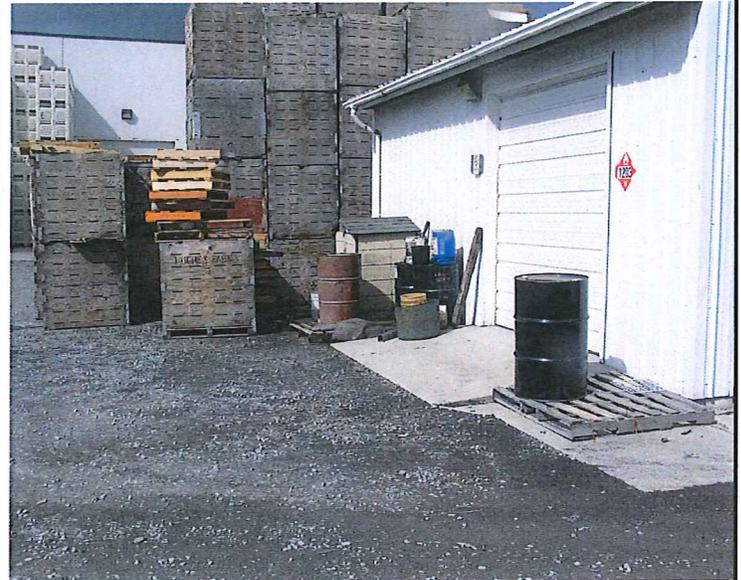
6) Hughes Farms has a few enclosed storage units in the back of the property. There is no drain in these storage units. Jose gave me a walkthrough of the area. I observed one drum of antifreeze was stored outside of the building. I asked Jose to provide a secondary containment for the drum and store it inside the building. Other than that, I observed no activity in this general area.

PHOTO #:10 DATE: 09/08/16
 TAKEN BY: JEANNE TRAN
 DESCRIPTION: A DRUM WITH ANTIFREEZE PRODUCT WAS STORED ON A PALLET, OUTSIDE OF THE SHOP. I ASKED JOSE TO STORE THE DRUM INSIDE THE BUILDING, WITHIN A SECONDARY CONTAINMENT.

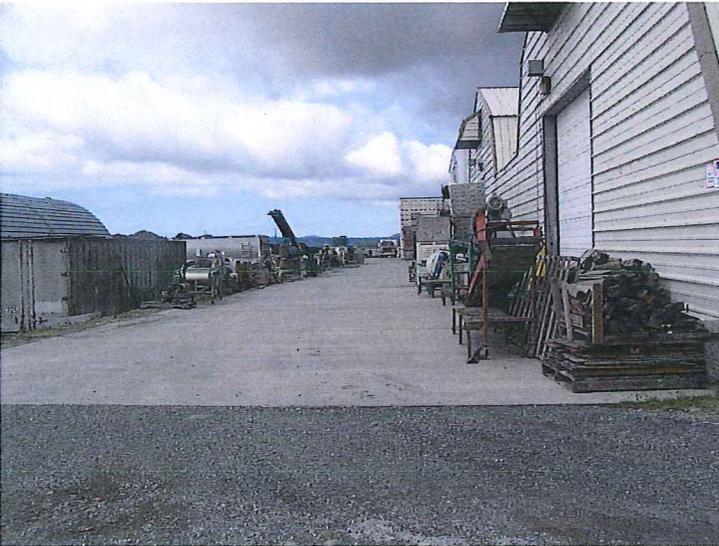
PHOTO #:11 DATE: 09/08/16
 TAKEN BY: JEANNE TRAN
 DESCRIPTION: MISCELLANEOUS UNUSED EQUIPMENT OR ITEMS WERE FOUND STORED OUTSIDE THE STORAGE BUILDINGS, ALONG THE BACK SIDE OF THE FACILITY.

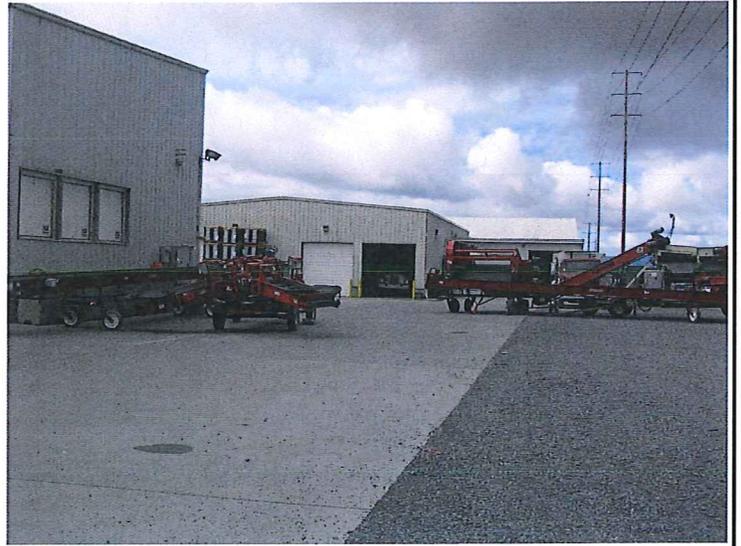
PHOTO #:12 DATE: 09/08/16
 TAKEN BY: JEANNE TRAN
 DESCRIPTION: A VIEW FROM THE BACK TO THE PROCESSING PLANT, SEVERAL IRRIGATION FIELD EQUIPMENT WERE FOUND TEMPORARILY STORED OUTSIDE OF THE BACK AREA OF THE FACILITY.
