STORMWATER COMPLIANCE INSPECTION REPORT

PHOTO ADDENDUM – GACO WESTERN 8/7/2006

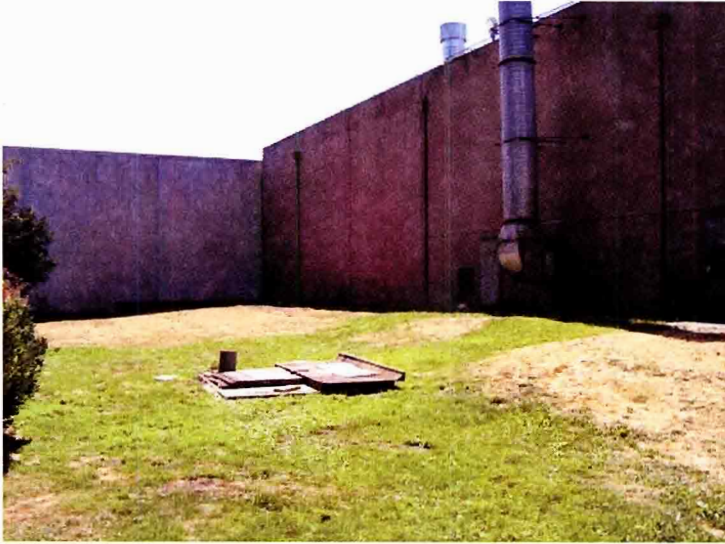
P8070017 DESCRIPTION: BACK OF FACILITY WHERE UNDERGROUND FRENCH DRAIN IS LOCATED

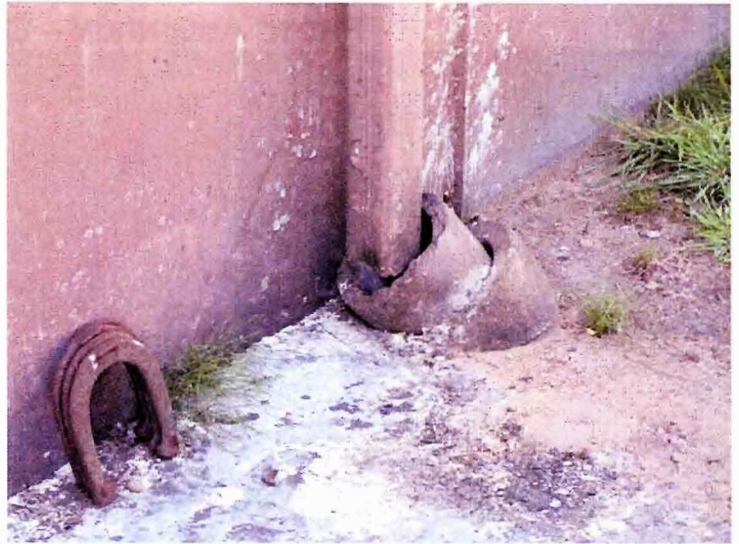
Ms. Dobbins said that Gaco Western was one of the test sites for a Zinc study performed by Ecology. She said that the representative suggested they sample from the roof drains due in part to their manufacturing process and because of the stormwater conveyance system layout (photo P8070019). Gaco Western manufactures waterproofing sealant and according to Ms. Dobbins the most likely spot for stormwater to come into contact with any potential pollutants at the facility is on the roof due to the venting systems from the manufacturing process. The roof drains go to a grassy field and then infiltrates to an underground French drain that connects to the outfall that is inaccessible from the site (photo P8070017). I saw two catch basins on-site, one in the parking lot and the other at the very edge of the property upslope from the front side of the building

P8070019 DESCRIPTION: ROOF DRAIN WHERE SAMPLES ARE COLLECTED

- Please resume sampling for pH, zinc, copper, hardness, lead and nitrate/nitrite. You can suspend sampling for these parameters only after eight (8) consecutive quarterly samples demonstrate attainment of benchmark values for each parameter.

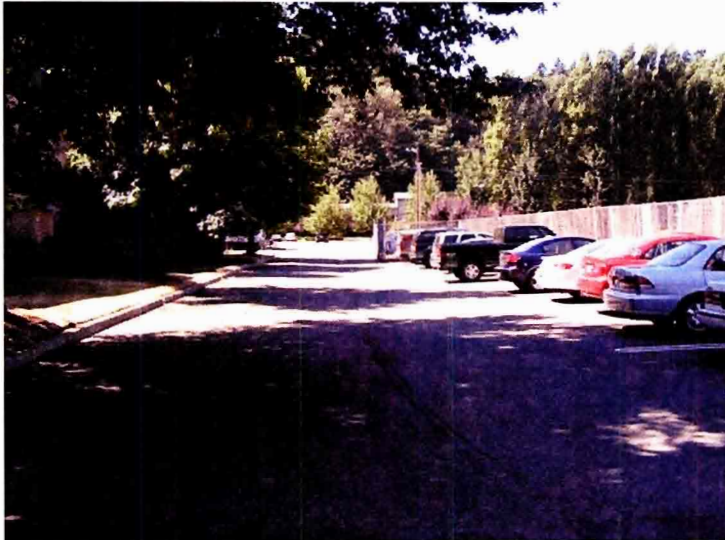
(Photo P8070023). Neither of these catch basins seemed appropriate for sampling due to location and likelihood of exposure to significant sources of pollution from the site.

P8070023 DESCRIPTION: EMPLOYEE PARKING

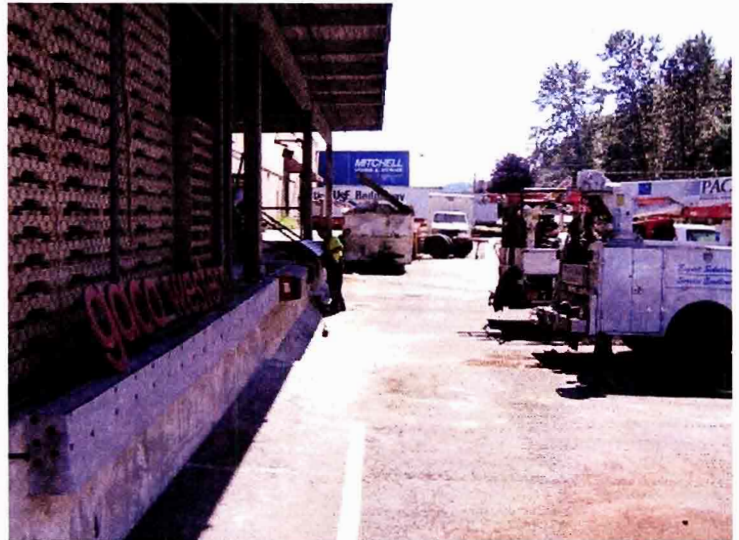
The front of the building is where they load and unload materials. They regularly have tankers that offload latex and oil to large vats that are stored inside via outside valves. Ms. Dobbins said that the tankers have spill kits with them and that the buckets under the valves are there for occasional drips that come from the connection points (Photo P8070024 and P8070030).

P8070024 DESCRIPTION: FRONT OF FACILITY

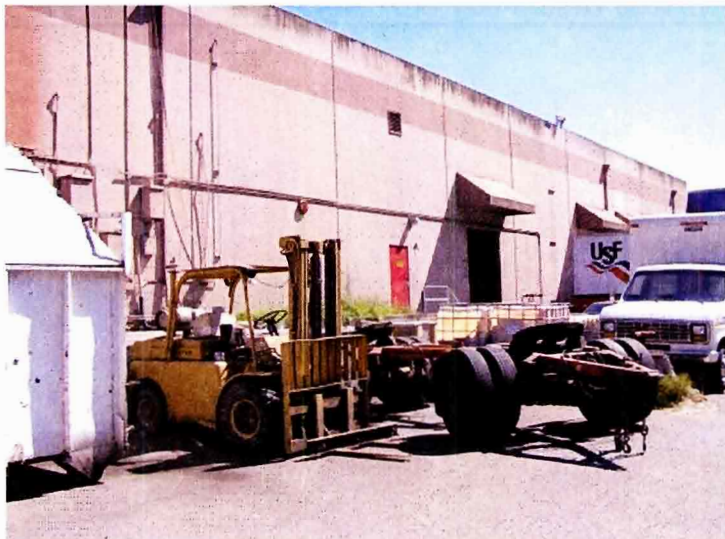
During the time of inspection there were several empty chemical containers and barrels that were being stored outside waiting to be removed from the site (Photo P8070028). One of the large square containers had been cut open and was being used to store a botched chemical reaction that had created a useless glass-like material (Photo P8070029). I suggested that they provide a cover for this container as soon as possible to prevent the open container from collecting stormwater. Also stored outside were two decommissioned vats that Ms. Dobbins said they plan on removing from the site and a forklift and trailer currently used by the facility (Photo P8070027 and P8070033).

P8070027 DESCRIPTION: MACHINERY STORAGE

- Monitor and cover machinery stored outdoors to make certain fluid leaks are not contaminating soils or stormwater.

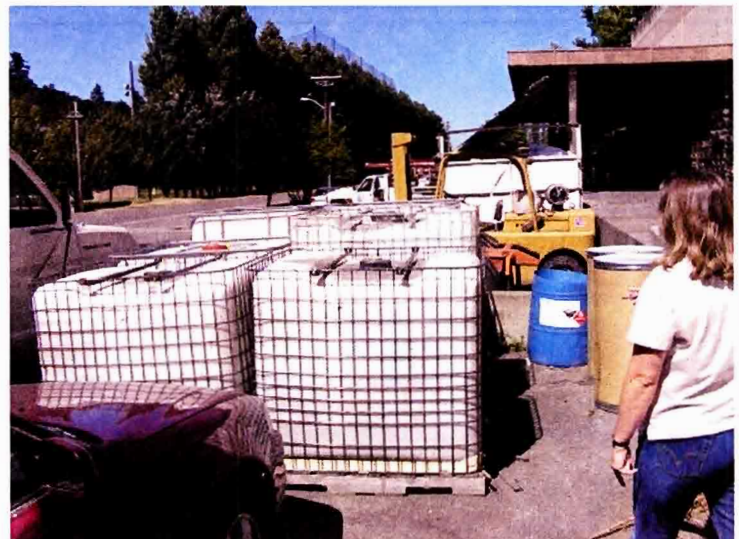
P8070028 DESCRIPTION: EMPTY CONTAINERS WILL BE HAULED OFF SITE

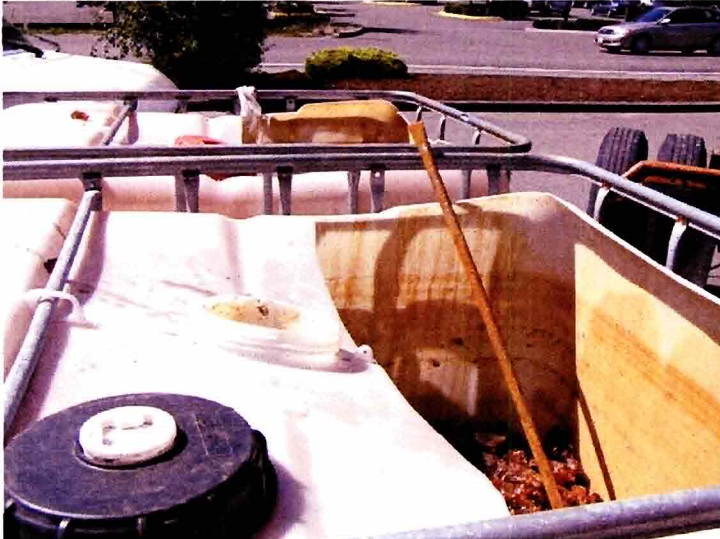
P8070029 DESCRIPTION: BIN WITH MATERIAL FROM BOTCHED CHEMICAL REACTION

- Please update the facility's Stormwater Pollution Prevention Plan to reflect current conditions.
- The container that is storing the substance that was formed from the botched chemical reaction needs to be covered immediately or stored indoors.

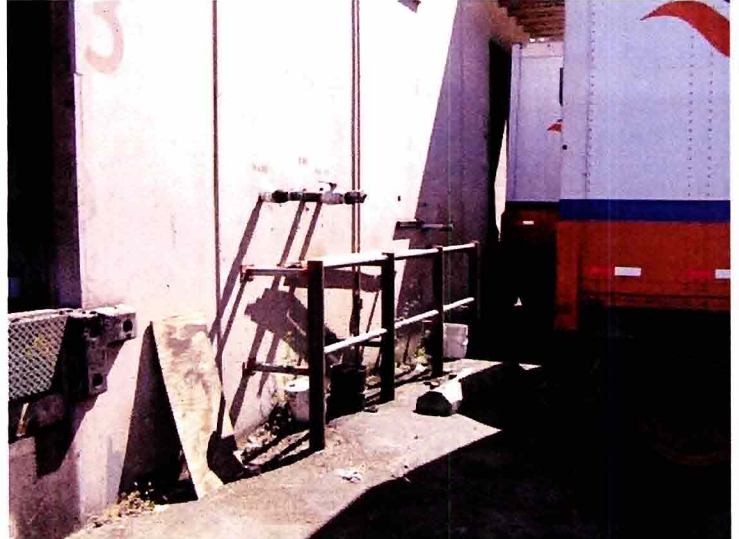
P8070030 DESCRIPTION: LATEX AND OIL OFFLOADED HERE, BUCKETS COLLECT OCCASIONAL DRIPS

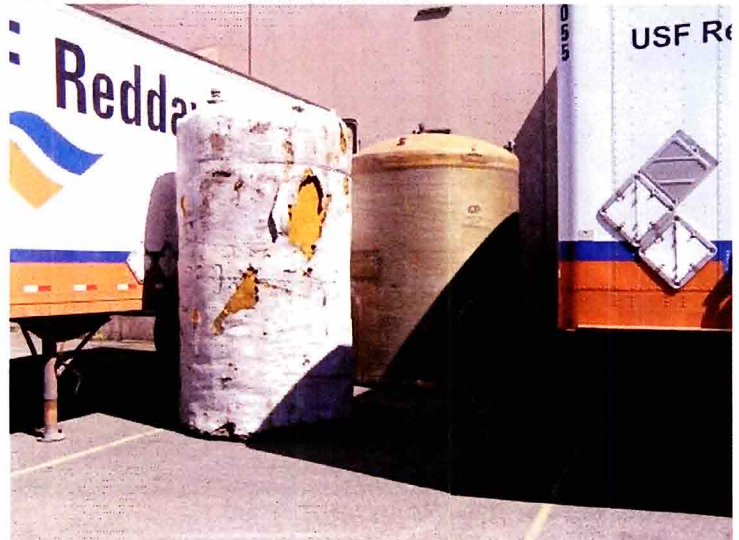
P8070033 DESCRIPTION: OLD TANKS WILL BE HAULED OFF-SITE
