STORMWATER COMPLIANCE INSPECTION REPORT

| Donald Seeberger Unit Supervisor Water Quality Program | 08/02/06 Date |

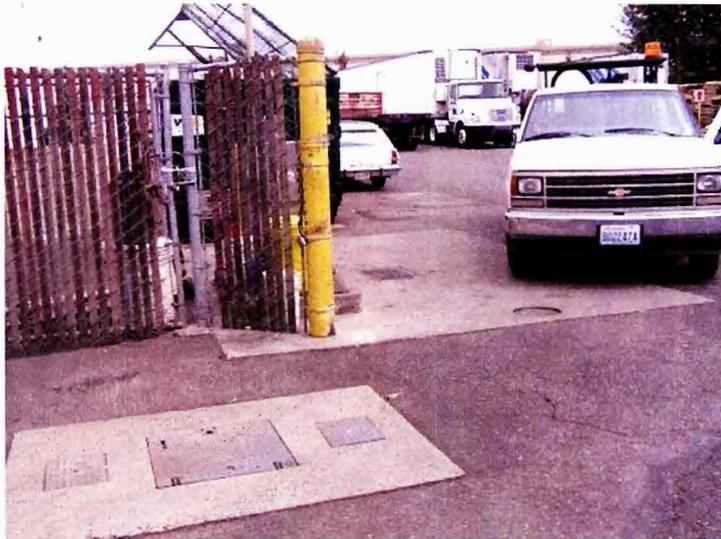
The facility has a fueling station that sits on a concrete pad which drains to a catch basin in the middle of the pad (P7250004 and P7250005). Mr. Gilbert said the catch basin drains into an oil/water separator and then into the sanitary sewer. Mr. Gilbert and I discussed sampling and we concluded that the sampling location for this facility should be at the last stormdrain on-site before the system ties in with the city system (P7250009). I also noted that the catch basins on-site appear to have a significant amount of sediment in them which should be clean out. For more information, please refer to the catch basin maintenance standards in the Stormwater Management Manual for Western Washington.

P7250004 DESCRIPTION: OIL AND WATER SEPERATOR

- **All catch basins on-site need to be cleaned.** The Stormwater Management Manual for Western Washington (SWMM) suggests, at a minimum, that catch basins be cleaned when the depth of the deposits reaches 60% of the sump depth (as measured from the bottom of the basin to the invert of the lowest pipe into or out of the basin). Furthermore, Condition S9.B.3 of the permit requires that Best Management Practices (BMPs) are implemented *and* maintained on a regular schedule to ensure they are effective in preventing the pollution of stormwater.

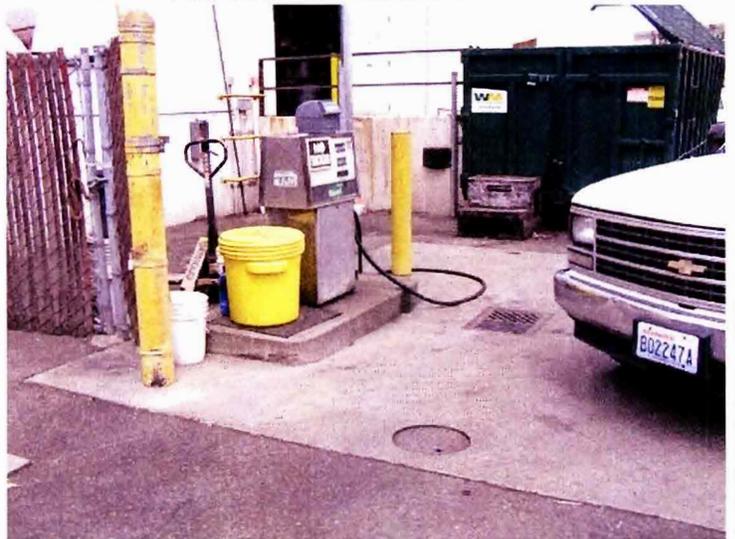
P7250005 DESCRIPTION: FUEL STATION DRAINS TO SANITARY SEWER

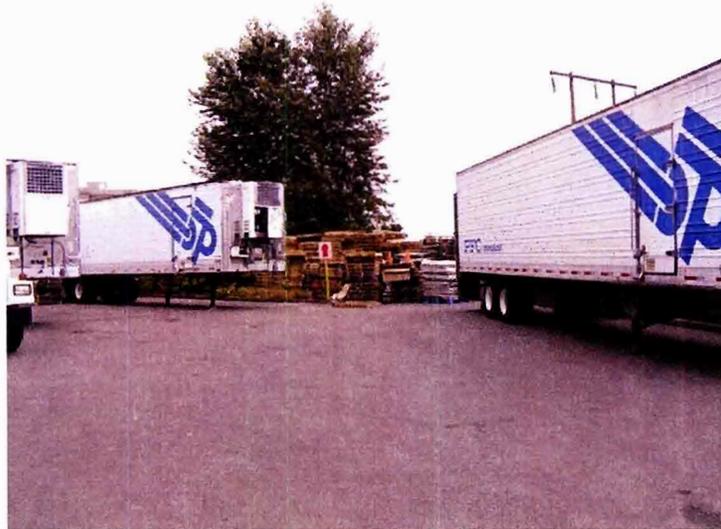
Mr. Gilbert accompanied me on the site inspection. Proficient Food Company is a wholesale distributor for Denny's restaurants. All outside industrial activity takes place on the south and east sides of the building. On the south side they load and unload delivery trucks (Photo P7250008). The east side is used primarily for storage and parking (Photos P7250006 and P7250007).

P7250006 DESCRIPTION: STORAGE AREA

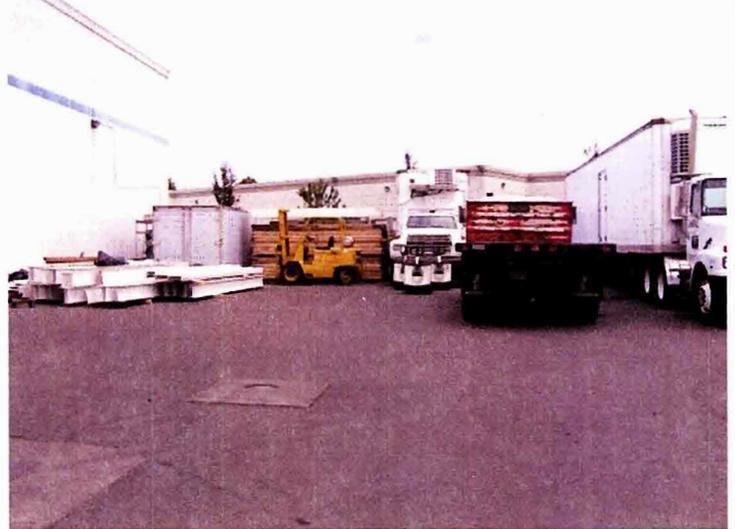
P7250007 DESCRIPTION: TEMPORARY STORAGE AREA

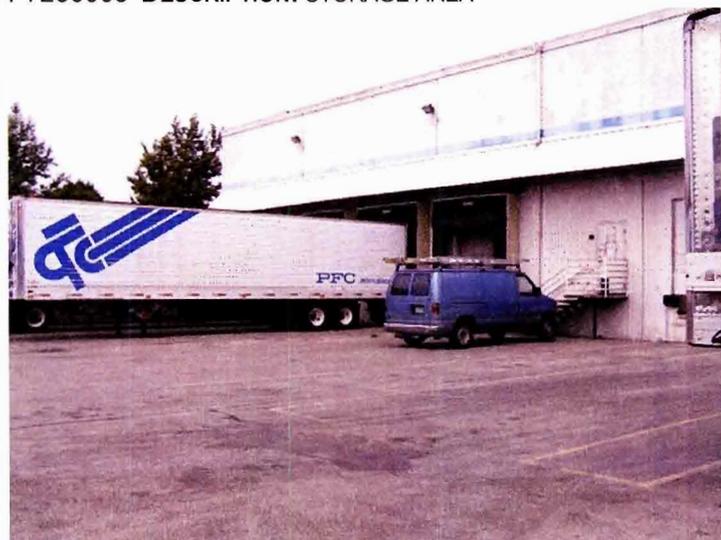
P7250008 DESCRIPTION: LOAD AND UNLOAD (MAIN ACTIVITY) AREA IN FRONT OF BUILDING

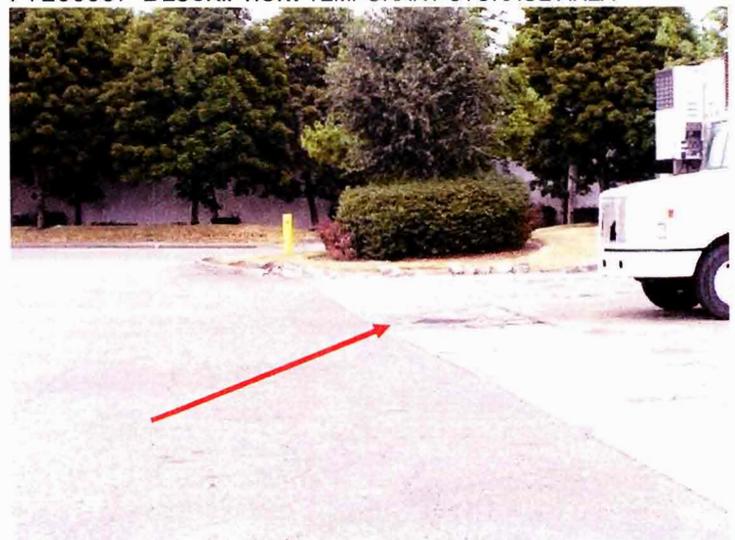
P7250009 DESCRIPTION: SUGGESTED SAMPLE POINT

- Condition S4.A of the permit requires that you take quarterly samples based on specific criteria. The permit also states that if the specific criteria cannot be met that quarter, a sample must still be taken. You are only required to

take one sample per quarter regardless of if the criteria can be met at a later time. If there is no rain event in a quarter you still must submit a DMR with an explanation as to why a sample was not taken. **Not sampling stormwater as required by condition S4 is a violation of the permit.**
