State of Washington Department of Ecology
Northwest Regional Office
**STORMWATER COMPLIANCE INSPECTION
REPORT**

Name and Location of Facility Inspected Iron Mountain Quarry Granite Falls 21100 Wayside Mine Road Granite Falls, WA 98252	Entry Time 1145	Permit Effective Date 2/14/2005
	Exit Time 1300	Permit Expiration Date 2/14/2010

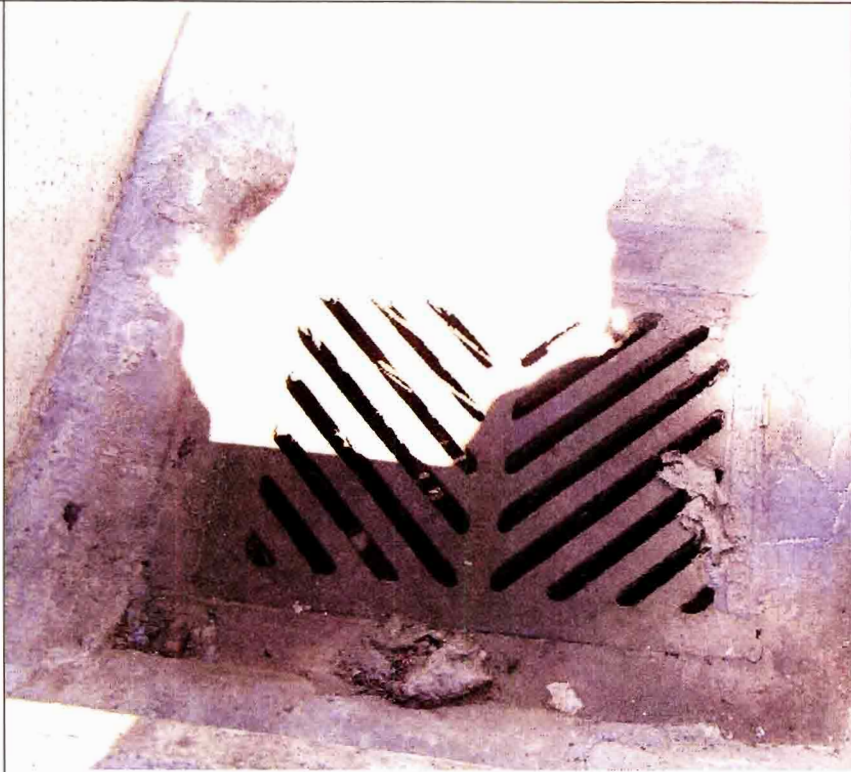
Photo #: 1

Pictured here is the secondary containment area where the large fueling tanks are placed. This drain within the containment area appears to be connected to the storm pond. The drain needs to be plugged immediately. The stormwater in the containment is considered contaminated and may not be discharged. This water must be taken off the property and disposed of by a qualified disposal company. No discharge of pollutants to ground or surface water is allowed.

- A fueling tank storage area at this facility does have secondary containment although there is no roof to keep out stormwater. A storm drain was also found within this containment area which appears to be connected to the storm pond. The drain needs to be plugged immediately since this stormwater is considered contaminated and may not be discharged. This water must be taken off the property and disposed of by a qualified disposal company. No discharge of pollutants to ground or surface water is allowed.

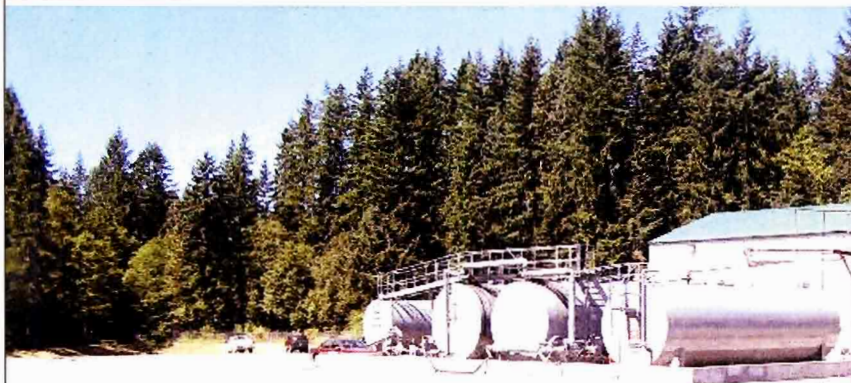
Photo #: 2

Pictured here is the secondary containment and fueling tanks.
