RE: Basin City Mobile Home Park - State Waste Discharge Permit No. ST0005398
Inspection Report

WASHINGTON STATE DEPARTMENT OF ECOLOGY WASTEWATER TREATMENT FACILITY SITE VISIT REPORT

| Basin City Mobile Home Park WWTP Photo Log | October 15, 2014 |

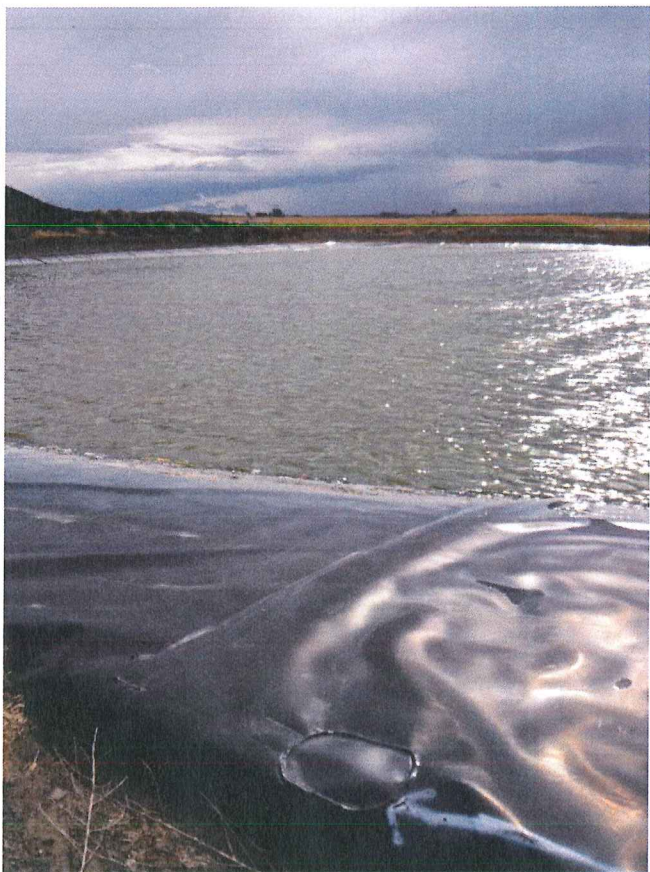
| Lagoon No. 1 receives influent flow. Repair to liner visible in foreground | |

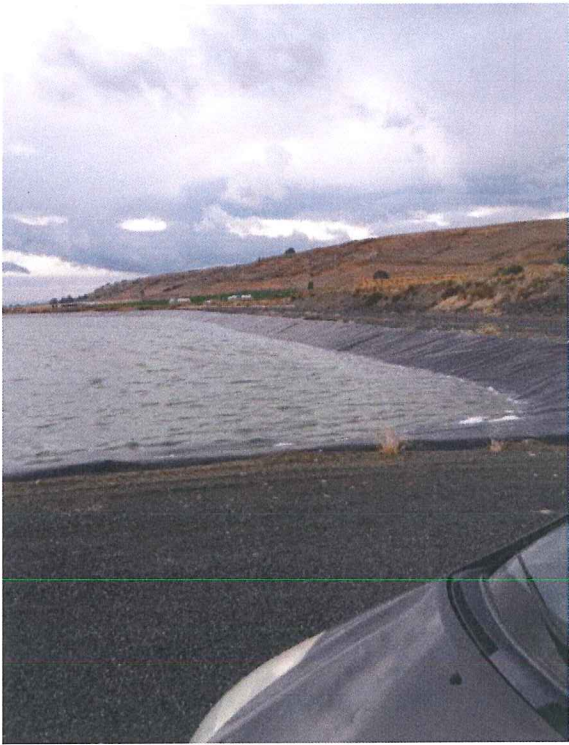
| <p>Evaporation lagoon, No. 4 looking south-southwest from the north berm</p> | |

After reviewing the paper records for the facility we drove to the treatment system. Entering the treatment system from the south, Lagoon No. 4 is the first encountered, which is an evaporation pond. The current depth is at 3.5 feet, with a noticeable odor. The next is Lagoon No. 3 to the north, effluent samples (# 001) are collected from the northwest corner of this lagoon. Lagoon No. 2 is east of Lagoon No. 3. Further to the east of Lagoon No. 2 is Lagoon No. 1, which receives influent flow. The lagoons are operated in sequence. Flows from Lagoon No. 3 are routed either to the evaporation Lagoon No. 4 or to the wetlands.

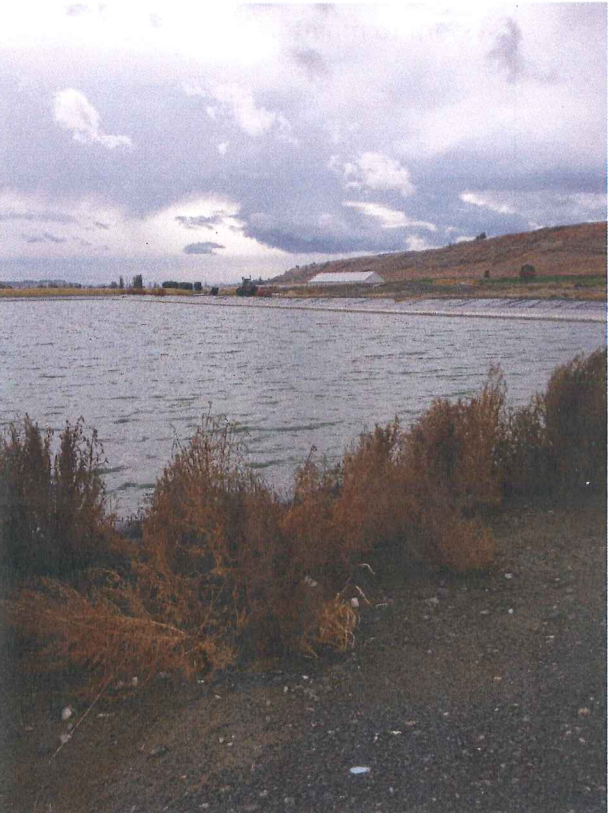
| <p>Treatment Lagoon No. 3, effluent samples are collected from the northwest corner of this lagoon, at the extreme right of this image. Treated wastewater is directed from this lagoon to the wetlands north of this lagoon, or to the evaporation lagoon No. 4 to the south.</p> | |

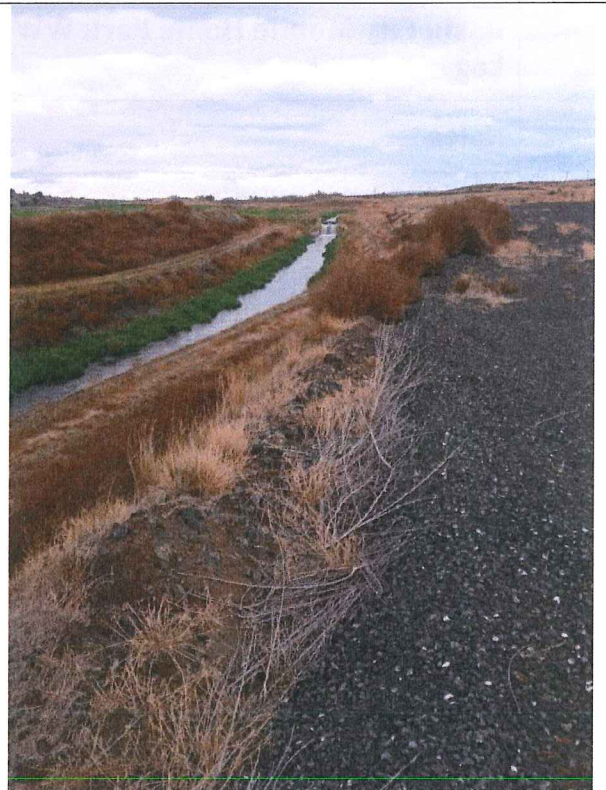
Drainage ditch runs parallel and to the west of the treatment system. Samples Up and Down are collected from this ditch, which has water flowing in it year round.

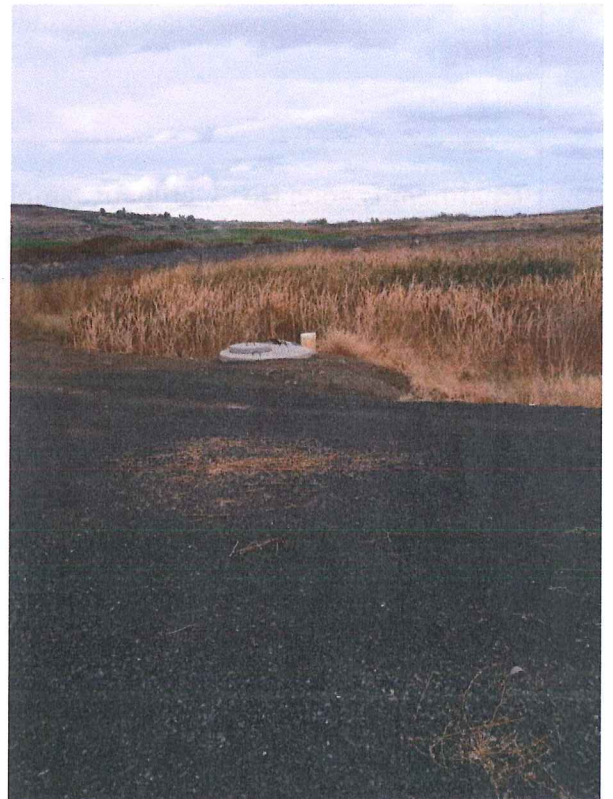
Monitoring well BC-3, south of wetlands, which are visible in the background. The original three cell wetlands area has been reduced, because there is not sufficient water discharged from the treatment system to maintain the entire wetland area.

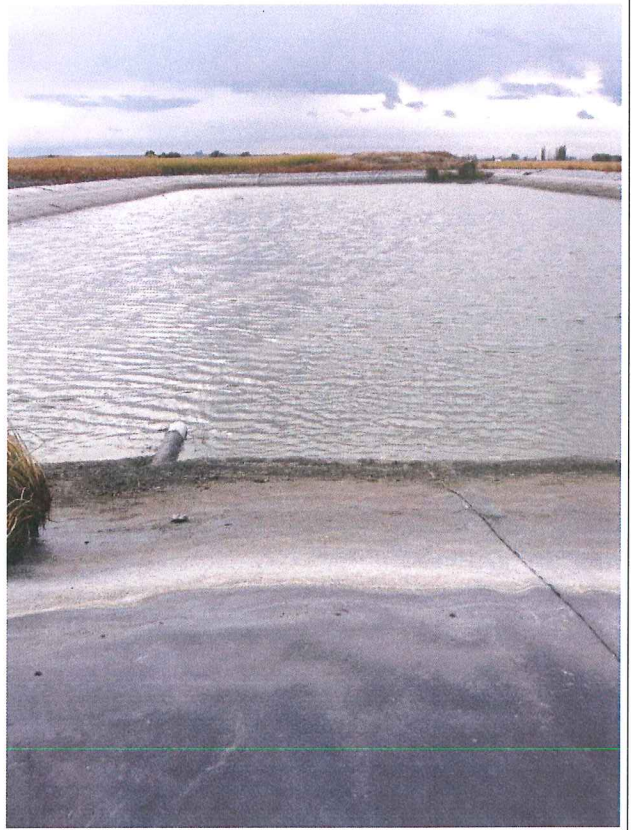
Lagoon No. 2 looking south

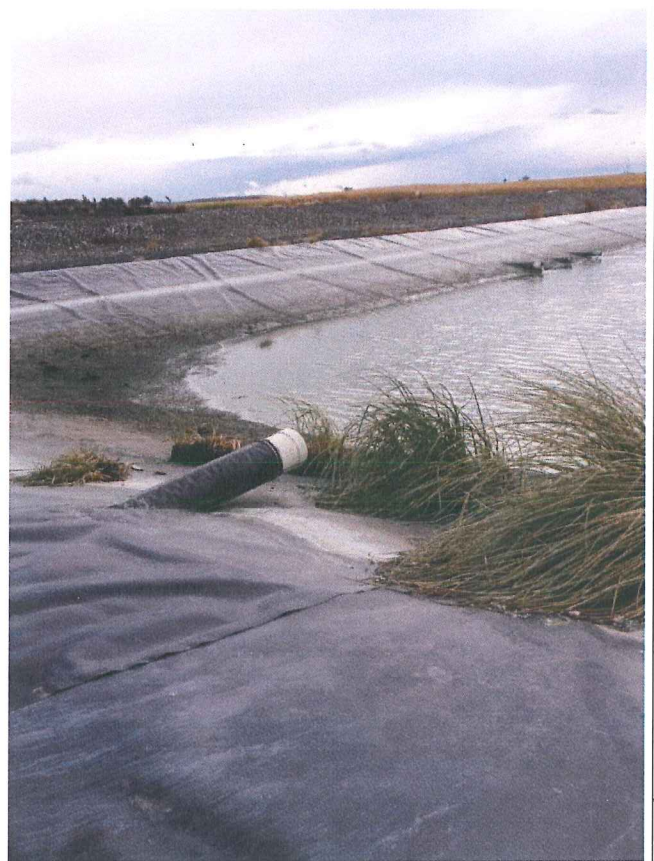
Lagoon No. 2 looking east. Vegetation removal is planned during maintenance this fall.
