# CONSTRUCTION STORMWATER COMPLIANCE INSPECTION REPORT

State of Washington Department of Ecology

Water Quality Name: Stetson Heights

NPDES Permit #: WAR306103

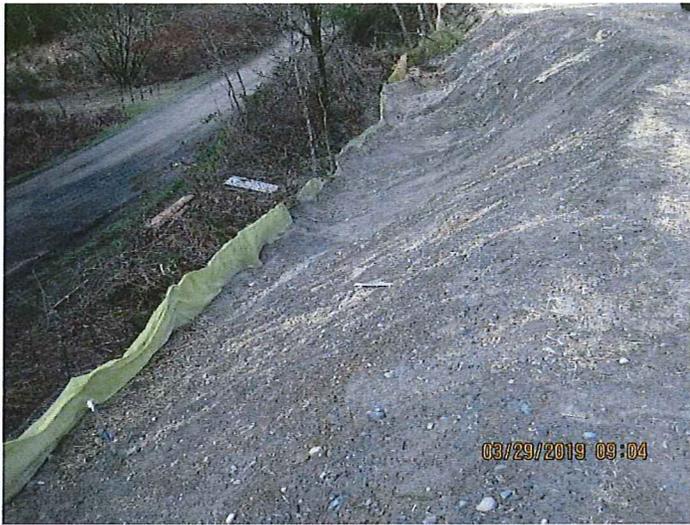
Met with Robert Terhune, site contactors, geo-tech guys, and Zack, Darren, and Ian with the city about the city's requirements to lift their red tag. They discussed wetland approval, geo-techs verifying the lower ponds were built per requirements and test roads moving forward. They currently only have one city permit and will need to apply for others to continue working this year. It was explained they could correct rills and gullies on slopes, installing pond control structures, and pipe across access from neighbor's driveway. It was agreed that weekly plans of what type of work would be done in which zones would be submitted while working to get into compliance. While hydroseed, straw mulch, or hog fuel had been added to much of the site, straw needed to be thicker in areas (**Photo 4**). Reminded that watering hydroseed to ensure growth and maintenance to straw mulch needed to be considered. We also pointed out there were still areas with no cover, including stockpiles and pond slopes (**Photo 3**). Silt fencing along neighbor's driveway need maintenance and the slope needs stabilized with cover (**Photo 1**). Slope above the wetland is gullied and needs to be stabilized (**Photo 2**).

Photo 1 Description: Silt fence needs to be maintained. Slope needs to be protected with cover.

**The site is in violation of permit condition S9.D.6. for failure to protect slopes.** Slopes must be stabilized and protected from erosion with effective BMPs. **This must be corrected within 7 days of the date you receive this document.**

**The site is in violation of permit condition S9.D.11.a. for failure to maintain BMPs.** Maintain and repair all temporary and permanent erosion and sediment control BMPs as needed to assure continued performance of their intended function in accordance with BMP specifications. **This must be corrected within 7 days of the date you receive this document.**

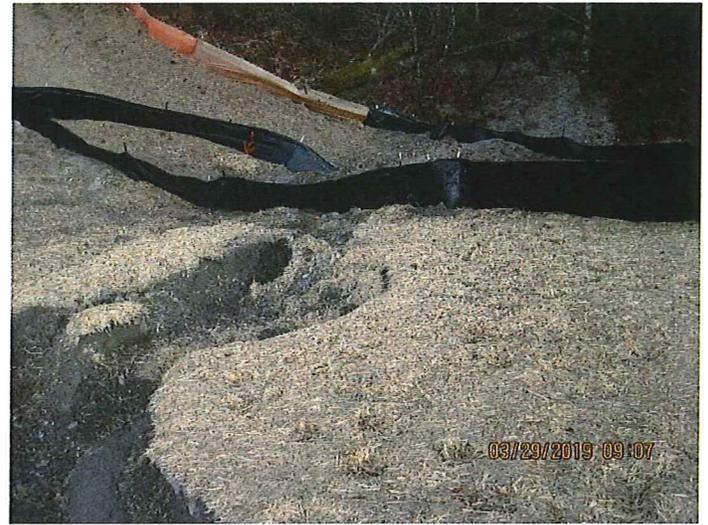
Photo 2 Description: Slope above wetland still needs to be stabilized.

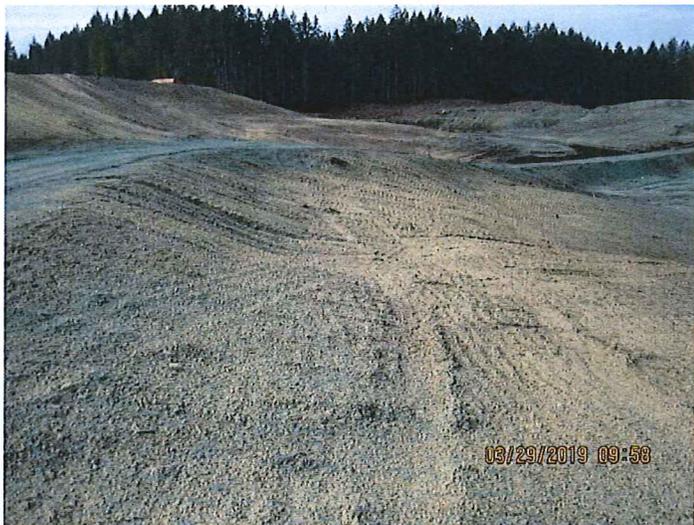
Photo 3 Description: The back of the site still has uncovered soil.

**The site is in violation of permit condition S9.D.5.d. for failure to stabilize all exposed and unworked soils within 2 days between October 1 and April 30.** Unworked soils must be stabilized or protected with a BMP like a seeding, mulching, plastic covering, or erosion control fabrics. **This must be corrected within 2 days of the date you receive this document.**

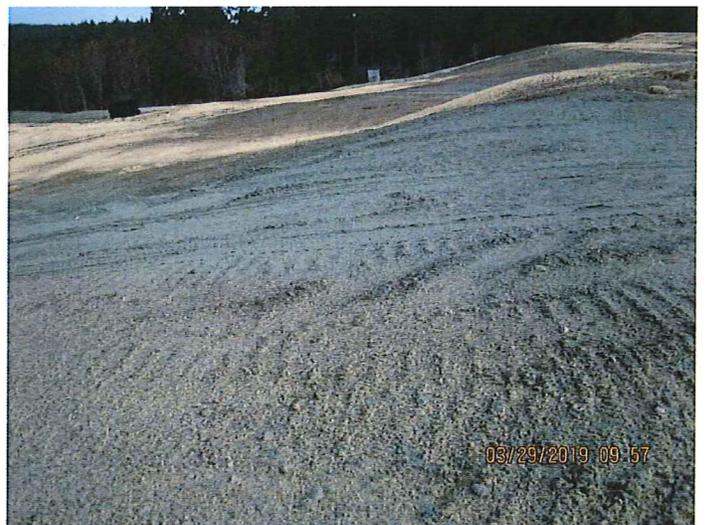
Photo 4 Description: Straw mulch is thin in areas and needs to be installed to specification: 2-3 inches thick.
