State of Washington Department of Ecology WASTEWATER TREATMENT PLANT COMPLIANCE INSPECTION REPORT			Northwest Regional Office 3190160 th Ave SE Bellevue, WA 98008 ph: (425) 649-7000 fax: (425) 649-7098 (rev. 9-15-15)	
Section A: General Information						
Report Version	PERMIT #	mm/dd/yy	Inspection Type	Inspector Code	Facility Type	
<input checked="" type="checkbox"/> New <input type="checkbox"/> Changed <input type="checkbox"/> Deleted	WA0029548	7/8/2019	S	S	<input checked="" type="checkbox"/> 1 Municipal <input type="radio"/> Public <input type="radio"/> Private	
Remarks						
Inspection work days	Facility Self-Monitoring	Photos Taken	Samples Taken	BI	QA

A NPDES Class I Inspection was conducted at the City of Snohomish Wastewater Treatment Plant (WWTP) on July 8, 2019. Lazaro Eleuterio (Municipal Permit Manager) with the Washington State Department of Ecology conducted the inspection with assistance from Mr. Duane Leach. This was an announced inspection to assure that a key facility contact was available.

Inspection Photos – City of Snohomish WWTP WA0029548
Photos taken on 07/08/2019 by Lazaro Eleuterio

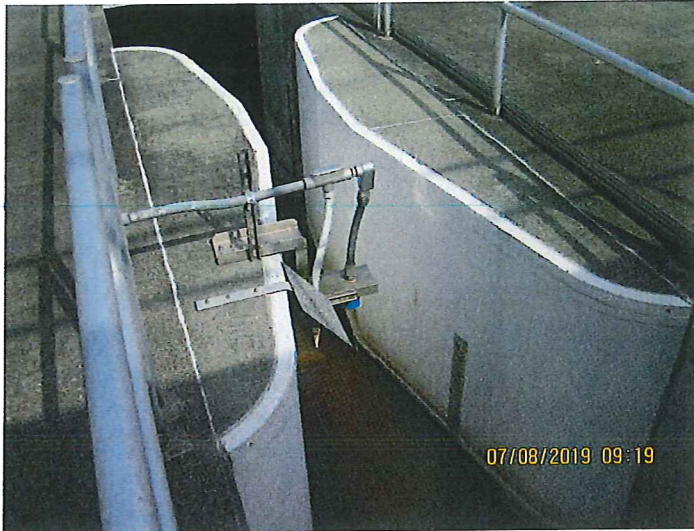
Photo 1 – Influent Parshall Flume and Ultrasonic Flowmeter

Raw sewage from the fifteen lift stations in the service area flows through a Parshall Flume equipped with ultrasonic flowmeter for flow measurement (Photo # 1), pumped by influent screw pumps (Photo # 2) and then screened by a ¼ inch mechanically cleaned bar screen (Photos # 3 and # 4). One 1/2-inch manual bypass bar screen (Photo # 5) is available for emergency, and in case of maintenance and inspection of the mechanical screen. After screening, wastewater flows into a grit chamber and then flows by gravity to the four-stage lagoon system. Magnesium hydroxide is flow-paced injected into the dewatered wastewater for alkalinity and pH control purposes (Photo # 6).

Influent flow is measured at the headworks using an ultrasonic flowmeter above a Parshall Flume (Photo # 1). Effluent flow is measured downstream of the chlorine contact basin using an ultrasonic flowmeter mounted above a weir. Lagoon # 4 is equipped with a flowmeter and a weir at the final effluent. Influent and effluent flowmeters are calibrated once a year as part of the plant's preventative maintenance program per manufacturer's recommendations. The last calibration was conducted on June 10, 2019.

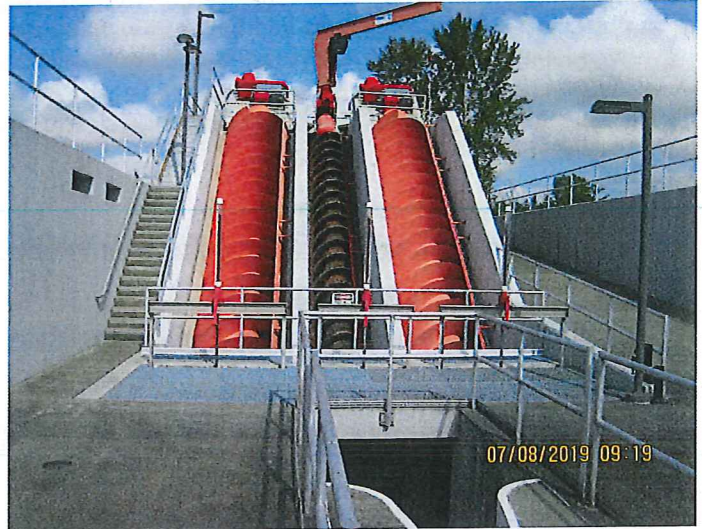
Photo 2 – Influent Screw Pumps

Typically, the plant can be operated with one screw pump on duty and two on standby under normal operating conditions. Under wet weather conditions, there are two pumps available but with limited redundancy with screening process.

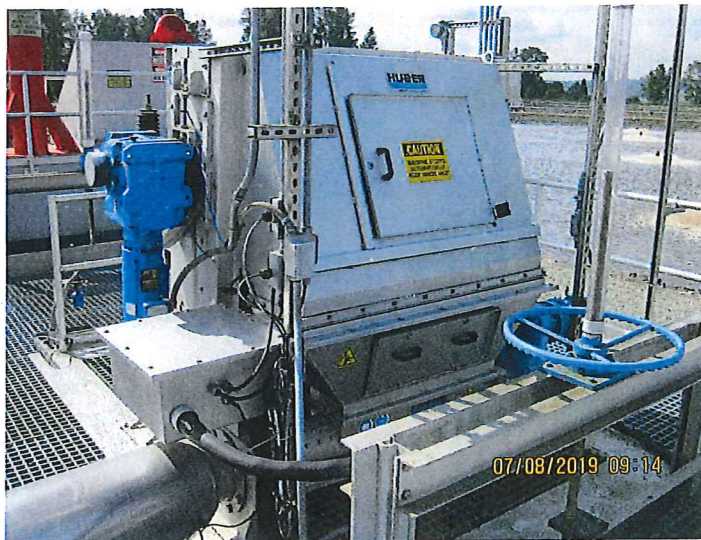
Photo 3 – 1/4-inch Mechanical Bar Screen

Daily checks of all major equipment and treatment processes are conducted and information is logged. At headworks, screw pumps and screens are inspected and greased weekly. Mechanical bar screen and channels are washed down with hose weekly or as needed. The manual bar screen can be placed in service every time the mechanical bar screen is placed offline for emergencies and maintenance services.

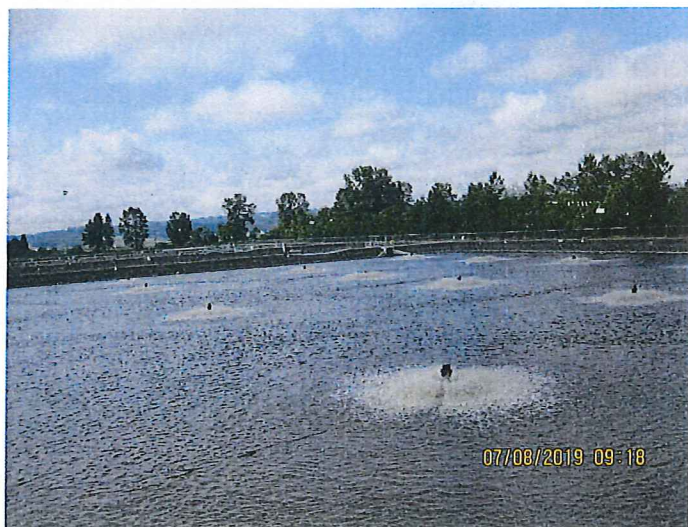
Photo 7– Lagoon # 1 and Mechanical Mixers/Aerators

Dewatered wastewater flows by gravity to the completely mixed aerated Lagoon # 1 (Photo # 7) with a total capacity of 10 million gallons and equipped with eighteen mechanical mixers/aerators. Following Lagoon # 1, wastewater flows through three partially-mixed lagoons in series with a total treatment capacity of 3.5 million gallons. Each partially-mixed lagoon (Lagoons #2, #3 and #4) is equipped with 18 integrated submerged fixed film (SFF) modules for further BOD removal and nitrification (Photos # 8, # 9, and # 10), and three mechanical mixers/aerators. The SFF modules are air scoured by coarse bubble diffusers weekly to remove excess biofilm. In the winter, only half of the WWTP's aerators are typically running. Conversely, in the summer, all aerators are ON at all times.

Lagoon # 1 is furnished eighteen mechanical mixers, and pH and DO probes. A SCADA system is used to monitor and control mixing, and oxygen, pH and alkalinity levels. Typically, in the summer months, all mixers are ON at all times. However, in the winter, due to lower oxygen demands, only six mixers are needed and rotation is applied using the SCADA system. Lagoons # 2, 3 and 4 are equipped with an ultrasonic unit (Sonic Solutions) to control algae growth without chemicals (Photo # 11). These units are ON at all times throughout spring and summer months (May through September), which is when most of the algal blooms occur at the facility. Plant staff is satisfied with this method to control algae and improve TSS removals.

The City has replaced seven existing mechanical mixers in Lagoon # 1 with high-energy efficiency mechanical mixers in the last years. The City is planning to replace the remainder in the next years to reduce operating costs. Mechanical mixers in

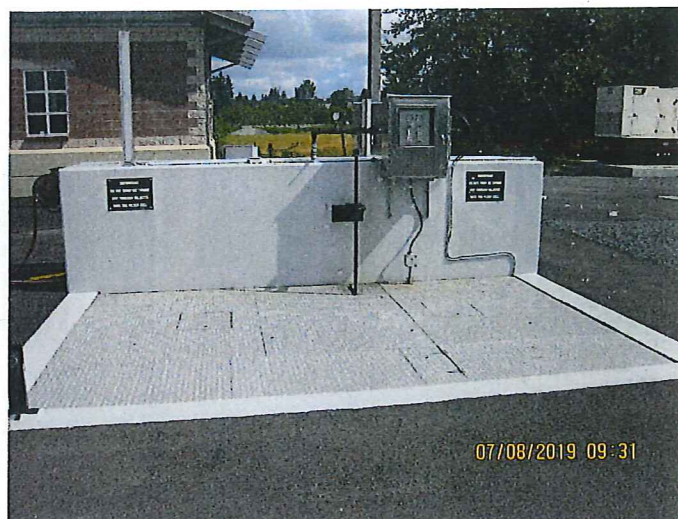
Photo 12 – DynaSand Filtration System

A portion of Lagoon # 4 effluent (approximately 1 MGD) flows to an effluent control structure and then to four Parkson DynaSand® EcoWash® continuous-backwash sand filters (Photos # 12 and # 13), which allow continuous filtration with intermittent sand washing. Therefore, filters are not shut down during backwashing. The primary purpose of the sand filters is to enhance TSS removals, particularly during dry weather conditions. The City has interest in expanding and upgrading the capacity of the filtration facility in the future; however, it has not determined which filtration technology would be suitable for the City of Snohomish WWTP yet. Air compressors are used for backwashing purpose (Photo # 14).

Even though the sand filters are continuously backwashed, they still get clogged. As a result, the City is not satisfied with the filters' performance and has conducted a one-month pilot testing with a mobile Fuzzy Filter in 2018. Fuzzy filters are well known for being compact, modular and suitable for a variety of wastewater applications. The purpose of the pilot testing was evaluate the performance of different filtration method and assist the City's decision-making with regards to the best alternative to upgrade and expand its filtration treatment facilities. At this time, the City has not made a decision related to this issue.

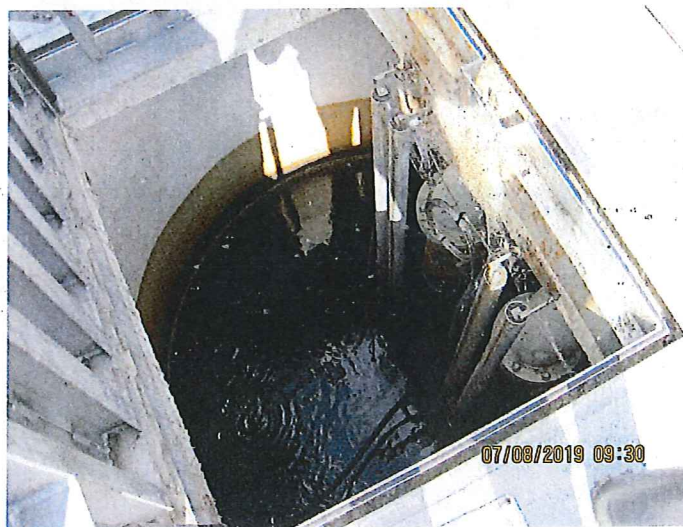
Photo 15 – Wet Well for Lagoon # 4's and Sand Filters' Effluent

The remainder of the Lagoon #4 effluent and the effluent from the sand filters are combined in a wet well (Photo # 15) and then pumped to the chlorine contact basin (Photo # 16) for disinfection prior to discharge to the Snohomish River. An effluent structure is used to control discharge flows downstream of the chlorine contact chamber. Sulfur dioxide gas is used for dechlorination.

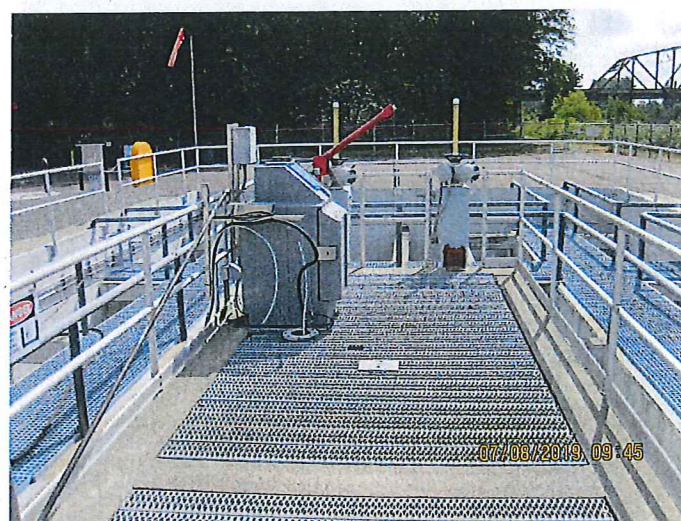
Photo 16 – Chlorine Contact Basin

Every summer, flows from Lagoon #4 are shut off so that the chlorination and sand filters facilities can be inspected, cleaned and properly maintained. Specifically, the chlorine contact basin is drained for a deep cleaning. Additionally, all ancillary equipment from both facilities are inspected and maintained. This year, the maintenance of the sand filters and chlorine contact basin is scheduled for the end of July.

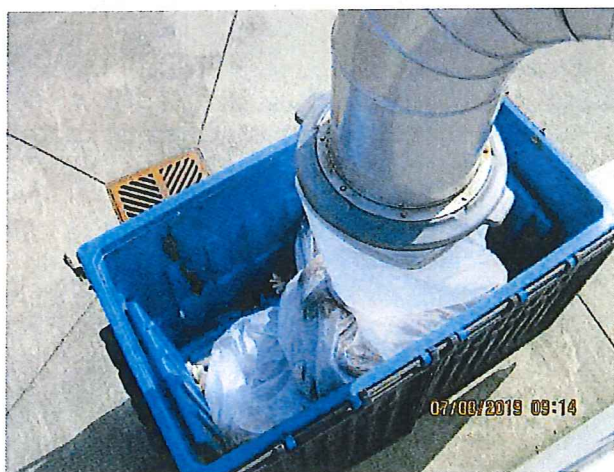
Photo 17 – Dumpster with Screenings, Rags and Grit

Screenings, rags and grit are dewatered, compacted and then discharged to a dumpster (Photo # 17). Captured grit passes through a grit classifier prior to being discharged to the dumpster, which is furnished with plastic bags. Waste activated sludge (WAS) is stabilized and stored in the four-stage lagoon system. The last time solids were dredged from the lagoons was in 2015. Approximately 697 dry tons of solids were removed and sent to BUF Cascade Materials for land application. The next biosolids dredging project may take place in 2025 or later. Biosolids survey is conducted every year to determine the level of biosolids accumulation in the lagoons and to plan for future dredging.

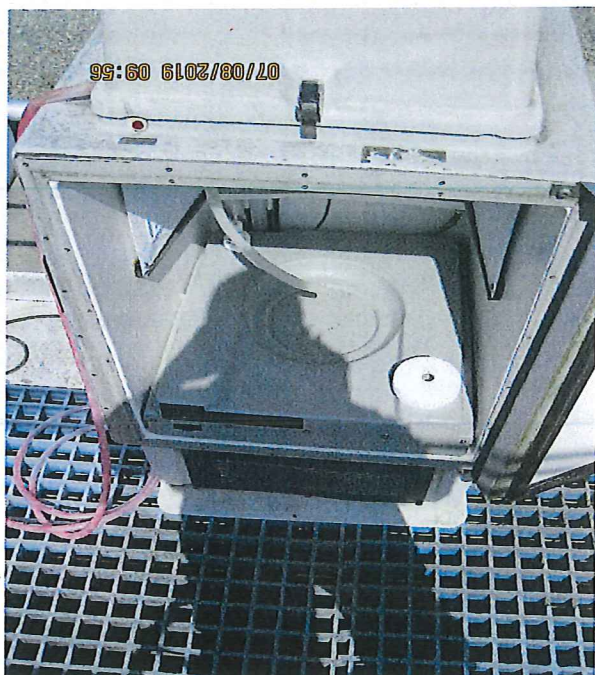
Photo 18 – Influent Composite Sampler

Both influent and effluent composite samplers were inspected. The composite influent sample (Photo # 18) and composite effluent sample (Photo # 19) have been refrigerated at 4.8° C and 5.1° C, respectively. Both temperature values meet the Standard Methods requirement for BOD (SM5210-B) and TSS (SM2540-D) analyses, which is sample storage and preservation between 2° and 6 °C. At the time of the inspection, the influent sampler indicated in the monitoring/control panel that sampling tube needs to be replaced.

1. Change sampling tube of the influent composite sampler as currently indicated by the equipment.
2. Control algae and duckweed growth in the chlorine contact basin during spring and winter.

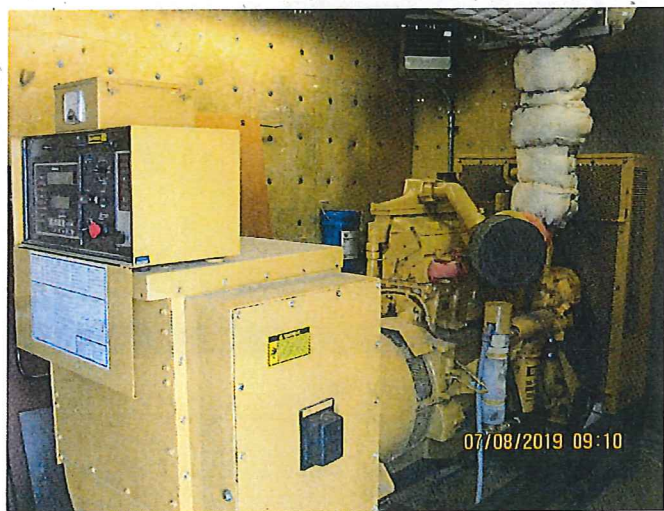
Photo 20 – Old Backup Power Generator

Two standby generators are used to power the plant and the laboratory during power outages. The old generator (Photo # 20) with a capacity of 350 Kilowatts can power Lagoon # 1, headworks and the laboratory. The new generator (Photo # 21) with a capacity of 300 Kilowatts can power Lagoons # 2, 3 and 4; blowers, sand filters and chlorine disinfection system. Generators are exercised once a week for one hour.

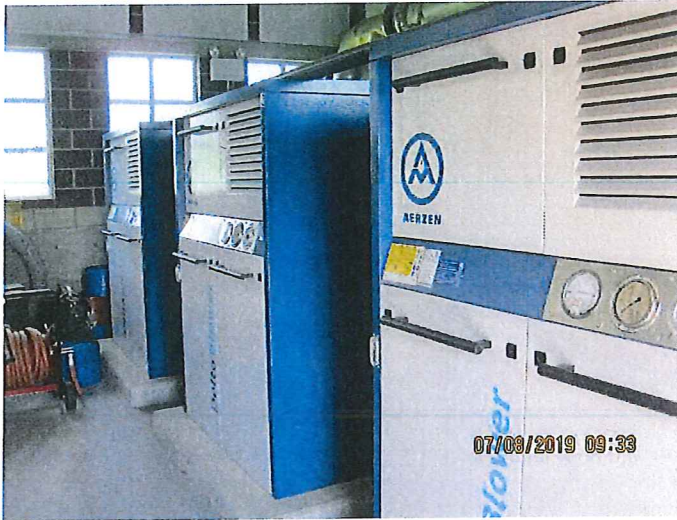
Photo 22 – Positive Displacement Aeration Blowers

Air is supplied to the four-stage lagoon system using three positive displacement blowers (Photo # 22). During summer, there are two blowers on duty and one standby. During winter, only one blower is needed and automatic rotation is scheduled for every seven days. Rotation schedule is programmed via SCADA. Blowers are checked daily, and oil and filter are changed as needed.

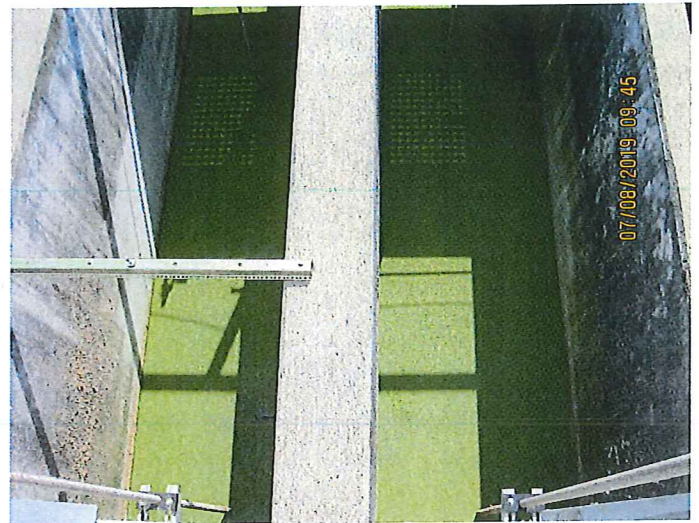
Photo 23 – Duckweed Growth in the Chlorine Contact Basin .

Chlorine disinfection system has a low residual alarm and a vacuum low alarm to indicate when there is no chlorine flow. The chlorine system has only one pump. If the pump fails, the system must be shut down until the pump is placed back in service or replaced. At the time of this inspection, the chlorine contact basin was completely covered with duckweeds (Photo # 23). Ecology has a concern that the high concentration of duckweeds may deteriorate the capacity of the final effluent to be properly disinfected.

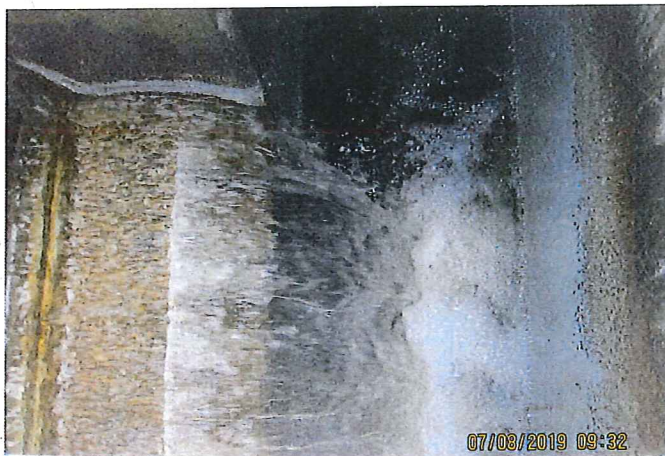
Photo 24 – Final Effluent

Overall, the facility is well operated and maintained, and the final effluent looked clear (Photo # 24) at the time of this inspection. Please contact Lazaro Eleuterio (425-649-7027) with permit related questions, Carl Jones (360-407-6431) with operation-related questions, Amy Jankowiak (425-649-7195) with compliance-related questions, and Amber Corfman (360-594-6407; amber.corfman@ecy.wa.gov) with biosolids-related questions.
