State of Washington Department of Ecology
Northwest Regional Office
**STORMWATER COMPLIANCE INSPECTION
REPORT**

Inspection Date June 19, 2019	NPDES Permit # WA-00 30830	County King	Receiving Waters Mud Lake Creek, Ginder Lake, Lake 12
----------------------------------	--------------------------------------	----------------	---

Name and Location of Facility Inspected
PACIFIC COAST COAL COMPANY,
30700 Black Diamond-Ravensdale Road
Black Diamond, WA 98010

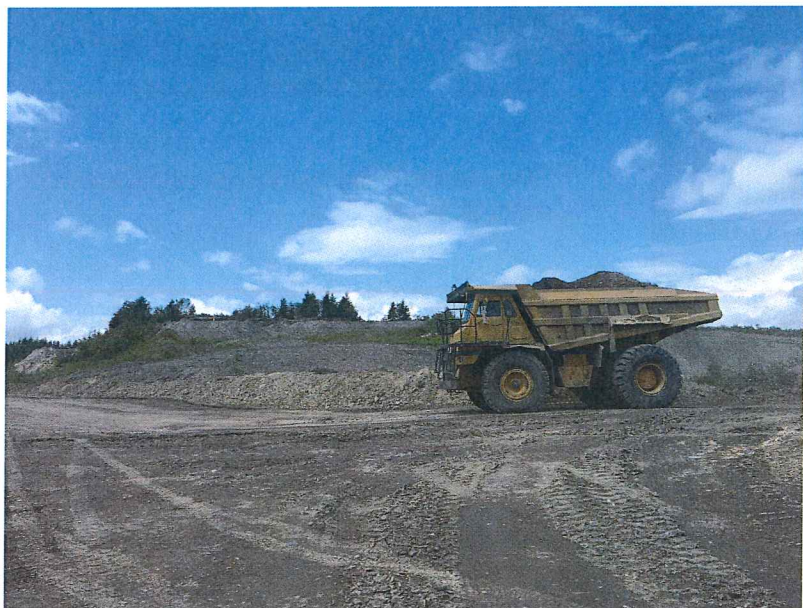
Photo 1: Pacific Coast Coal Company

Mr. Morris informed us that PCCC has started reclamation activities but he is not anticipating any coal mining in the near future as he does not have any potential buyers for the coal. PCCC has initiated reclamation in Stockpile 2 area. We saw a dozer and an excavator moving material at the stockpile #2. Two trucks were hauling the material away from Stockpile 2 and backfilling along Pit 1 (Photo 1). Mr. Morris told us that PCCC is not planning to bring or accept any external fill for this phase of reclamation. He anticipated that it will take approximately 2 years to completely reclaim Stock Pile 2 area.

Description: Haul truck moving the material away from Stockpile #2

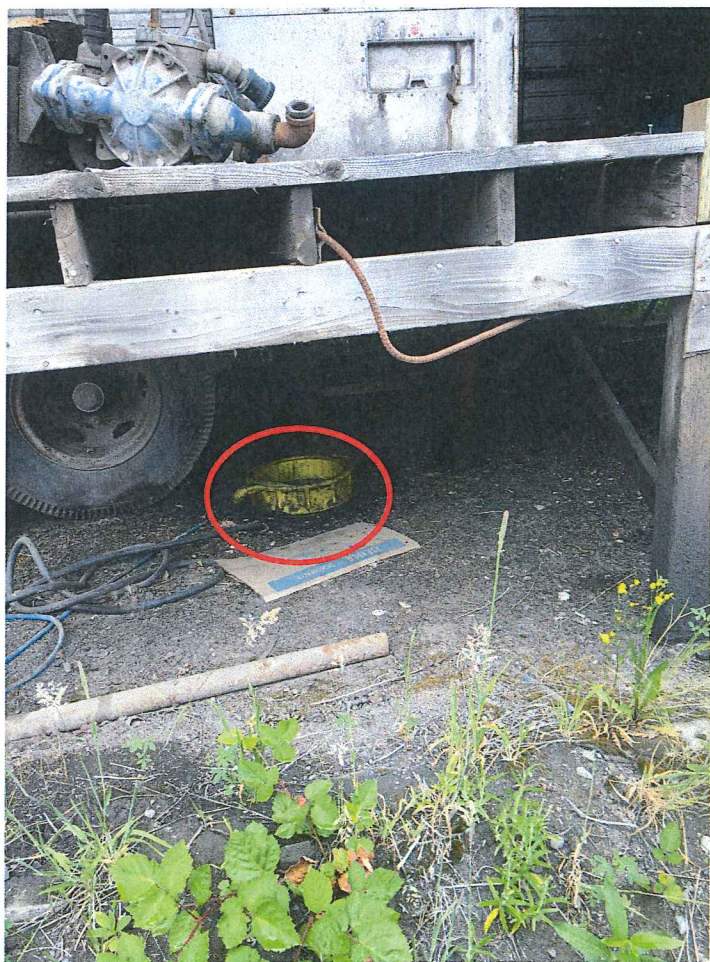
Photo 2: Pacific Coast Coal Company

Most of the oil containers were moved out of this area. We saw an approximately 18" diameter yellow container under this storage area with used oil (Photo 2). Mr. Morris did not know the source of this oil and we could not determine whether there was a leak in the yellow container or not.

Description: Yellow container with waste oil.

PCCC needs to properly dispose of the oil and the container.

The berm around the containment area needed repair.

In general, PCCC needs to clean this old oil/fuel storage area prior to decommissioning.

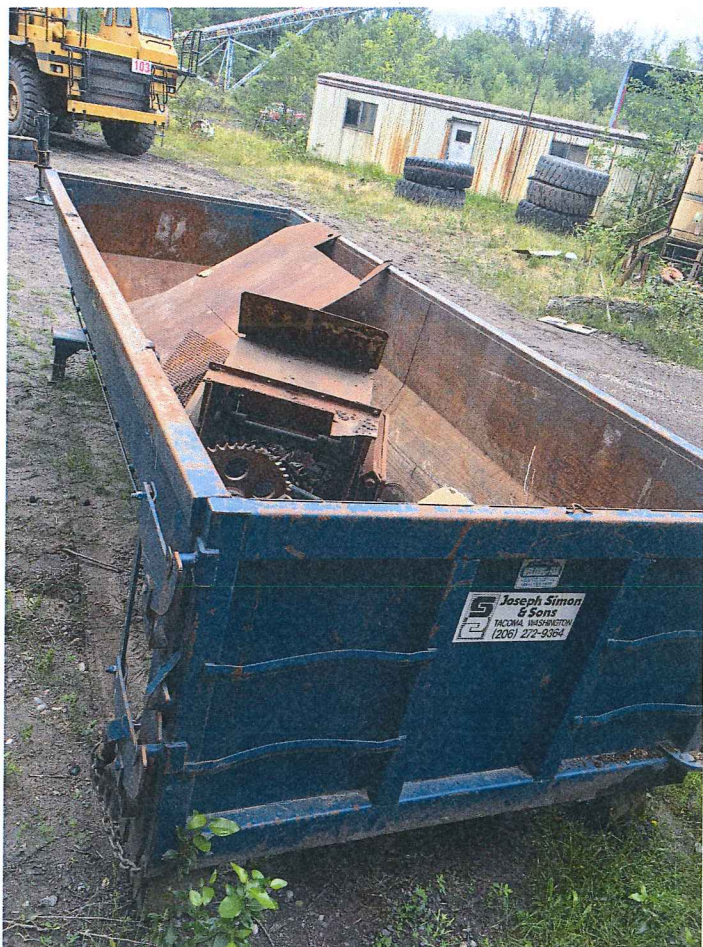
Photo 3: Pacific Coast Coal Company

There was a large blue container (Photo 3 and 4) placed next to the oil/fuel storage shed for collecting metallic waste from the site. We saw PCCC efforts around the site to collect metallic waste. Some of the waste was moved to the blue containers. Mr. Morris told us that PCCC is in the process of collecting all metallic waste and dispose or recycle it properly.

Description: Onsite container for collection of metallic waste

PCCC needs to collect and properly dispose of all the metallic waste.

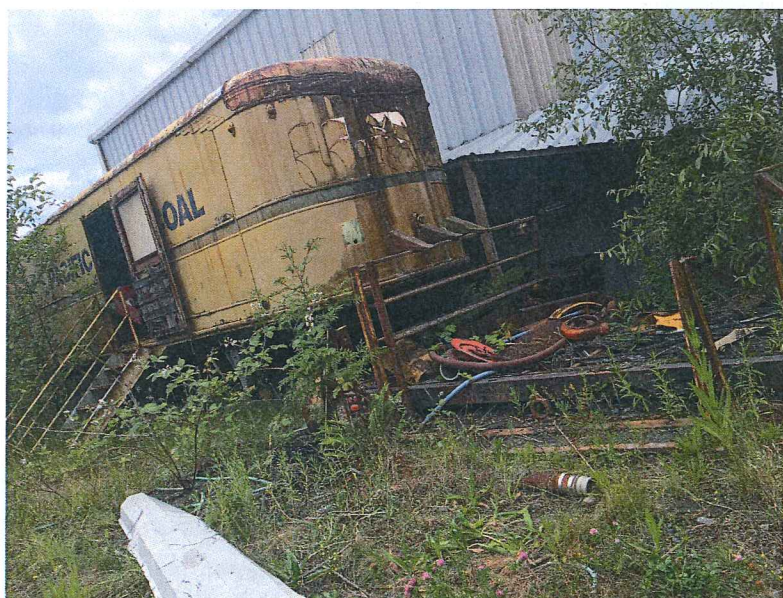
Photo 4: Pacific Coast Coal Company

Description: Metallic waste in this area needs to be disposed of or recycled properly.
