State of Washington Department of Ecology
**WASTEWATER TREATMENT PLANT
 COMPLIANCE INSPECTION REPORT**

Name, Location, and Phone of Facility Inspected King County – Brightwater Wastewater Treatment Plant and Brightwater Reclaimed Water Facilities 22505 SR 9 SE Woodinville, WA 98072	Entry Time 8:40 AM	Permit Effective Date 3/1/2018 (WWTP) 5/1/2019 (Reclaim)
	Exit Time 12:24 PM	Permit Expiration Date 2/28/2023 (WWTP) 4/30/2024 (Reclaim)

**PHOTO ADDENDUM – KING COUNTY BRIGHTWATER WASTEWATER TREATMENT FACILITY,
PERMIT NOS. WA0032247 AND ST0045498**

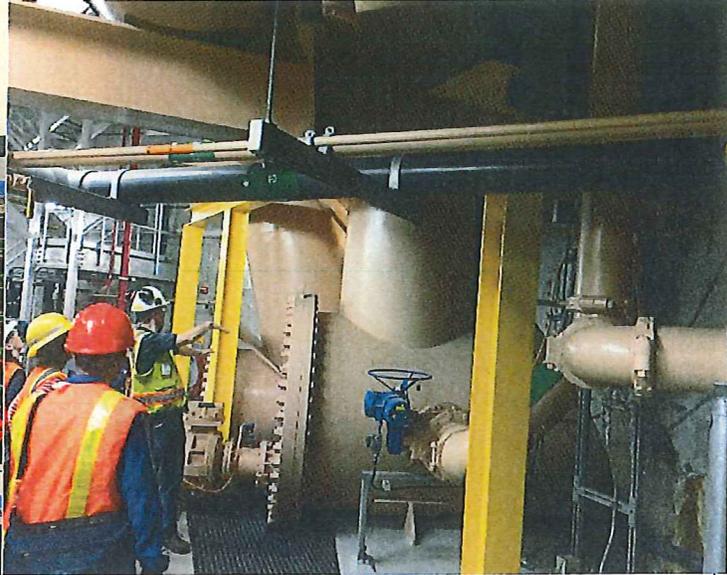
Photo # 2 Image: IMG_0107 Date: 6/25/2019
Taken by: Shawn McKone
Description: Raw sewage force mains to Brightwater facility at IPS.

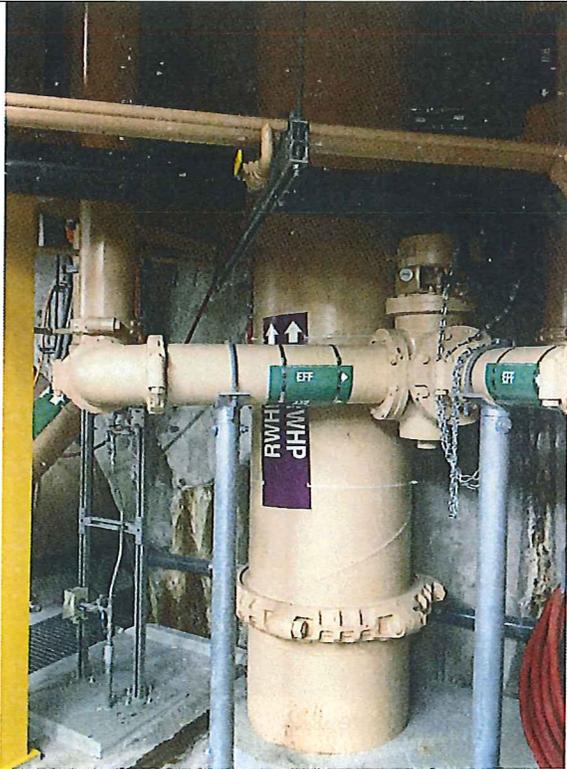
Photo # 3 Image: IMG_0108 Date: 6/25/2019
Taken by: Shawn McKone
Description: Section of reclaimed water high pressure distribution pipeline at IPS.

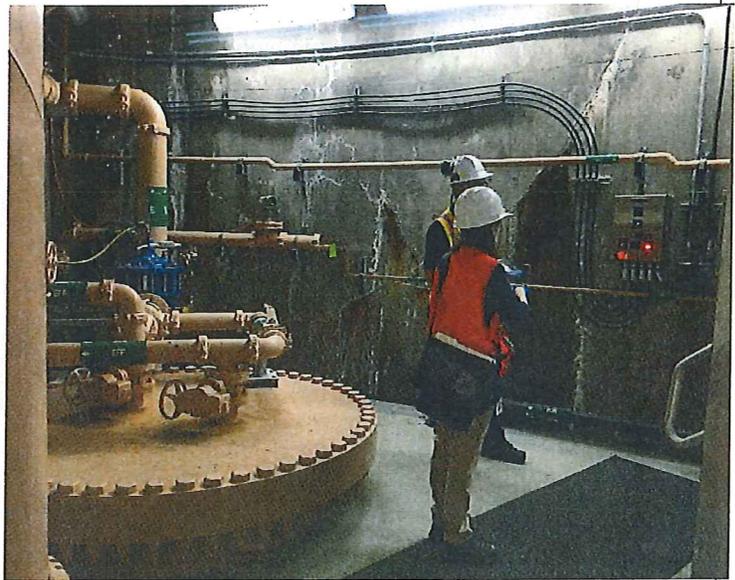
Photo # 4 Image: IMG_0112 Date: 6/25/2019
Taken by: Shawn McKone
Description: Access riser for 72" effluent pipeline at IPS.

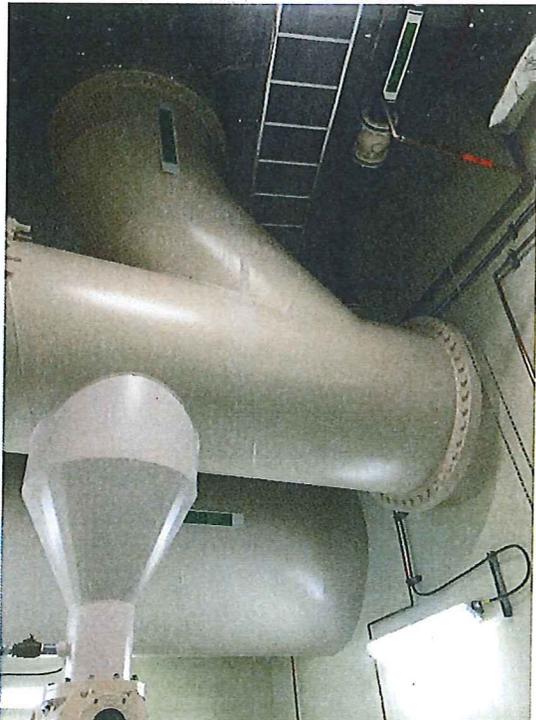
Influent flow enters the facility at the headworks where a distribution channel routes flow from the two influent force mains (photo #11) to four 10 mm perforated plate screens. Magnetic flow meters on each influent force mains (photo #12) monitor the influent flow rate for compliance and process monitoring purposes. Screened influent moves through grit chambers (photos #13 and #14) before entering the primary treatment area. While the primary clarifiers are capable of operating in a "chemically-enhanced primary" (CEPC) mode, they were operating in standard mode during the visit. Use of the CEPC mode is limited to wet weather periods when influent flow rates can exceed the operating capacity of the membrane system. The primary clarifiers (photo #15) appeared to be operating normally with no obvious signs of maintenance neglect.

Photo # 11 Image: IMG_0149 Date: 6/25/2019
Taken by: Shawn McKone
Description: Raw sewage influent force mains at Brightwater facility – distribution channel to screens located one level above.

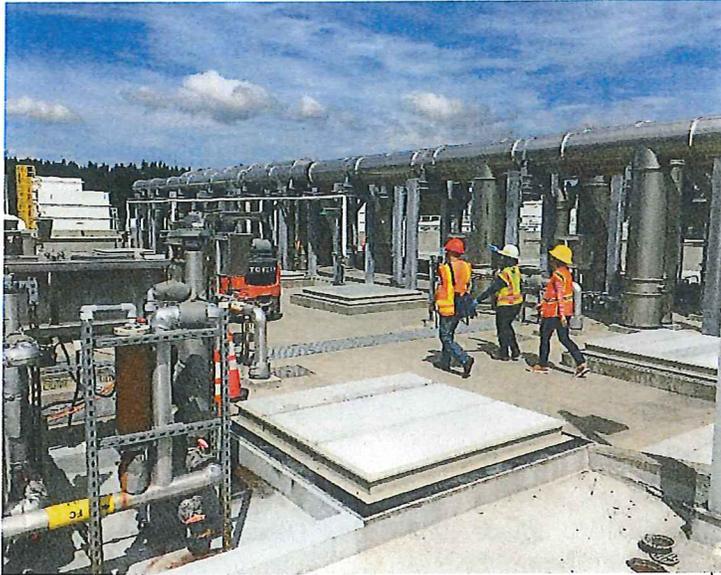
Photo # 13 Image: IMG_0154 Date: 6/25/2019
Taken by: Shawn McKone
Description: Exterior of grit basins.

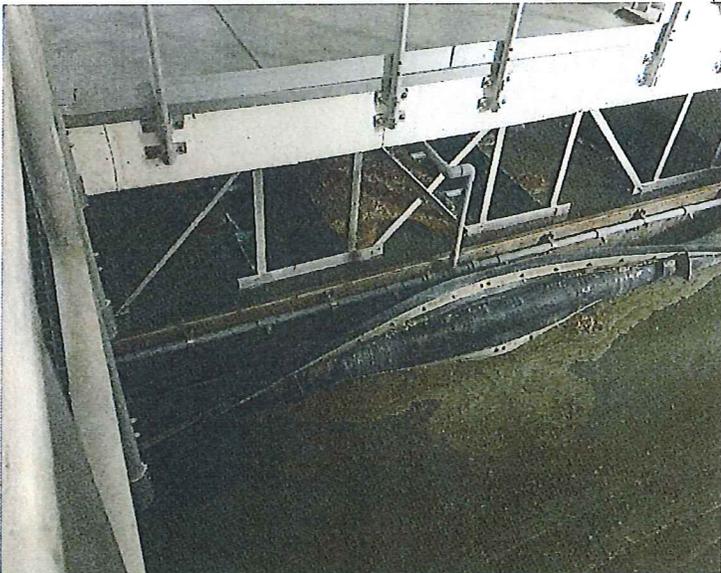
Photo # 15 Image: IMG_0156 Date: 6/25/2019
Taken by: Shawn McKone
Description: Scum skimmer and effluent launders in primary clarifier.

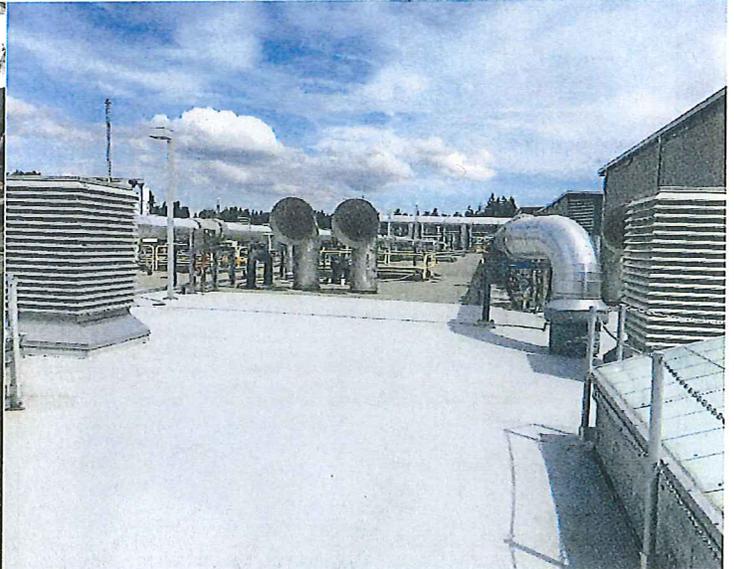
Primary effluent flows from the clarifiers to 2 mm fine screens before entering the aeration basins (photos #16 and #17). The facility has three separate trains of aeration basins, each consisting of one anoxic zone and four aerobic zones. Activated sludge returned from the downstream membrane basins (return activated sludge, or "RAS") enters the aeration basins in the first aerobic zone. A separate mixed liquor recycle stream returns activated sludge from the last aerobic zone to the anoxic zone. At the time of the site visit the facility was operating with a total combined recycle flow rate equal to approximately four times the flow rate of influent entering the facility (Q). Return flow from the membranes accounted for approximately three-quarters of the return flow (3Q) and the mixed liquor return to the anoxic zone accounted for approximately one-quarter of the recycle flow (1Q). The County recently added variable frequency drives to the recycle pumps to help keep the internal recycle flow rates at a consistent 4Q rate.

Photo # 16 Image: IMG_0159 Date: 6/25/2019
Taken by: Shawn McKone
Description: Exterior of aeration basins.

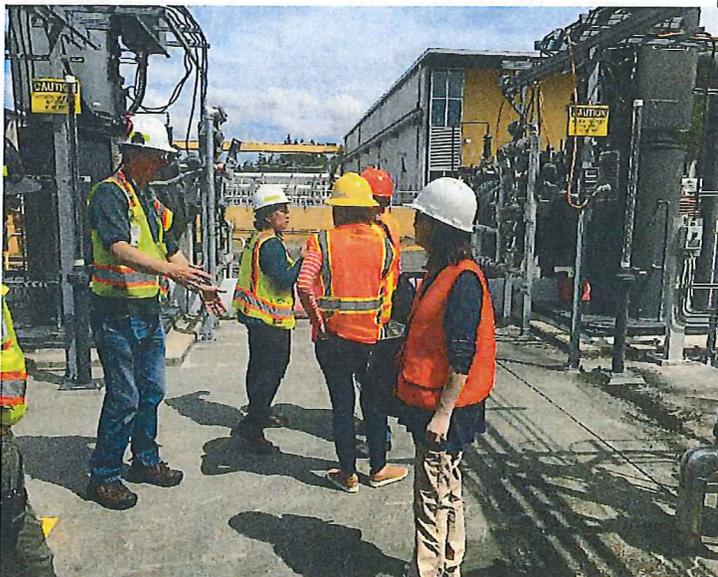
Pumps located at the end of the aeration basins (photo #19) transfer mixed liquor to the membrane basins (photo #20) for solids-liquid separation. The facility was constructed with 10 membrane basins, although only 8 basins currently contain membranes. The County can expand treatment capacity by adding membranes to the two empty basins. Two additional basins are in place for expansion, but will require addition of support equipment. Each basin contains 20 cassettes of 48 membrane modules (photo #21). The existing membrane configuration can treat up to approximately 36 MGD, however the actual flow capacity can vary based on the filterability characteristics of the mixed liquor.

Photo # 19 Image: IMG_0166 Date: 6/25/2019
Taken by: Shawn McKone
Description: Mixed liquor feed pumps (behind group) from aeration basins to membrane basins.

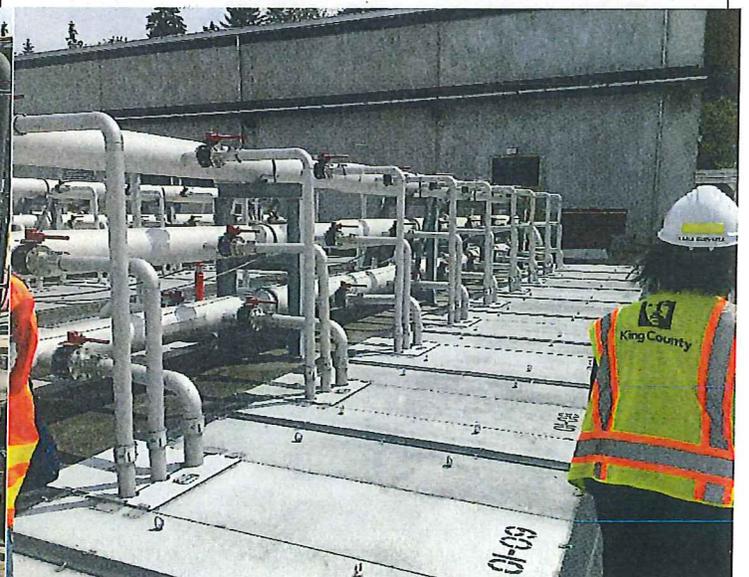
Photo # 20 Image: IMG_0168 Date: 6/25/2019
Taken by: Shawn McKone
Description: Process air (top 2 lines) and membrane effluent suction (bottom line) headers for membrane basin 3.

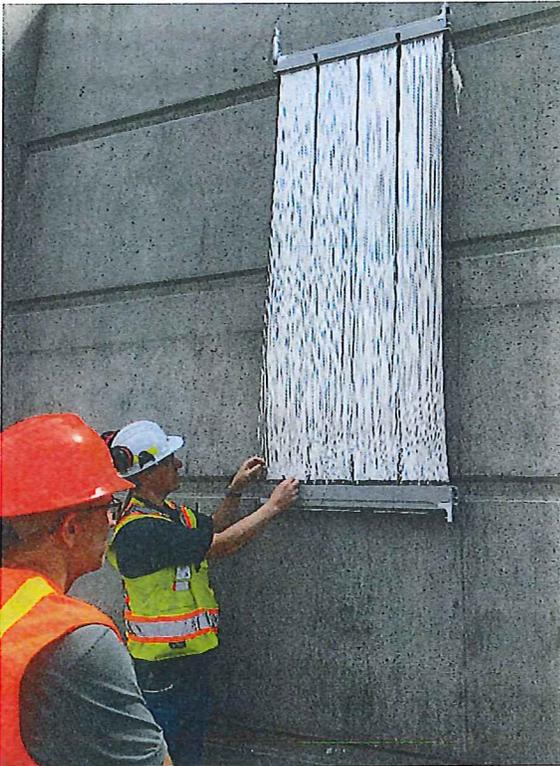
Photo # 21 Image: IMG_0169 Date: 6/25/2019
Taken by: Shawn McKone
Description: Sample membrane module displayed outside of the membrane basins.

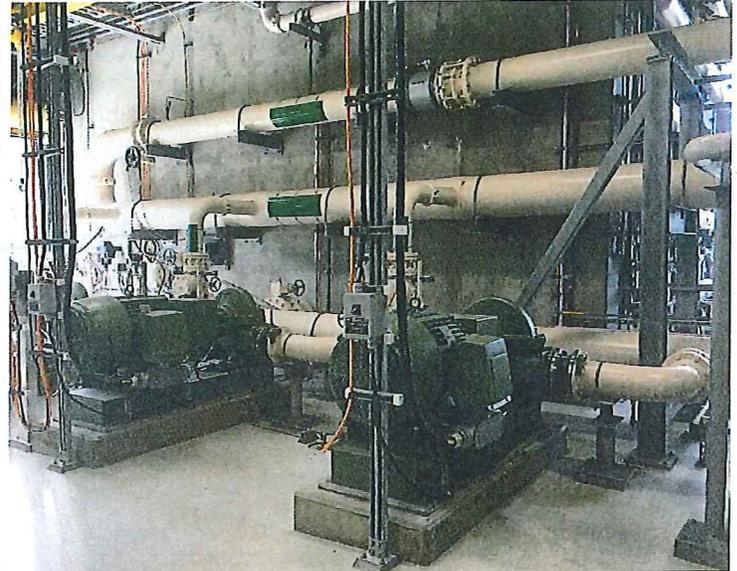
or utility water (photo #22). Metering pumps inject sodium hypochlorite into the utility water distribution system to provide appropriate disinfection (photo #23). A separate feed pump pulls water from the C3 water intake header for use as Class A reclaimed water in the facility's "Demonstration" distribution system (photo #24). This reclaimed water system uses a dedicated sodium hypochlorite injection pump and a serpentine pipe network (photo #25) to achieve adequate disinfection for use as reclaimed water.

Photo # 22 Image: IMG_0132 Date: 6/25/2019
Taken by: Shawn McKone
Description: High-pressure "C3" utility water pumps inside disinfection building. Wall to MEB is behind the pumps, supporting the C3 water pipes.

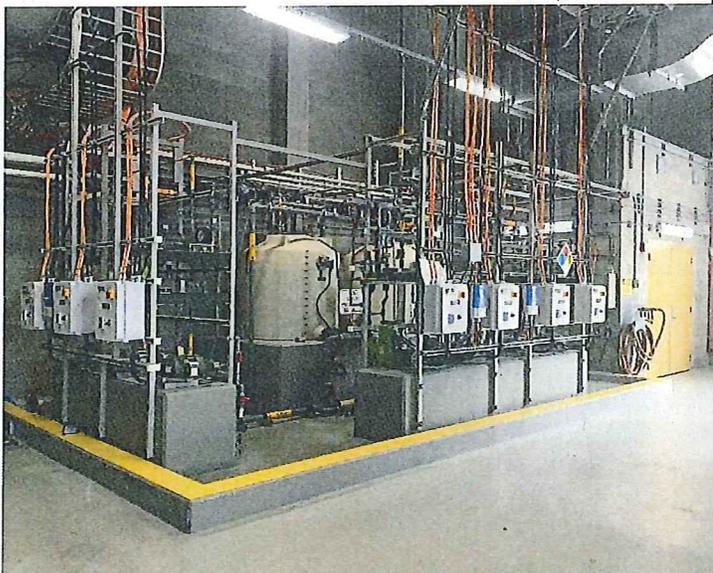
Photo # 23 Image: IMG_0284 Date: 6/25/2019
Taken by: Amy Jankowiak
Description: Sodium hypochlorite dosing pumps and chemical day tanks (background). Pumps supply hypochlorite to C3 water system, both reclaimed water systems, and effluent disinfection system.

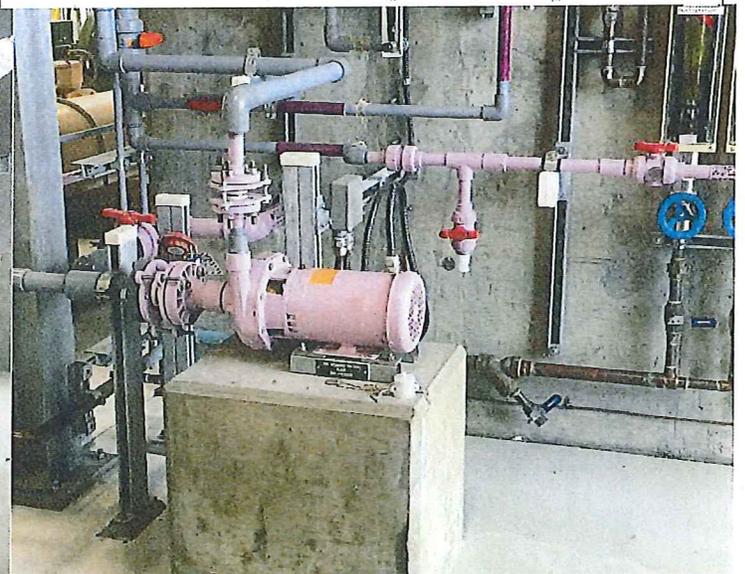
Photo # 24 Image: IMG_0129 Date: 6/25/2019
Taken by: Shawn McKone
Description: Water feed pump for reclaimed water demonstration system

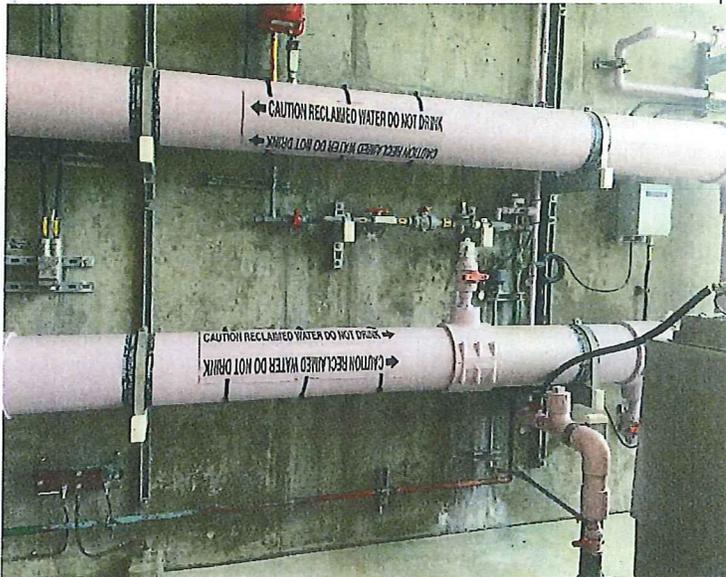
Photo # 25 Image: IMG_0281 Date: 6/25/2019
Taken by: Amy Jankowiak
Description: Disinfection contact pipe network for reclaimed water distribution system.

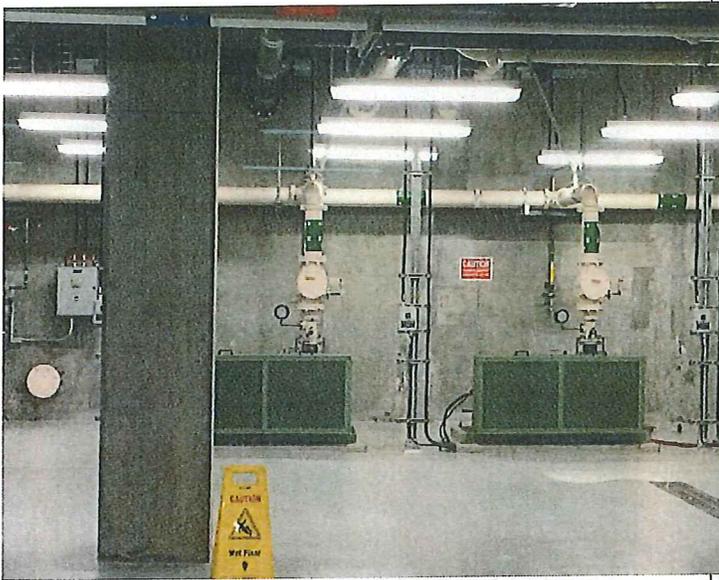
Plant staff noted during the site visit that they were experiencing problems in two areas of solids processing. The GBTs were not operating efficiently. They were designed to thicken the blended sludge to approximately 6% solids, but were only thickening to about 3%. Operators were working to resolve the issue. In addition, the plant has experienced issues with the buildup of struvite in the centrate line from the centrifuges. The buildup has required frequent maintenance, with cleanings every 6-9 months. A pilot study is underway to examine ways of removing the struvite and, therefore, reduce the maintenance frequency.

Photo # 29 Image: IMG_0147 Date: 6/25/2019
Taken by: Shawn McKone
Description: GBT feed pumps

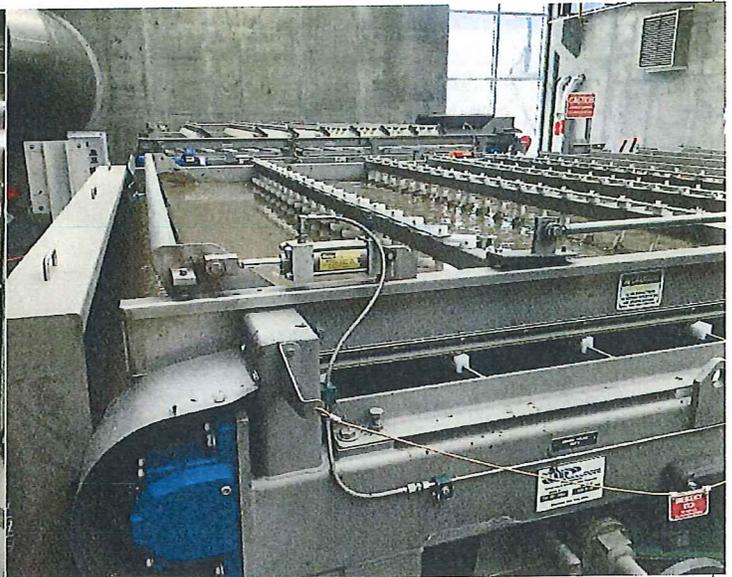
Photo # 30 Image: IMG_0143 Date: 6/25/2019
Taken by: Shawn McKone
Description: Discharge end of GBT

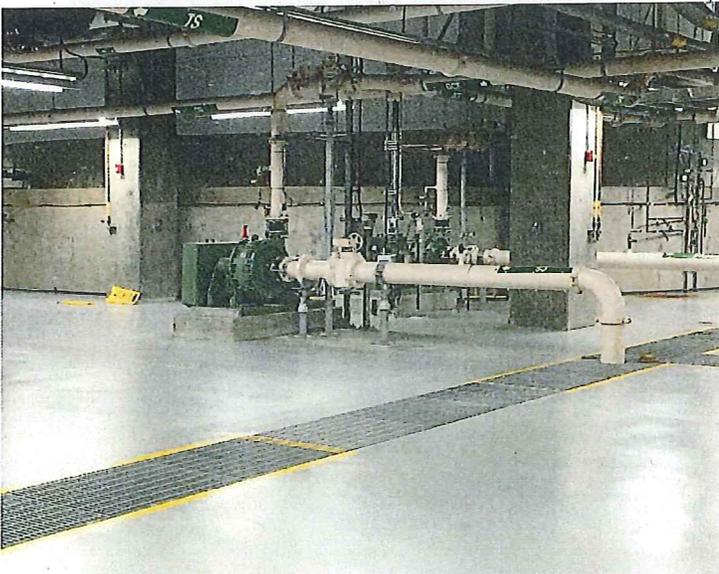
Photo # 31 Image: IMG_0148 Date: 6/25/2019
Taken by: Shawn McKone
Description: Digester circulation system pumps.
