King County

Water and Land Resources Division

RE: S.4.F Notification

Site-Specific Incident Date and Location Information

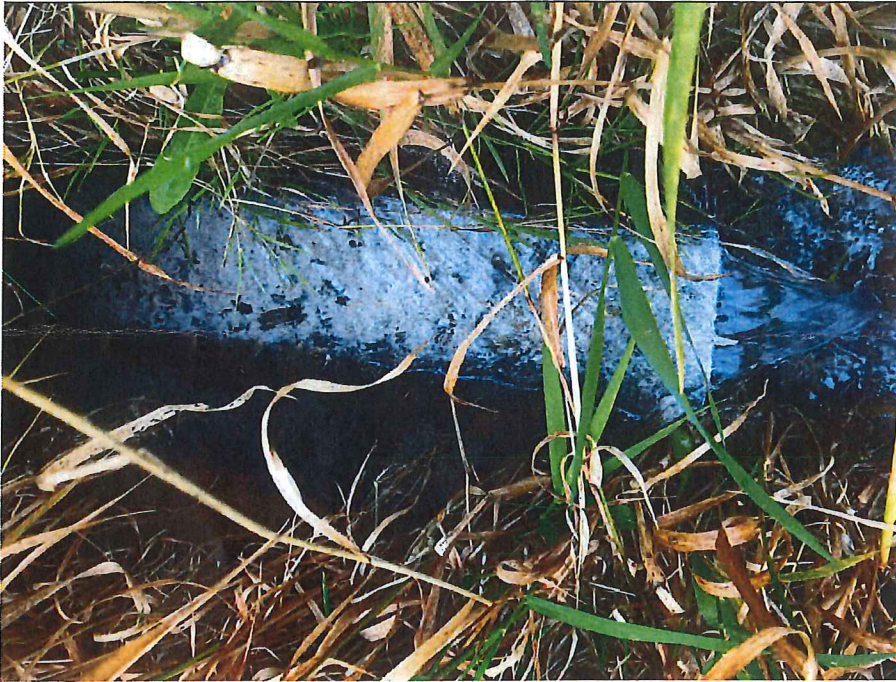
Sampling taken at the end of the County's MS4 ditch had an *E. coli* result of 7800 cfu/100 mL. Coliscan easy gel tests yielded *E. coli* colonies too numerous to count.

It appears that the discharge from the County's MS4 has conveyed sewage to an outfall and the sewage has reached the tributary of May Creek (a receiving water). This is likely to have caused a violation of Water Quality Standards and could constitute a threat to human health, welfare, or the environment.

End of MS4 Ditch and Outfall into May Creek

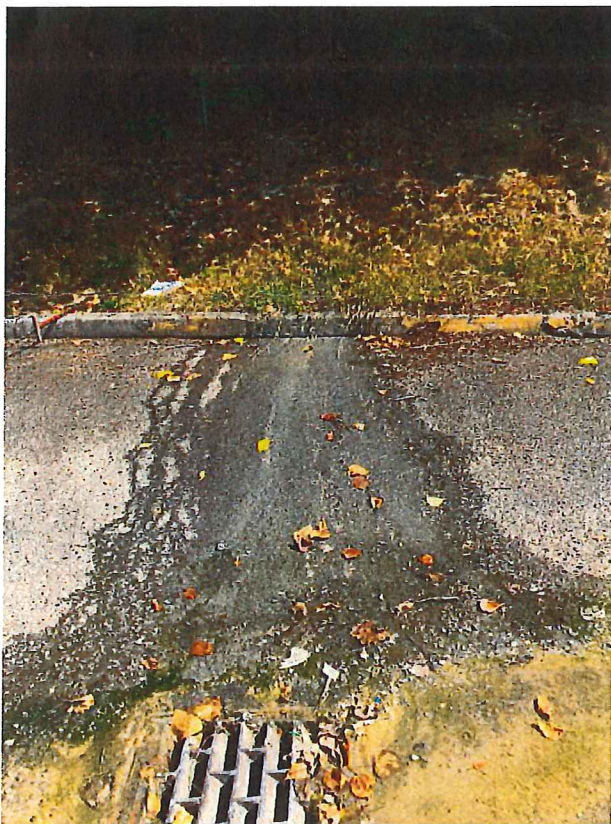
On August 6, 2019, an inspector conducting a routine drainage facility inspection in the Briarwood Shopping Center noticed a pipe coming out of the hillside behind the Sno-King Ice Arena, discharging something other than stormwater. There was distinct white slime (*Sphaerotilus Natans*) in the pipe and in the ditch downstream. *Sphaerotilus Natans* is associated with sewage in water. The discharge went a short distance to a catch basin and then into the large detention tank (drainage facility) on site. The tank outlet goes to a roadside ditch that drains to a small tributary of May Creek.

The source was quickly determined to be from the Large-On-Site-Septic-System (LOSS) that serves the shopping complex. One of the surge tanks had overflowed and a drain field had failed.

Entry Location into King County's MS4

Ecology and Public Health - Seattle & King County (PHSKC) were immediately notified. The State Health Department was also notified because it is the permitting authority for LOSS. The Briarwood Shopping Center property manager was also contacted and told that the drainage facility and conveyance lines needed to be pumped out as soon as possible. A corrective action letter was also sent informing them of the same.

At the time of this letter, the property management company has not cleaned the stormwater system and King County is proceeding with corrective enforcement actions. The two property owners of the five involved parcels of land have been contacted directly and are working with staff to address the problem.
