PHASE II ENVIRONMENTAL SITE ASSESSMENT REPORT  
West Pierce Fire & Rescue  
Maintenance Facility  
LAKEWOOD, WASHINGTON

Subject: PHASE II ENVIRONMENTAL SITE ASSESSMENT REPORT, WEST PIERCE FIRE  
& RESCUE MAINTENANCE FACILITY, LAKEWOOD, WASHINGTON

Shannon & Wilson completed a Phase II Environmental Site Assessment (ESA) to support Sound Transit's planned property acquisition of West Pierce Fire & Rescue Maintenance Facility (subject property) as part of the Sounder Maintenance Base Project. The subject property is located at 9410 39<sup>th</sup> Avenue Court SW in Lakewood, Washington.

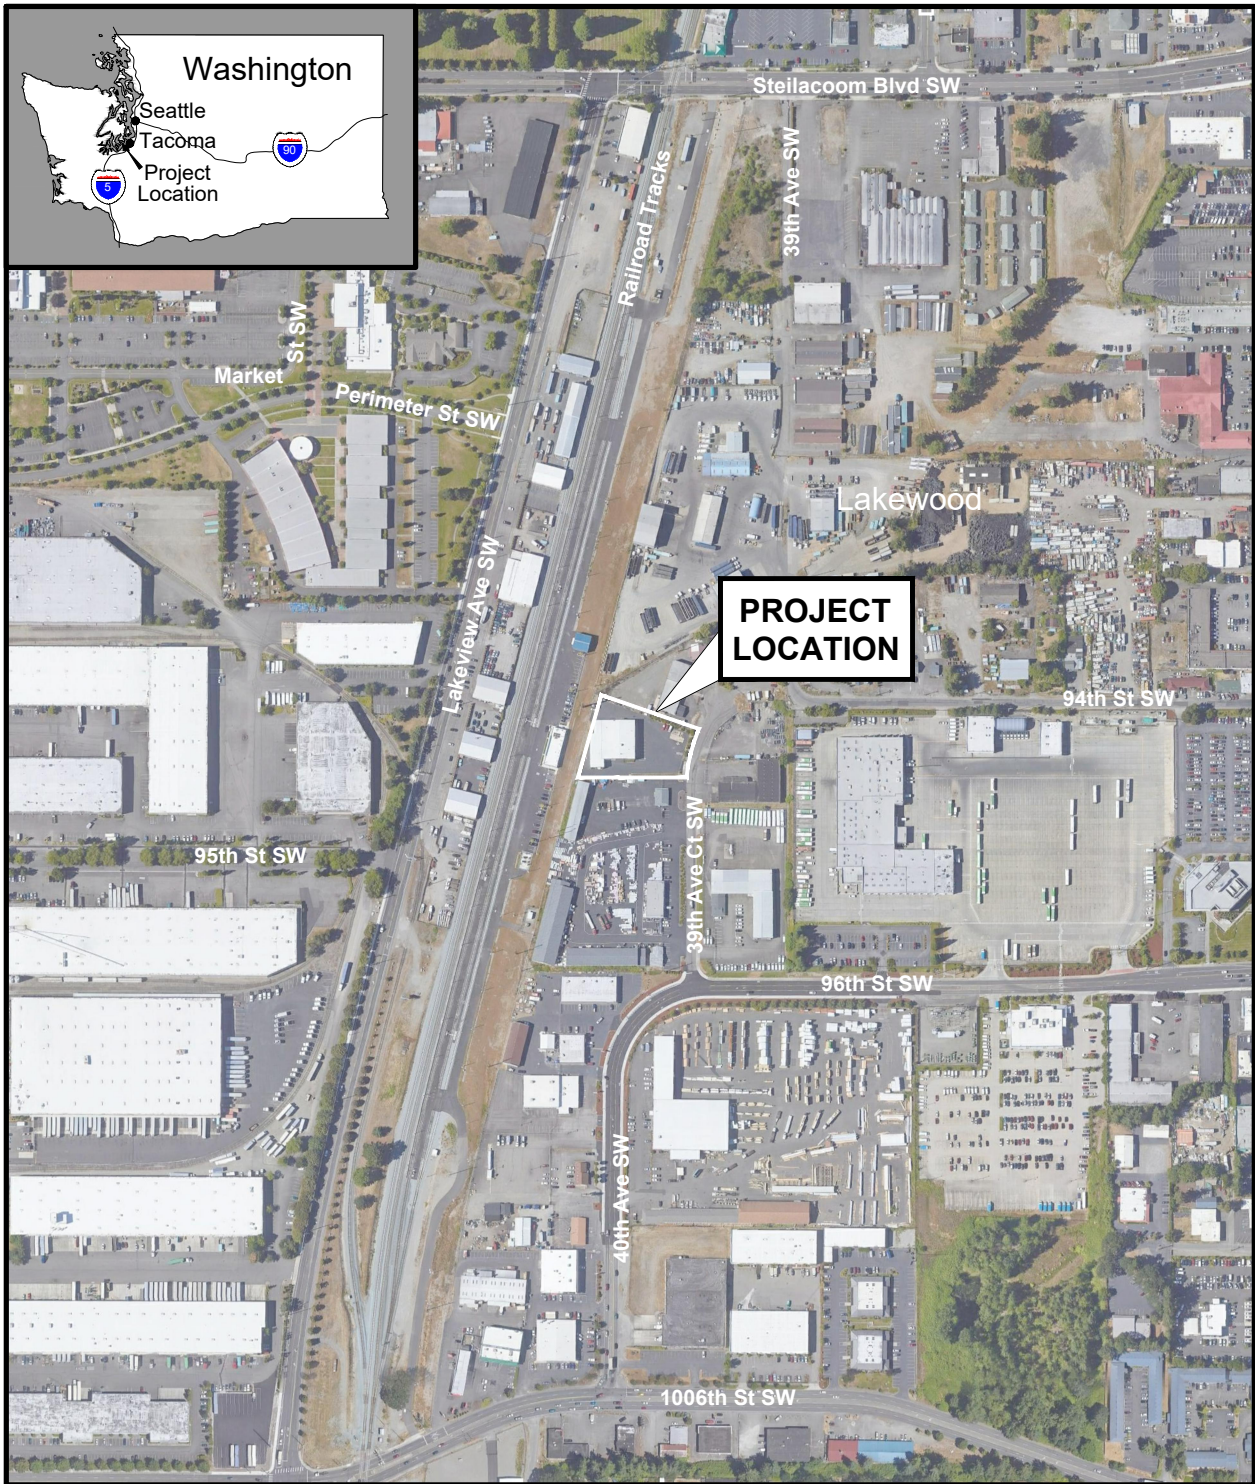
**FIG. 1**

The subject property is located in the southwest quarter of the southeast quarter of Section 36, Township 24 North, Range 2 East of the Willamette Meridian. The subject property is identified as Pierce County tax parcel 5087000040. The site vicinity is shown in Figure 1.

## VICINITY MAP
