CONSTRUCTION STORMWATER COMPLIANCE INSPECTION REPORT

State of Washington Department of Ecology

Water Quality Name and Location of Site Inspected: WA DOT US 195 Colfax to Spangle add PL1 195 Colfax to Spangle Colfax, WA 99111	GPS Lat: 47.006283 Long: -117.354089	Entry Time 2:15 pm Exit Time 2:30 pm
On-Site Representative Name: Drive by inspection due to Covid 19 restrictions. Title: Phone: Email:	Additional Participants:

WA DOT US 195 Colfax to Spangle add PL1 was a road-widening project on US 195 north of Colfax. This project is permitted for 27 acres of soil disturbance.

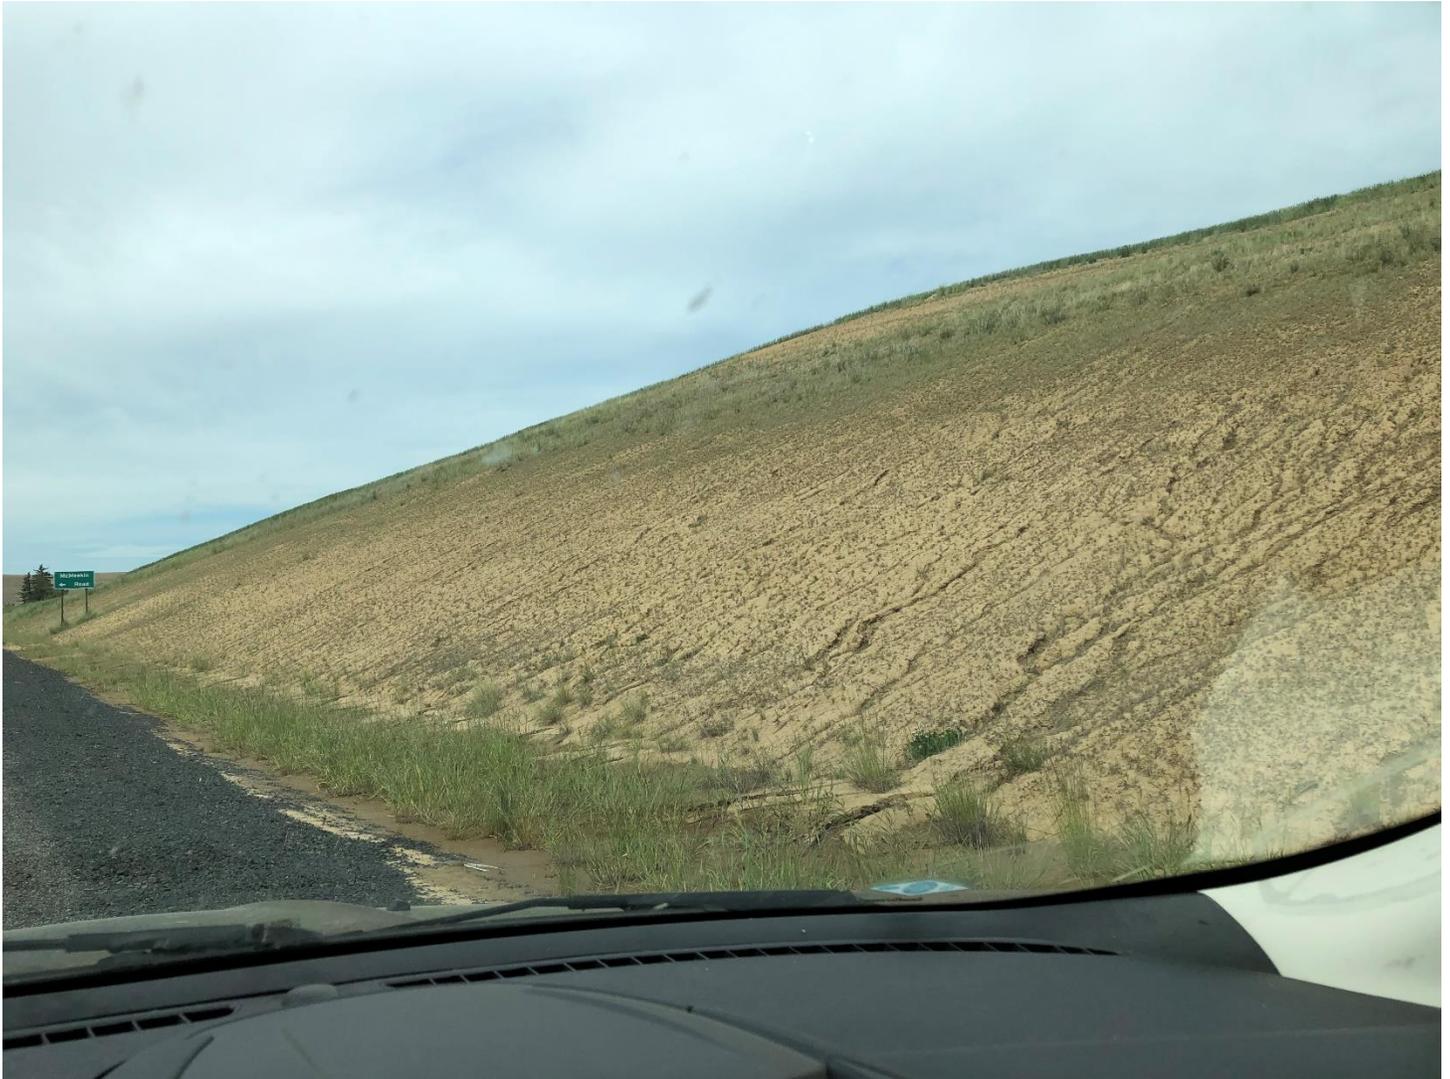
I drove along the site and pulled off the road to take photos. I saw that the slopes that were hydroseeded in the fall of 2017 have not established adequate vegetation. Rills have continued to develop in the slopes transporting sediment laden water off site into surface waters. **Failure to design, install and maintain erosion and sediment controls to minimize sediment discharges from the site is a violation of permit condition S9.D.4.b. Failure to stabilize exposed and unworked soils by the application of effective Best Management Practices (BMPs) is a violation of permit condition S9.D.5.a. Leaving exposed and unworked soils for 5 days during the wet season (October 1 – June 30) or 10 days during the dry season (July 1 – September 30) is a violation of permit condition S9.D.5.d.**

Figure 01 Description: Sparse vegetation on slopes. Rills continue to discharge sediment into the ditch.

These slopes must be adequately stabilized to prevent the continued rilling and sediment transport off site. Erosion and sediment controls must be implemented until vegetation establishes. Prepare and implement a plan to stabilize exposed and unworked soils.

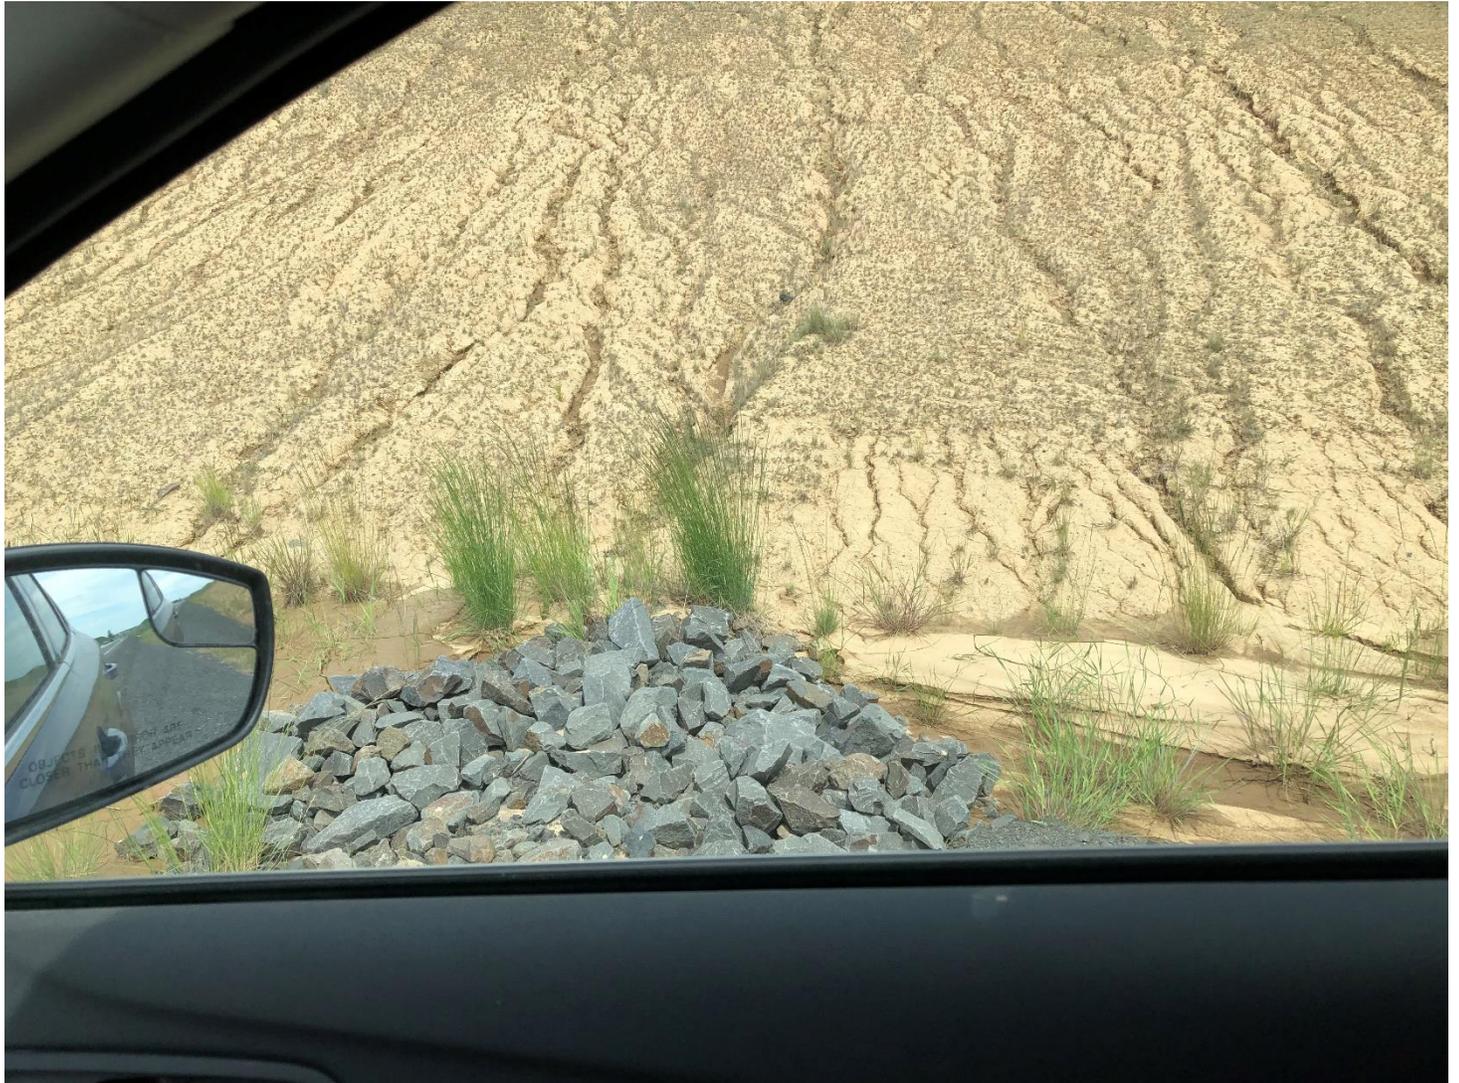
Permanent erosion and sediment controls have not been repaired or maintained. Sediment has been removed from the ditch at times, but slopes are not stabilized. **Failure to repair or maintain all temporary and permanent erosion and sediment control BMPs to assure continued performance of their intended function in accordance with BMP specifications is a violation of permit condition S9.D.11.a.** Maintain and repair permanent BMPs so that turbid water and sediment does not discharge off site.

Figure 02 Description: Sparse vegetation on slopes. Rills continue to discharge sediment into the ditch. Check dam in ditch line.

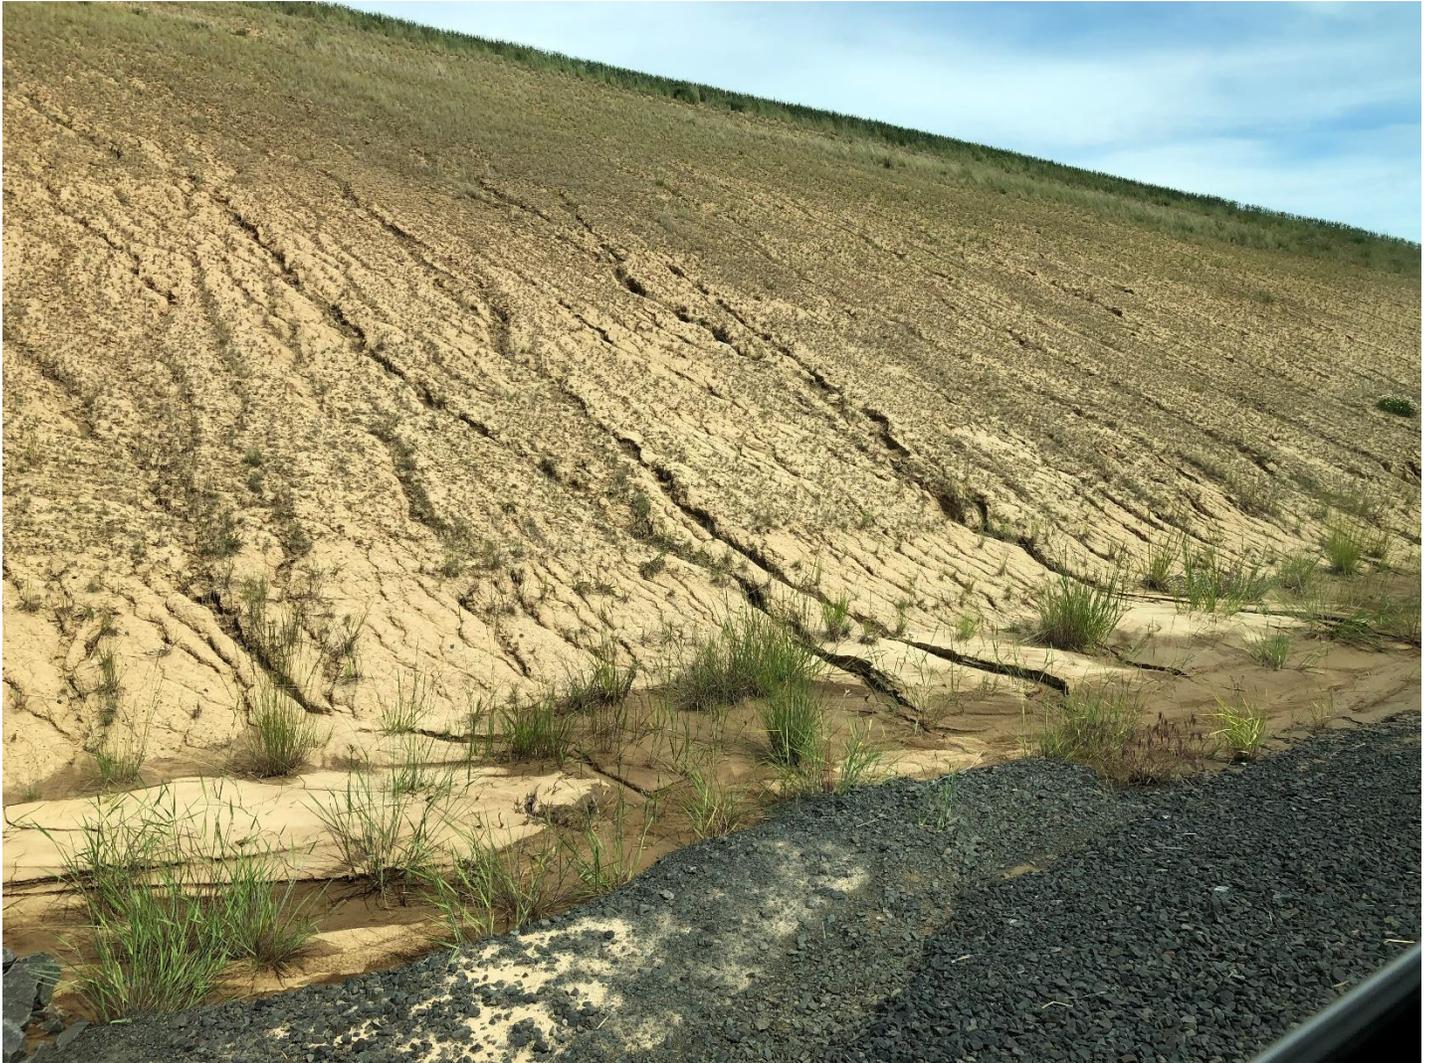
Figure 03 Description: Sparse vegetation on slopes. Rills continue to discharge sediment into the ditch.

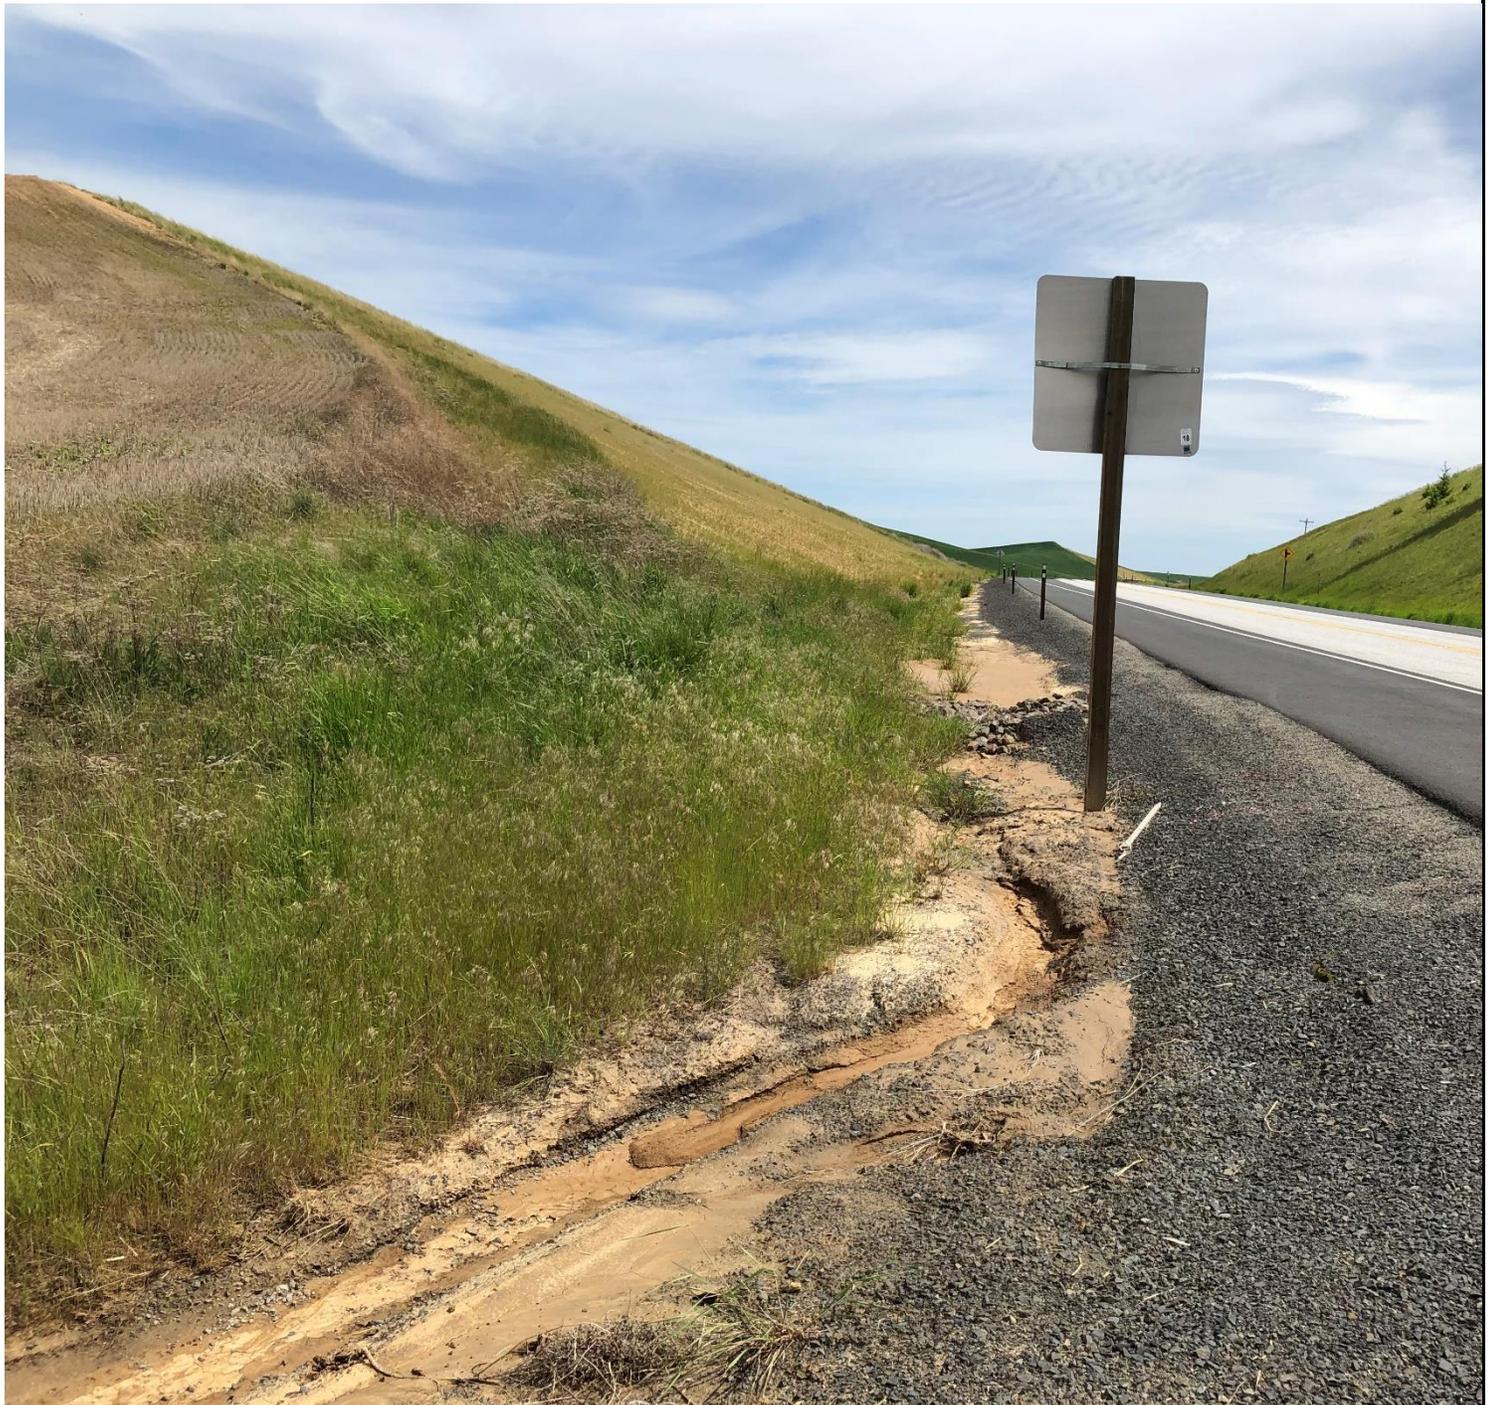
Figure 04 Description: Ditch line below sparse vegetation and rills. Sediment discharging off site towards surface waters.

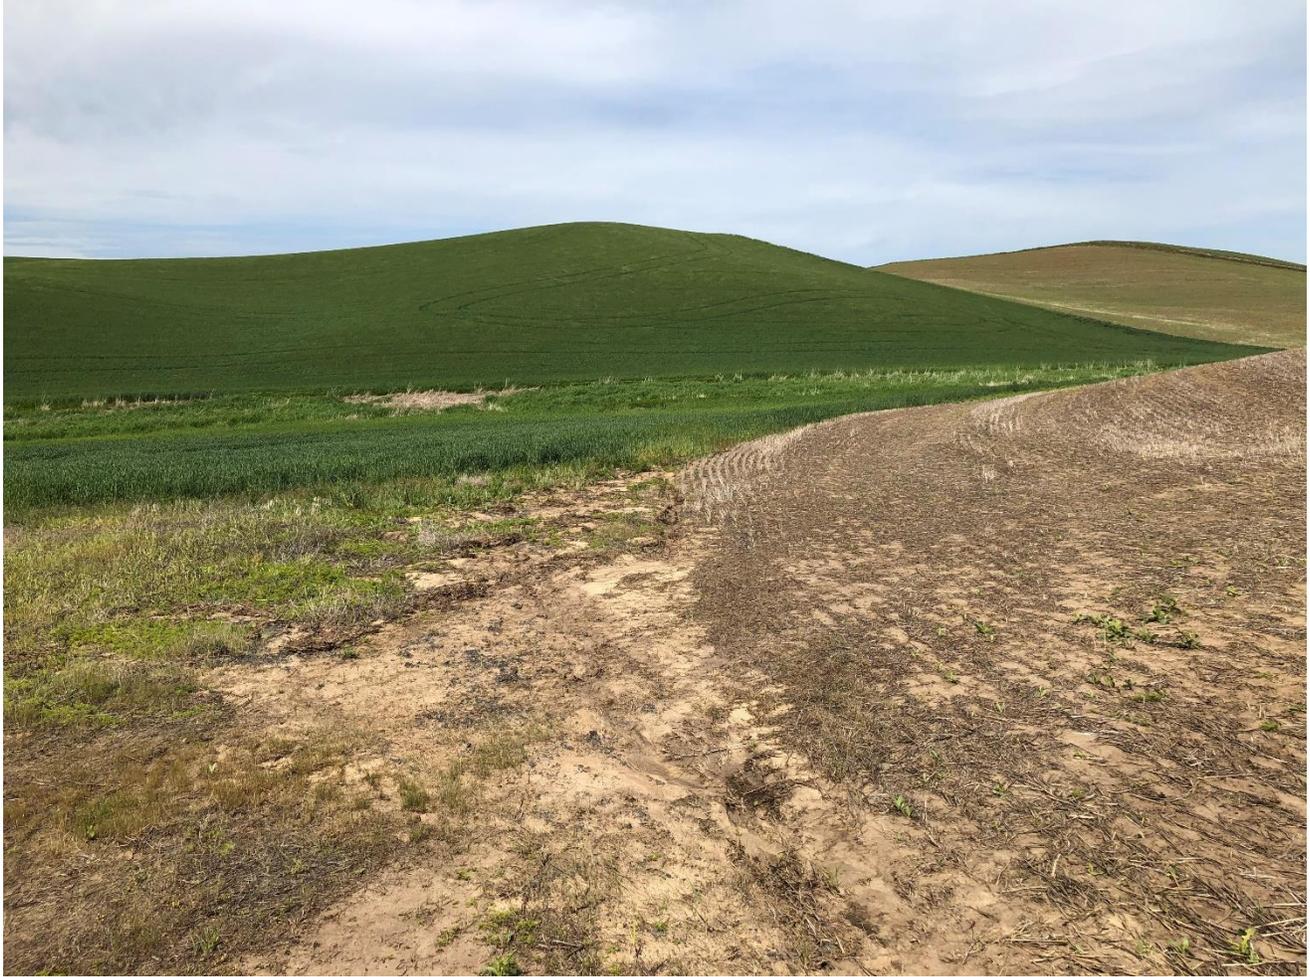
Figure 05 Description: Farmers field next to surface water. Site discharges below the farmer's field toward surface waters. Continuation of discharge from Figure 04.
