MUNICIPAL STORMWATER INSPECTION REPORT

Municipal Stormwater
Inspection Form

Name and Location of Site Inspected		Entry Time	Permit Effective Date									
Medina Operations & Maintenance Center 1000 80 th Ave NE Medina, WA		12:05 pm	Aug 1, 2019									
Permittee Contact(s)		Exit Time	Permit Expiration Date									
Ryan Osada – Public Works Director rosada@medina-wa.gov 425-233-6439		1:25 pm	July 31, 2024									
Responsible Official(s):		Additional Participants:										
Michael Sauerwein -City Manager 501 Evergreen Point Rd Medina, WA 98039		Pat Crickmore – Public Works Superintendent Katy, Kent, Dave – Maintenance Staff										
msauerwein@medina-wa.gov 425-233-6412

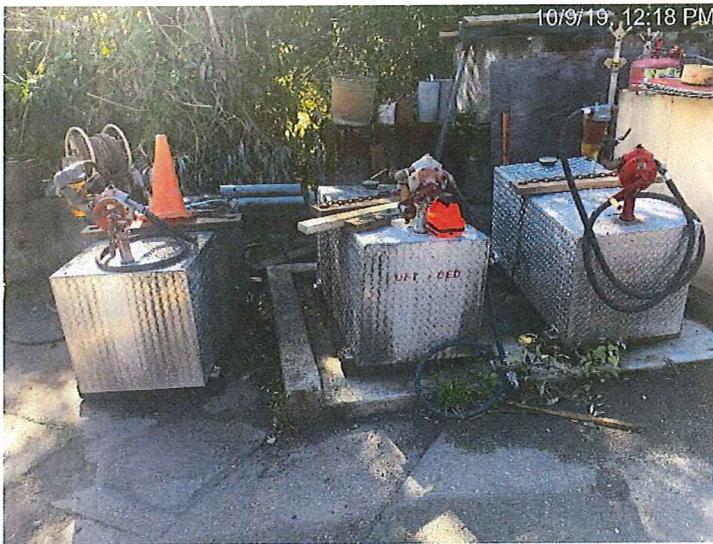
01 DESCRIPTION: FUELING STATION – NO COVER OR SECONDARY CONTAINMENT. MANY DARK AREAS ON PAVEMENT.

- 2.) Per [BMP S409](#) – BMPs for Fueling at Dedicated Stations should be followed to correct the current conditions at the fueling station. Additionally, drain and properly dispose of any residual fuel in the 4th fuel tank located with other collected parts and debris on the north perimeter of the property. The pad is improperly sized for the two tanks it holds, the drain in the center does not have a shutoff valve, and the pad is sized such that a single rain event would likely fill up the depression in the pad when the valve is shut. The fueling pad needs to be appropriately sized and designed. **Submit plans to correct this within two months.**

- 3.) Per [BMP S428](#), all above ground storage tanks of liquids (excluding uncontaminated water) must be in double-walled containers or have adequately sized, impermeable secondary containment. Secondary containment should be sized to hold a volume of 10% of the total enclosed tank volume or 110% of the volume contained in the largest tank, whichever is greater. Place adequately sized drip pans beneath all mounted taps and drip/spill locations during filling/unloading of tanks. Vacuum sweep and clean the tank storage area regularly, if paved. Specifically, this pertains to the 3rd fuel tank which is not inside the fueling station pad – **Complete within two months. Submit photos of containment for above ground fueling tanks.**

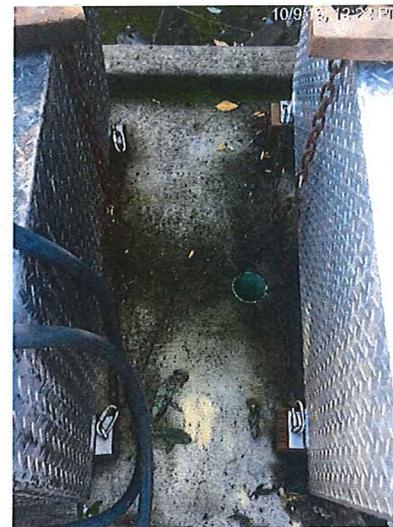
02 DESCRIPTION: DRAIN FROM CENTER OF CONCRETE PAD BETWEEN FUELING TANKS, LARGE SEDIMENT BUILDUP ON GROUND

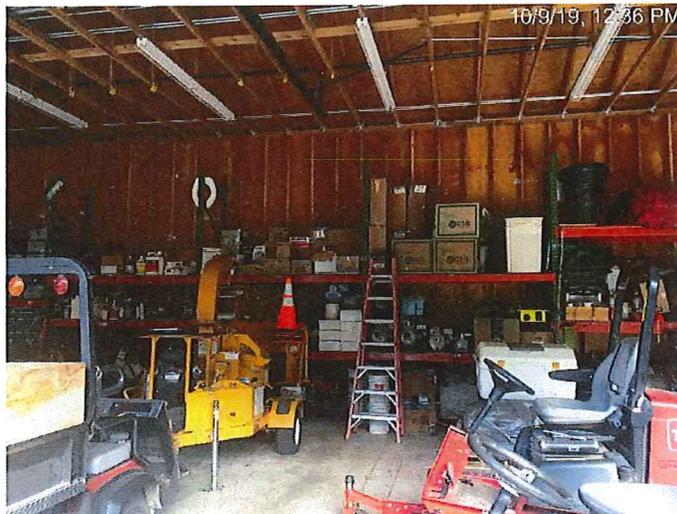
03 DESCRIPTION: EQUIPMENT STORAGE BUILDING, MANY CHEMICALS AND PAINTS STORED ALONG WALL

- 4.) Per [BMP S427](#), individual hazardous liquids and wastes should be stored appropriately, under cover and in sufficiently sized secondary containment. **Complete within two months. Submit photos of containment**

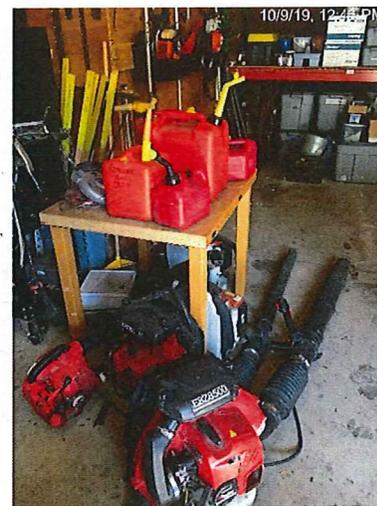
04 DESCRIPTION: NO SECONDARY CONTAINMENT FOR FUEL

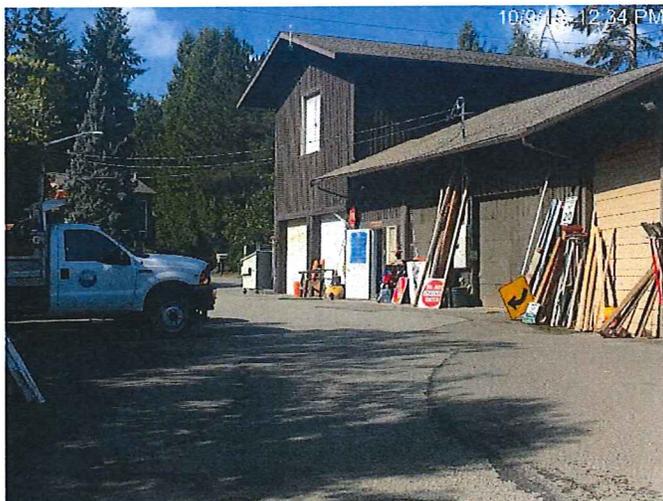
05 DESCRIPTION: OVERHANG OF STORAGE BUILDING

- 5.) Per [BMP 412](#), Hand sweep paved areas that are not accessible by the street sweeper on the property. For example, at the perimeter of the heavy equipment facility overhang and at the leading edge of materials storage bays to remove loose materials from paved areas and contain them within designated storage areas. Consider adding low berms at openings of material stockpile bays and the maintenance shop where it will not impede vehicle access. **Complete sweeping within one week. Send photos of cleaned pavement areas.**

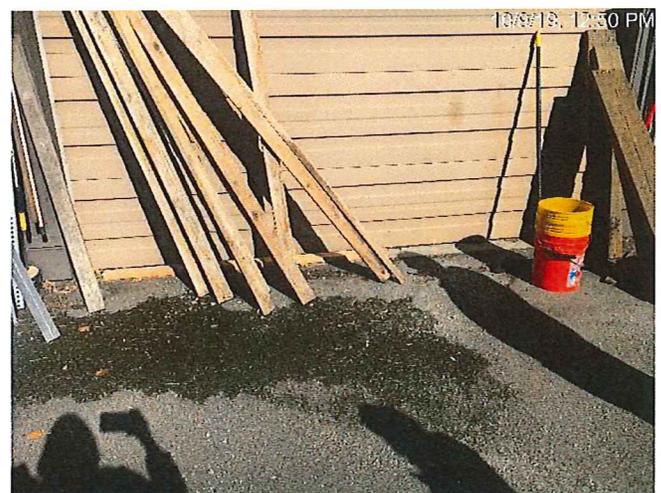
06 DESCRIPTION: LOOSE SEDIMENT/DEBRIS ON GROUND
