Appendix C:
Summary of Source Tracing Results by Outfall

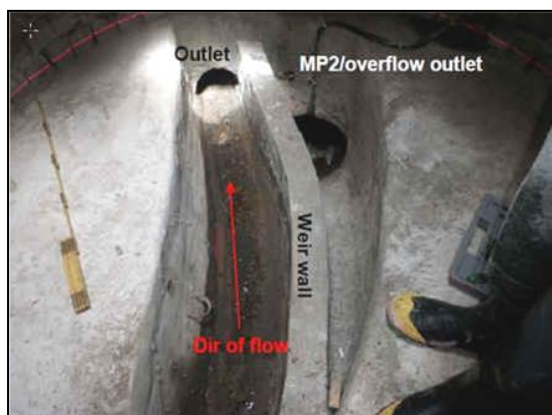
Figure 1: S Brighton CSO before sealing.

The S Brighton St SD serves an 18.6-acre industrial basin located between Slip 3 and Slip 4 (Map 15). SPU plugged the overflow from the combined sewer that had been connected to this outfall in 2012 (Figure 1 and Figure 2).

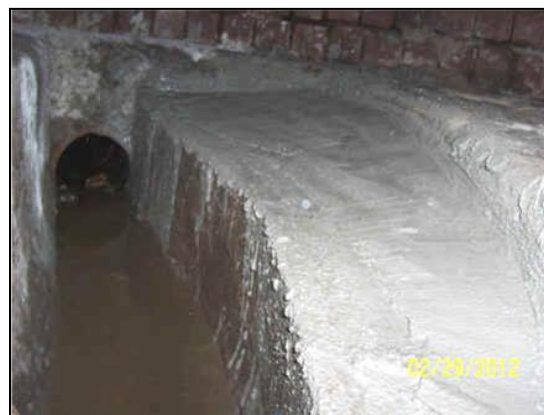
Figure 2: S Brighton CSO after sealing.

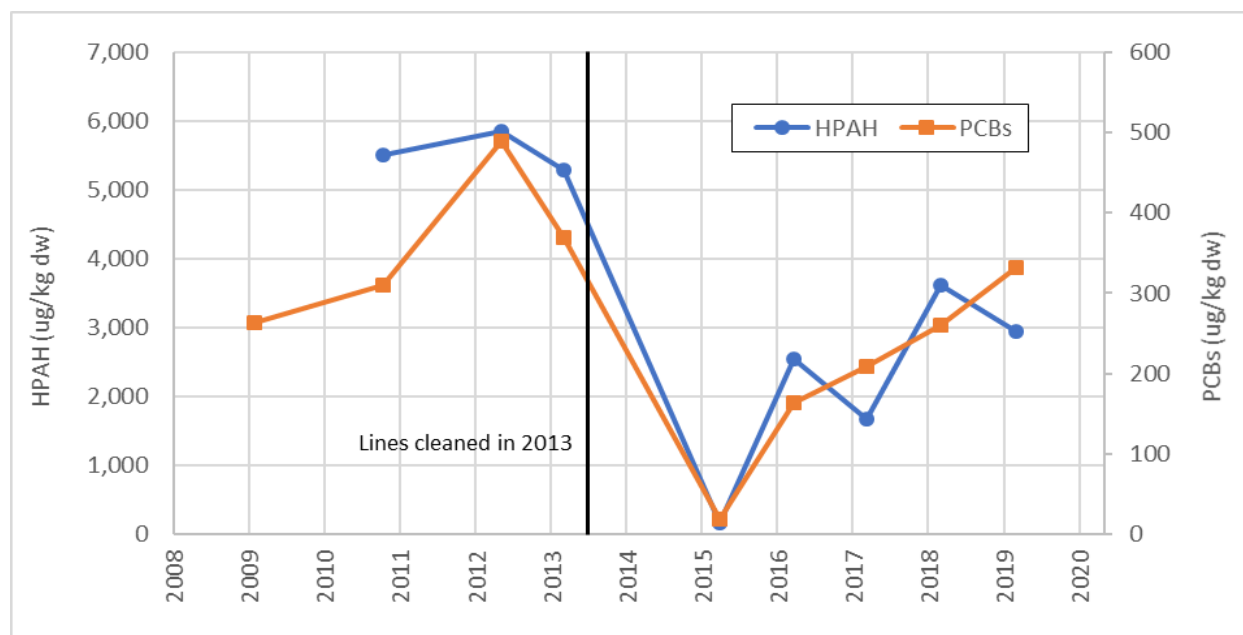
Figure C-3: HPAH and PCBs in 7th-ST1 sediment trap before and after line cleaning.

As shown in Figure C-3, although HPAH and PCBs in the near end-of-pipe sediment trap samples (7th-ST1) were initially much lower after cleaning, both have shown a steady increase in the years following cleaning and are approaching the pre-cleaning levels.

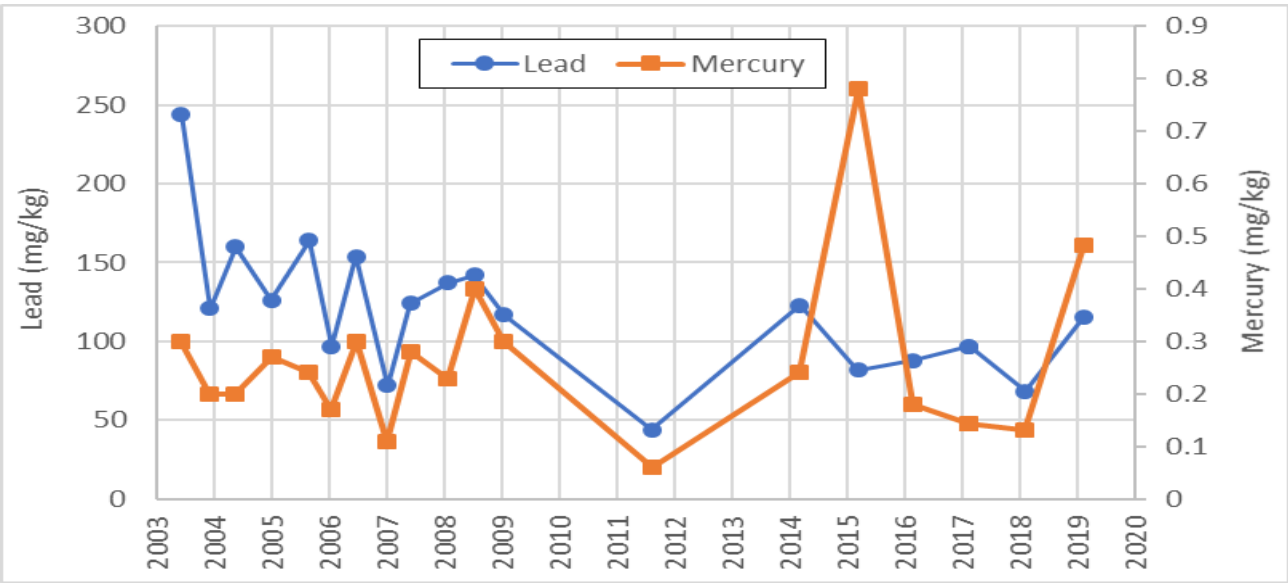
Figure C-4: Lead and mercury in ST1 trap samples (2003-2019).

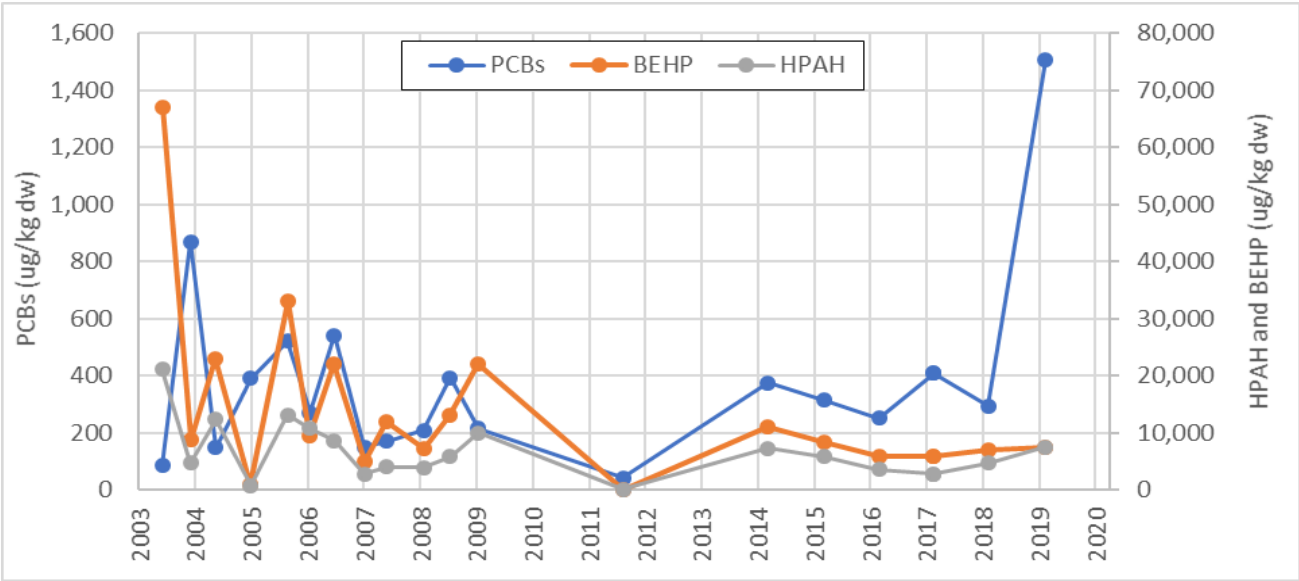
Figure C-5: PCBs, HPAH, and BEHP in ST1 trap samples (2004 - 2019).

HPAH, PCBs, and BEHP are plotted in Figure C-5. Since 2006, HPAH at ST1 have been below the LAET and 2 LAET screening levels. Except for 2019, PCBs, ranging from 85 to 870 ug/kg dw (320 ug/kg dw average) were consistently below the 2LAET screening level. A spike of 1,508 ug/kg dw was observed in 2019. This may be

associated with the PCB spill that the City found and cleaned up in 2019 (see Appendix D for details). Bis(2-ethylhexyl)phthalate exceeded the 2 LAET screening level in 90 percent of the trap samples collected at ST1. Phthalates are widespread in urban areas and will be difficult to control.

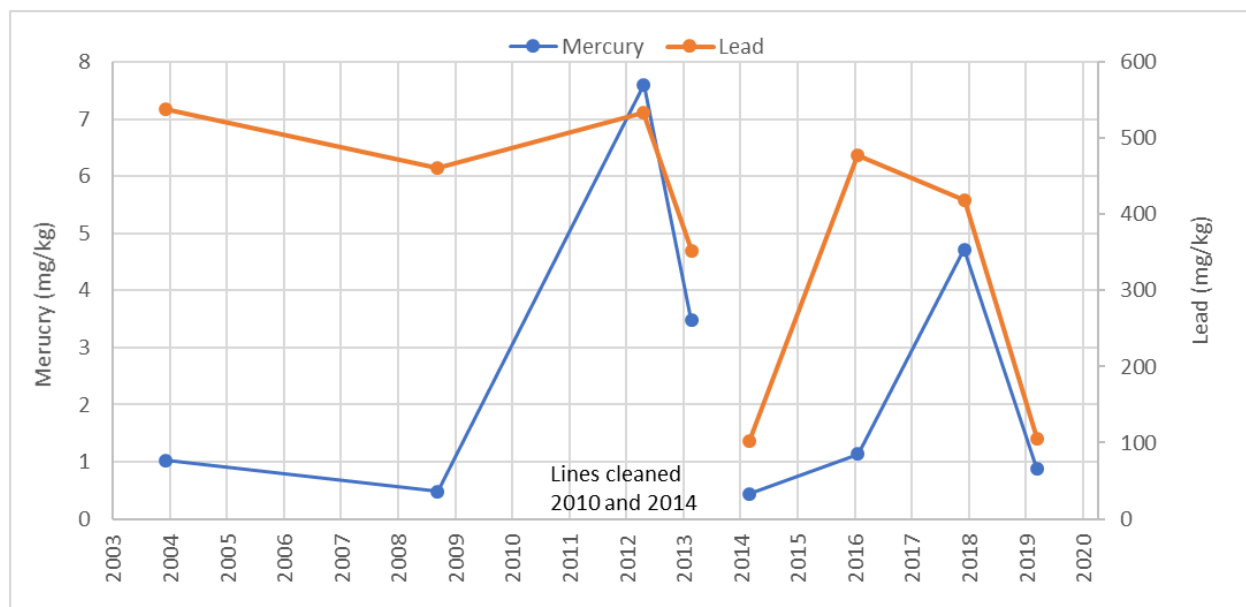
*2014 partial cleaning of lines on 7th Ave S to MH18 by Western Waterproofing

Figure C-6: Mercury and lead in MH18 (2003-2019).

As shown in Figure C-6, mercury concentrations continued to exceed SCO screening level after cleaning. Given the industrial nature of this sub-basin, there are likely multiple sources of mercury.

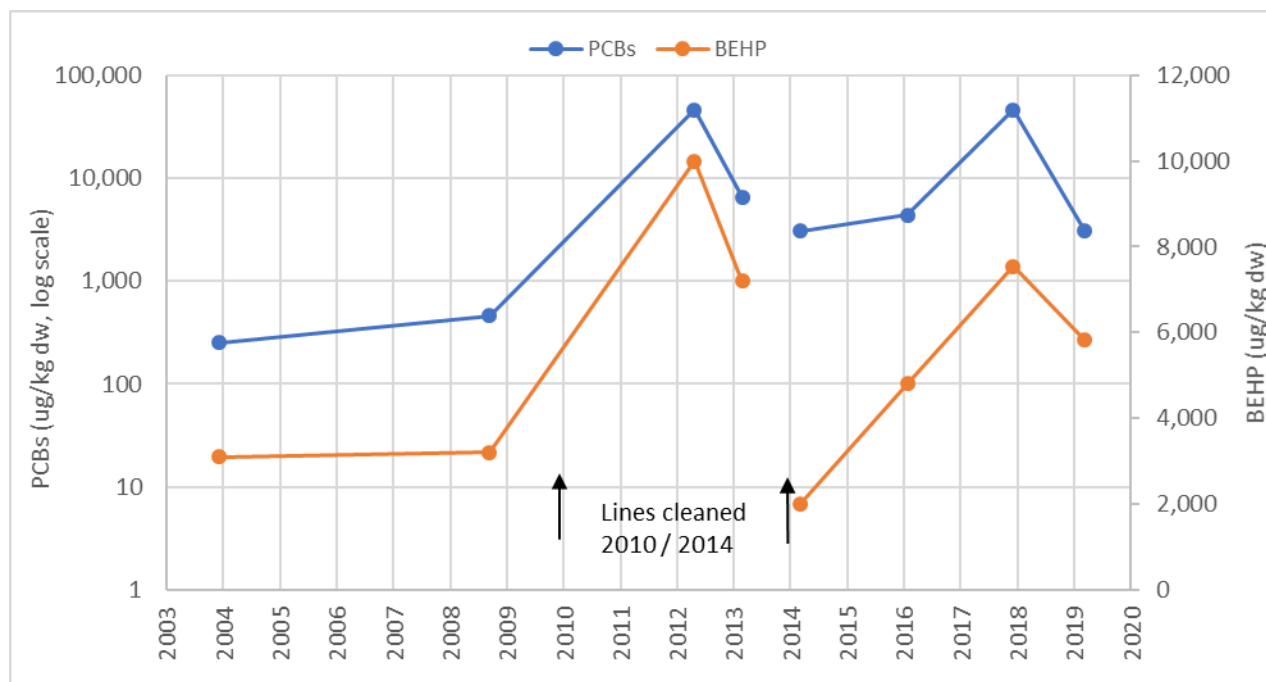
Figure C-7: PCBs and BEHP in MH18.

*2014 partial cleaning of lines on 7th Ave S to MH18 by Western Waterproofing

In addition, PCB concentrations increased after cleaning, indicating a potential new source of PCBs. PCBs increased at this location in 2013 and remained elevated in the 4 samples collected between 2014-2019. Results for PCBs and bis(2-ethylhexyl)phthalate are shown in Figure C-7. Both chemicals followed a similar pattern indicating that source(s) may be related. This maintenance hole is equipped with a 3-foot deep sump which serves to trap sediment. SPU has cleaned the MH twice since 2010 (2013 and 2019). During the previous reporting period, SPU completed an intensive inspection/sampling effort and identified two likely sources of PCBs (a masonry/waterproofing facility and an exterior paint source, see Appendix D for additional details). The masonry facility swept and later paved over areas where PCBs were suspected. The other site jetted and cleaned the onsite drainage system to remove paint residues. During this reporting period, SPU deployed the detection dog and installed two new sediment traps to aid in source tracing. The dog found several potential sources of PCBs in building materials (primarily caulk). Trap samples retrieved in 2019 found only low levels of PCBs in two of the three laterals connected to MH18 (265 and 284 ug/kg dw). The third was not sampled because a suitable location for trap installation was not identified.

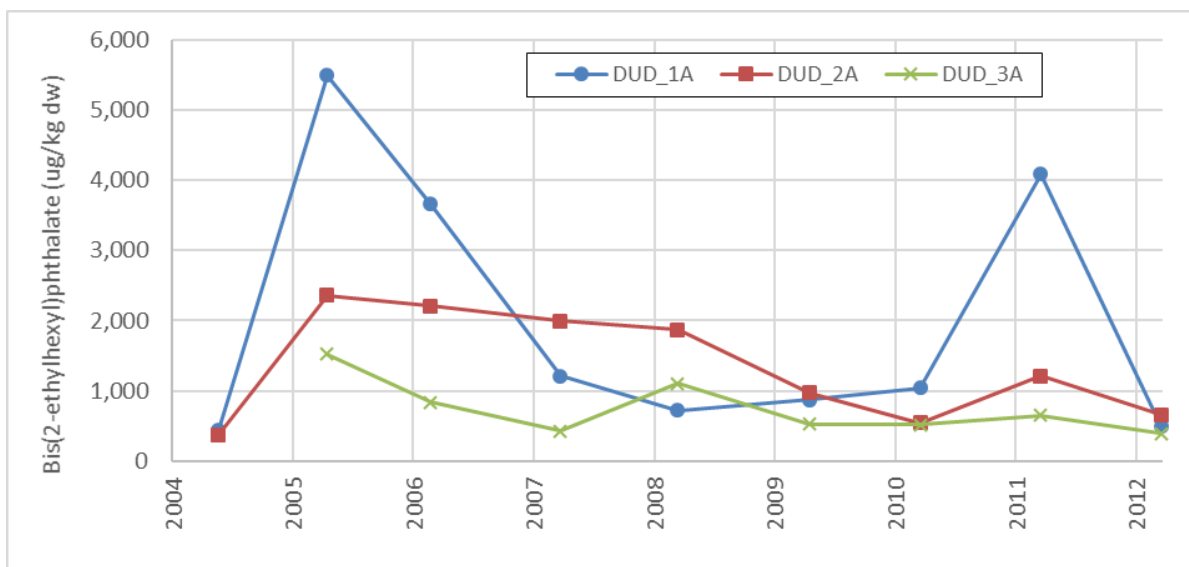
Figure C-8: BEHP in samples collected offshore of the Diagonal Ave S CSO/SD outfall post cleanup.

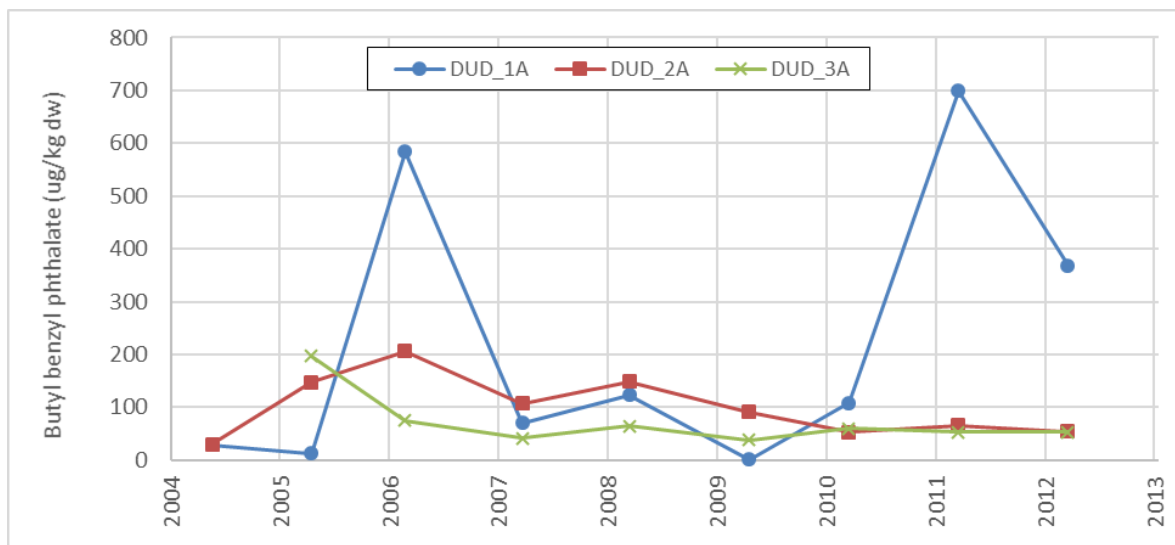
Figure C-9: Butyl benzyl phthalate in samples collected offshore of the Diagonal Ave S CSO/SD after cleanup.

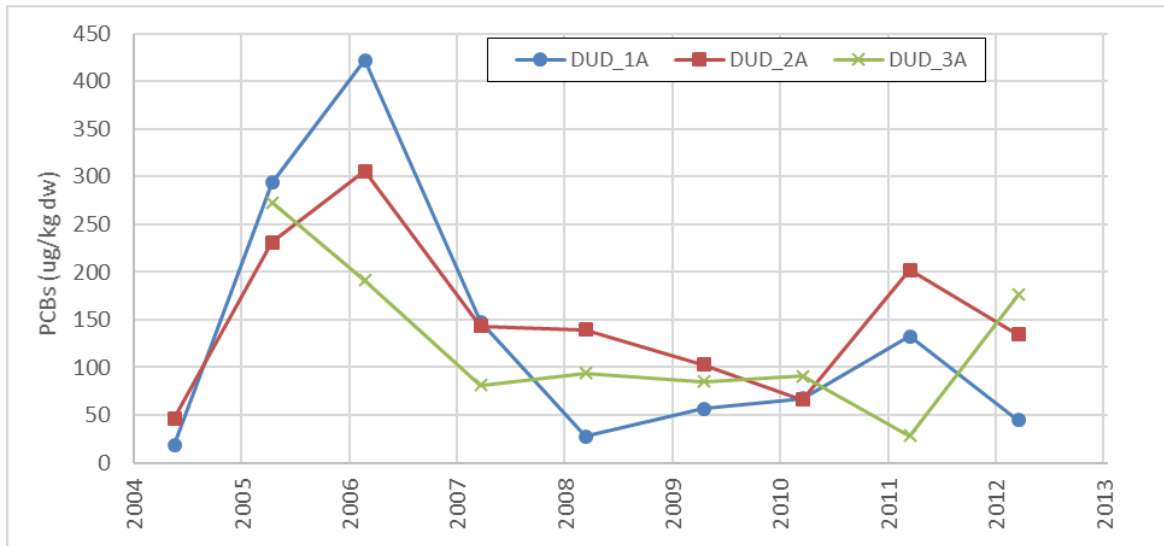
Figure C-10: PCBs in samples collected offshore of the Diagonal Ave S CSO/SD outfall after cleanup.

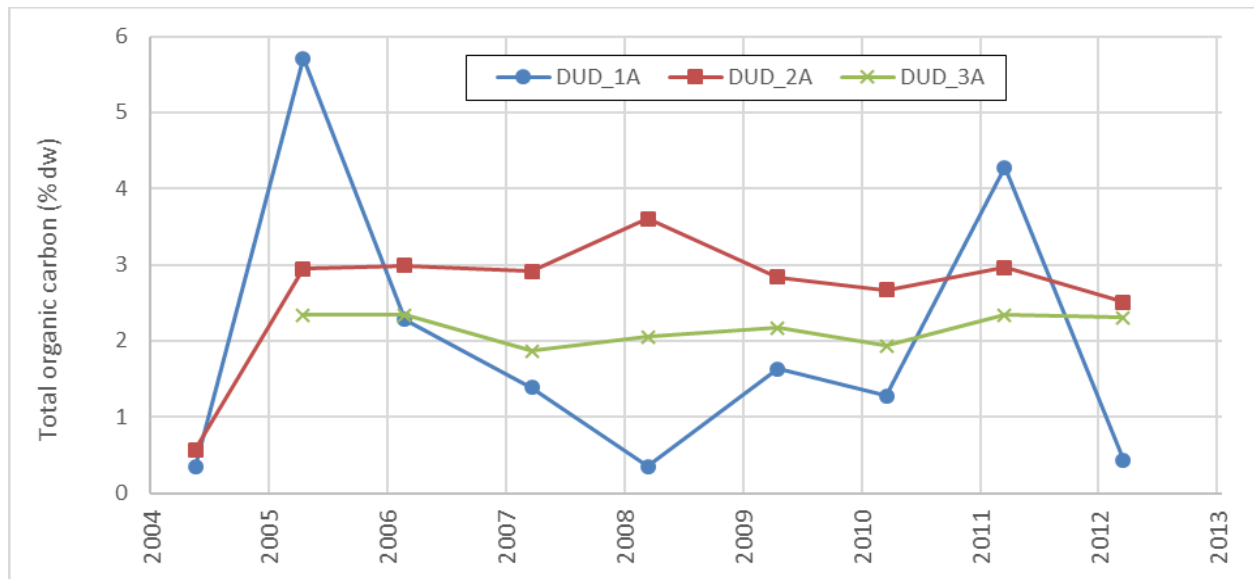
Figure C-11: Total organic carbon in samples collected offshore of the Diagonal Ave S CSO/SD after cleanup.
