# Application for a State Waste Discharge Permit to Discharge Domestic Wastewater to Ground Water by Land Treatment or Application

1. Applicant Name: BCSCBN, Inc.
2. Facility Name: Vantage Bay Water Reclamation Facility  
(if different from applicant)
3. Applicant Address: 21828 87<sup>th</sup> Avenue SE, Suite 200  
Street  
Woodinville, WA 98072  
City/State Zip
4. Facility Location Address: Kittitas County Parcels 272933 and 622933  
(if different from above) Street  
Vantage, WA 98050  
City/State Zip
5. Latitude/longitude of the processing facility as decimal degrees (NAD83/WGS84):  
46.9333 / 119.9883
6. Latitude/longitude of sprayfield/infiltration site discharge location (approximate center) as decimal degrees (NAD83/WGS84):  
46.9333 / 119.9887
7. Person to contact who is familiar with the information contained in this application:

**PROPOSED SITE PLAN**  
**ATTACHMENT B.5**  
**VANTAGE BAY**  
**STATE WASTE DISCHARGE**  
**PERMIT APPLICATION**

**Subject: Infiltration Evaluation  
Proposed Vantage Bay PUD  
Huntzinger Road  
Kittitas County (Vantage), Washington**

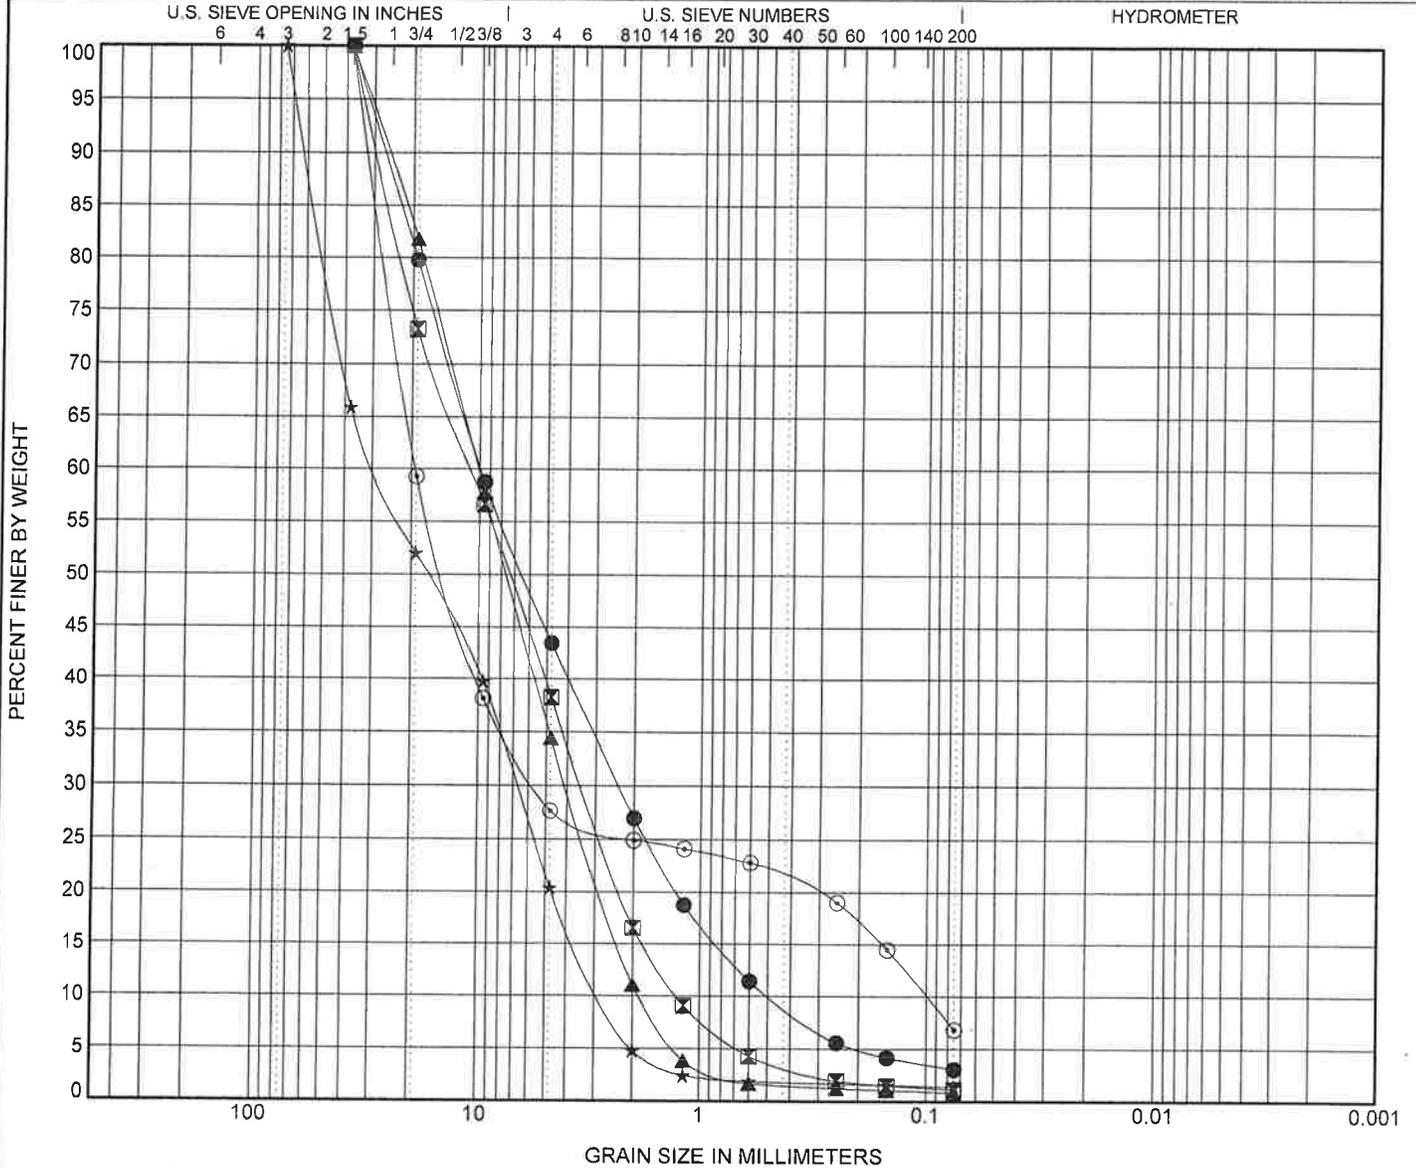
Specimen Identification	Classification						Cc	Cu
● TP-01 9.0ft.	USDA: Gray Extremely Gravelly Coarse Sand. USCS: GW with Sand.						1.14	20.40
⊠ TP-03 7.0ft.	USDA: Gray Extremely Gravelly Coarse Sand. USCS: GP with Sand.						0.85	8.68
▲ TP-06 9.5ft.	USDA: Gray Extremely Gravelly Coarse Sand. USCS: GP with Sand.						0.86	5.48
★ TP-07 8.0ft.	USDA: Gray Extremely Gravelly Loamy Coarse Sand. USCS: GP with Sand.						0.60	10.51
⊙ TP-09 3.0ft.	USDA: Gray Extremely Gravelly Very Fine Sandy Loam. USCS: GP-GM with Sand.						16.06	192.49

The design infiltration rates were calculated based on the soil grain size analysis method developed by Massman. A total correction factor of 0.12 was used to calculate the design rate with a maximum recommended design infiltration rate of 20.0 iph. The design recommendations are suitable for facilities designed within the vicinity of the test pit locations; ESNW should complete additional testing if alternative locations are proposed. ESNW should observe construction of the infiltration facilities and complete confirmation testing as necessary.

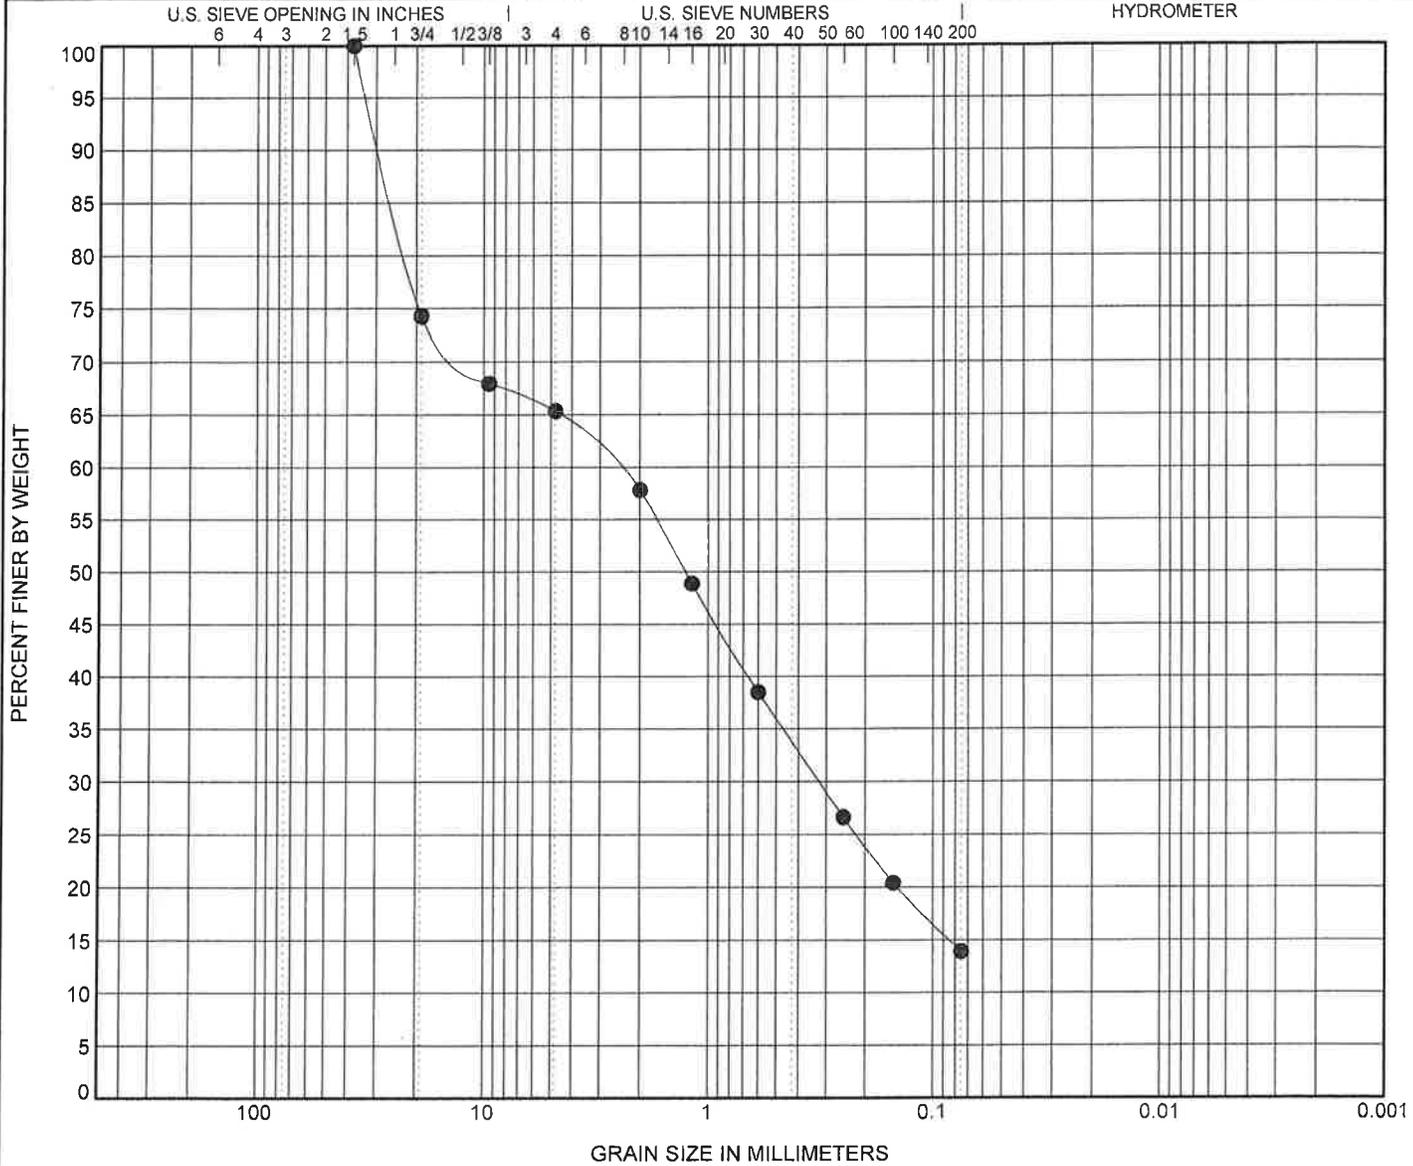
Specimen Identification	Classification										Cc	Cu
● TP-12 3.0ft.	<b>USDA: Gray Very Gravelly Loamy Coarse Sand. USCS: SM with Gravel.</b>

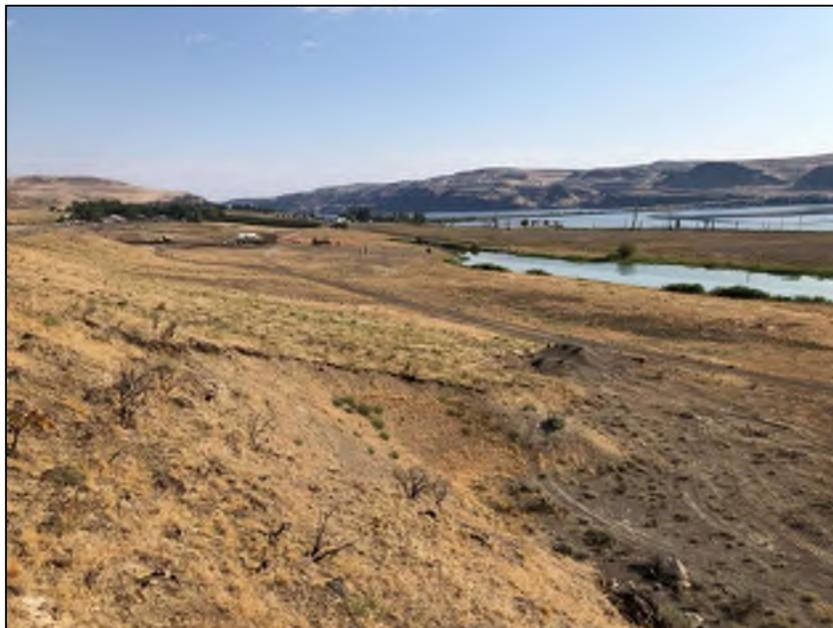
*Photo 1. Vantage Bay PUD Site looking north. July 2020.*

The Site (before grading) was covered mostly with shrub-steppe vegetation consisting primarily of grass and sagebrush (**Photo 1**). Aquatic, shrub, and grass vegetation grows within 25 feet of the Inlet shoreline (**Photo 2**). The Site was lightly developed up until the grading activity, and included irrigated pasture, stock grazing, and soil borrow excavation. Property to the north is used for irrigated orchard. Property to the west and south is essentially undeveloped. Property to the east across the Inlet is owned by GCPUD and was developed with a paved airstrip but is otherwise undeveloped.

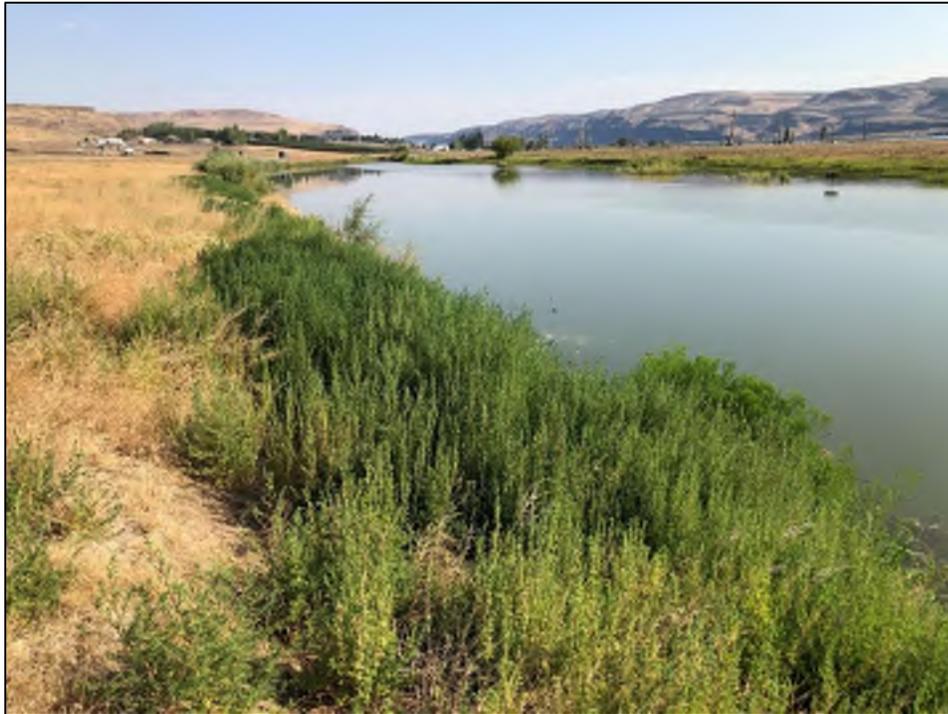
*Photo 2. Columbia River Inlet looking north. July 2020.*

The surface water in the Inlet was observed at the time of the site visit in July 2020 (**Photo 2**). A grab sample of water was obtained, and field instrumentation indicated the following water quality parameters:

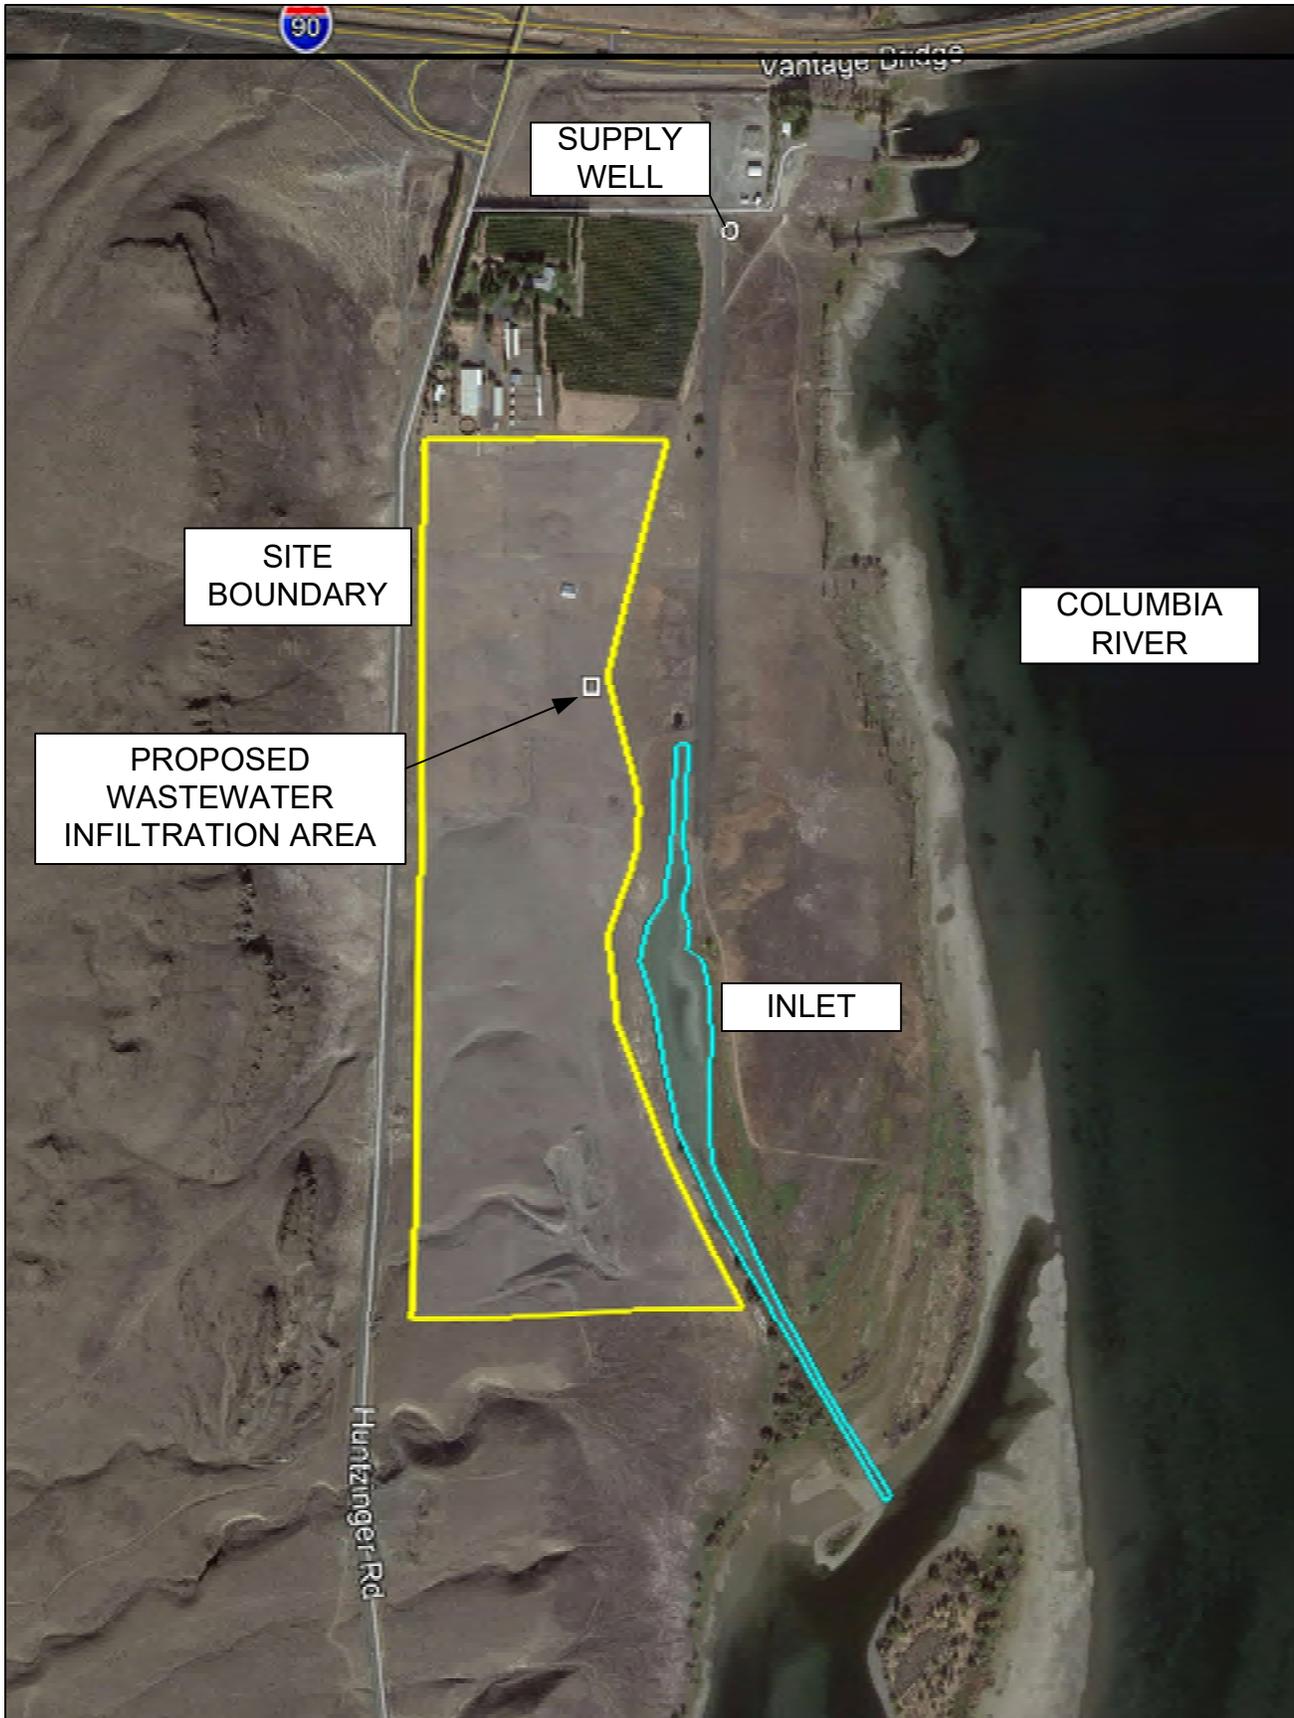
# FIGURE 1 SITE MAP VANTAGE BAY PUD

The proposed residential Vantage Bay planned unit development (PUD) on approximately 58 acres of land near the Town of Vantage, Washington, will use an on-site wastewater treatment system with membrane bioreactor (MBR) technology to generate Class A wastewater that will be partially discharged to ground for reuse and partially reclaimed in the summer months for irrigation supply. The Class A wastewater will be discharged to an on-site infiltration system, and the wastewater will percolate into unconsolidated permeable soil, migrate laterally, and ultimately discharge into a mixing zone along an inlet (Inlet in this memorandum) of the nearby Columbia River and into the Columbia River mainstem. The wastewater discharge rate at full build-out is estimated to range from 37,600 to 66,300 gallons per day (gpd). The site is shown on **Figure 1**.

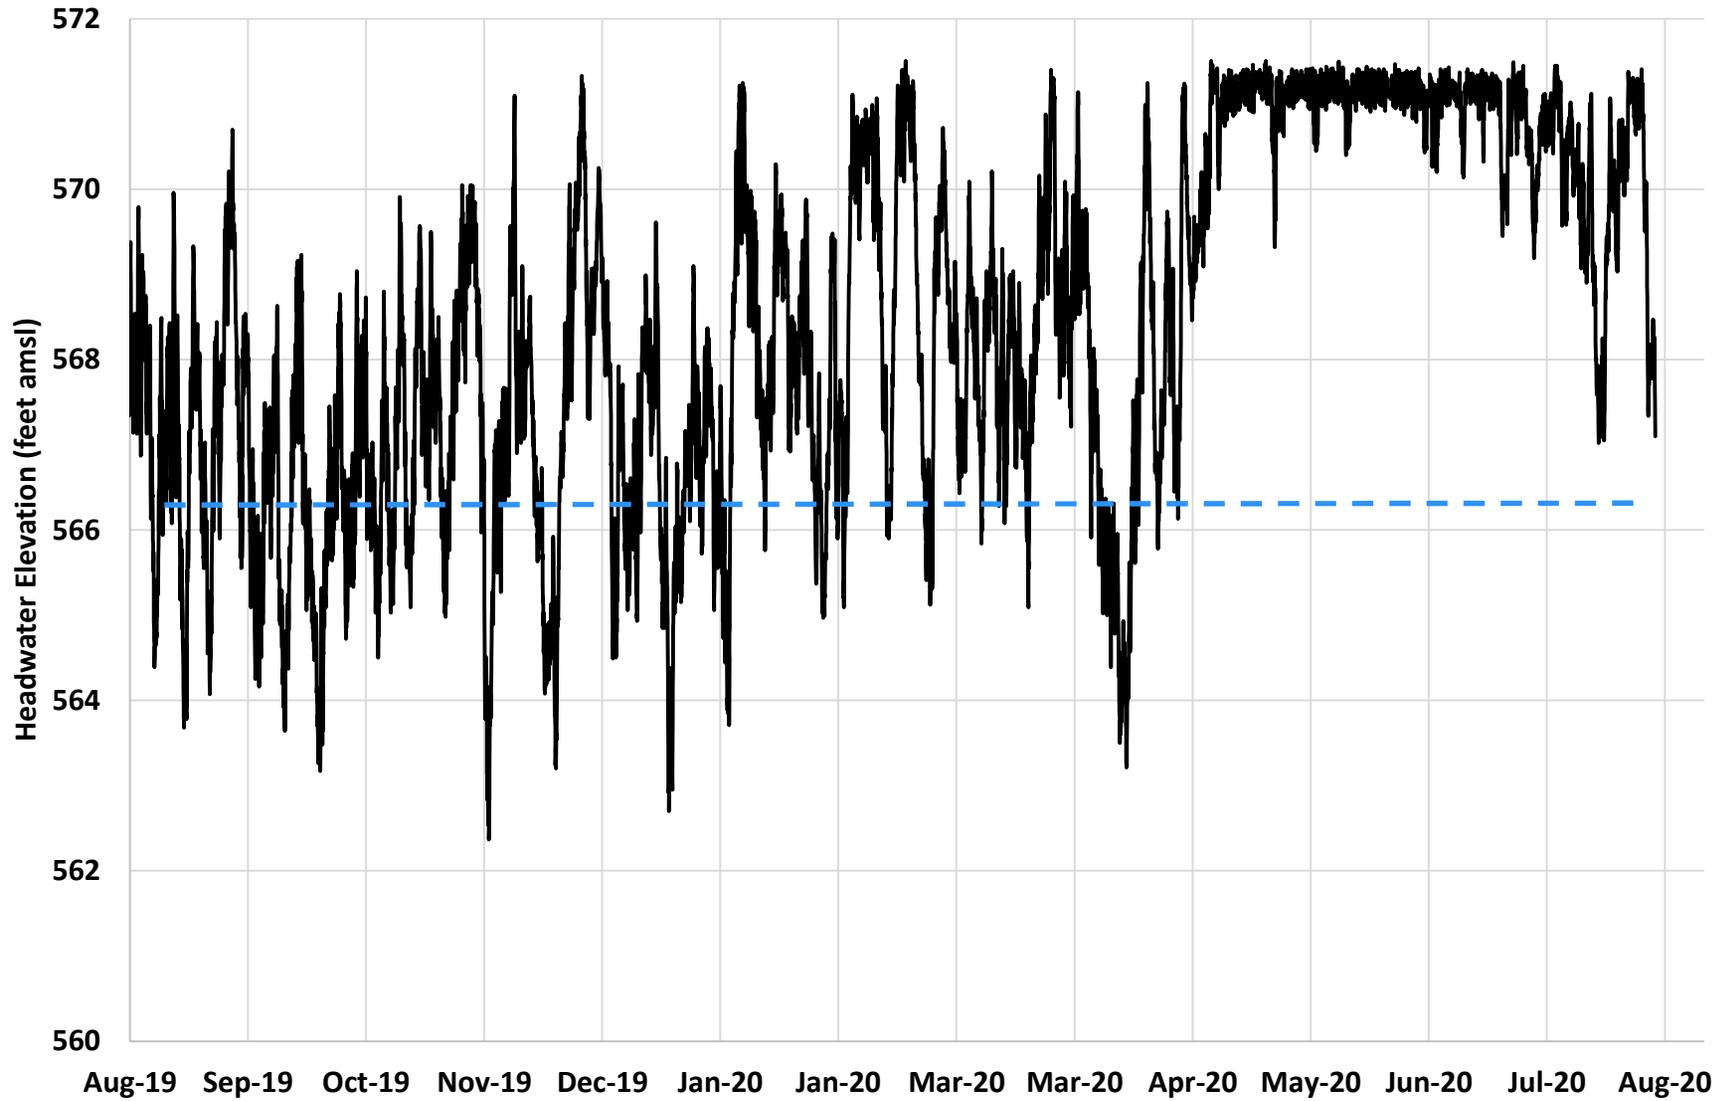
**Figure 2**  
**Wanapum Headwater Elevation - August 2019 to August 2020**  
**Vantage Bay Hydrogeologic Evaluation**

Public Utility District No. 2 of Grant County (GCPUD) operates the Wanapum Dam on the Columbia River. Dam operation causes the river water (headwater) elevation behind the dam to fluctuate daily and seasonally. The headwater data are available on the United States Army Corps of Engineers (USACE) website at <https://www.nwd-wc.usace.army.mil/dd/common/dataquery/www/?k=wanapum>. GCPUD developed a bathymetric map of the Columbia River shoreline and bottom topography of the Columbia River upstream of the dam. **Attachment 3** shows the bathymetry of the Columbia River adjacent to the Site.

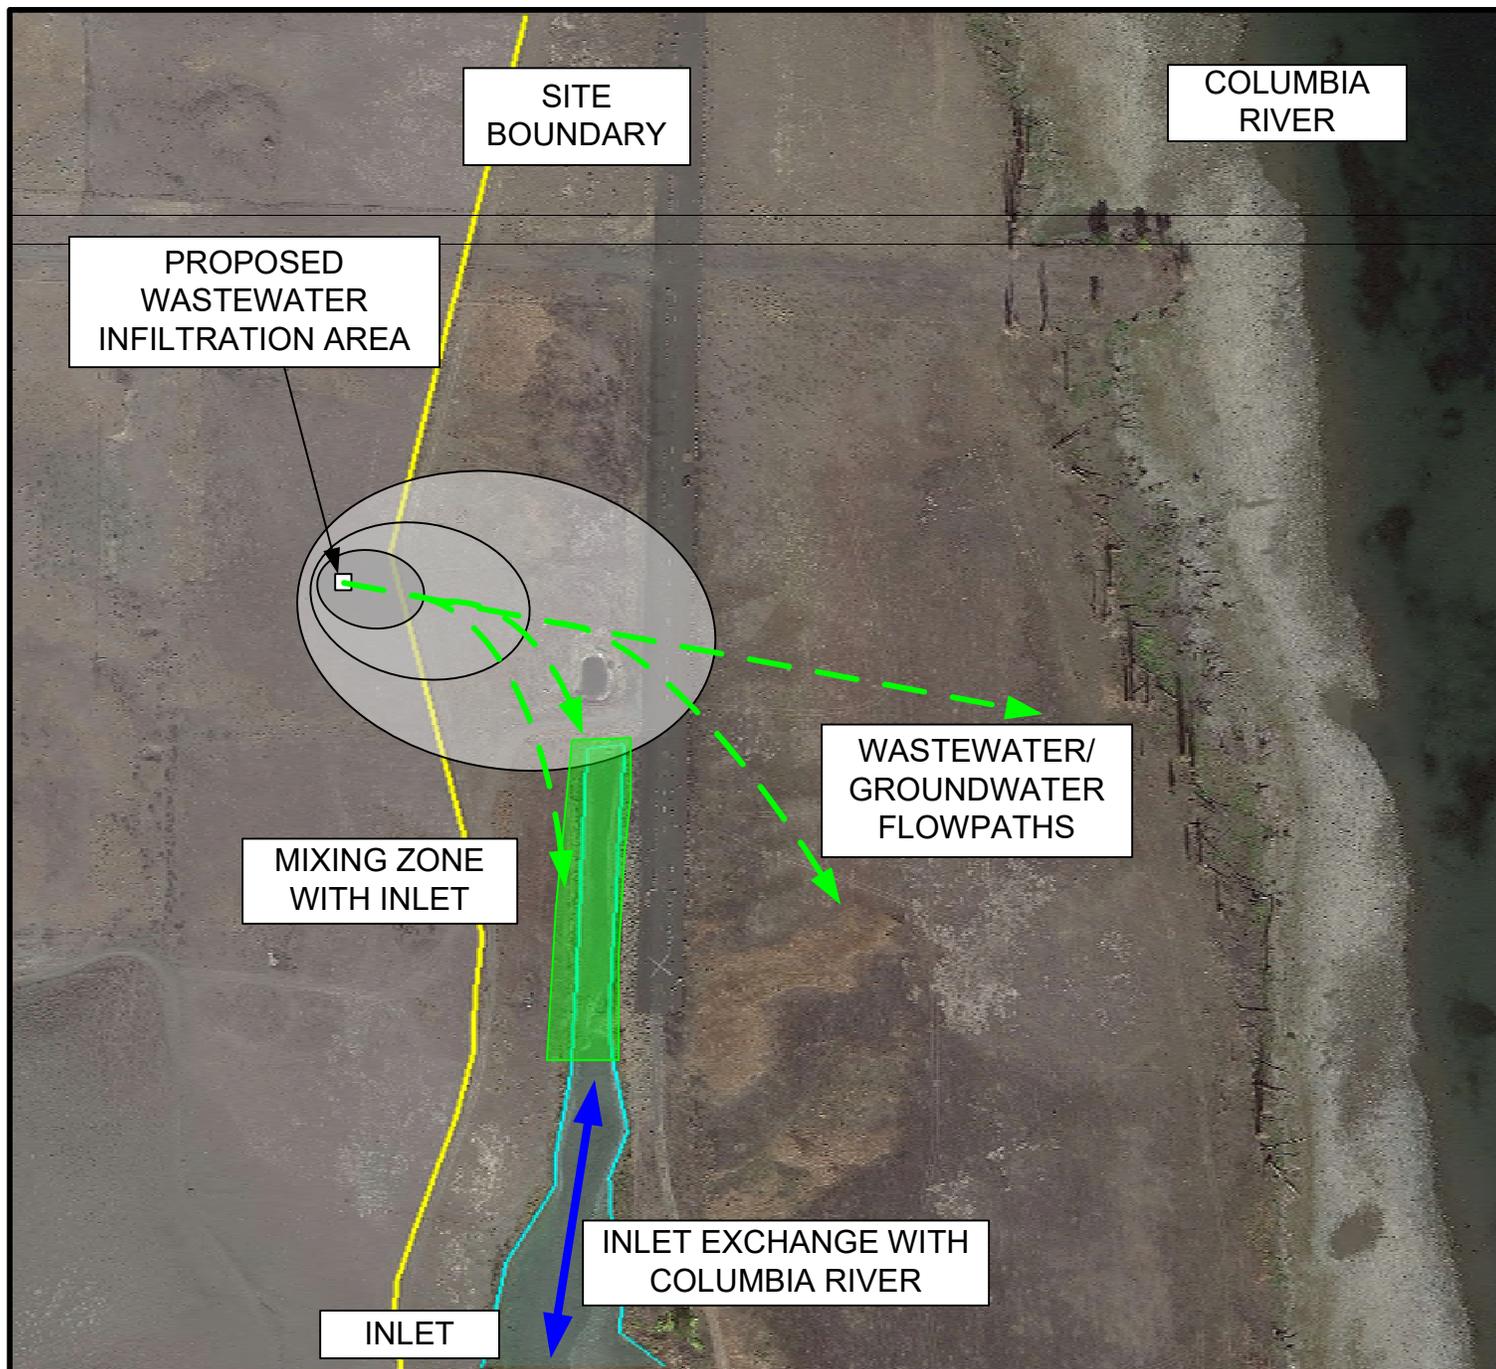
# FIGURE 4 INFILTRATION AREA AND WASTEWATER/ GROUNDWATER FLOW PATH VANTAGE BAY PUD

Wastewater infiltrating to the subsurface will accumulate below the infiltration area then flow predominantly to the east towards the Inlet. As the wastewater interacts with the unconsolidated soil, the water quality will improve through nutrient removal, soil absorption, and mineral precipitation, processes that are typical for all wastewater discharges to the subsurface. Portions of the infiltrated wastewater will discharge to the Inlet, and a portion will bypass the Inlet and flow towards and ultimately discharge along a broad mixing zone along the Columbia River shoreline (**Figure 4**).

The Class A wastewater will infiltrate into the surficial geologic unit at the infiltration area, percolate downwards approximately 8 to 10 feet to the basalt layer, and then spread and accumulate as a small groundwater mound on top of the basalt. As the accumulated wastewater (now groundwater) builds in volume, the water will then flow radially into unsaturated soil below the infiltration area and to the east following the topography of the interface between the surficial geologic unit and the basalt (**Figure 4**). The topography of this interface likely varies, and is not known precisely, but it is reasonable to assume that the contact slopes easterly towards the Inlet.

Assuming a 420-foot distance from the infiltration area and an average height of groundwater above the Inlet elevation of 12 feet as the elevation drop from the groundwater mound, the estimated hydraulic gradient is 0.029 feet per foot. Using the soil grain-size analysis method of the Washington State Department of Ecology's *Stormwater Management Manual for Eastern Washington* and the sieve analysis results for soil samples collected at Test Pit 9, the estimated saturated hydraulic conductivity of the surficial geologic unit is 68 feet per day. Based on these data, the time of travel from the infiltration area to the nearest point on the Inlet shoreline is about 186 days or 6 months.

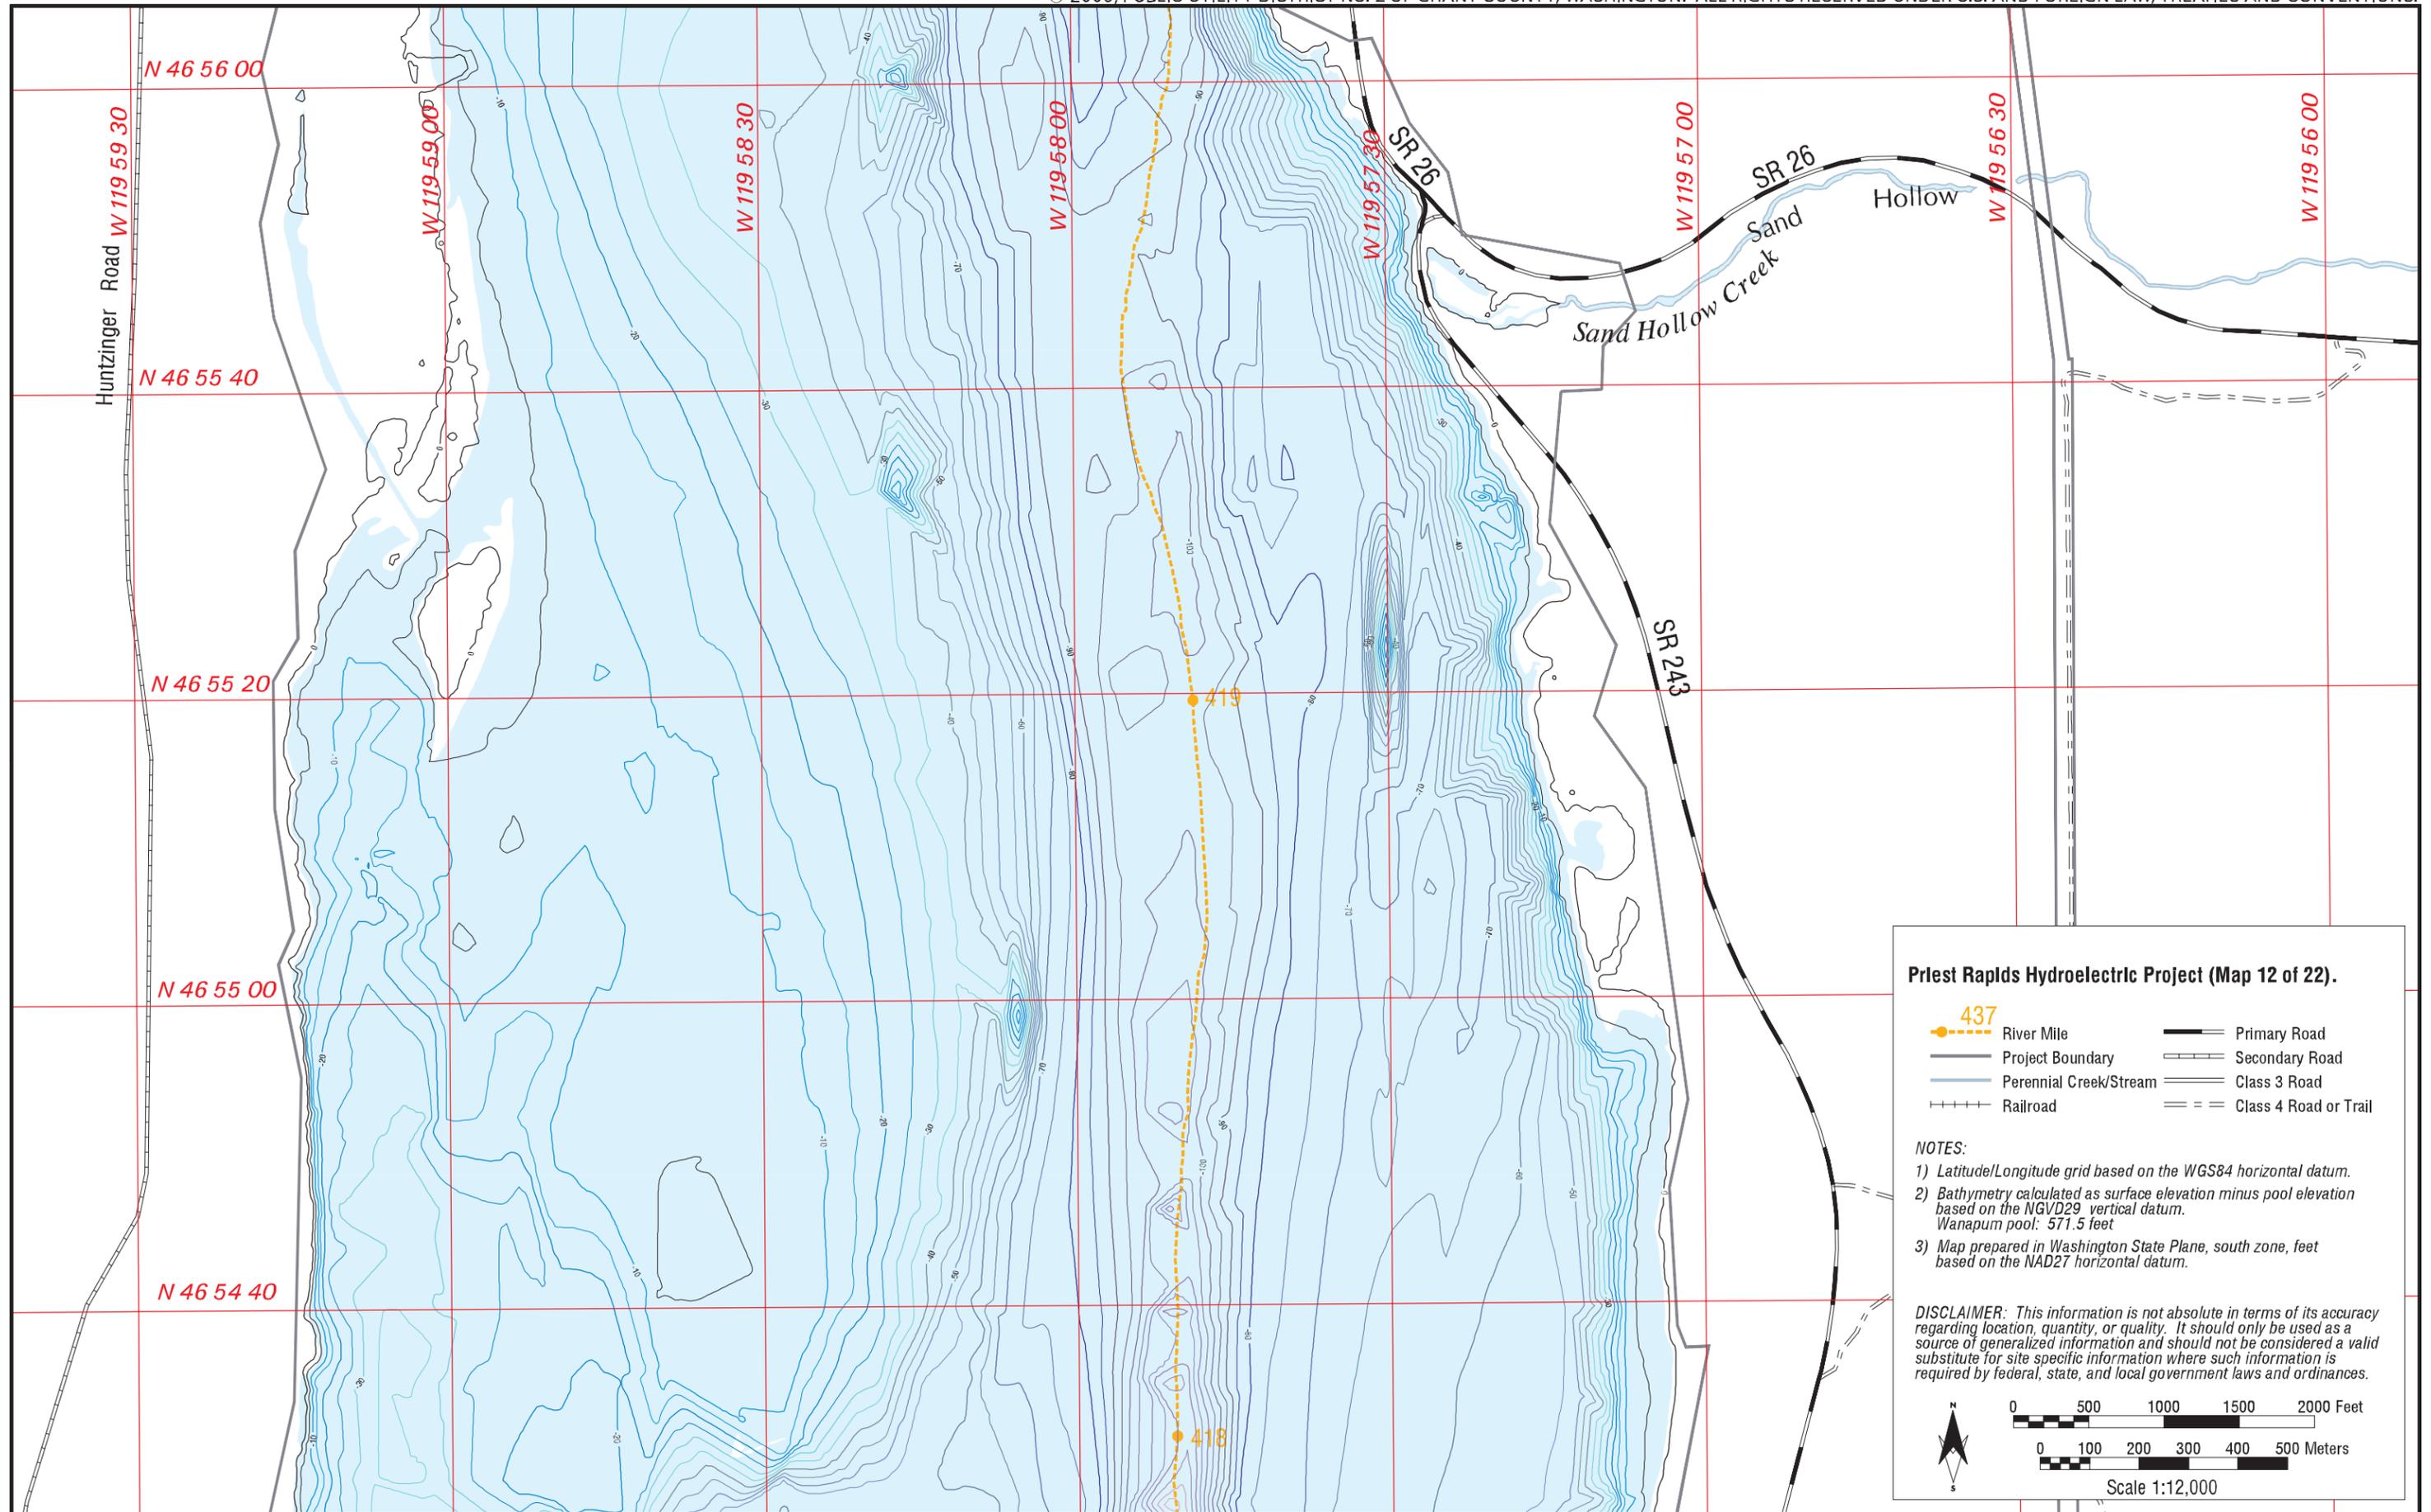
**Attachment 3**  
**Vantage Bay Bathymetry**

**Priest Rapids Hydroelectric Project (Map 12 of 22).**

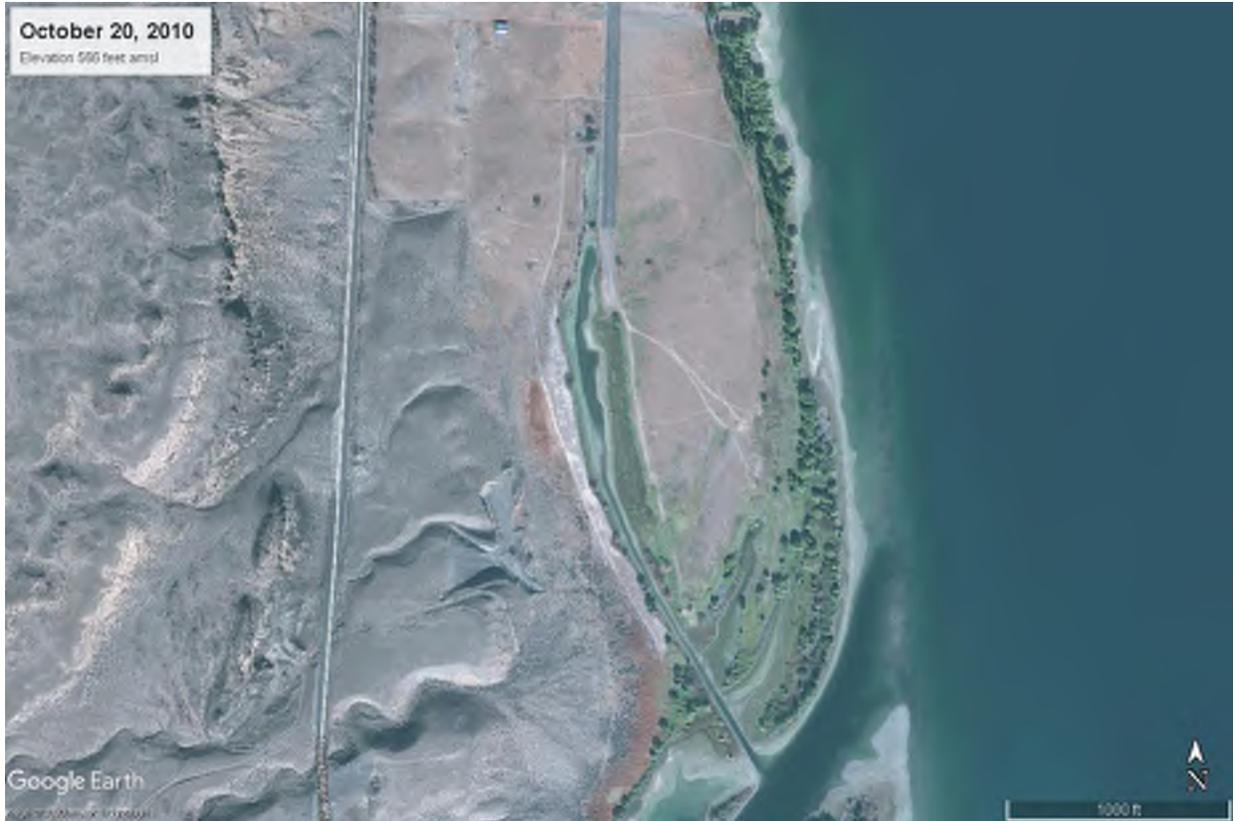
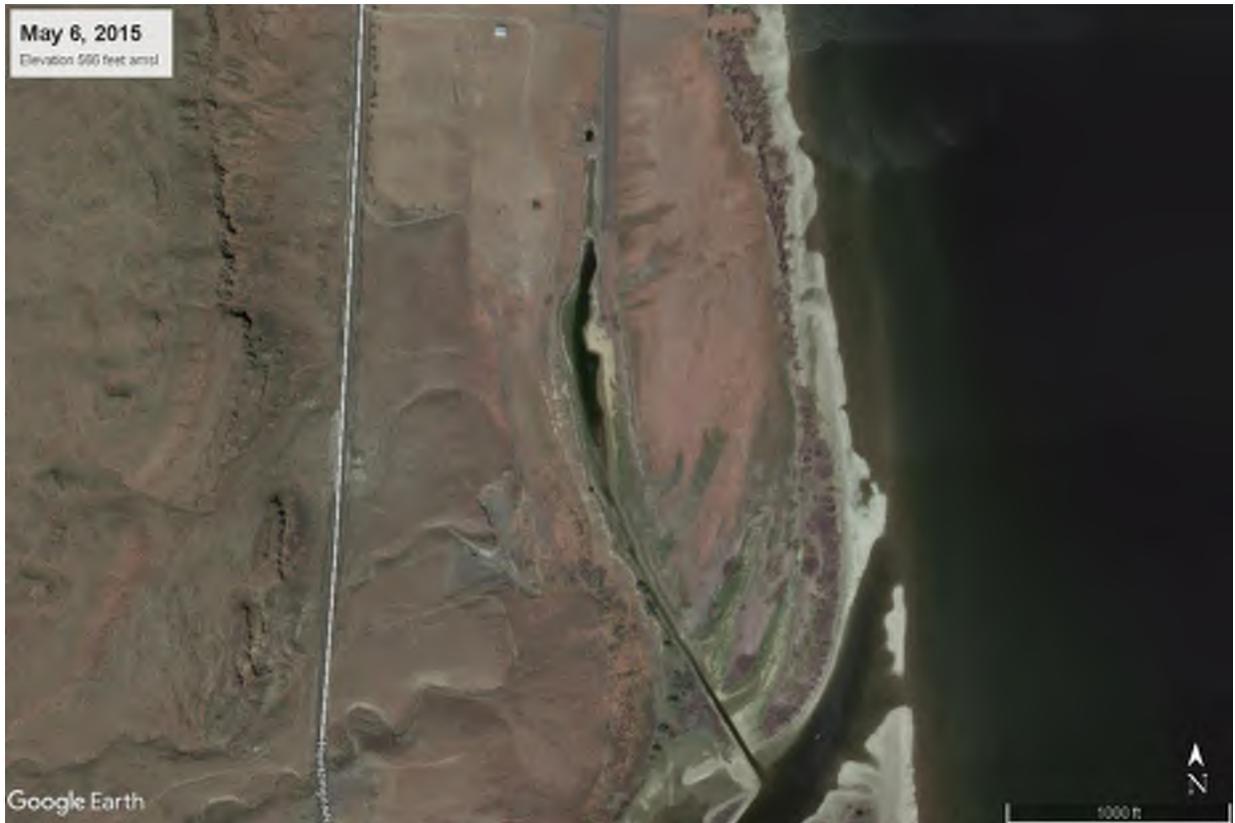
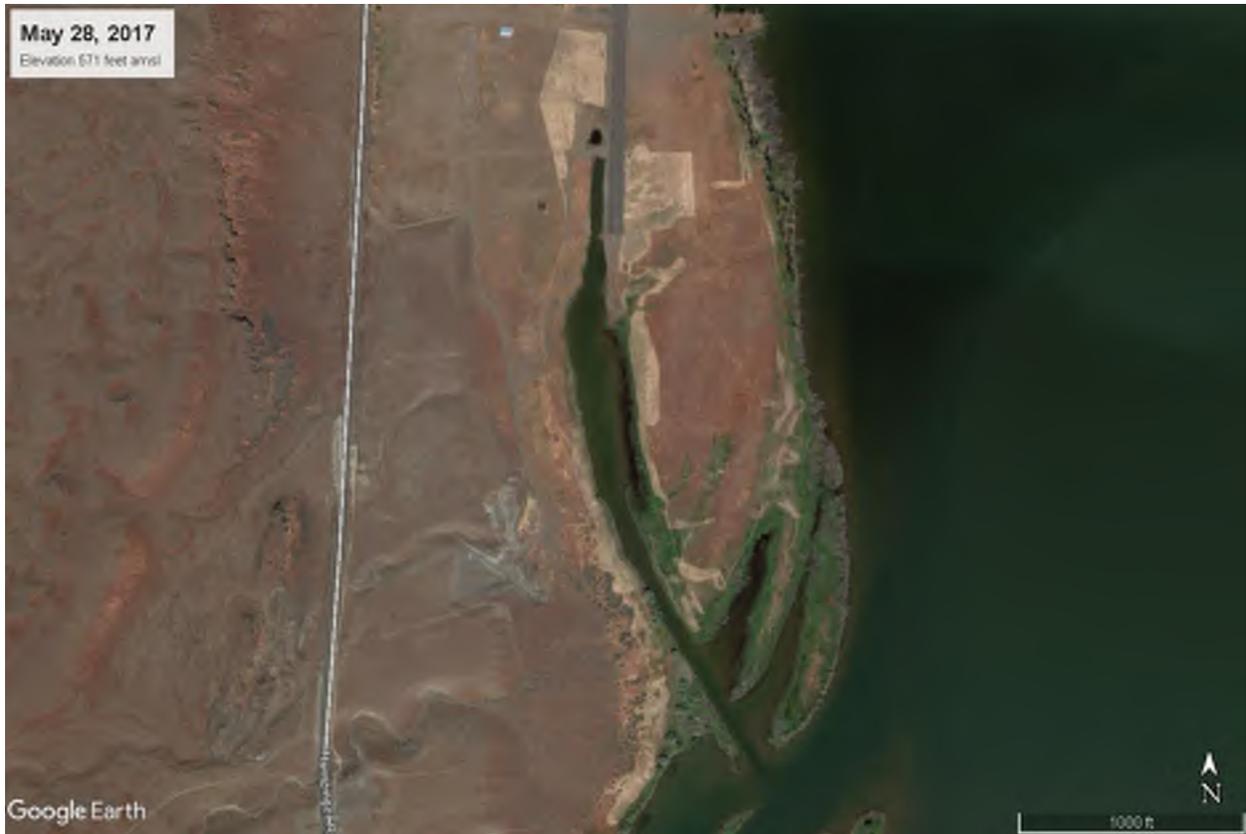
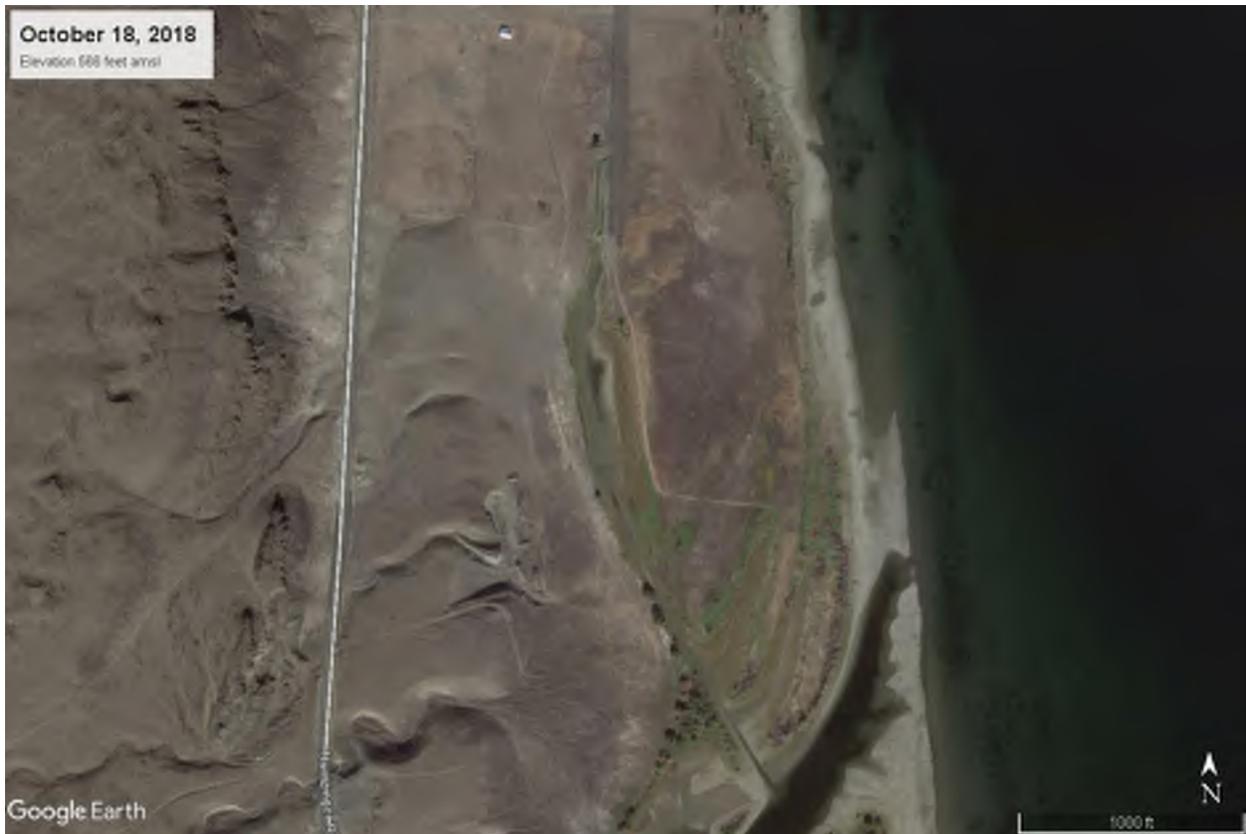
**Vantage Bay Historical Aerial Photographs**

Drawdown of the Wanapum headwater to below 566 feet amsl may cause the water in the Inlet to completely recede, leaving it dry during periods of fall to spring. Several Google Earth photos illustrating the amount of water in the Inlet during different times of the year are included in **Attachment 4**.
