Lynnwood Hauling Facility Level III Corrective Action Engineering Report

21309 66th Ave W, Lynnwood, WA 98036

Golder Associates Inc.

May 14, 2021

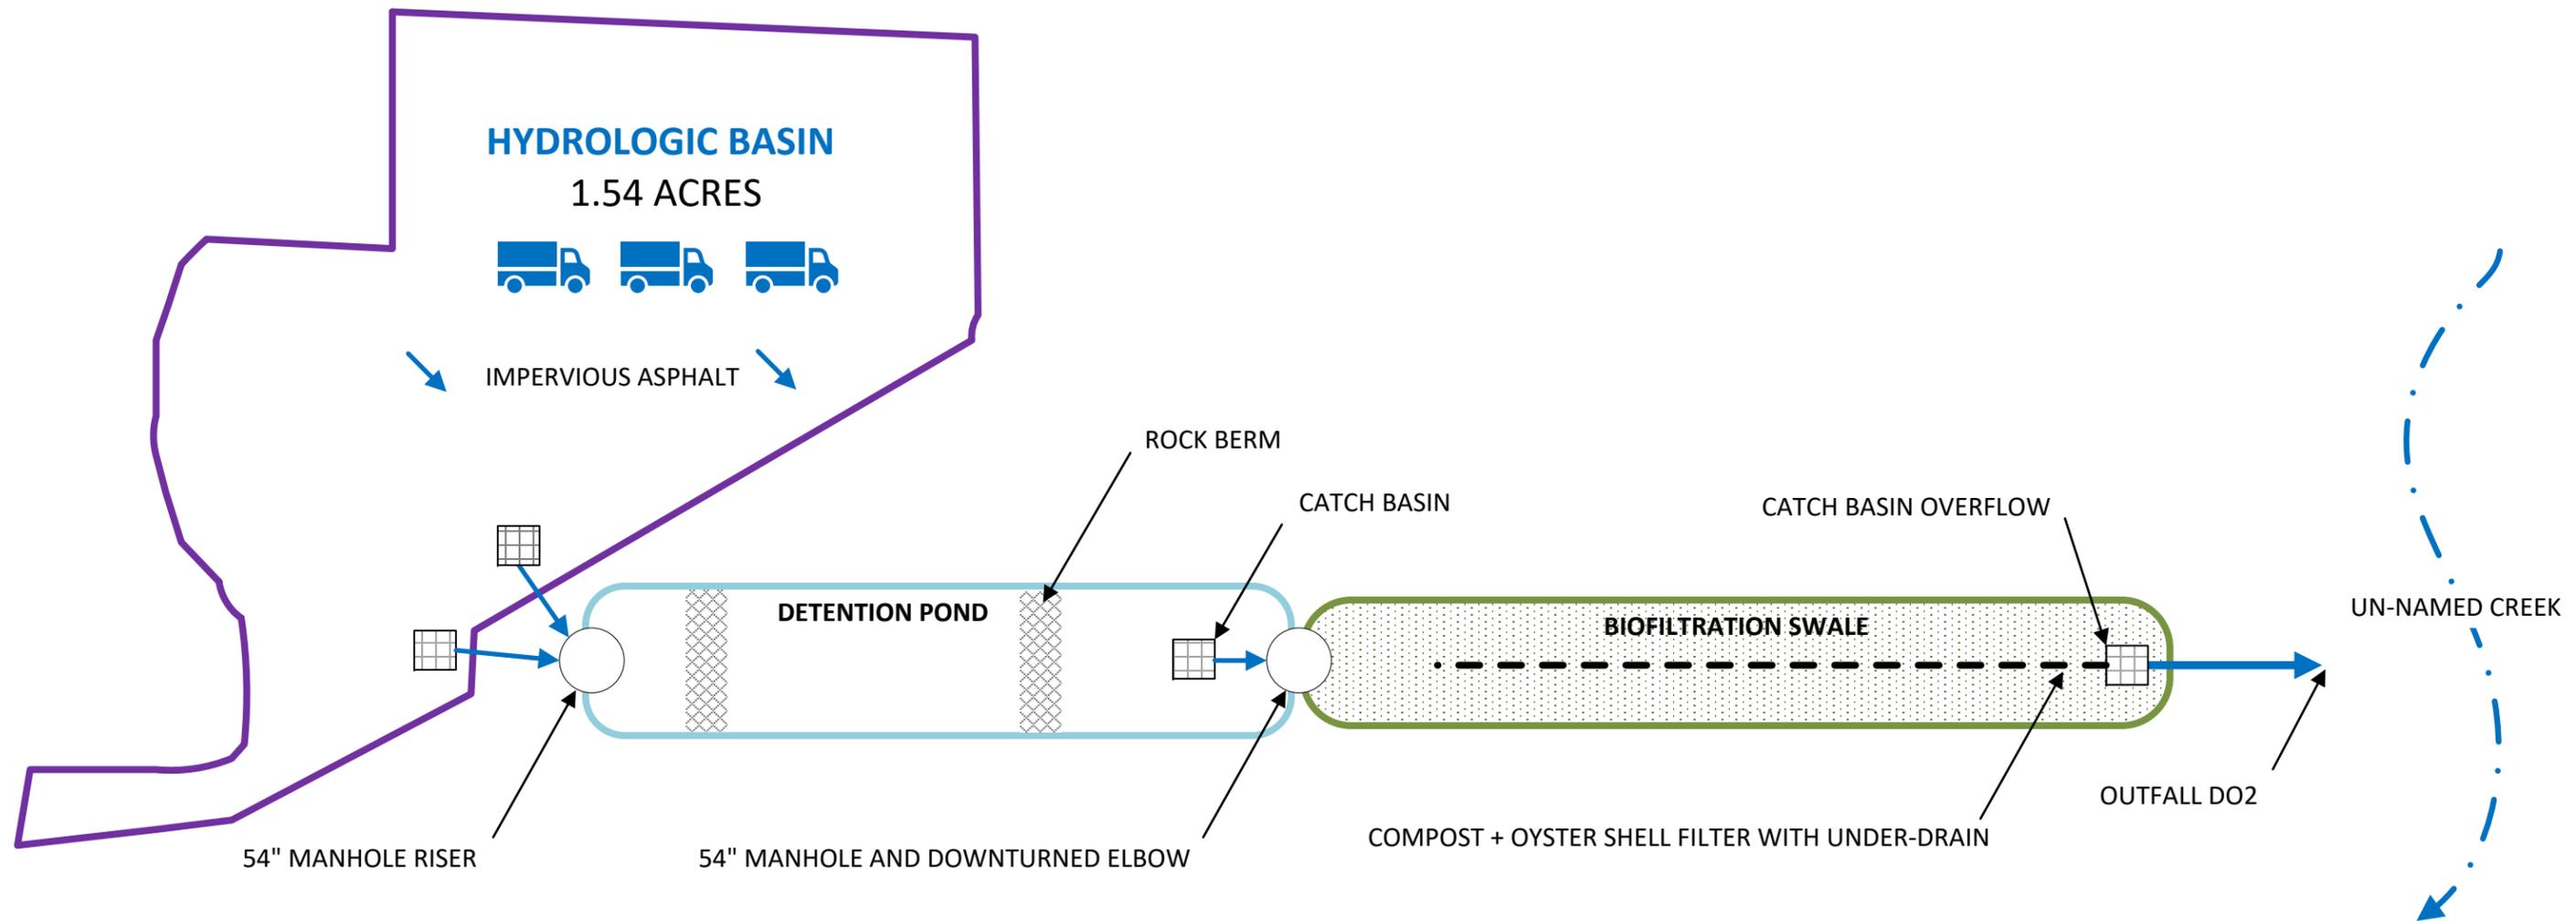
PROJECT NO. 20148751	PHASE 300	REV. 0	FIGURE 1
-------------------------	--------------	-----------	-------------

TITLE
EXISTING BMP PLAN

The Lynnwood Hauling Facility covers approximately 2.5 acres and is used for truck parking, fueling, washing, vehicle maintenance, and storage of waste bins. The portion of the facility discharging industrial stormwater consists of a single hydrologic basin with 1.54 acres of impervious asphalt and rooftops. A process diagram of the facility is found in Figure 1 of Appendix A and a facility layout is found in Sheet 1 of Appendix B.

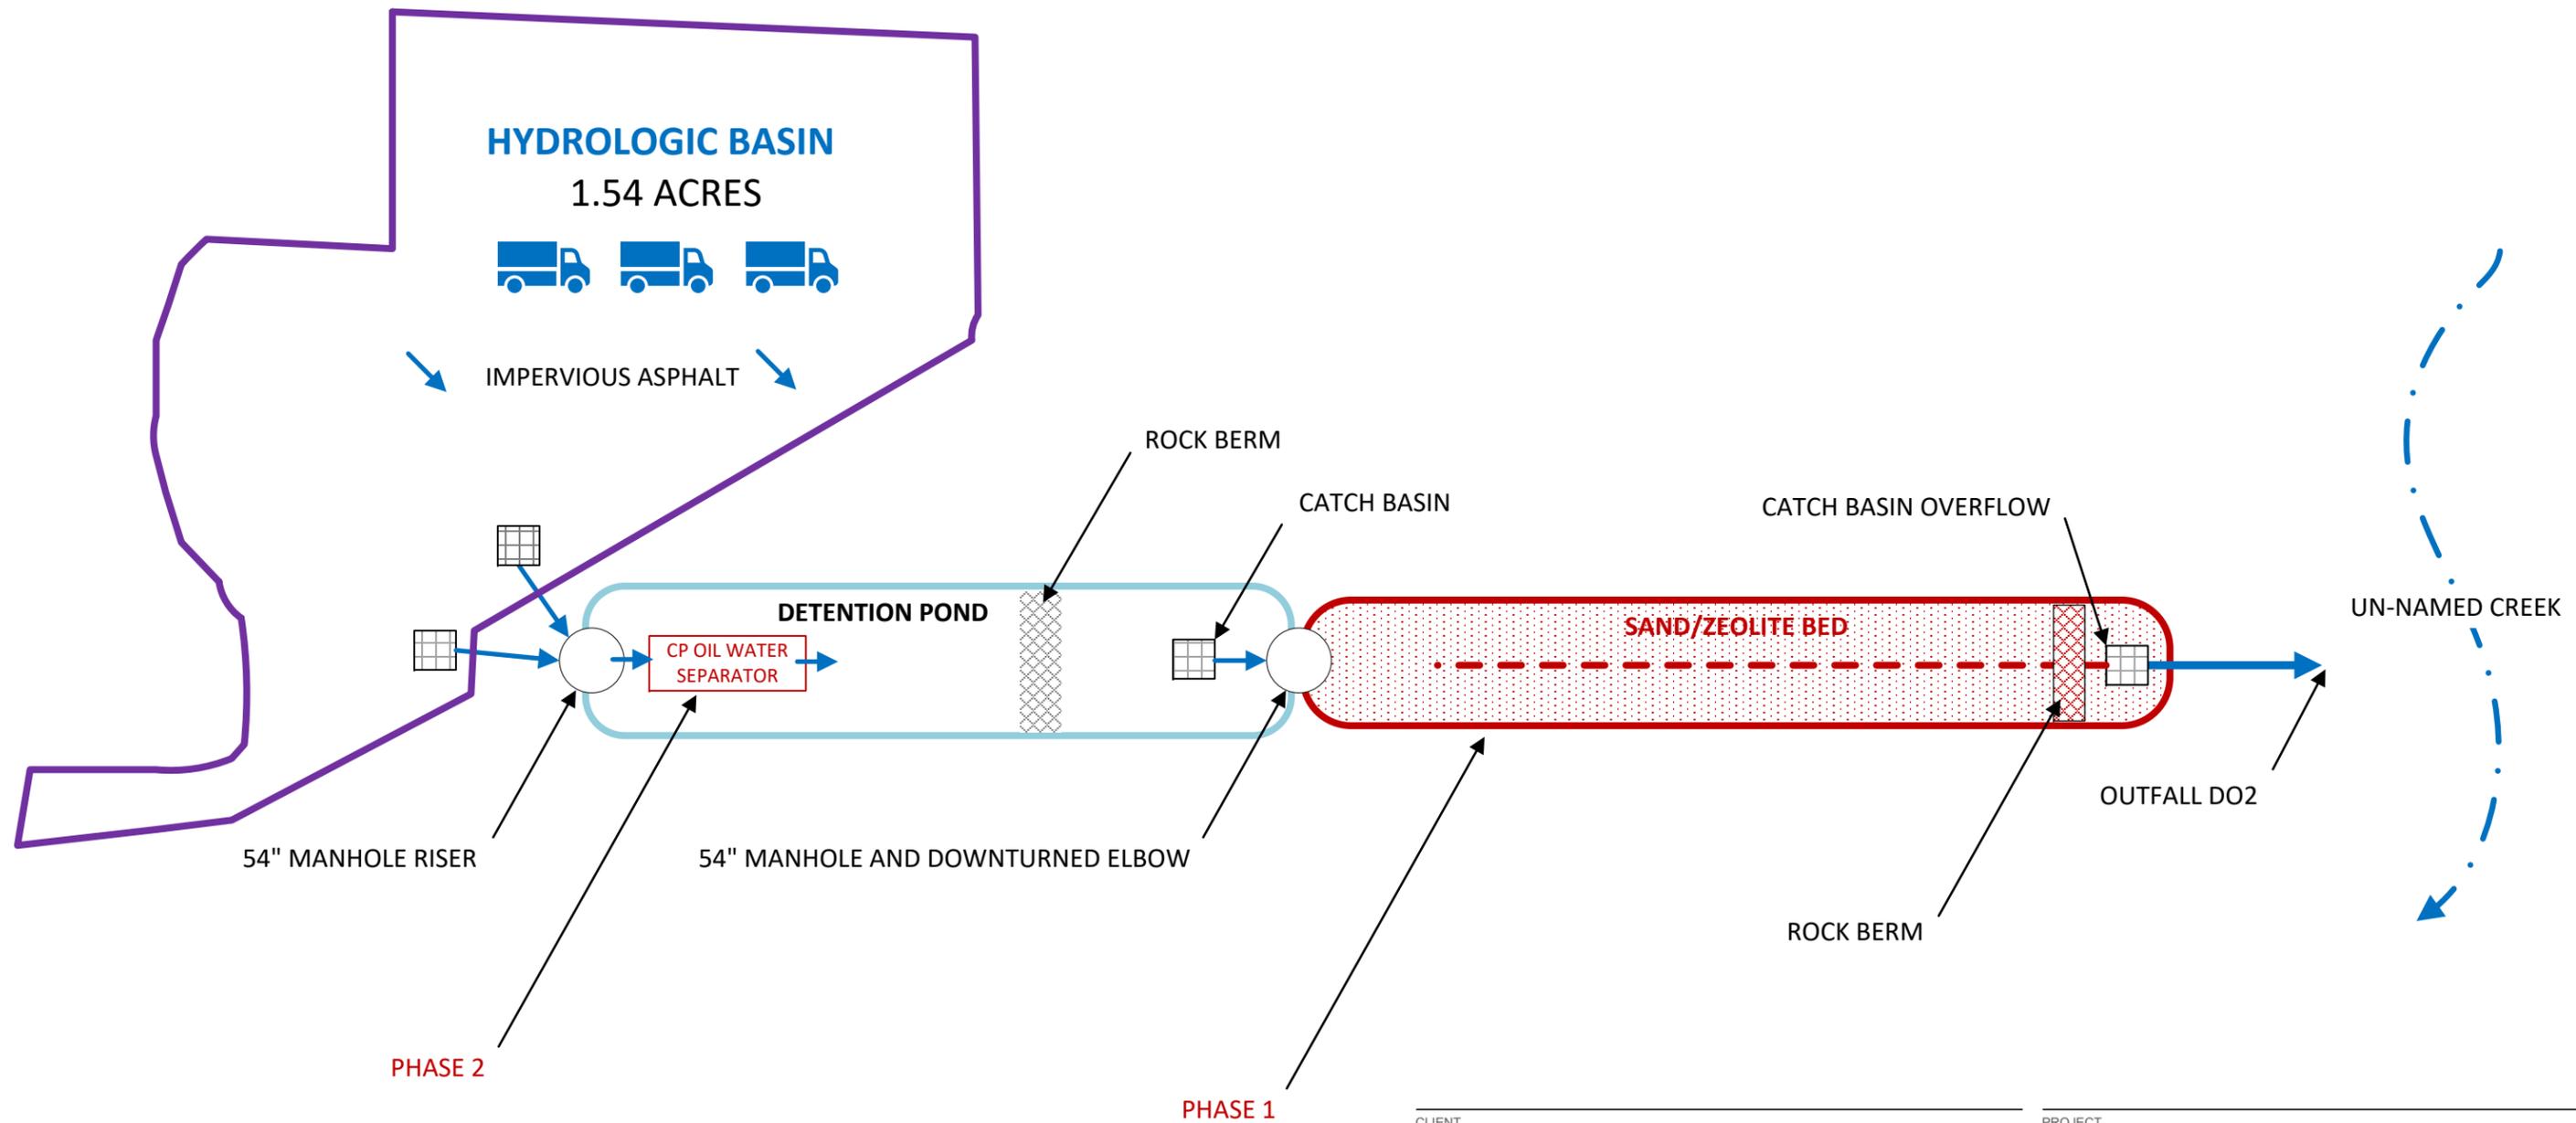
PROJECT NO. 20148751	PHASE 300	REV. 0	FIGURE 2
-------------------------	--------------	-----------	-------------

TITLE
PROPOSED BMP PLAN

A process flow diagram of the suggested improvements is shown in Figure 2 of Appendix A with a detailed BMP plan figure provided as Sheet 2 of Appendix B.

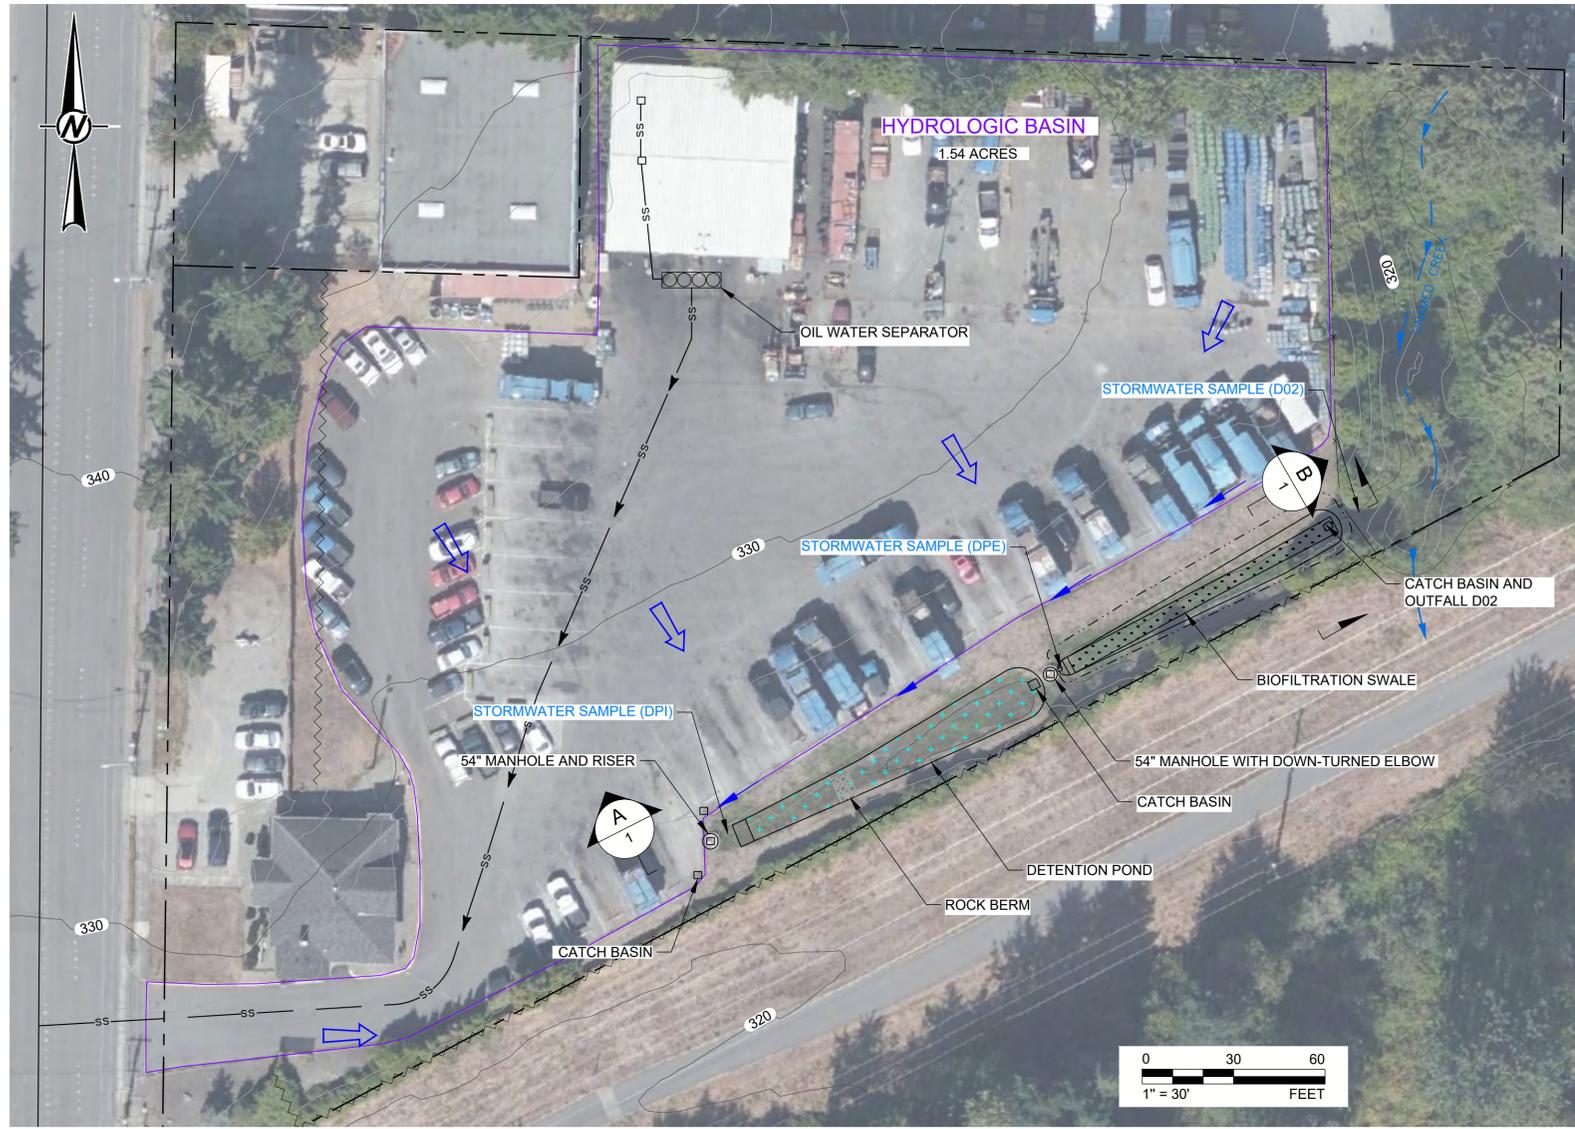
PROJECT NO. 20148751 PHASE 300 REV. A 1 of 2 SHEET 1

TITLE
EXISTING BMP PLAN

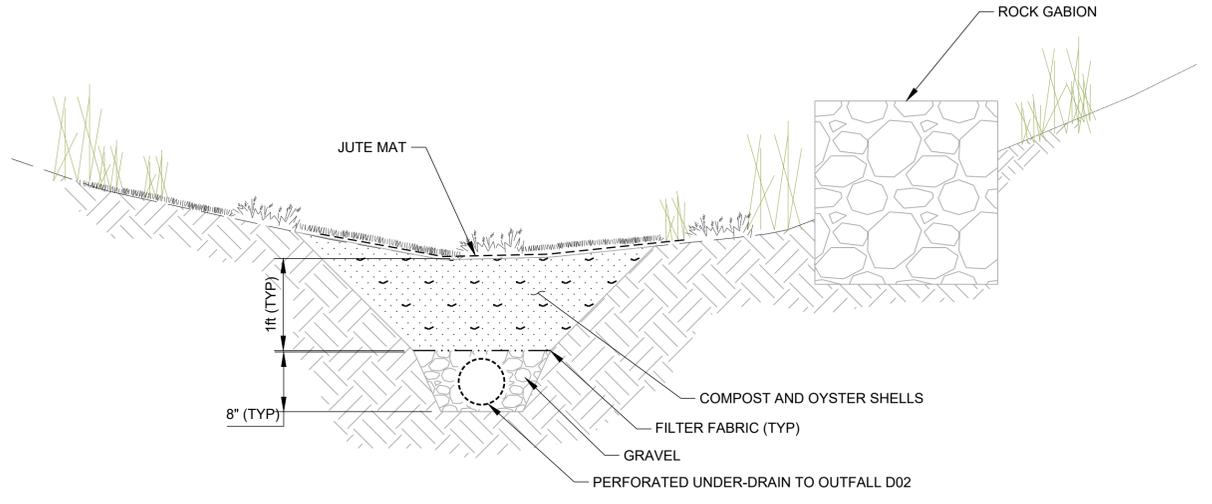
SCALE NTS **B** LYNNWOOD BIOFILTRATION SWALE (TYP)
VERT. SCALE 1:1

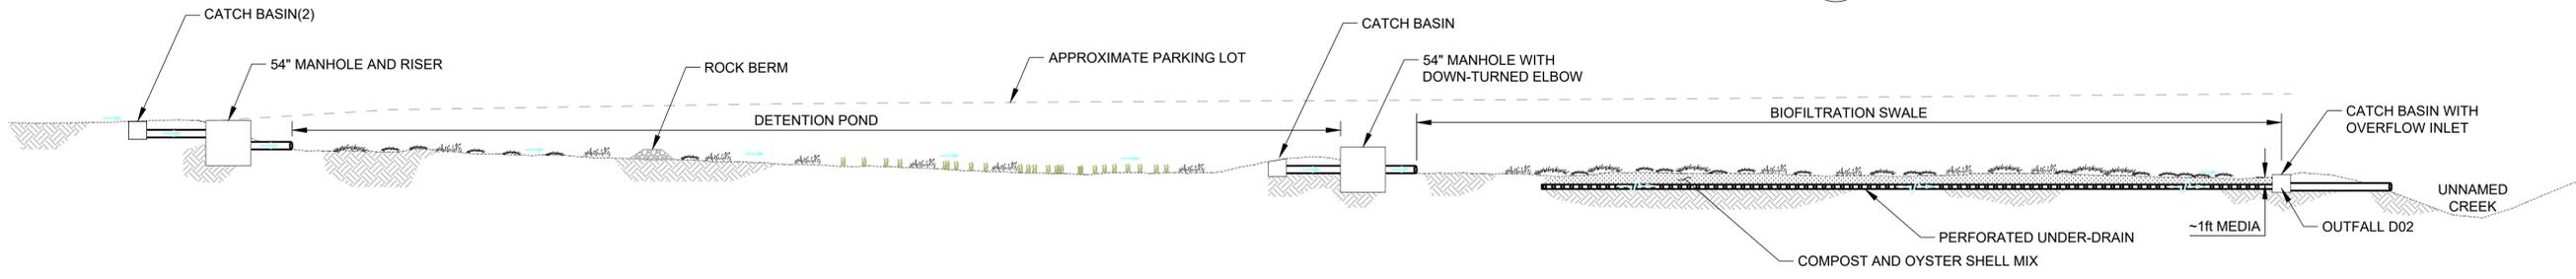
SCALE NTS **A** EXISTING BMP PROFILE
VERT. SCALE 1:1

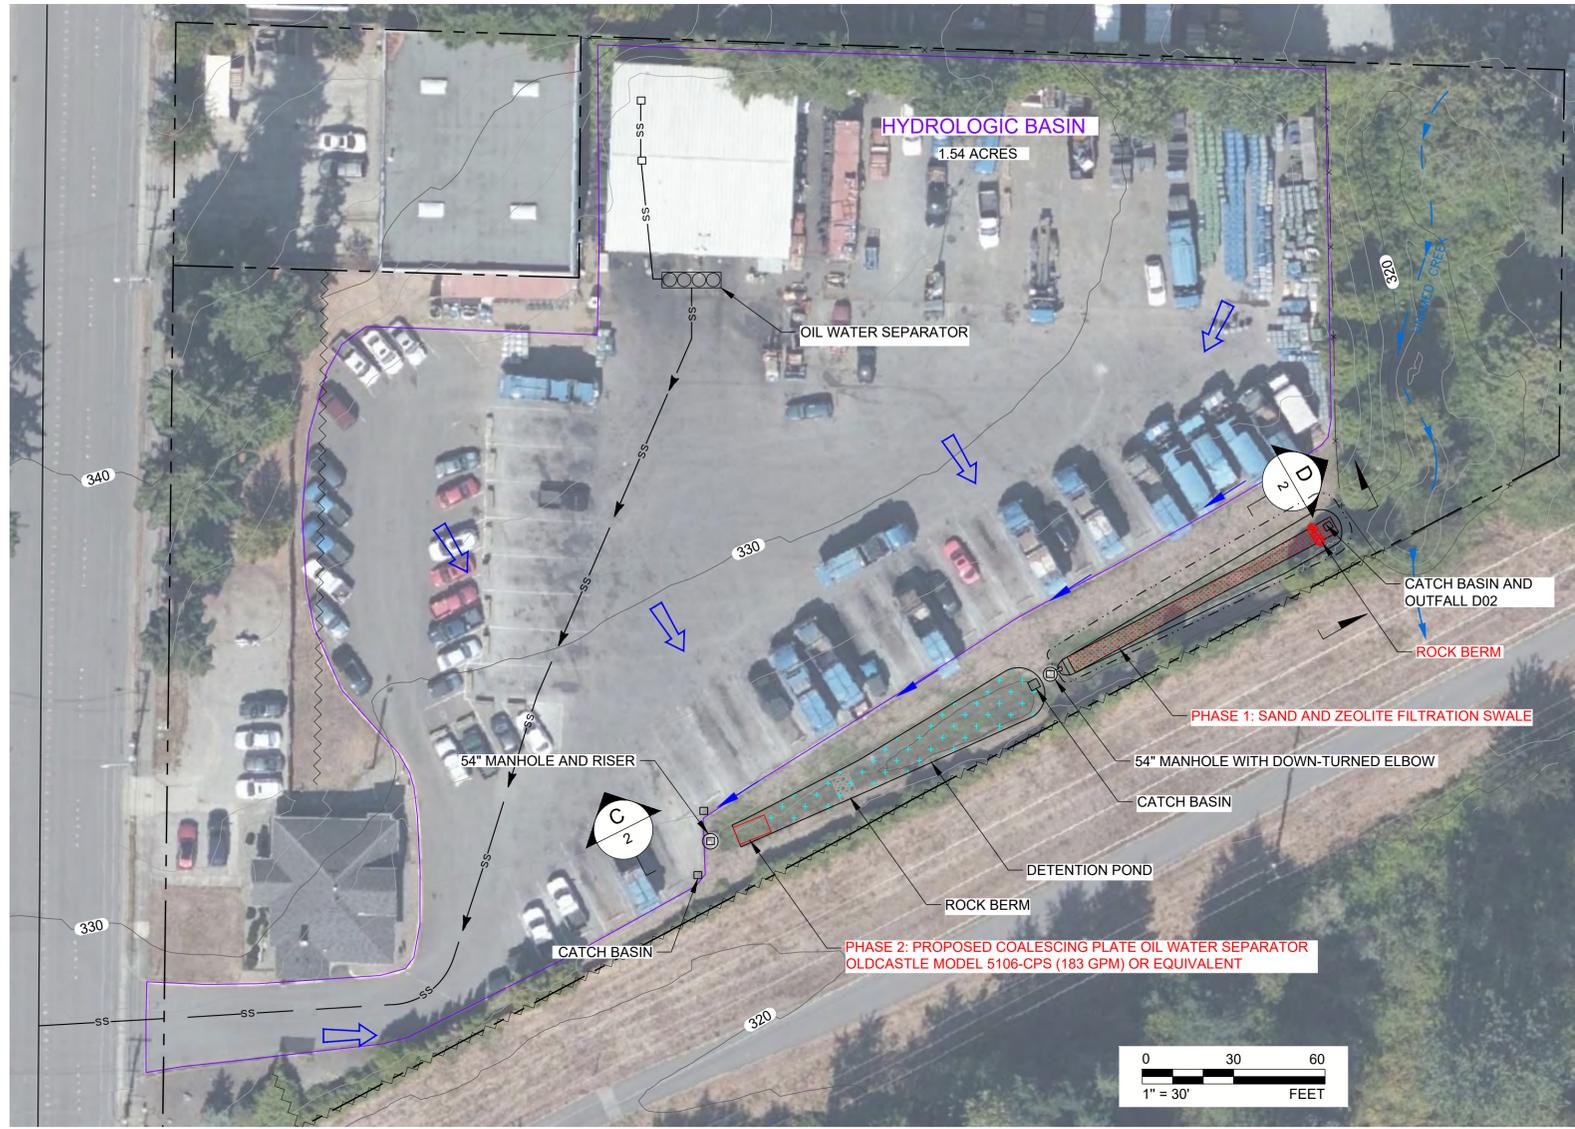
CLIENT	REPUBLIC SERVICES INC	500 ROOSEVELT GRADE ROAD	ROOSEVELT, WA 99356
CONSULTANT			
PROJECT	LYNNWOOD HAULING FACILITY CORRECTIVE ACTION		
TITLE	PROPOSED BMP PLAN		
PROJECT NO.	20148751	PHASE	300
REV.	A	2 of 2	SHEET 2
DESIGNED	JMM	PREPARED	REDMOND KWW SJS
REVIEWED	REDMOND KWW	APPROVED	SJS
DATE	2021-05-12	DESCRIPTION	CONCEPTUAL DESIGN

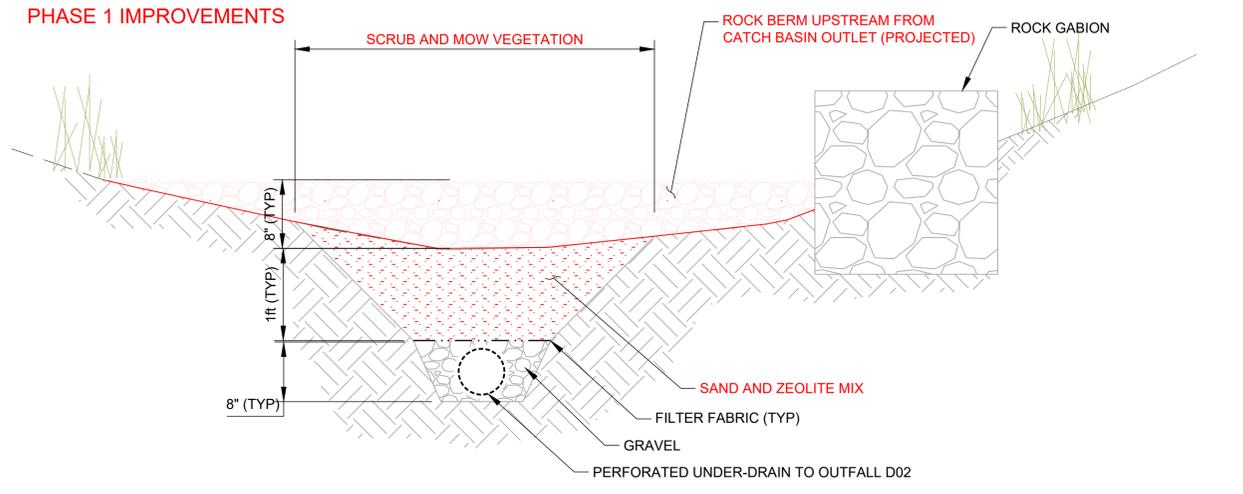
SCALE NTS: **D**
VERT. SCALE 1: **2**
PROPOSED BIOFILTRATION SWALE MODIFICATION

- **Replace the biofiltration swale oyster shell and compost media with a sand and zeolite mix for enhanced zinc and copper adsorption. Install a rock berm upstream the catch basin outlet to slightly increase the maximum water surface elevation in the filtration swale.**

A sand and zeolite media blend are recommended to provide filtration (sand) of particulate zinc and copper and adsorption (zeolite) of dissolved zinc and copper. The existing compost and oyster shell media would be removed and replaced with approximately 1-foot of sand and zeolite. In addition, an approximately 8"-12" rock berm (to be field fitted) would be installed just upstream the catch basin overflow to slightly increase the storage capacity of the modified biofiltration swale where stormwater would otherwise bypass the filter media through the overflow catch basin inlet. Golder has designed and constructed several projects for removal of total and dissolved zinc using sand/zeolite beds and has sourced a 7-14 mesh zeolite from IDA-ORE in Nampa, ID (Appendix F). The specific zeolite-to-sand ratio and specifications to be used in the present project will be determined using column tests as part of the engineering design and construction package. The spent sand zeolite media would be replaced using a vacuum truck or excavator and new media (shipped in large sacks) would be spread using an excavator

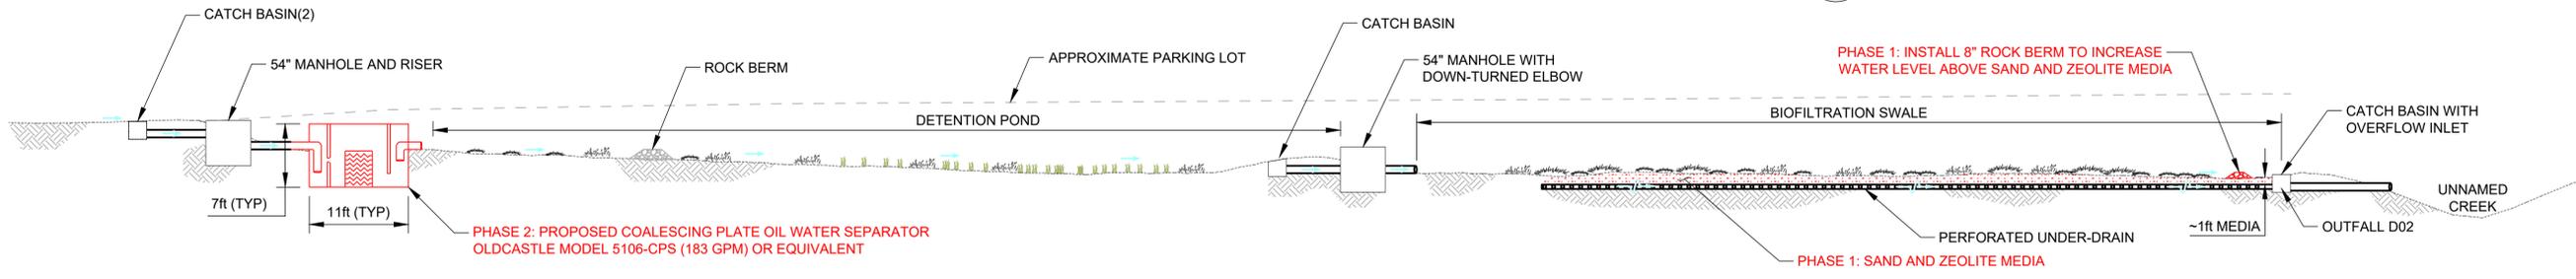
SCALE NTS: **C**
VERT. SCALE 1: **2**
PROPOSED BMP PROFILE

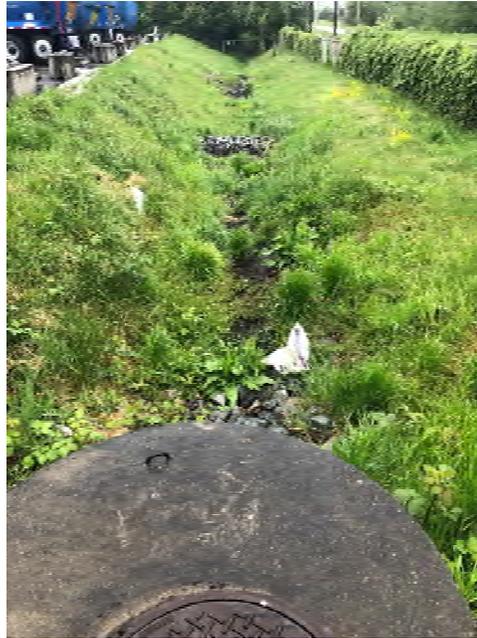
PHOTO 1

Photo from the most upstream side of the Lynwood Hauling Facility treatment BMP system.

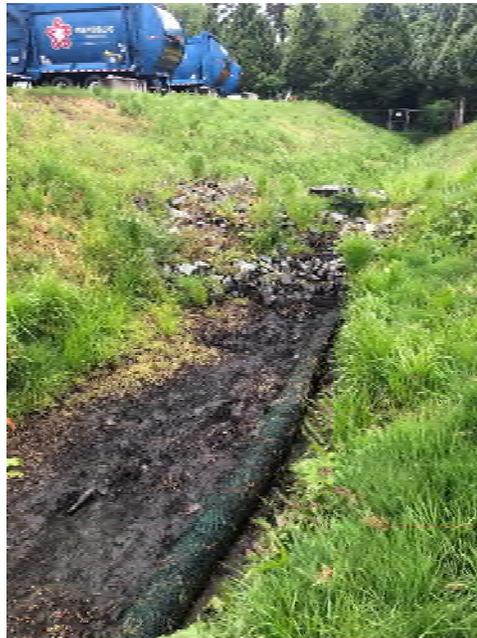
PHOTO 2

Photo of the detention pond with soil staining.

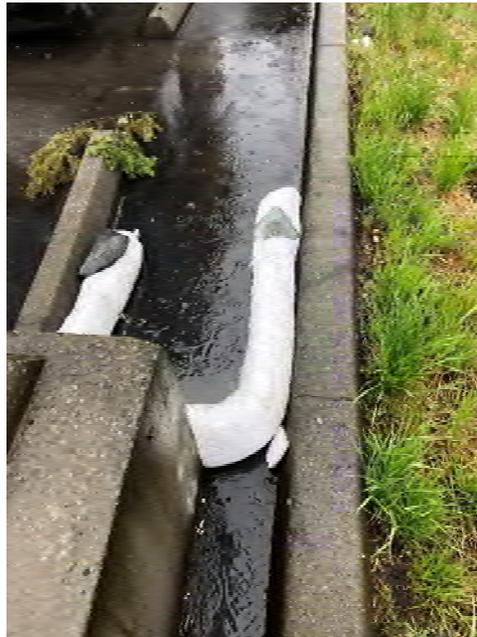
PHOTO 3

Absorbent booms intercepting stormwater runoff along the curb of the parking lot.

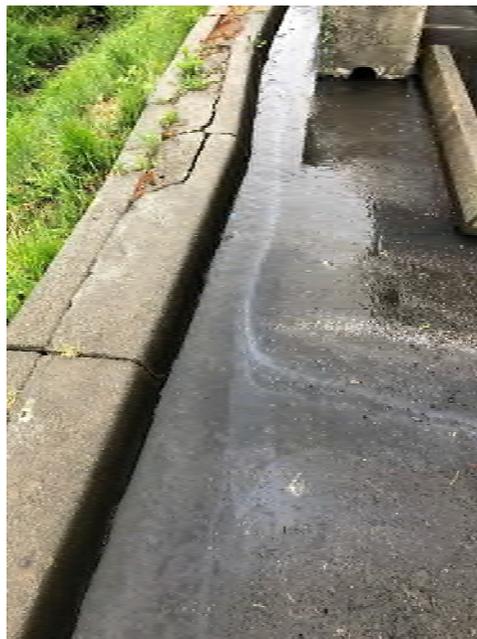
PHOTO 4

Photo showing stormwater runoff and oil sheen along the curb of the parking lot

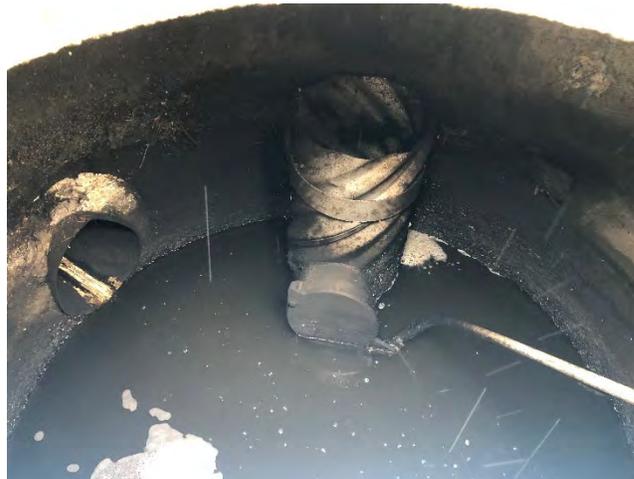
PHOTO 5

Photo of the inside of the 54" diameter manhole and flow control riser.

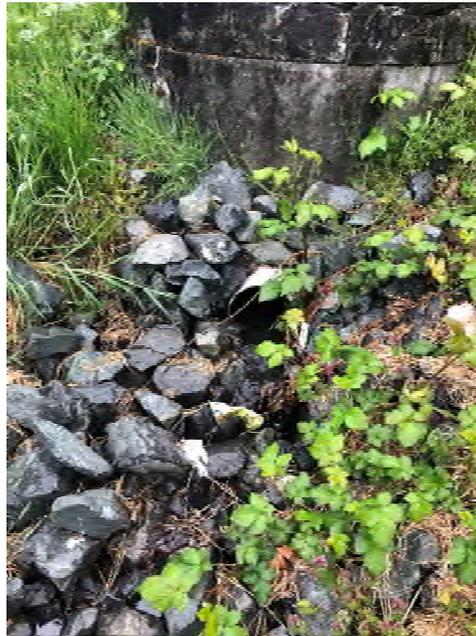
PHOTO 6

Stormwater discharge from the 54" diameter manhole to the detention pond (sample DPI).

- **Detention Pond Influent (DPI)** – a sample was collected from the 10" PVC pipe discharging from the 54" diameter manhole and flow-control structure into the detention pond BMP.
- **Detention Pond Effluent (DPE)** – a sample was collected from the 10" PVC pipe discharging from the 54" diameter manhole and down-turned elbow into the biofiltration swale BMP.
- **Outfall (D02)** – a sample was collected from the 10" PVC pipe discharging from the under-drain of the biofiltration swale through Outfall D02. Discharge through the outfall was a slight trickle from the under-drain and no stormwater was discharging through the bypass overflow.

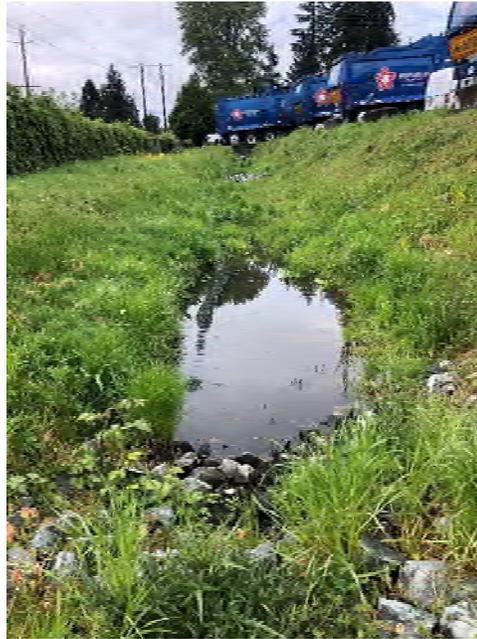
PHOTO 9

Photo of the detention pond as precipitation accumulates.

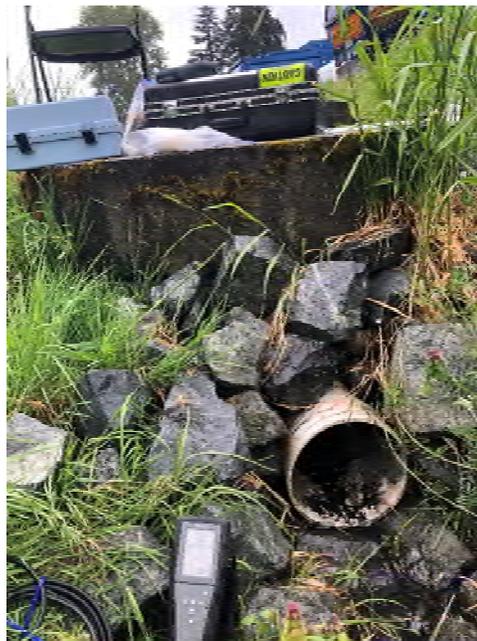
PHOTO 10

Stormwater discharge from the 54" diameter manhole and down-turned elbow to the biofiltration swale.

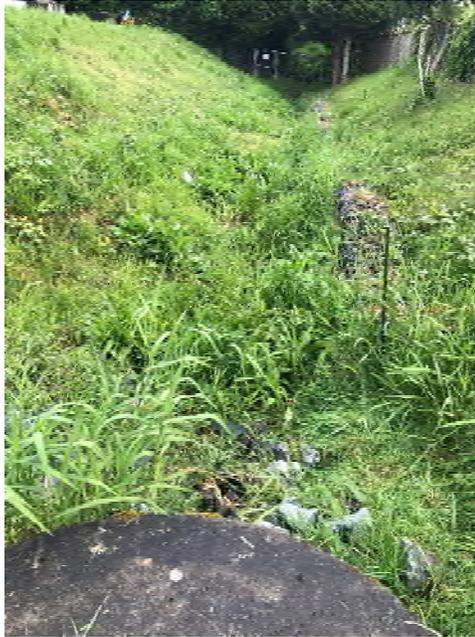
PHOTO 10

Photo of the biofiltration swale looking downstream.

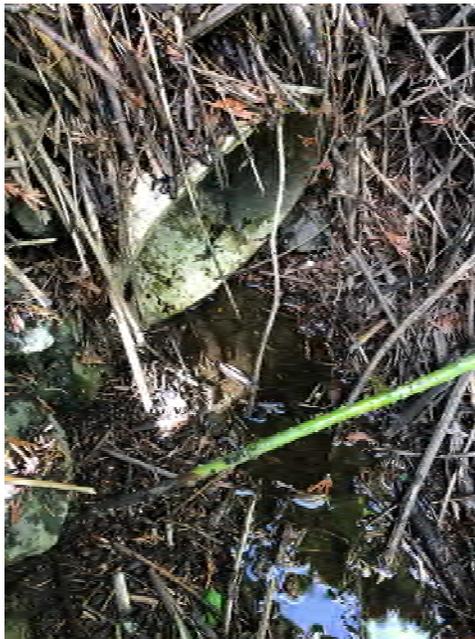
PHOTO 11

Photo of a slight discharge from Outfall D02. Stormwater was discharging to the outfall through the biofiltration swale underdrain, but no the bypass overflow.

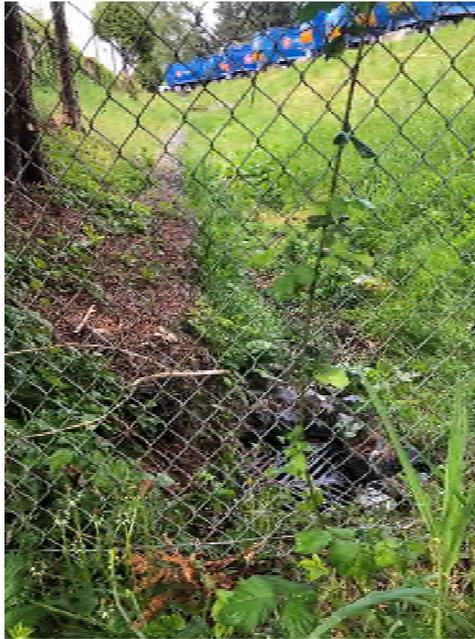
PHOTO 12

Photo of the catch basin outfall and overflow bypass looking upstream.

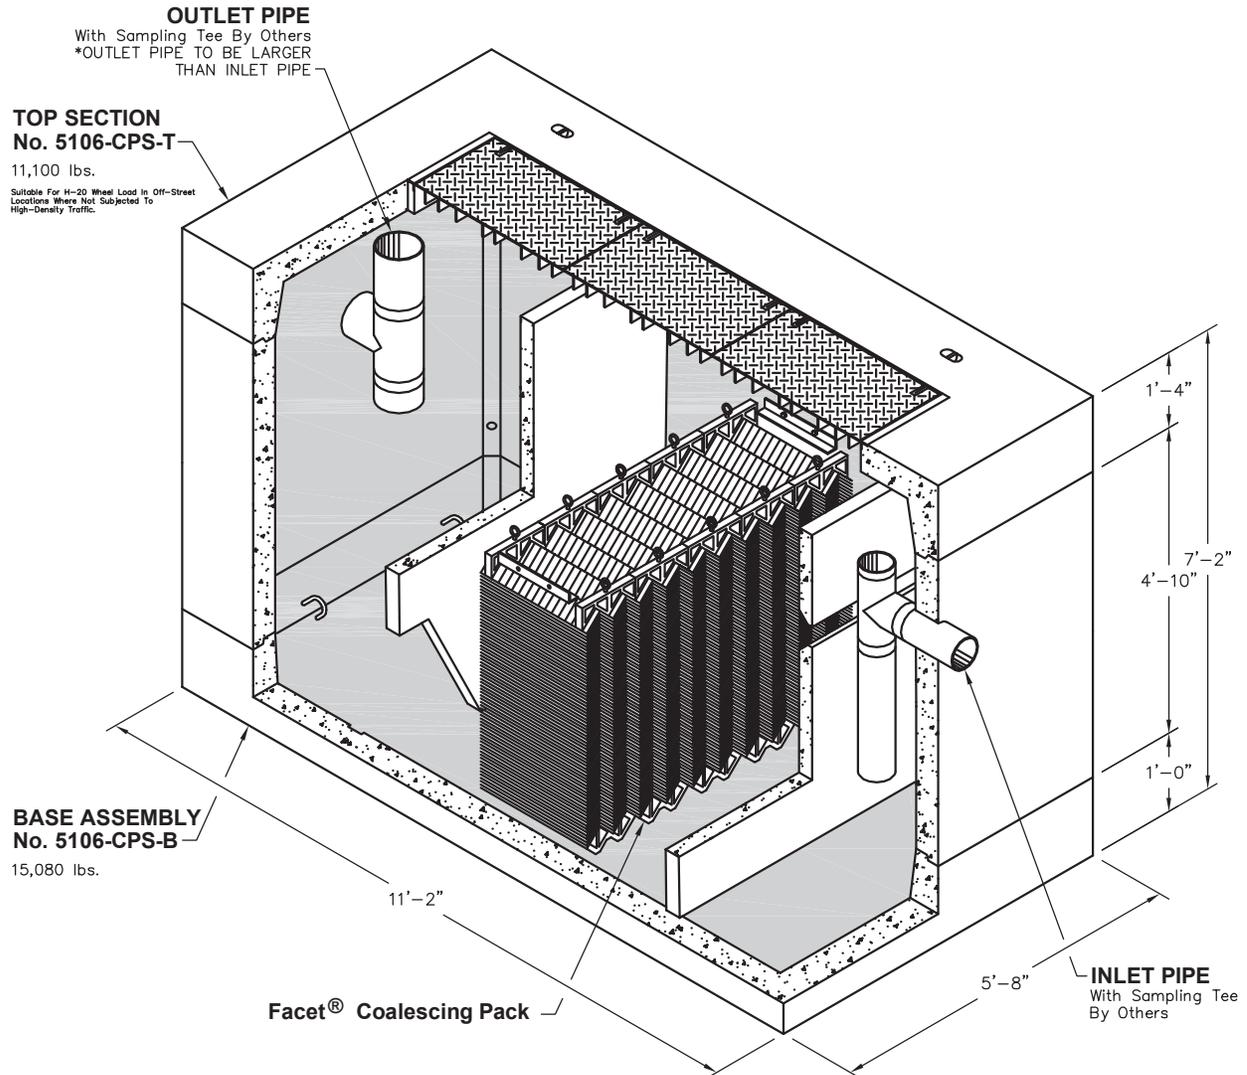
5106-CPS OIL WATER SEPARATOR

Project Plate Area = 740 Sq/ft
Maximum Process Flow = 690 GPM

A design flow rate of 188 gpm would require an Oldcastle 5106-CPS (183 GPM) or equivalent (Appendix F). If small amounts of metals in the oils escape the oil-water separator, the metals will be removed by the detention pond vegetation, and eventually the sand/zeolite filtration.

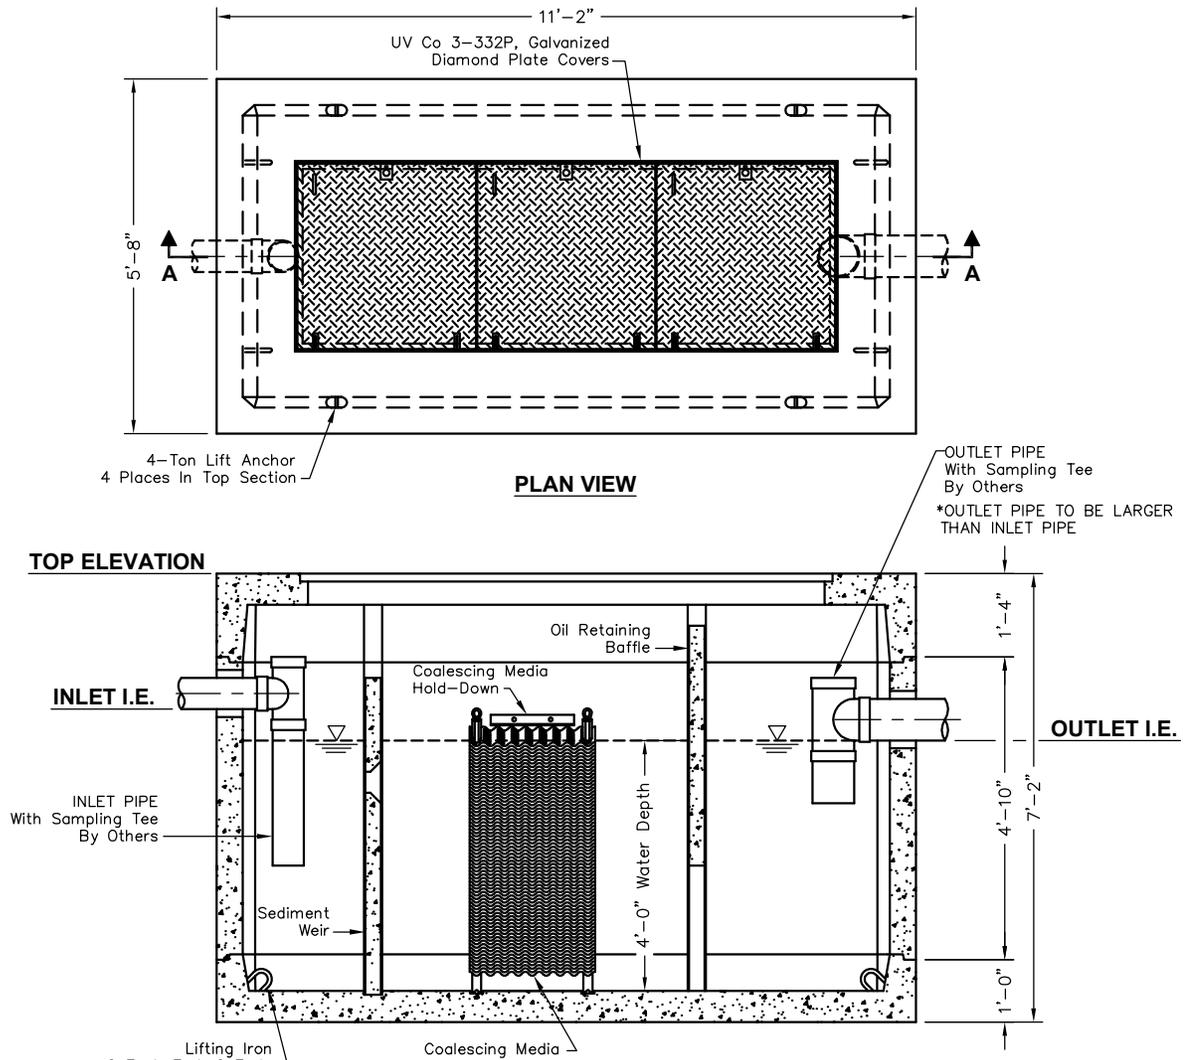
5106-CPS

Project Plate Area = 740 Sq/ft
Maximum Process Flow = 690 GPM

- STRUCTURAL NOTES:**
1. Concrete: 28 Day Compressive Strength $f'_c = 7000$ psi
 2. Rebar: ASTM A-615 Grade 60
 3. Mesh: ASTM A-185 Grade 65
 4. Design: ACI-318-05 Building Code
ASTM C-890 "Minimum Structural Design Loading For Underground Precast Concrete Water and Wastewater Structures"
 5. Loads: HS-20 Truck Wheel w/ 30% Impact Per AASHTO

- GENERAL NOTES:**
1. All Baffles and Weirs To Be Precast Concrete
 2. Static Water Depth = 4'-0"
 3. Contractor to:
Supply and Install All Piping & Sampling Tees
Grout In All Pipes
Fill With Clean Water Prior To "Start-Up" Of System
Verify All Blockout Sizes and Locations
