State of Washington Department of Ecology  
 Central Regional Office  
**PERMIT COMPLIANCE INSPECTION REPORT**

<b>Name and Location of Facility Inspected</b> Interstate Concrete & Asphalt dba Columbia ReadyMix Ellensburg Asph Plant 1071 Hwy 97 Ellensburg, WA 98926  East of 1-90 less than a mile northwest of Ellensburg	<b>Entry Time</b> 1:28 PM	<b>Permit Effective Date</b> 4/01/2021
	<b>Exit Time</b> 1:56 PM	<b>Permit Expiration Date</b> 3/31/2026
<b>Name(s) of On-Site Representative(s)/Title(s)/Contact Information</b> Garrett Sullivan/ Environmental Specialist/ (541) 520-8874	<b>Additional Participants:</b> Billy Demoss – Plant Operator Ken Dragoo – Plant Manager	
<b>Mailing Address of Responsible Official/Title/Contact Information</b> PO Box 3366 Spokane, WA 99220-3366	<b>Samples Taken?</b> <input type="checkbox"/> Yes <input checked="" type="checkbox"/> No	<b>Photos Taken?</b> <input checked="" type="checkbox"/> Yes <input type="checkbox"/> No

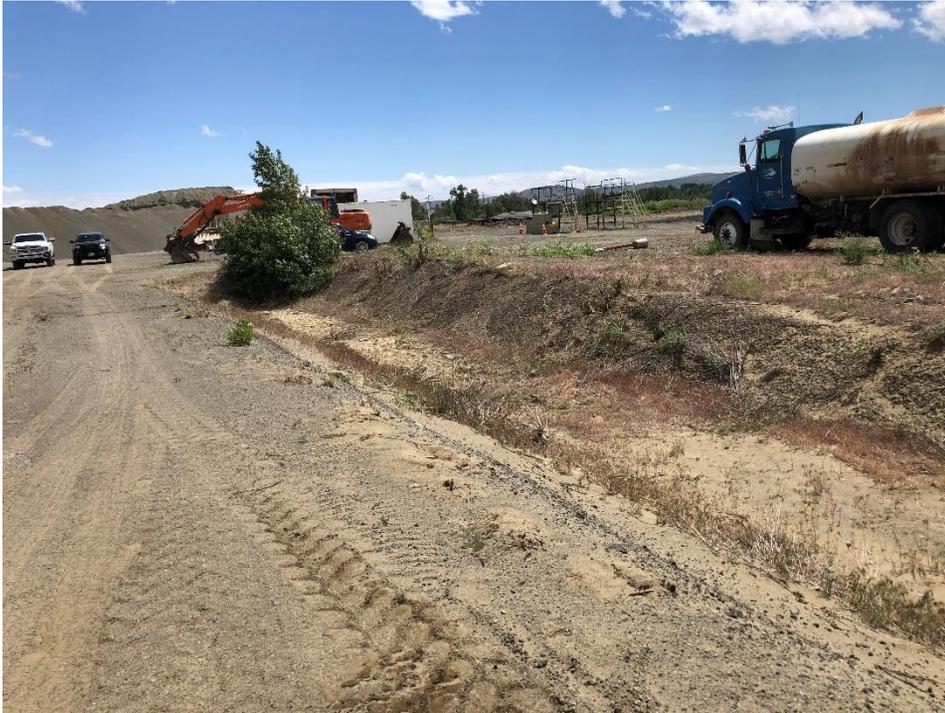
I arrived on site before Garrett. Billy Demoss, Plant Operator, and Ken Dragoo, Plant Manager, accompanied us on the inspection. The asphalt plant was not in operation during the inspection. Ken said they have not produced much asphalt this year. To the east of the asphalt plant, is a retention pond to contain stormwater, sampling point GSW2 (photo 1). North of the asphalt plant are the asphalt oil tanks and diesel fuel in secondary containment (photo 2). There is a spill kit located near the

Photo 1  
Stormwater containment

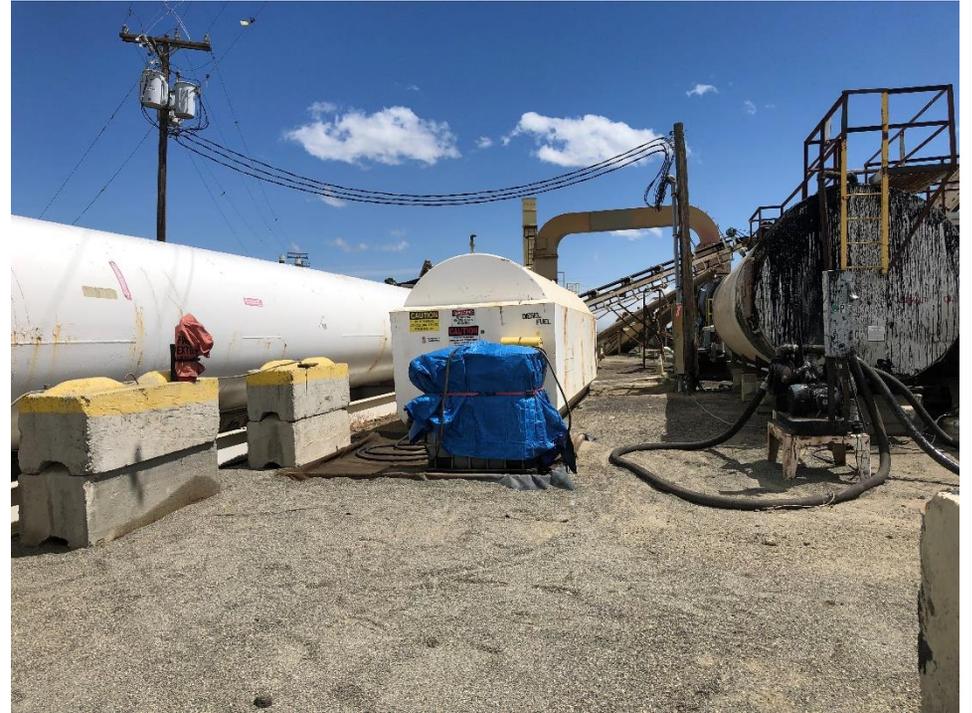
Photo 2  
Diesel fuel within secondary containment

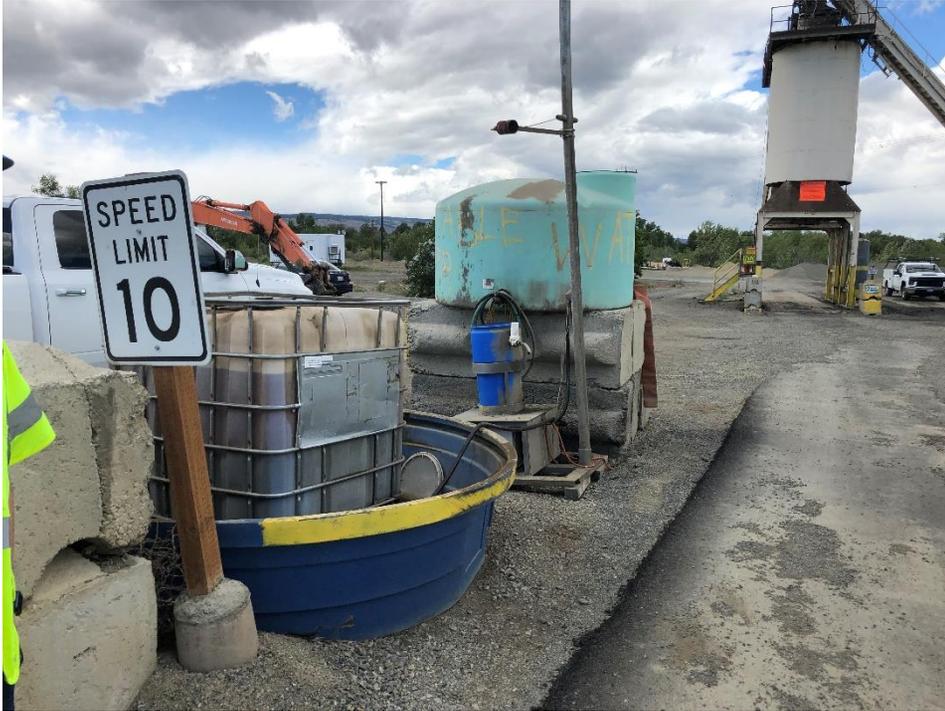
fuel tanks. There are some small stockpiles of recycled asphalt northeast of the tanks. Bed release agent is within secondary containment near a potable water tank (photo 3). Portable silos are at the south end of the site, they have not been used at this site yet (photo 4). Site conditions were dry.

Photo 3  
Bed release agent within secondary containment

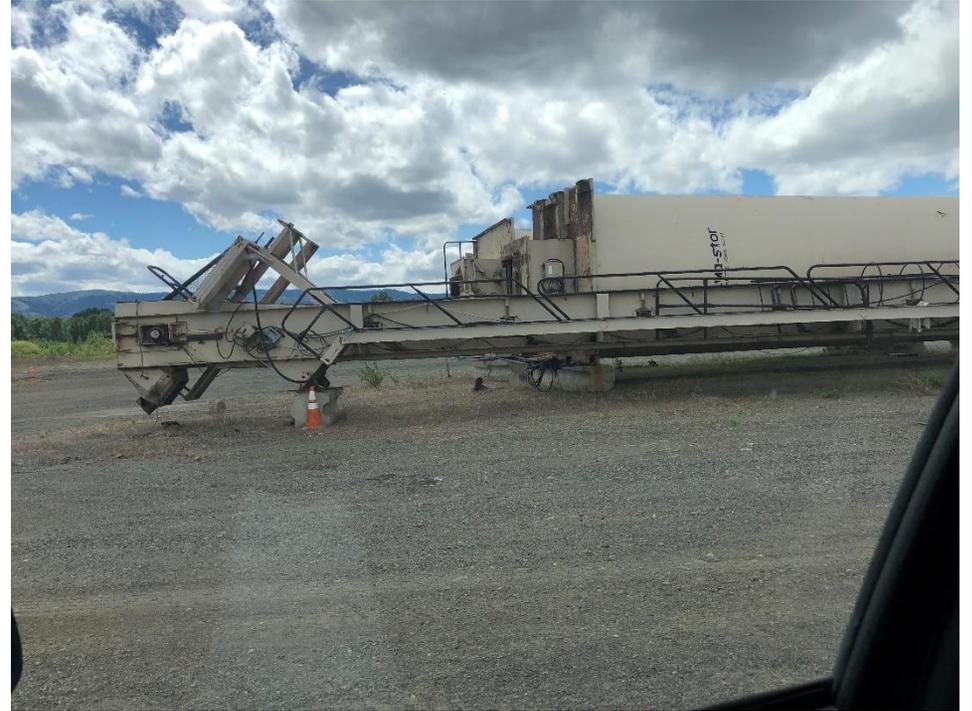
Photo 4  
Portable silo
