CONSTRUCTION STORMWATER GENERAL PERMIT INSPECTION REPORT

State of Washington Department of Ecology

The Goodwill Industries project is permitted for 2.5 acres of soil disturbing activities. The project consists of a new Goodwill Retail Facility and associated parking.

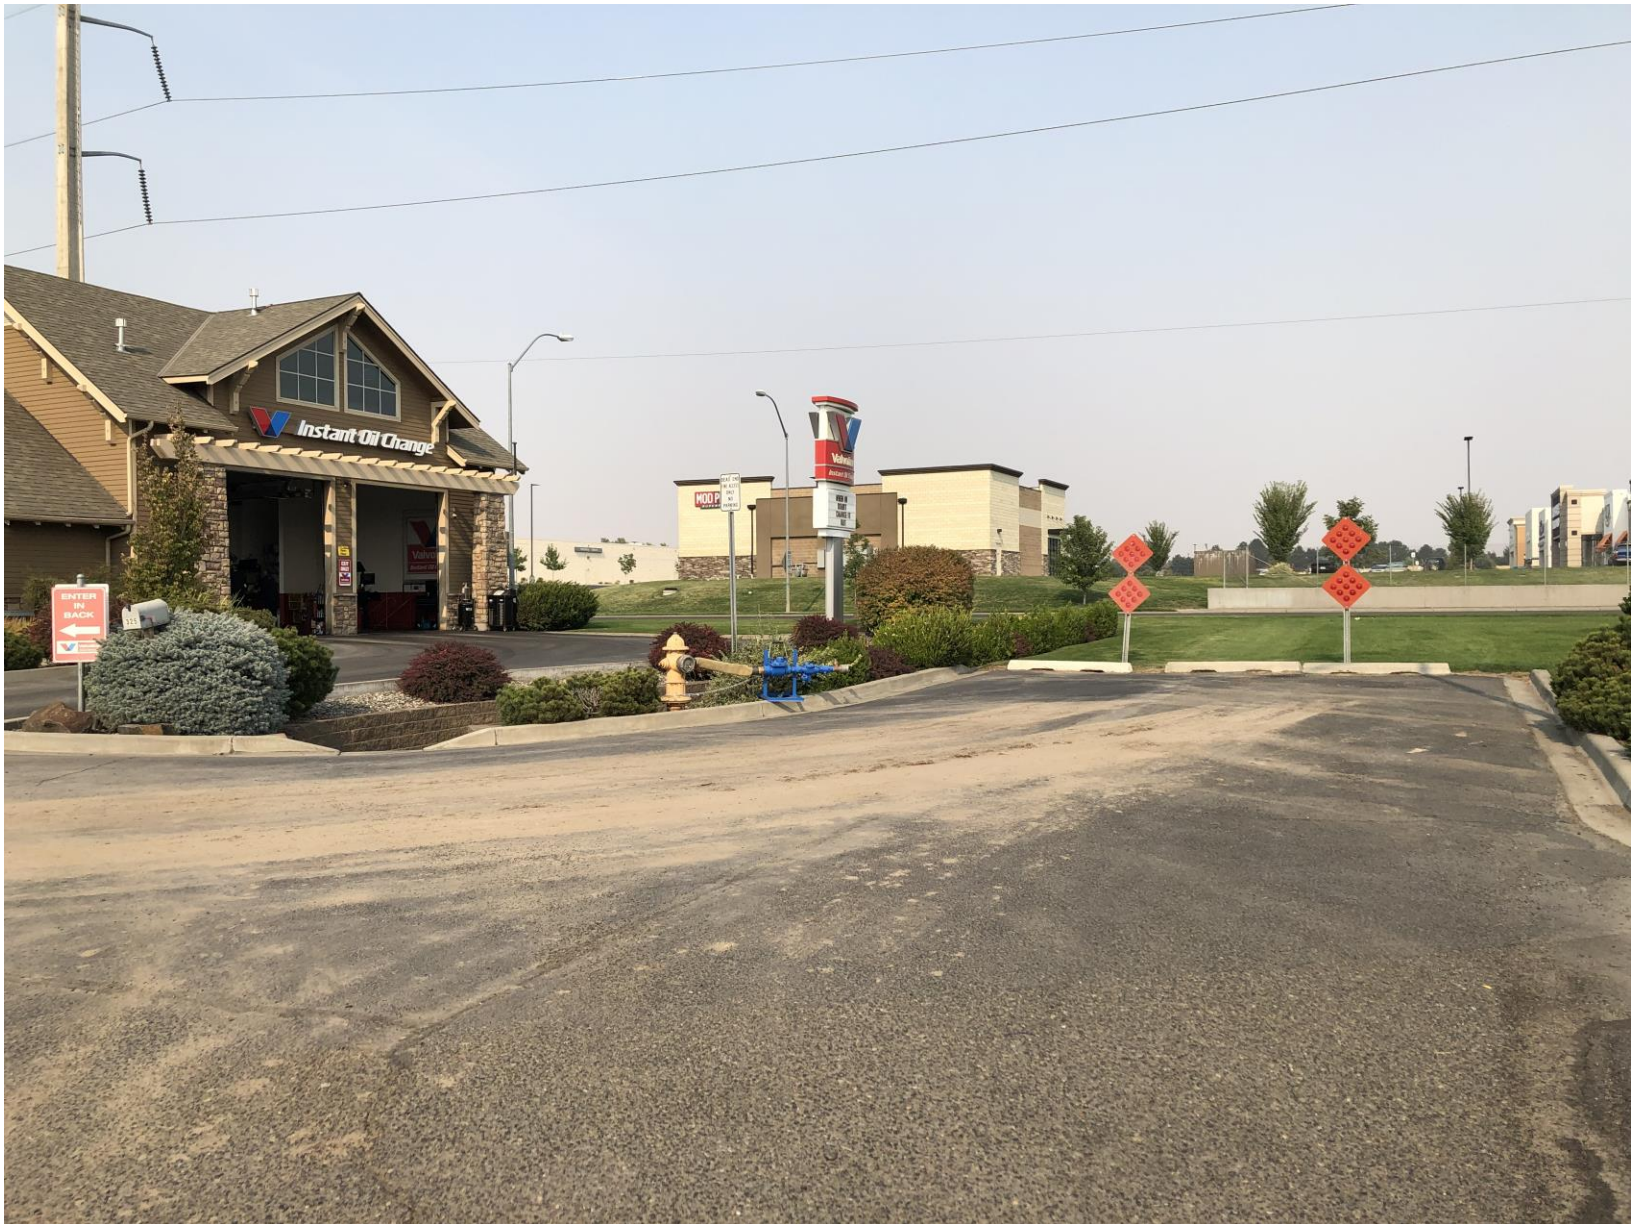
Photo 1

I then drove over to the road spur between Banner Bank, Valvoline Instant Oil Change, and the site. I saw there was a thick layer of sediment on this road that had been tracked off the Goodwill Industries site.

Photo Description: Sediment tracked off site and left on roadway.

<u>Violations and action required to achieve compliance</u>	<u>Complete or submit date</u>	<u>Guidance</u>
<u>S9.C.1 Stormwater Best Management Practices (BMPs)</u> Failure to meet S9.C1: BMPs must be consistent with the Stormwater Management Manual for Eastern Washington.	Immediately begin. Address the problems no later than 10 days from the receipt of this inspection report.	Ecology's SWMMEW, Chapter 7 BMP Standards and Specifications
<u>S9.D.2 Establish Construction Access</u> Failure to meet S9.D.2.a: Limit construction vehicle access and exit to one route, if possible., Failure to meet S9.D.2.d: If sediment is tracked off site, clean the affected roadway thoroughly at the end of each day, or more frequently as necessary (for example, during wet weather). Remove sediment from roads by shoveling, sweeping, or pickup and transport of the sediment to a controlled sediment disposal area., Failure to meet S9.D.2.e: Conduct street washing only after sediment removal in accordance with Special Condition S9.D.2.d. Install and maintain adequate construction access to prevent track-out off-site.	Clean the affected roadway thoroughly at the end of each day , or more frequently as necessary . Immediately begin. Address the problems no later than 10 days from the receipt of this inspection report.	BMP C105E, BMP C106E, BMP C107E

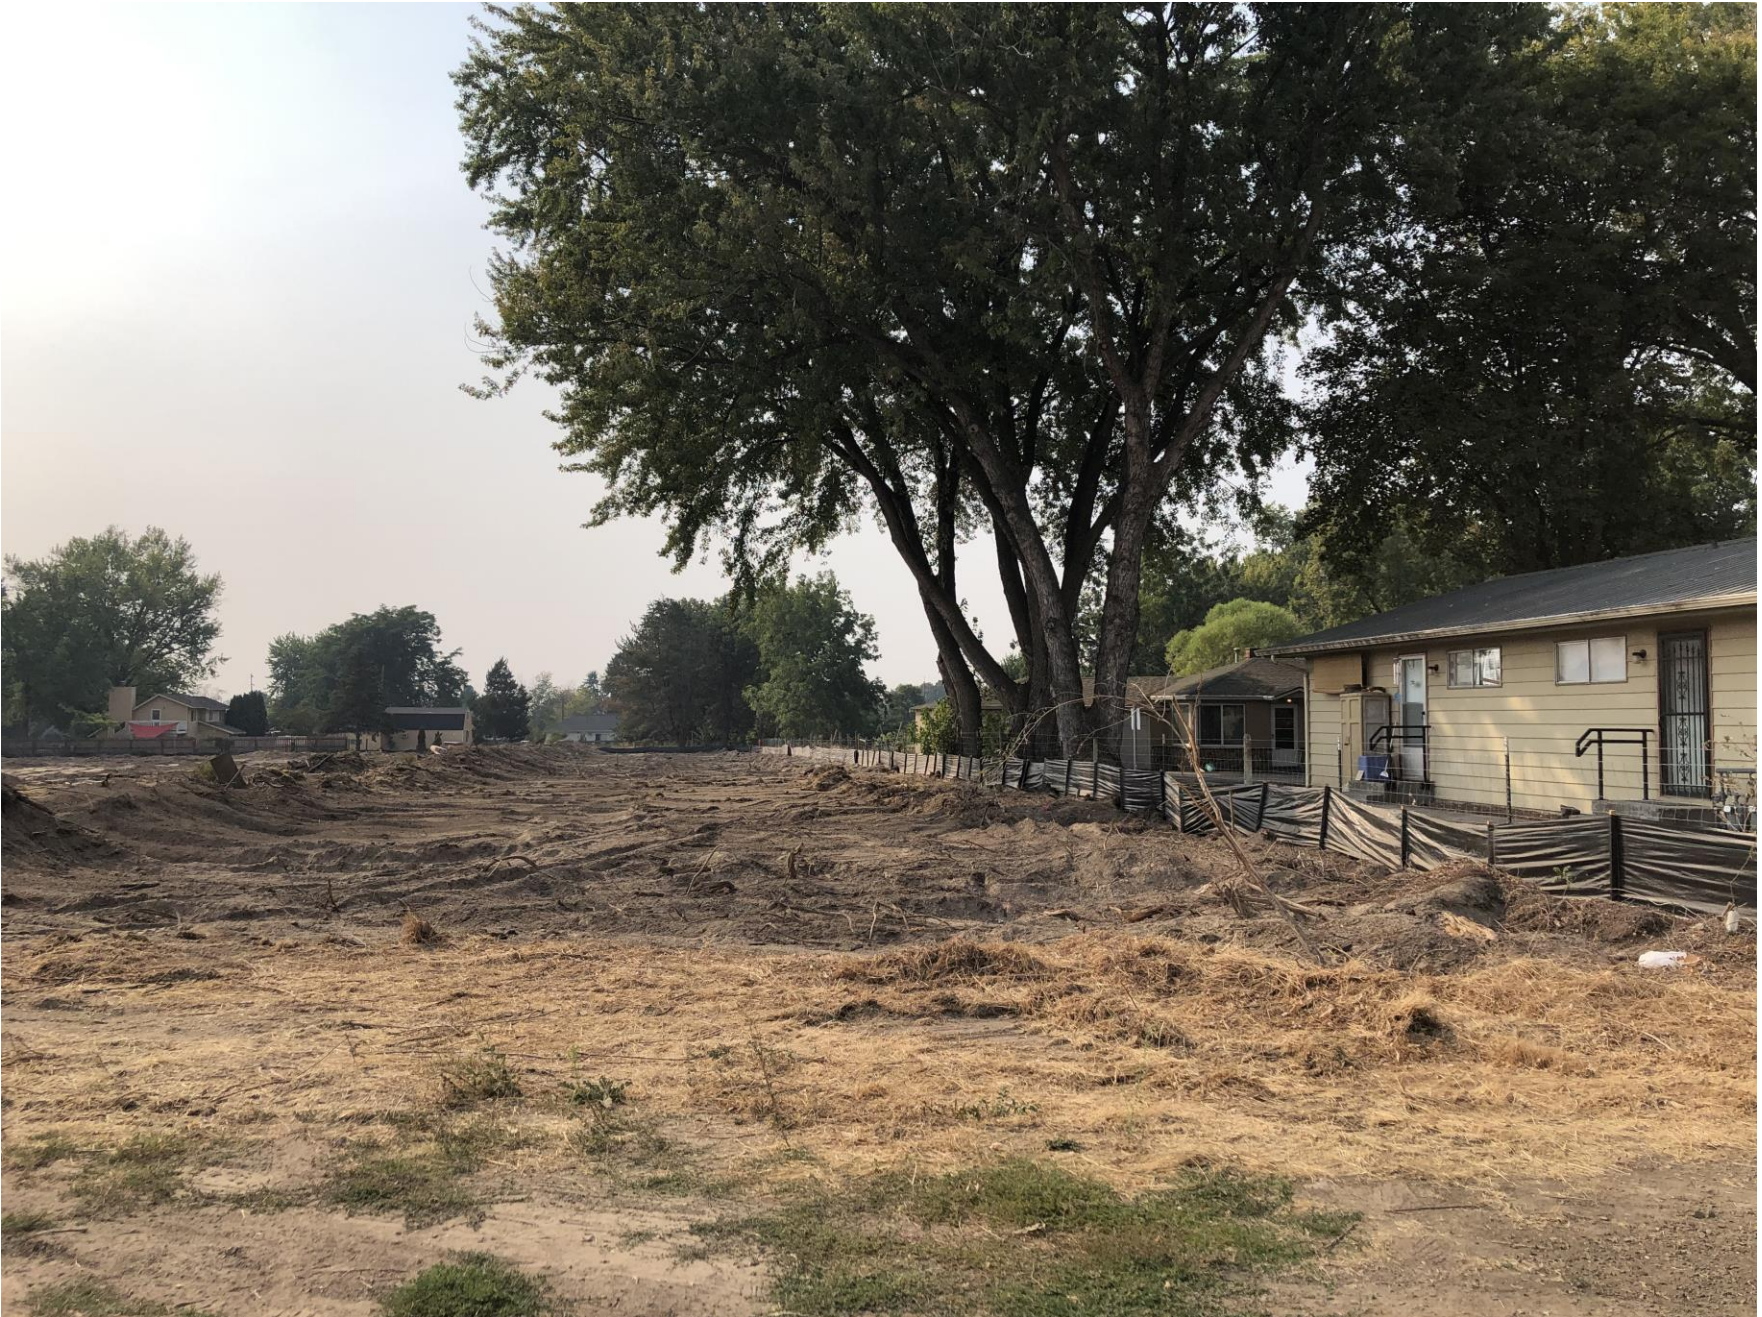
Photo 2

I then drove through the site. I saw the silt fence installed throughout the site was not properly installed. The silt fence was not buried in the ground. Soil had been placed on the interior of the silt fence and no soil was placed on the other side of the silt fence. Soil was leaving the site under the silt fence, and moving onto the sidewalk. The silt fence installation is not consistent with BMP C233E: Silt fence. Information on properly installing a silt fence is provided as an attachment.

Photo Description: Earthwork activities and silt fence improperly installed properly.

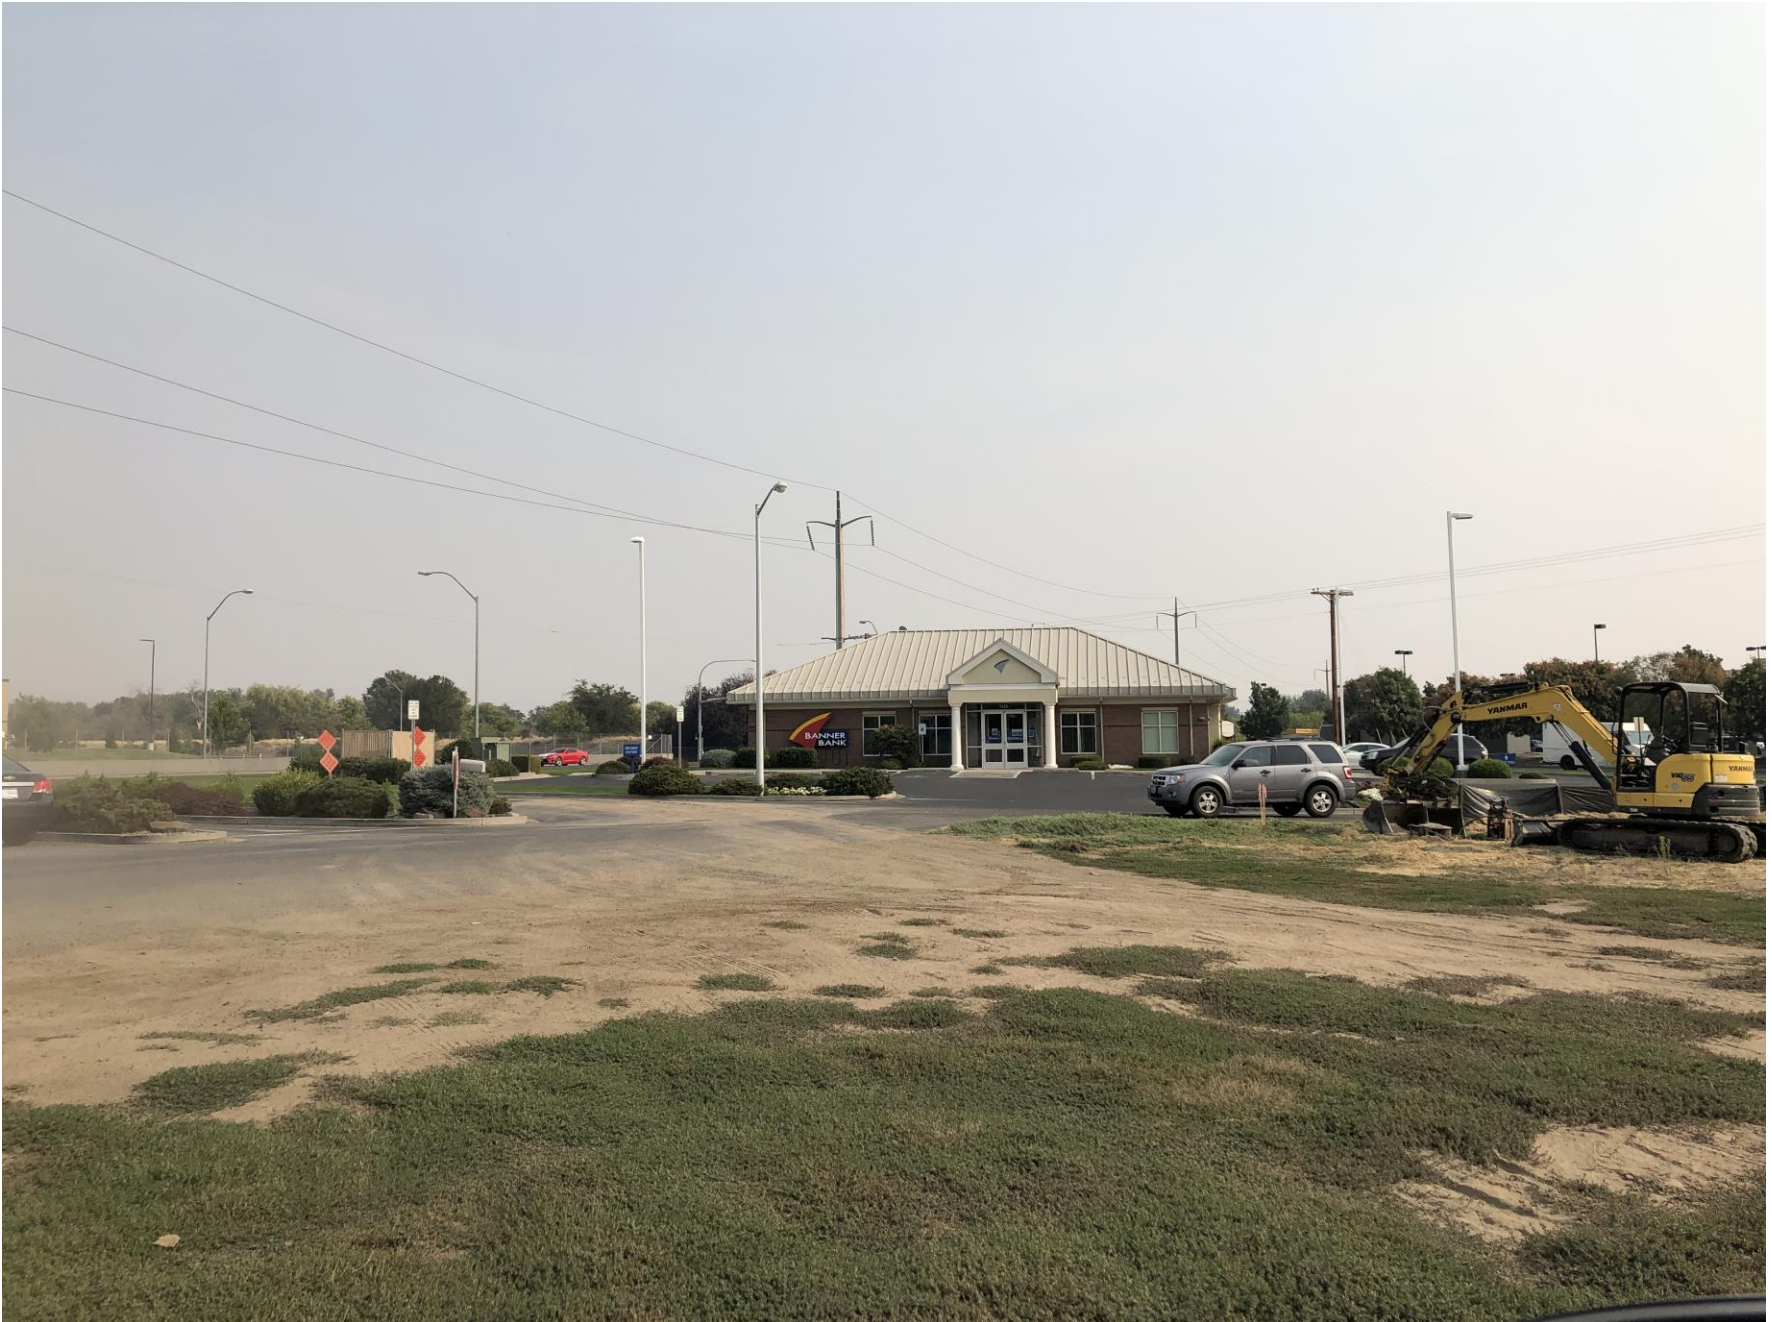
Photo 3

Photo Description: Soil tracked off site and left on roadway.

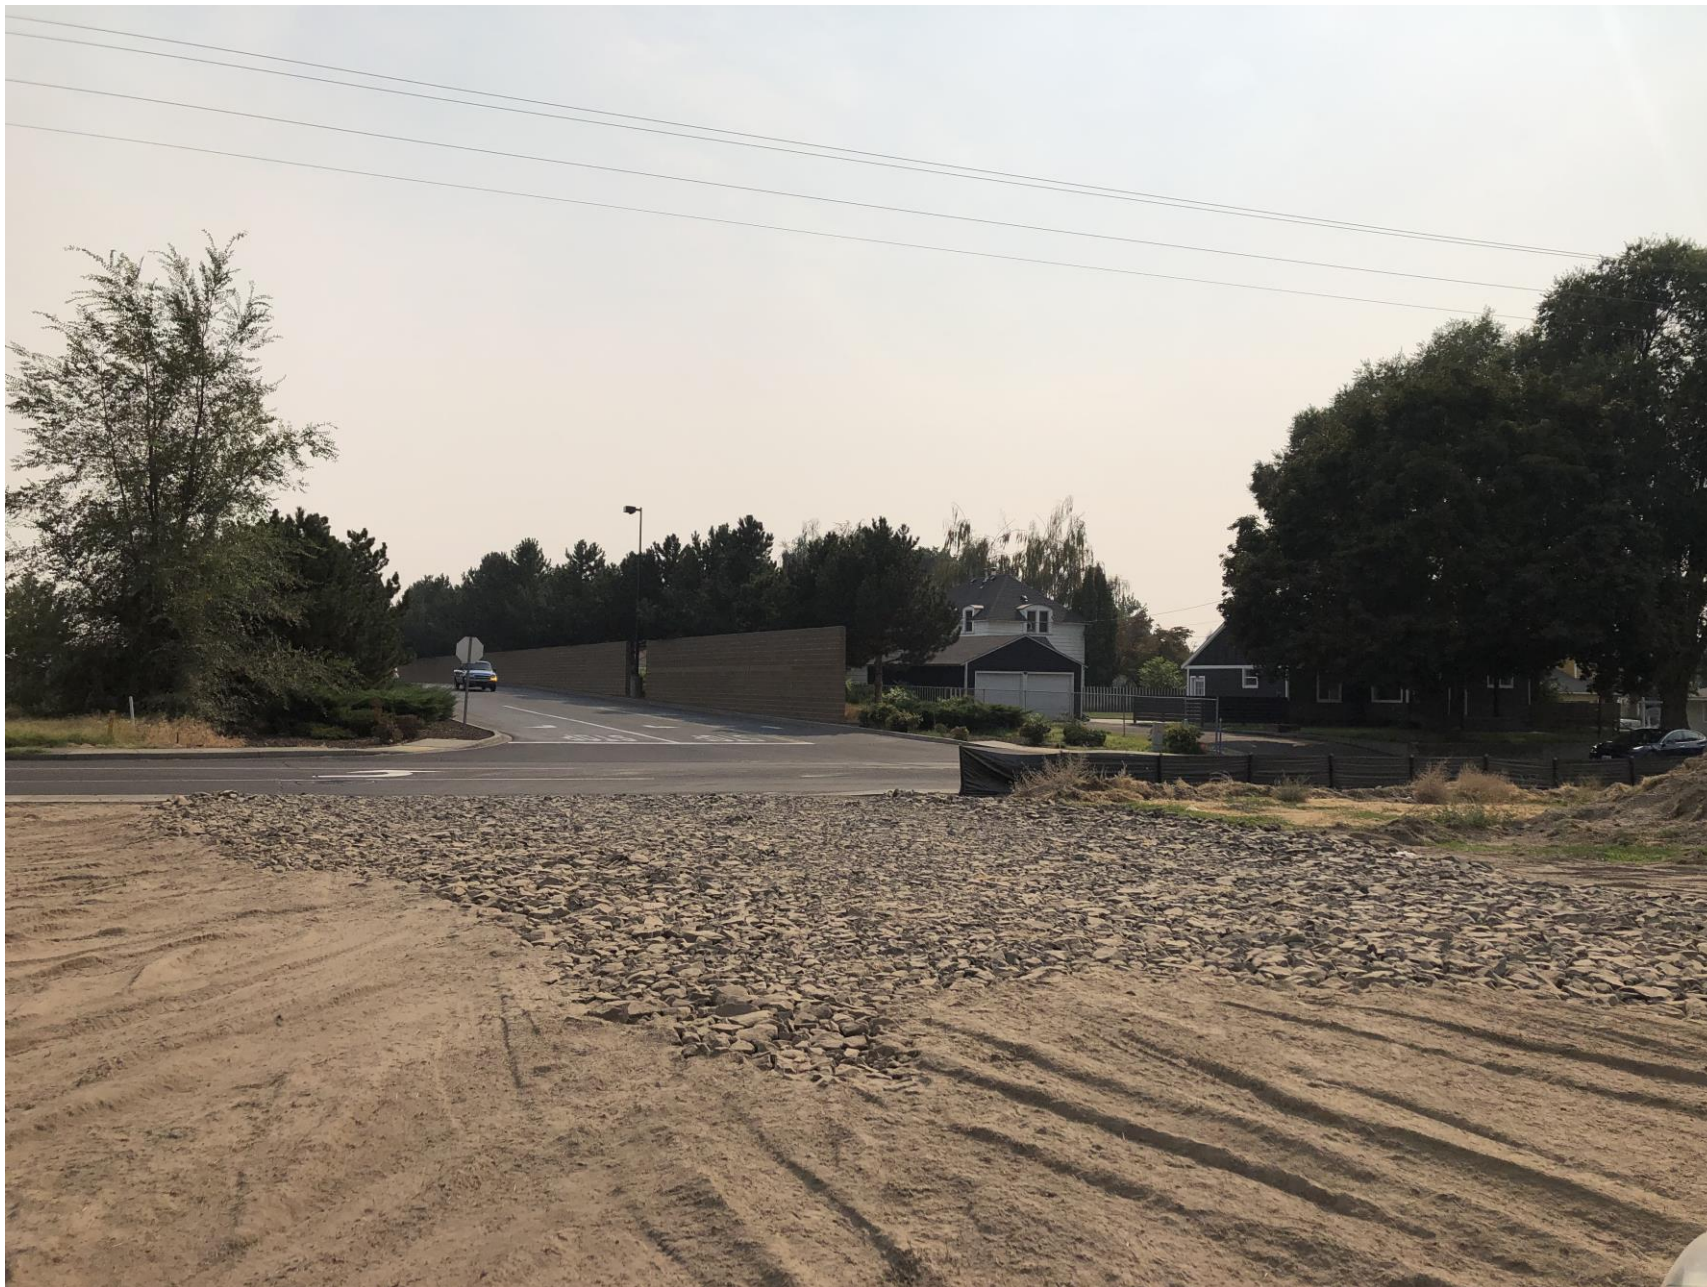
Photo 4

The site soil had a consistency of powder and is easily suspended if disturbed. Fugitive dust may be an ongoing issue at this site while equipment is moving.

The site access off Northeast C Street consisted of quarry spalls. I saw light track out on Northeast C Street.

Photo Description: Powdery site soil and quarry rock site entrance.

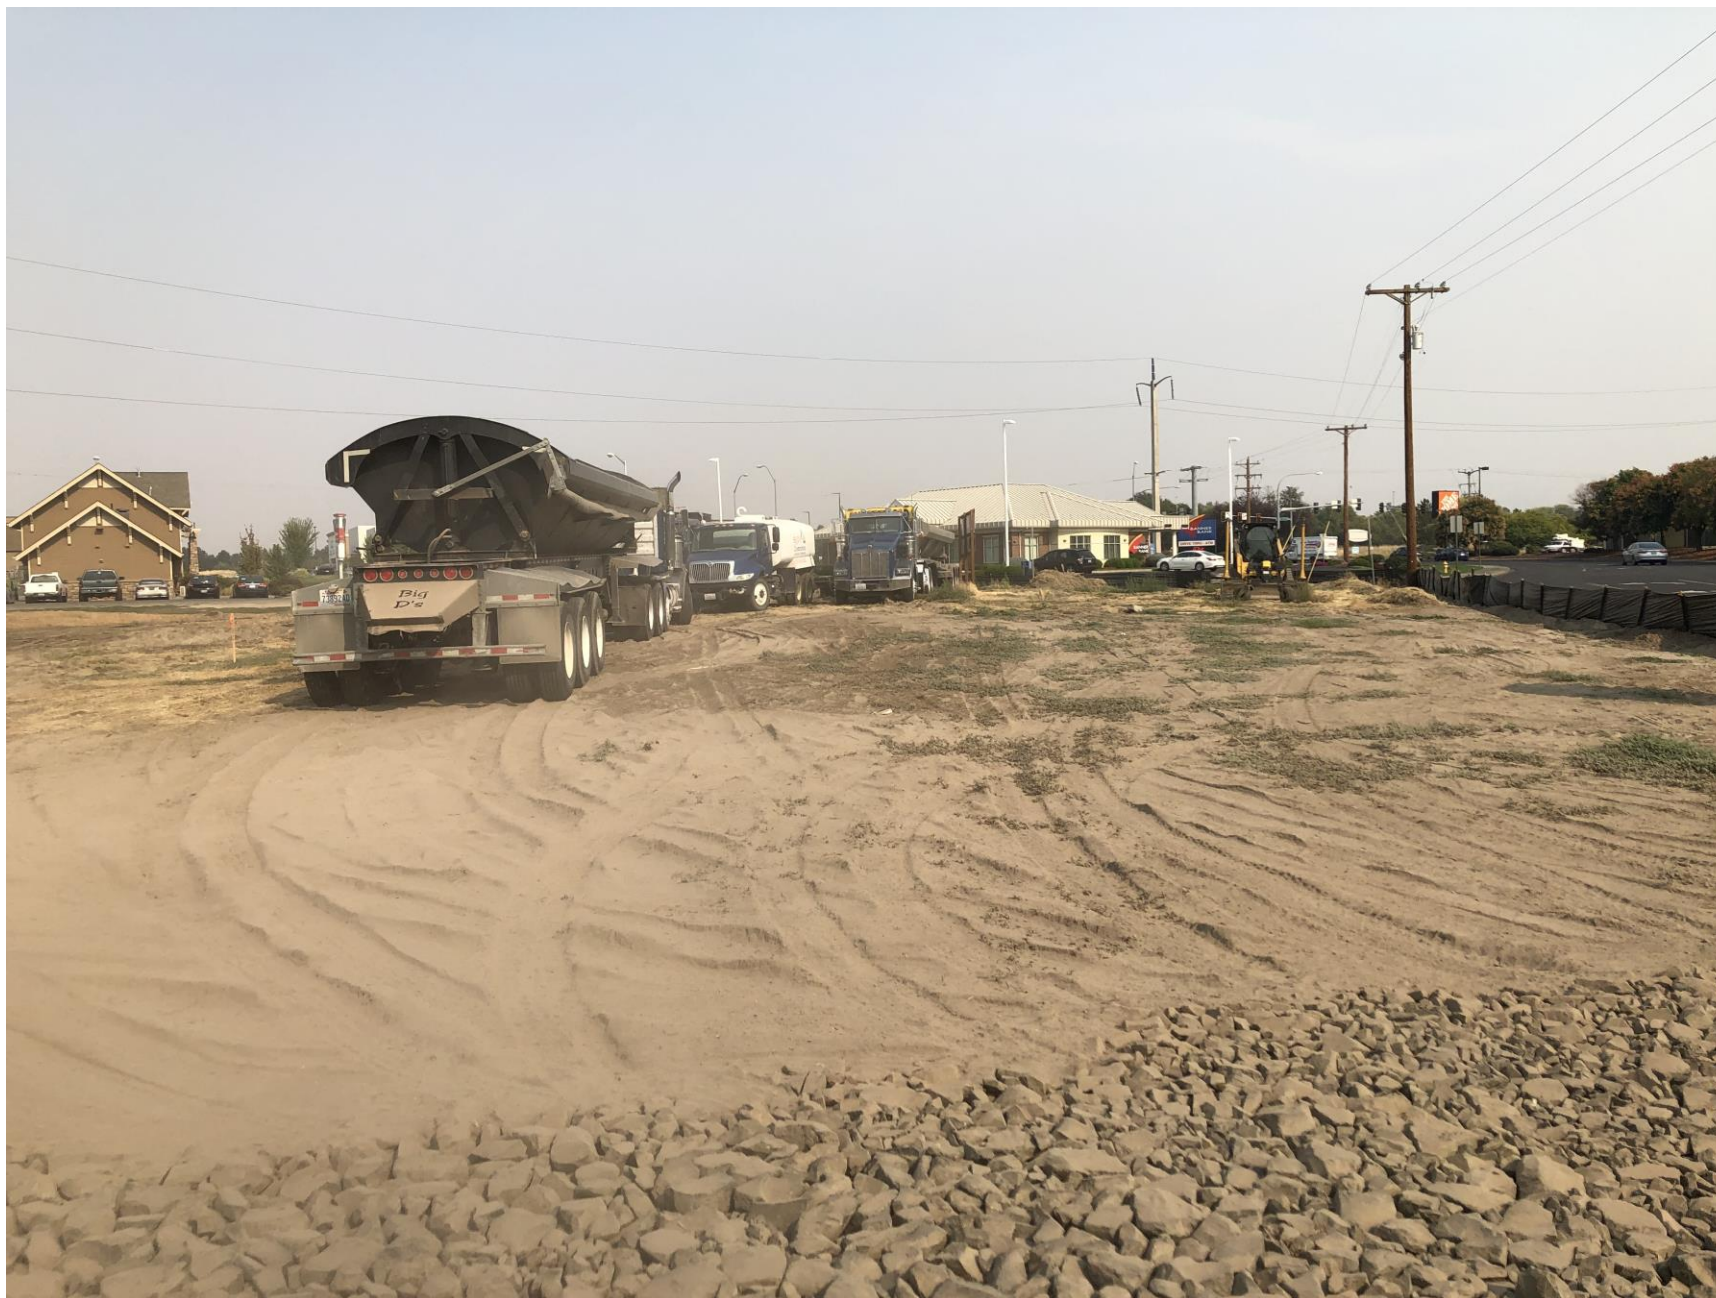
Photo 5

Photo Description: Quarry rock site entrance. Sediment on the quarry rock. Powdery site soil.

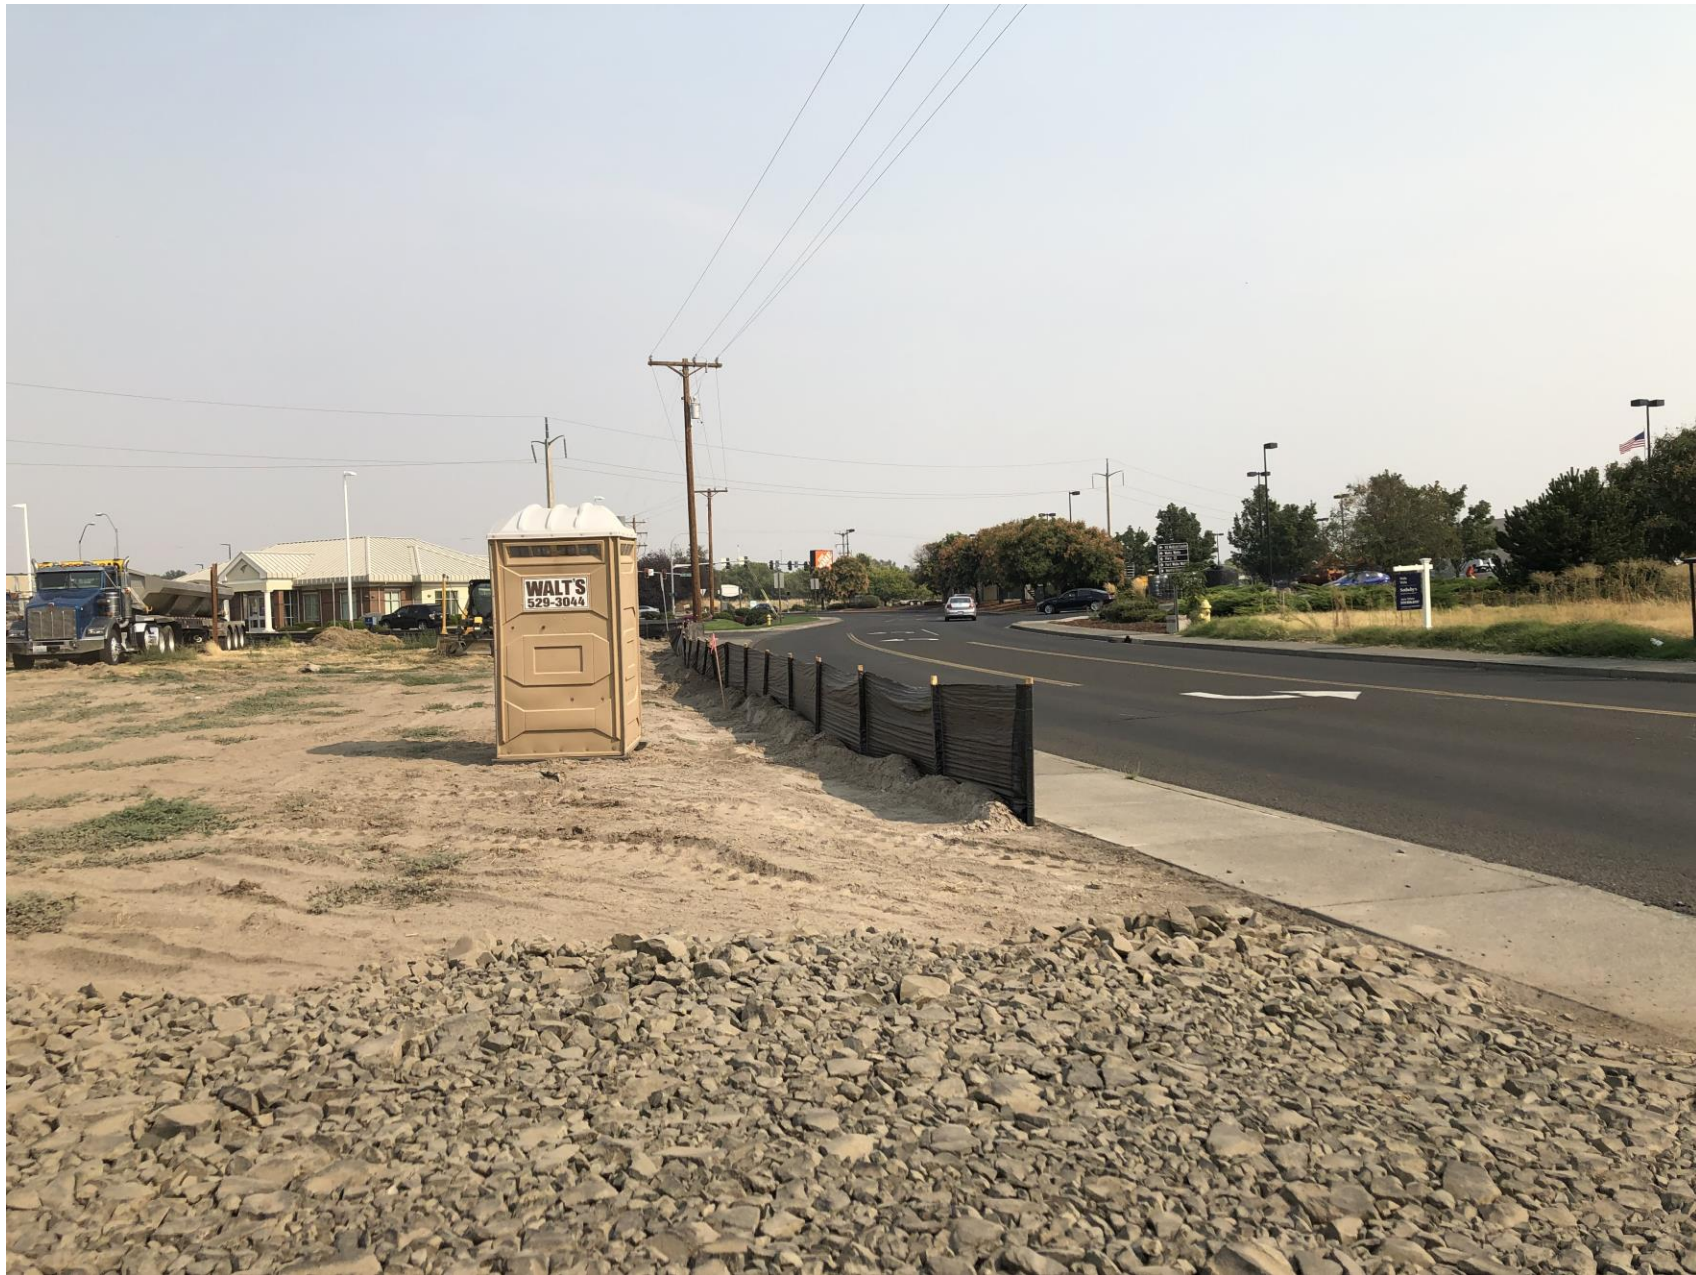
Photo 6

Photo Description: Sediment placed against the silt fence.

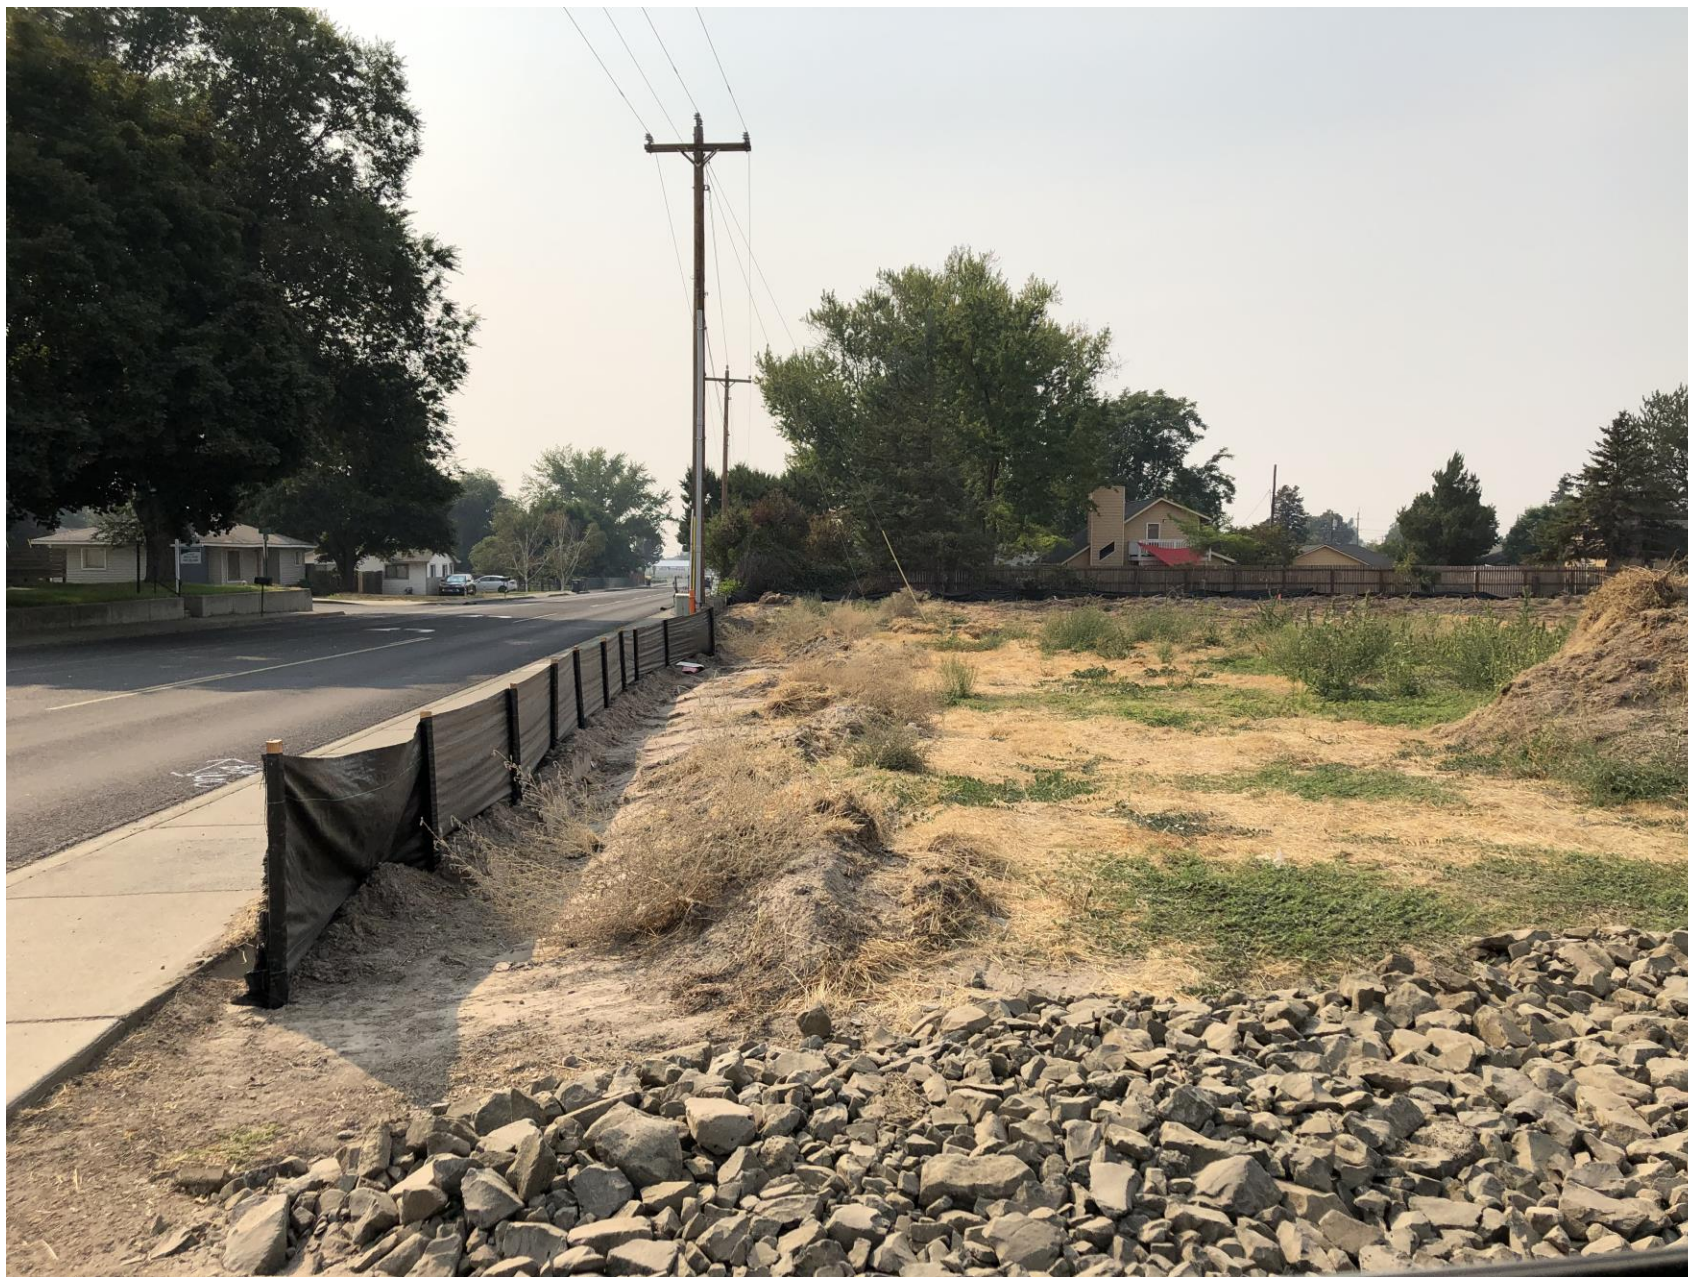
Photo 7

Photo Description: Sediment placed against the silt fence.

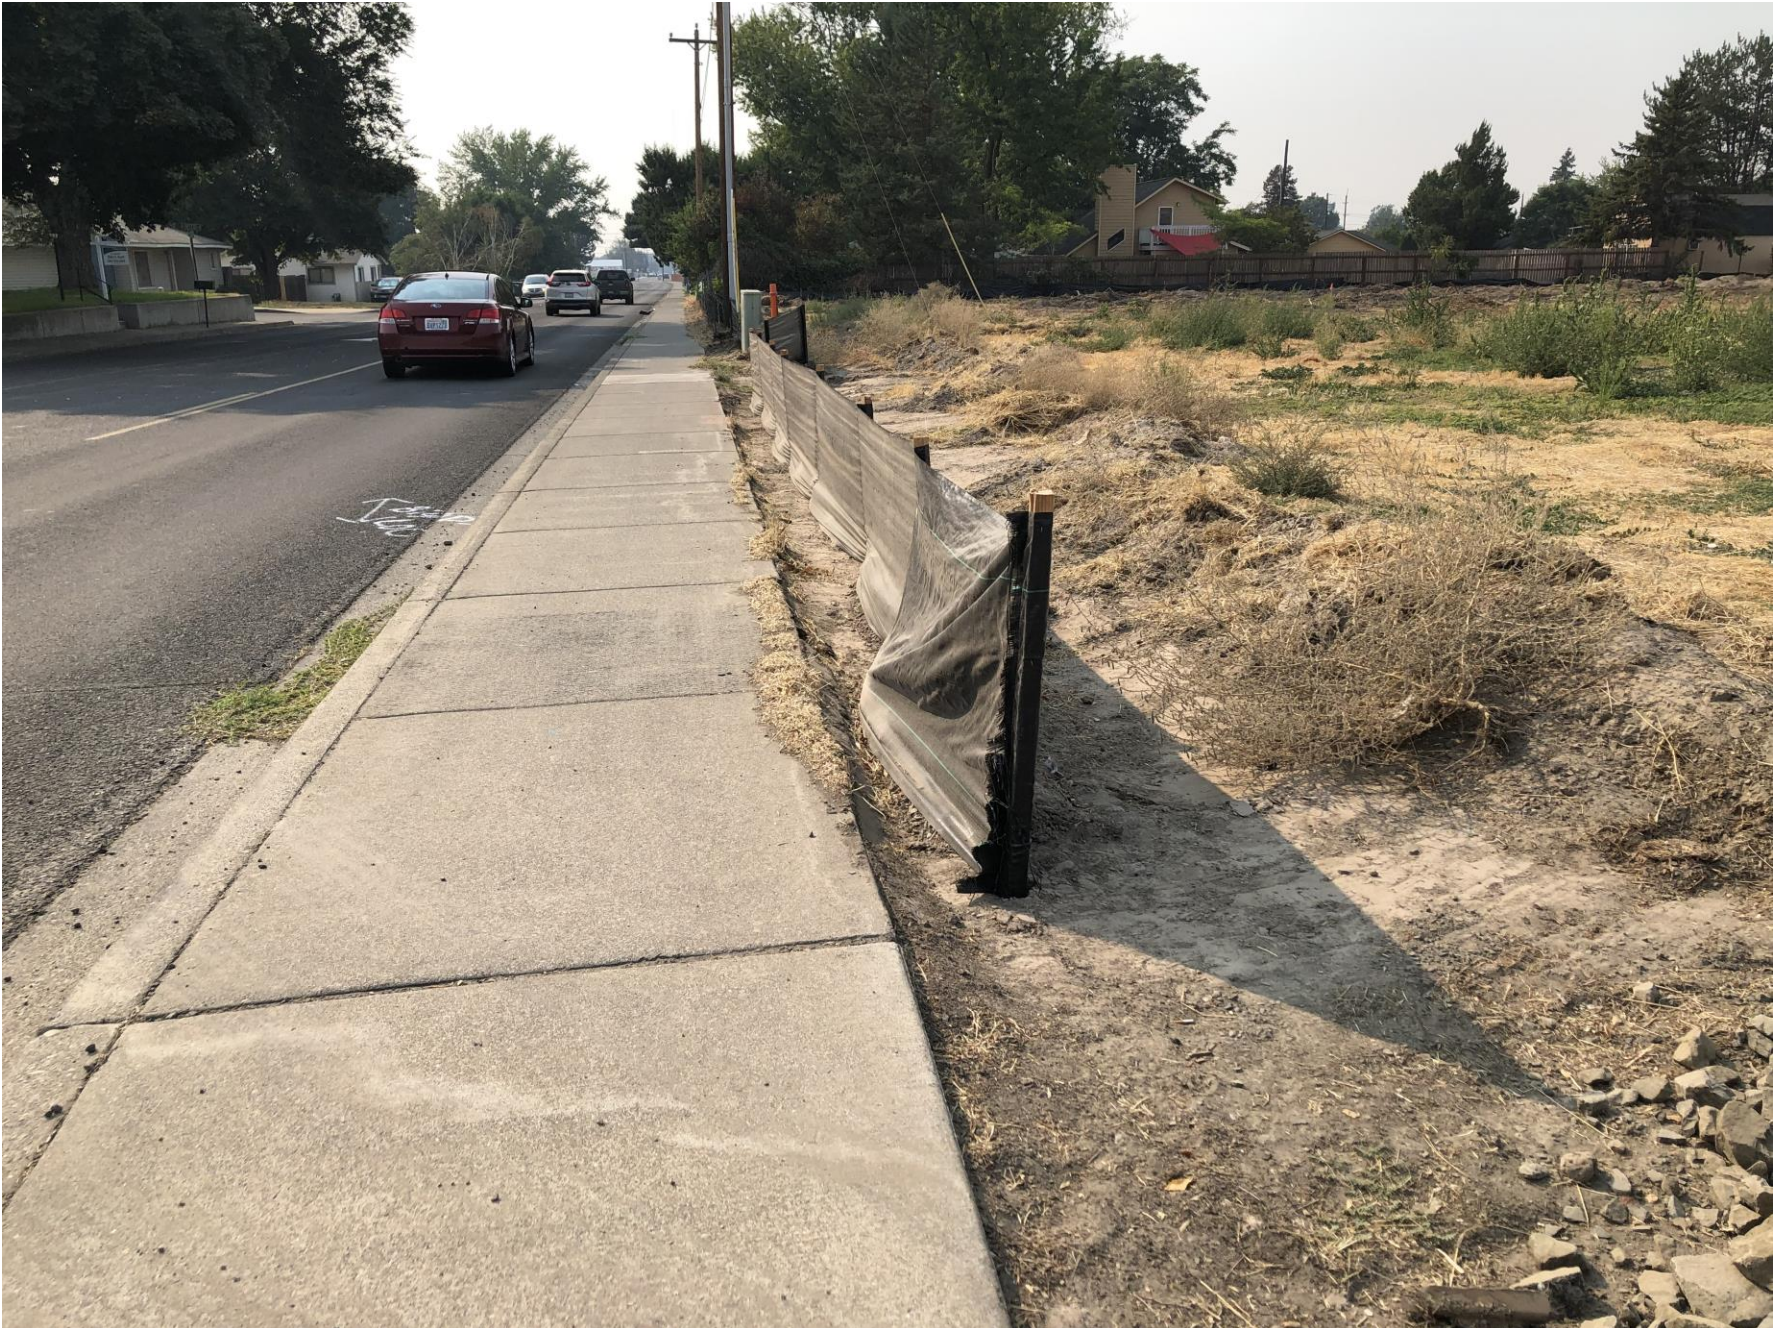
Photo 8

Photo Description: Silt fence is not buried.

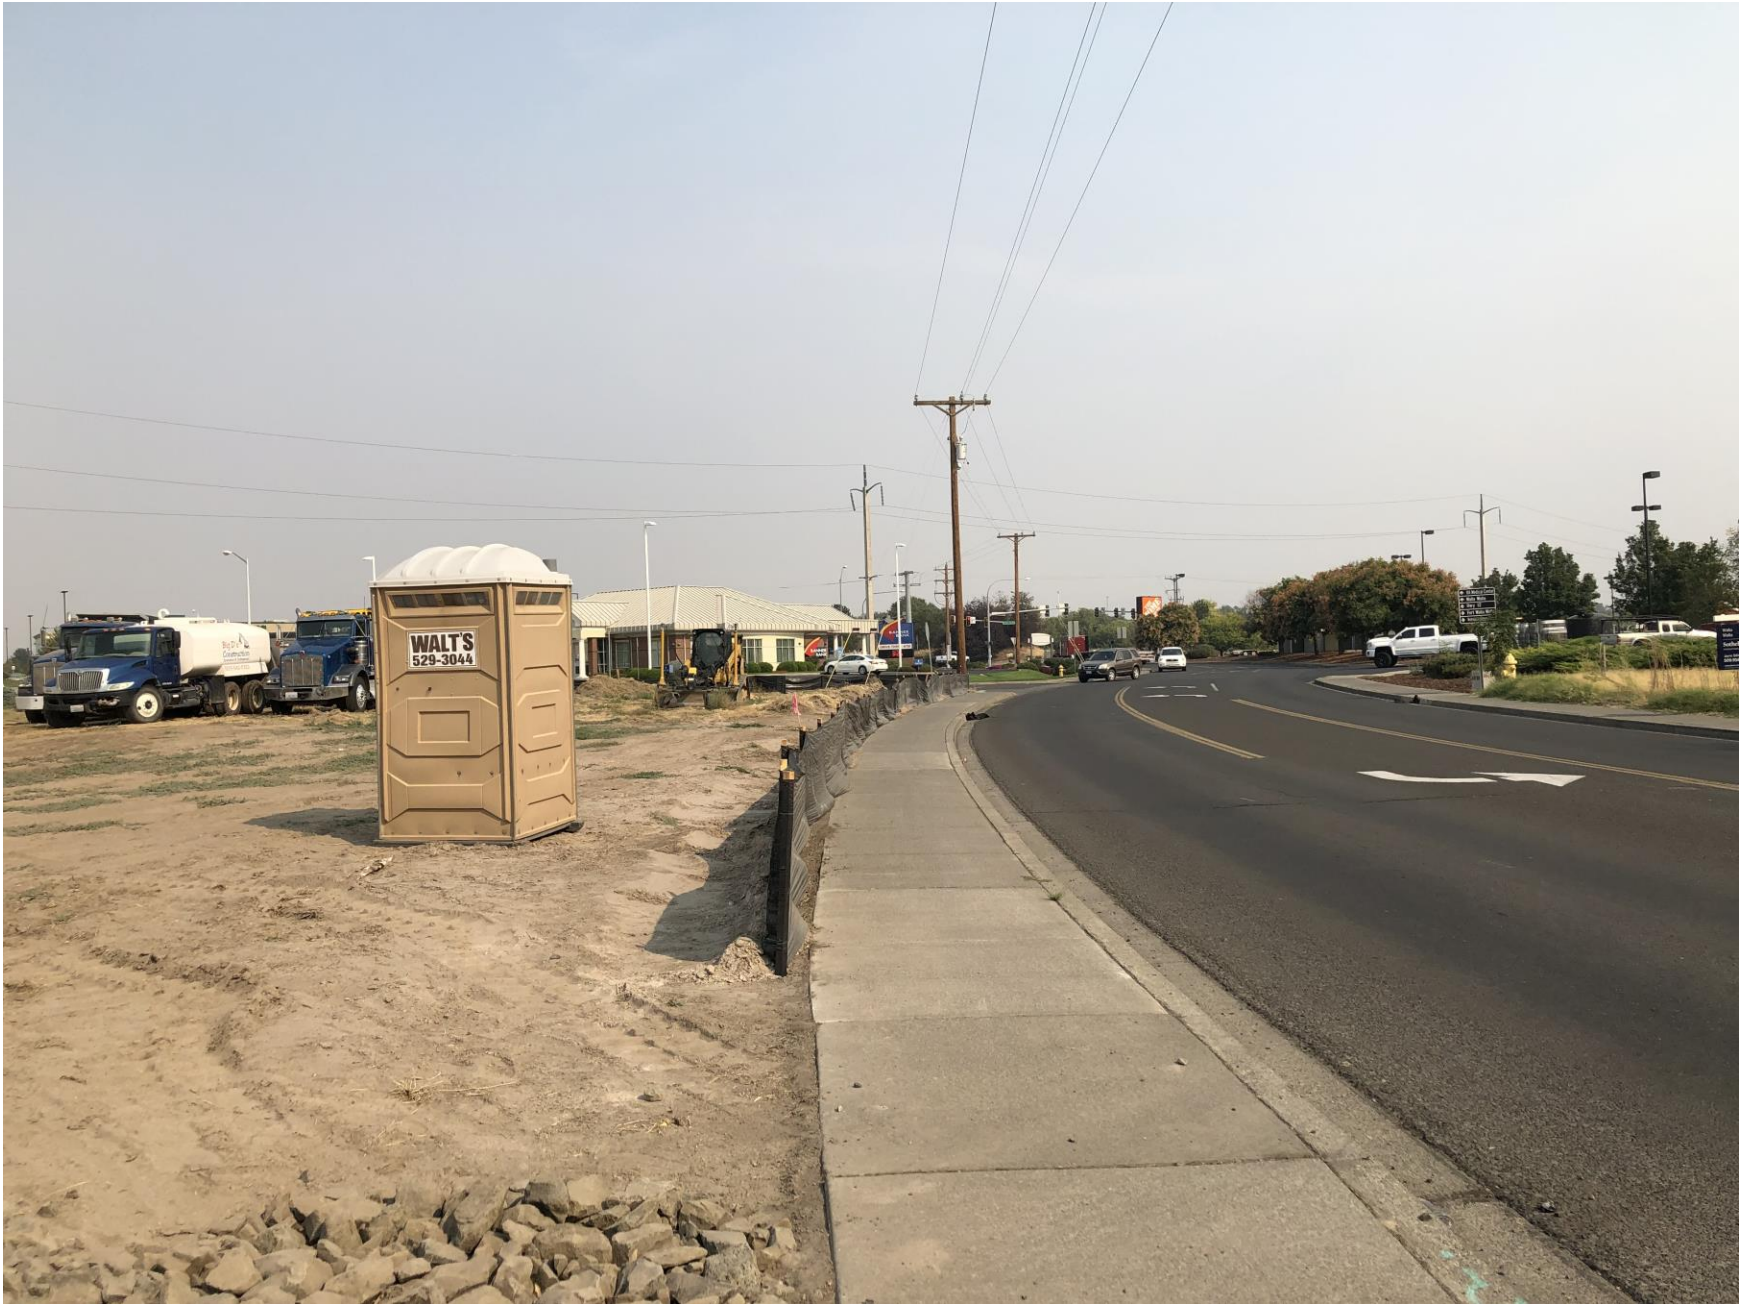
Photo 9

Photo Description: Sediment against silt fence pushing the silt fence off site and discharging sediment under the silt fence.
