CONSTRUCTION STORMWATER GENERAL PERMIT INSPECTION REPORT

State of Washington Department of Ecology

The Goodwill Industries project is permitted for 2.5 acres of soil disturbing activities. The project consists of a new Goodwill Retail Facility and associated parking.

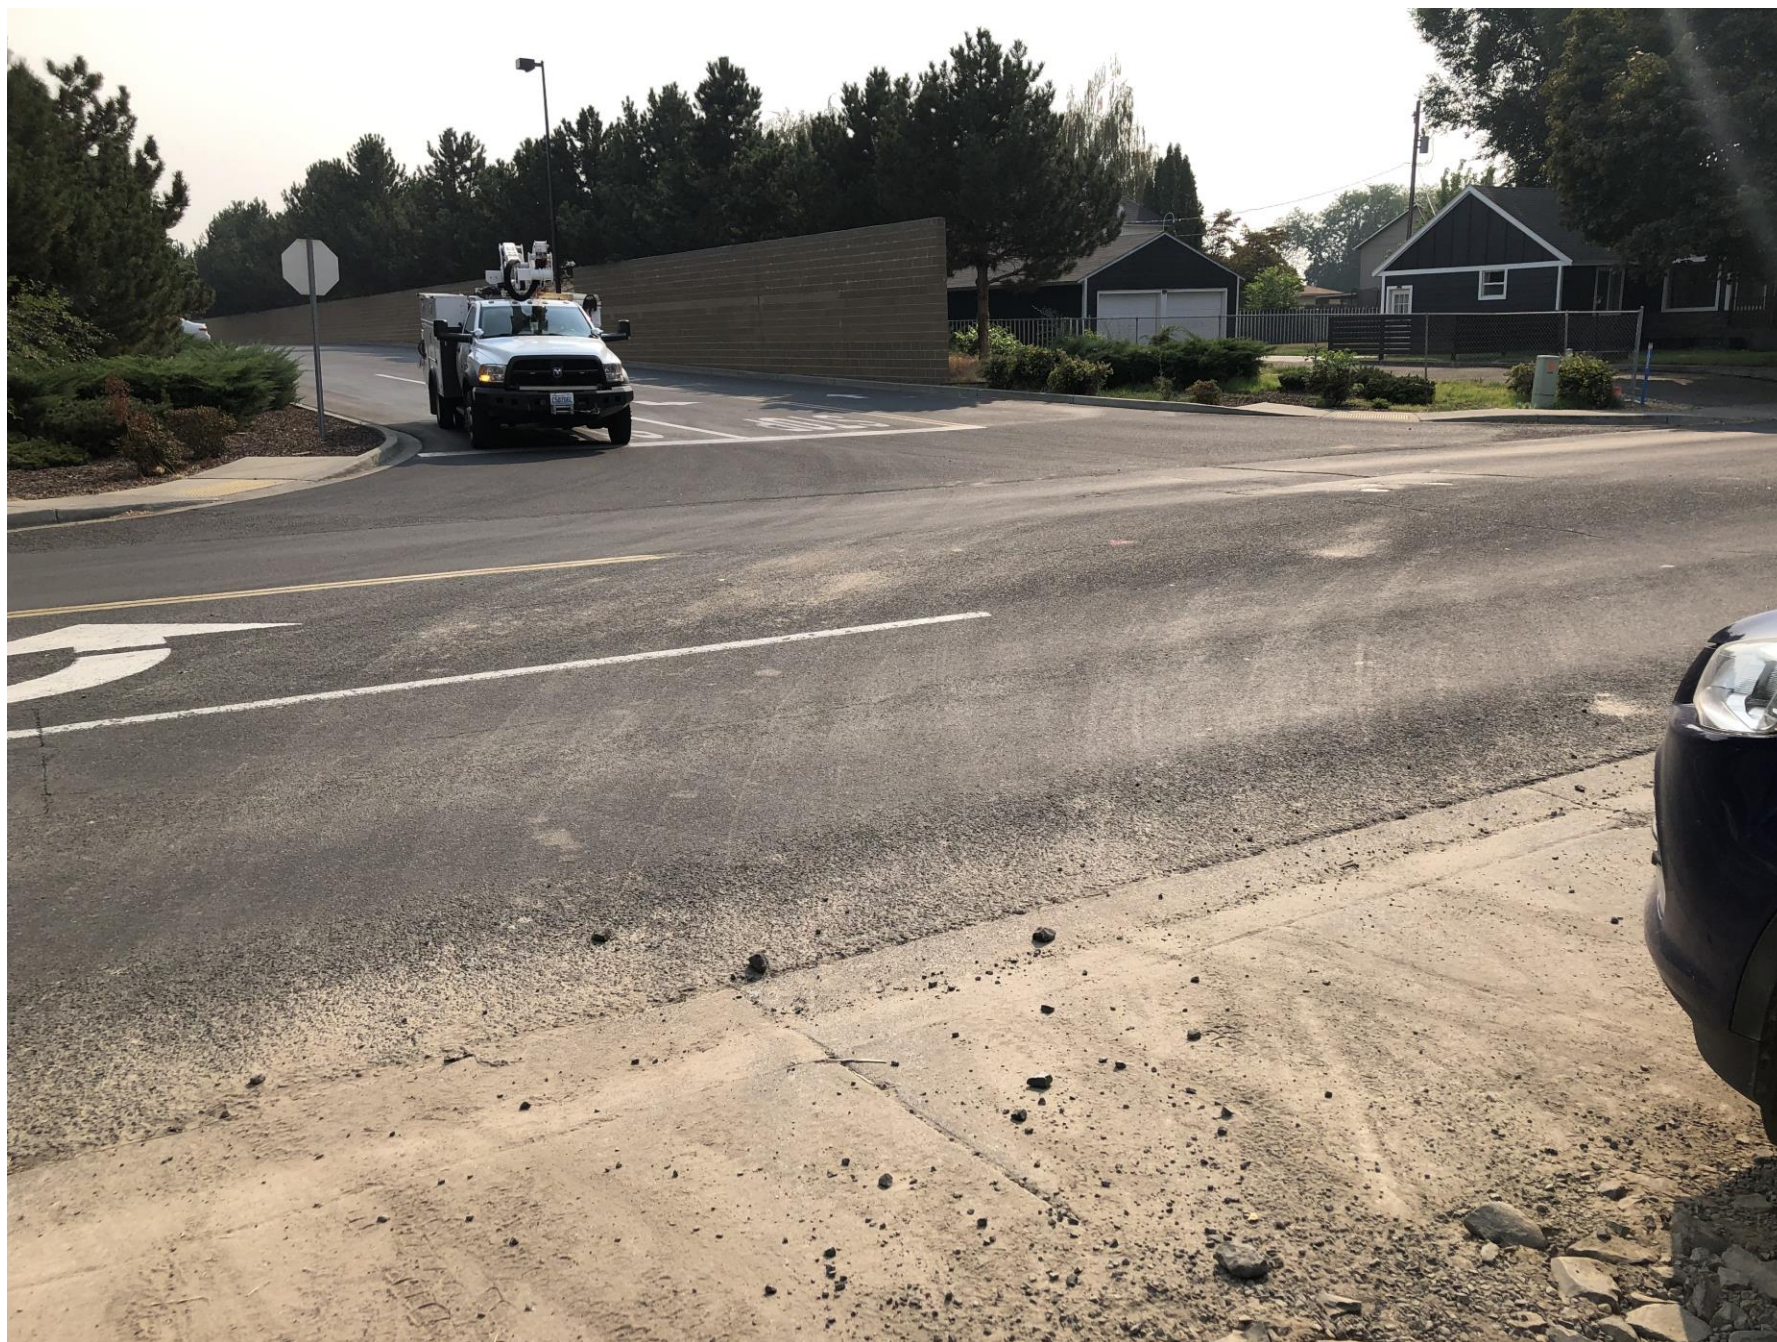
Photo 10

The site access off Northeast C Street consisted of quarry spalls. I saw light track out on Northeast C Street.

Photo Description: Light track out on Northeast C Street.

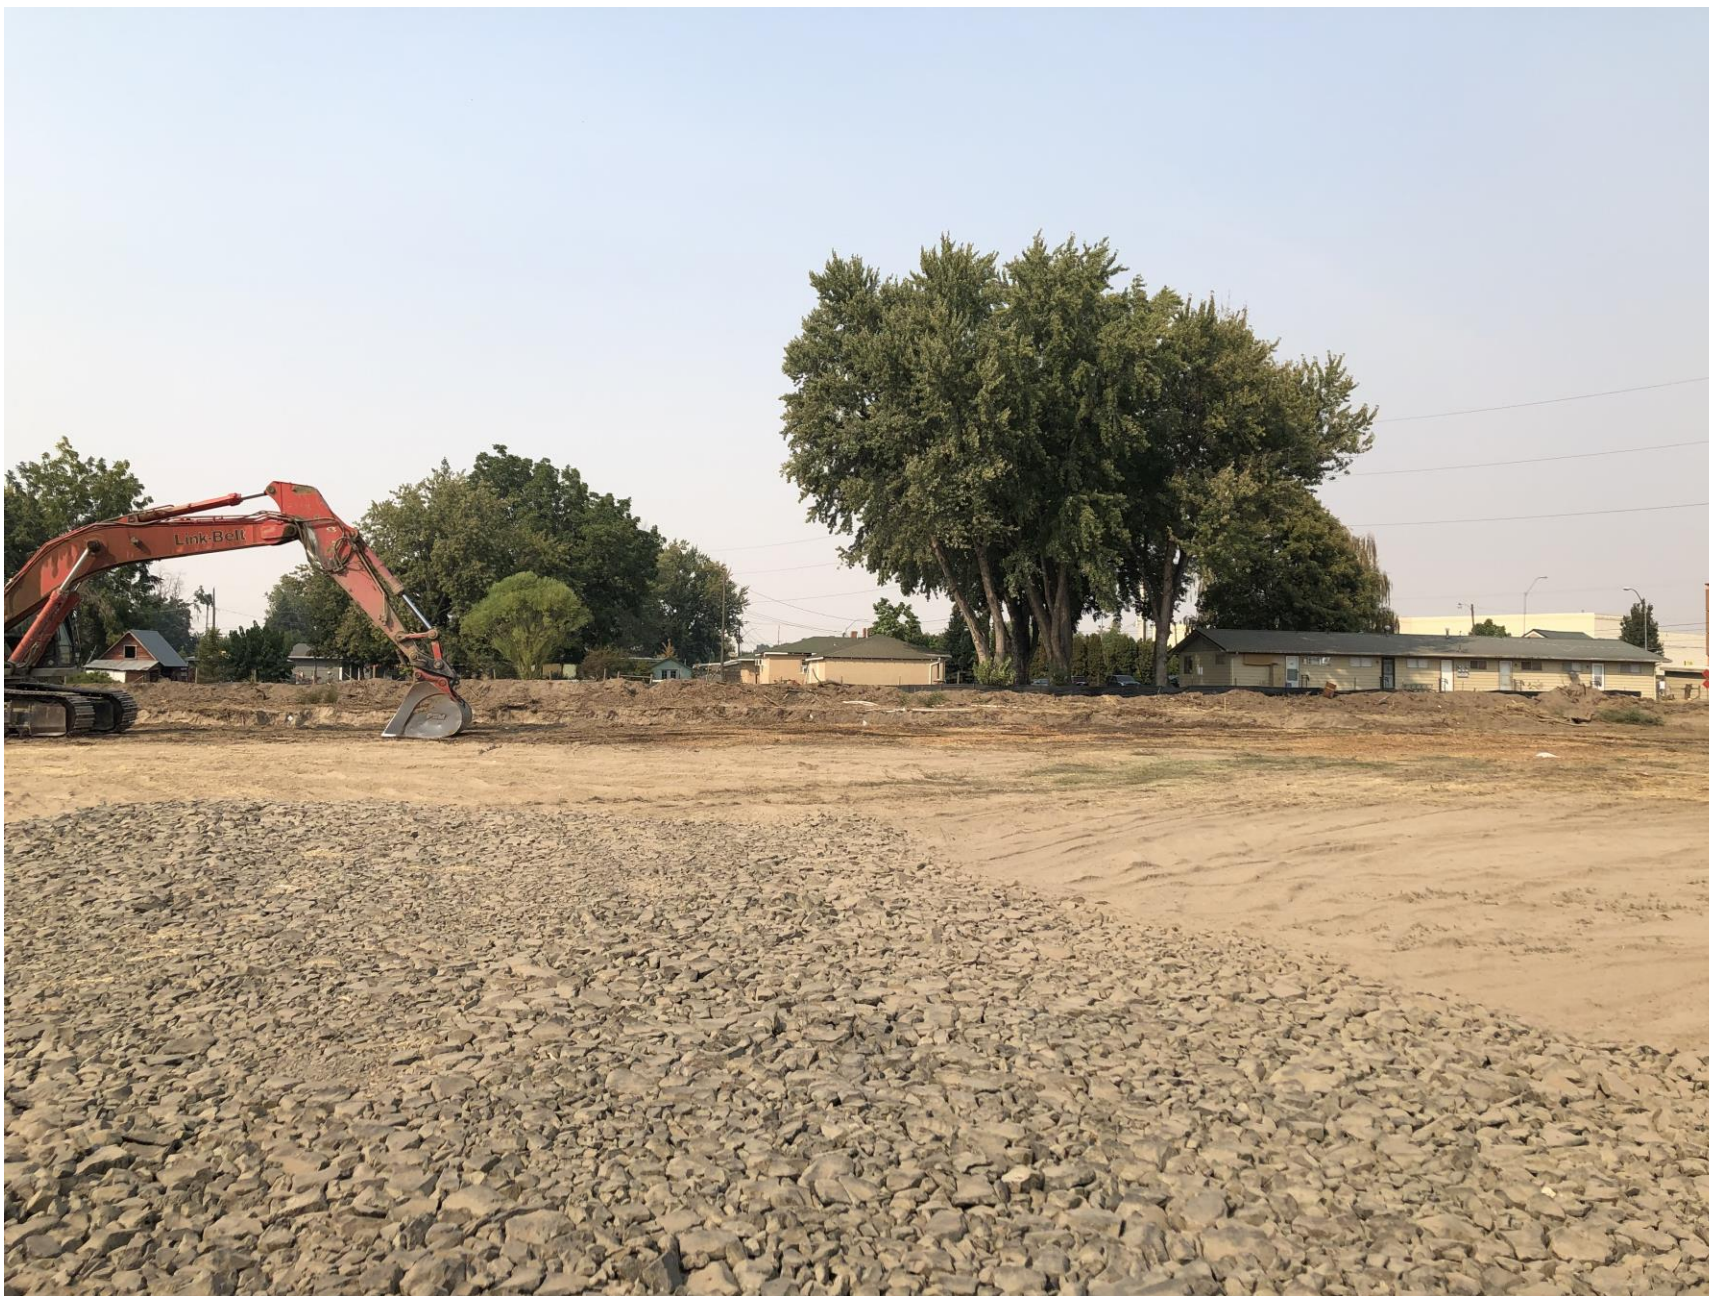
Photo 11

The site soil had a consistency of powder and is easily suspended if disturbed. Fugitive dust may be an ongoing issue at this site while equipment is moving.

Photo Description: Quarry spall site access. Powdery soil.
