DEPARTMENT OF ECOLOGY State of Washington	CONSTRUCTION STORMWATER GENERAL PERMIT INSPECTION REPORT State of Washington Department of Ecology		
Section A: General Data			
Ecology Inspector(s): Shannon Adams	On-Site Representative Name: Clint Hale	Inspection Date: November 9, 2021 Entry/Exit Time: 13:05/13:41	Inspection Type: Unannounced
		Receiving waters: Walla Walla Watershed	Permit webpage: Facility Summary
Section B: Background			
<p>The Goodwill Industries project is covered under the State of Washington's Construction Stormwater General Permit (CSWGP). The CSWGP is a National Pollutant Discharge Elimination System (NPDES) and a State Waste Discharge permit for discharge of construction-related stormwater. The purpose of this inspection is to conduct a compliance inspection and to provide technical assistance as appropriate.</p> <p>Clint Hale, Chervenell Construction, was present during inspection and all observations and recommendations were discussed.</p> <p>Weather at time of inspection: Overcast <u>Precipitation in the past 24 hours?</u> <input checked="" type="checkbox"/> Yes <input type="checkbox"/> No </p>

Section C: Compliance			
<p>The Goodwill Industries project is p

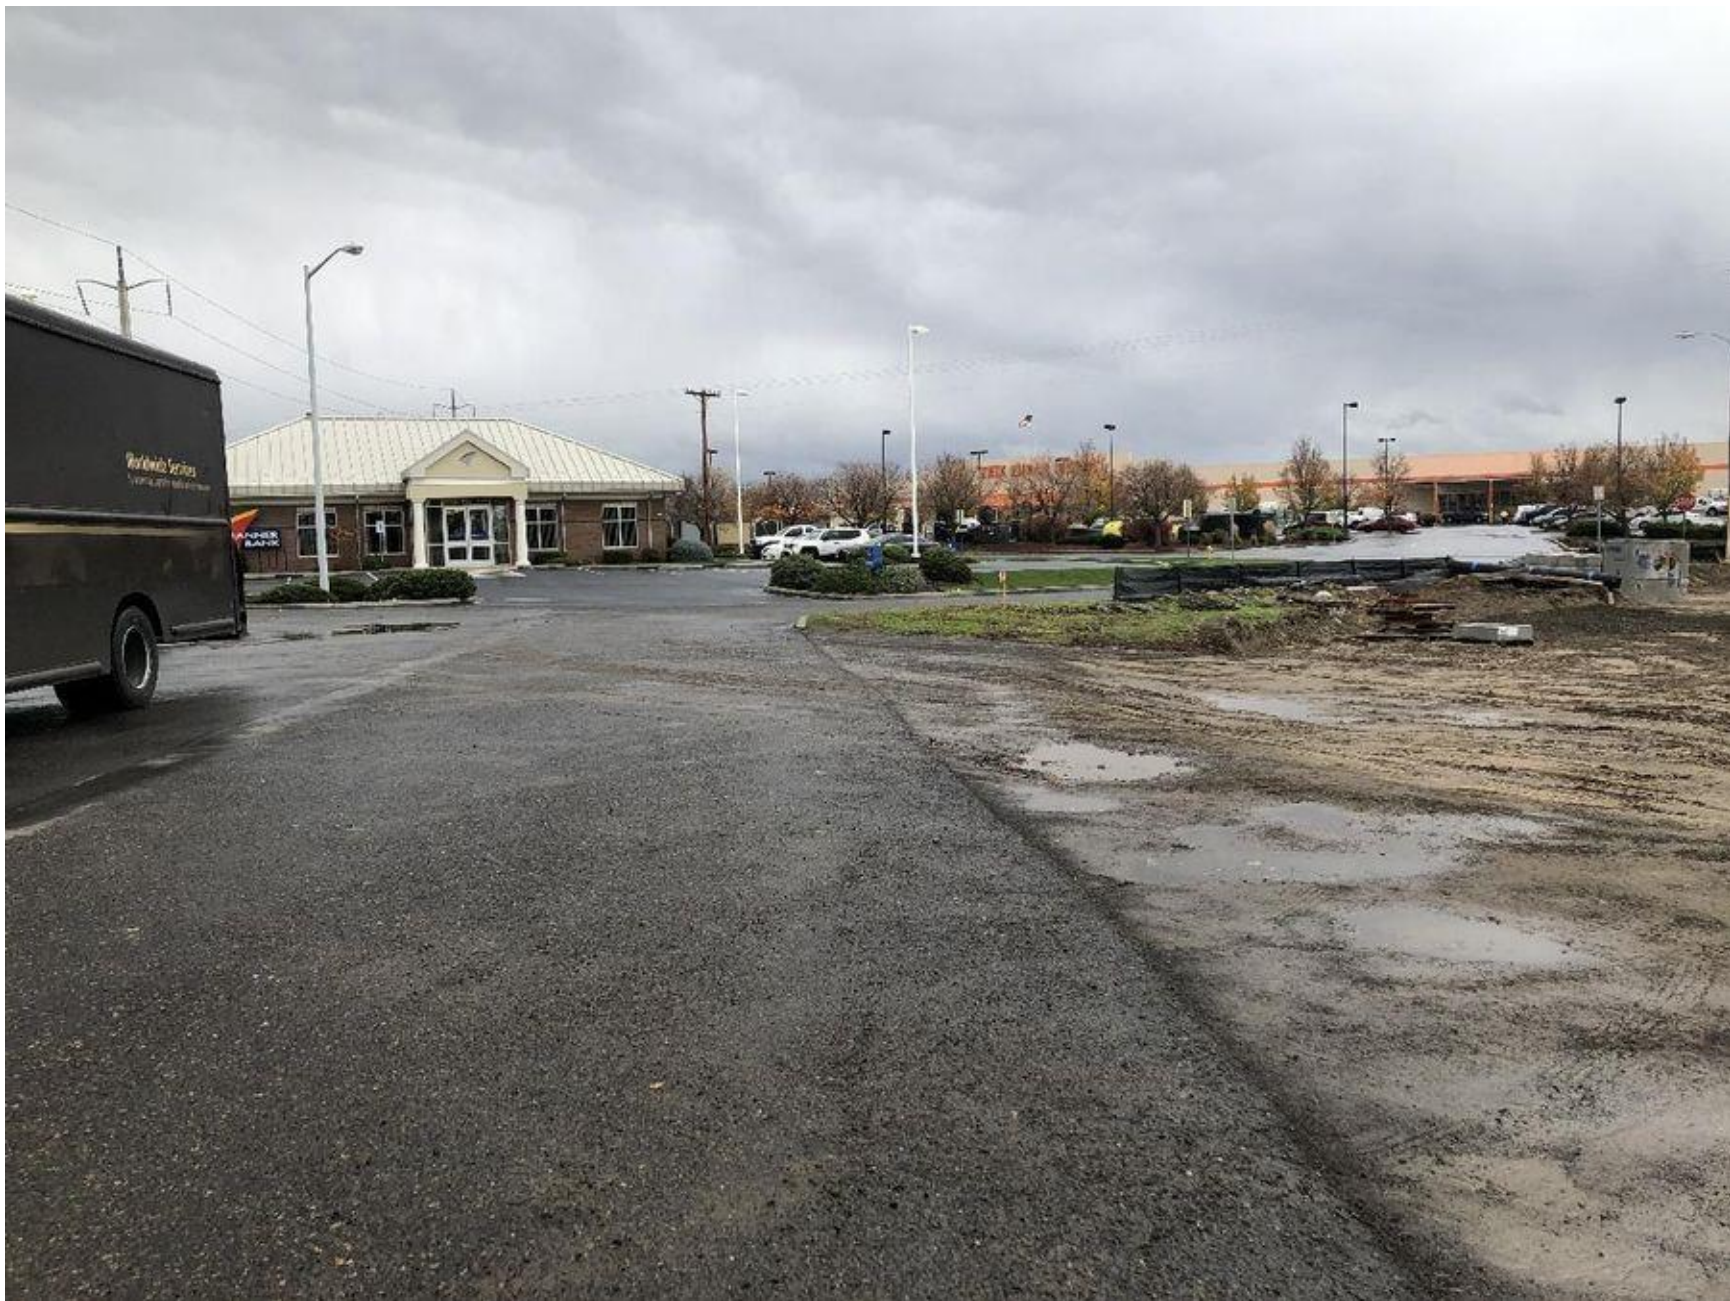
Photo 1

We discussed tracking sediment off site. Clint told me that the sediment that is tracked off site on the northeastern section of the site is hosed down at the end of each day and flows back to the site. I told Clint that if they choose to use this access point, they need to install a construction access with geotextile fabric and quarry rock. There are businesses north and east of the site that have the potential for patrons of those establishments to drive through tracked off sediment and carry it to the local streets.

Photo Description: Sediment tracked off the northeastern part of the site. Site access is not stabilized adequately for traffic.

<p><u>S9.D.2 Establish Construction Access</u> Failure to meet S9.D.2.a: Limit construction vehicle access and exit to one route, if possible., Failure to meet S9.D.2.b: Stabilize access points with a pad of quarry spalls, crushed rock, or other equivalent BMPs, to minimize tracking sediment onto roads. Install and maintain adequate construction access to prevent track-out off-site.</p>	<p>Clean the affected roadway thoroughly at the end of each day, or more frequently as necessary. Immediately begin. Address the problems no later than 10 days from the date of this inspection.</p>	<p>BMP C105E, BMP C106E, BMP C107E</p>

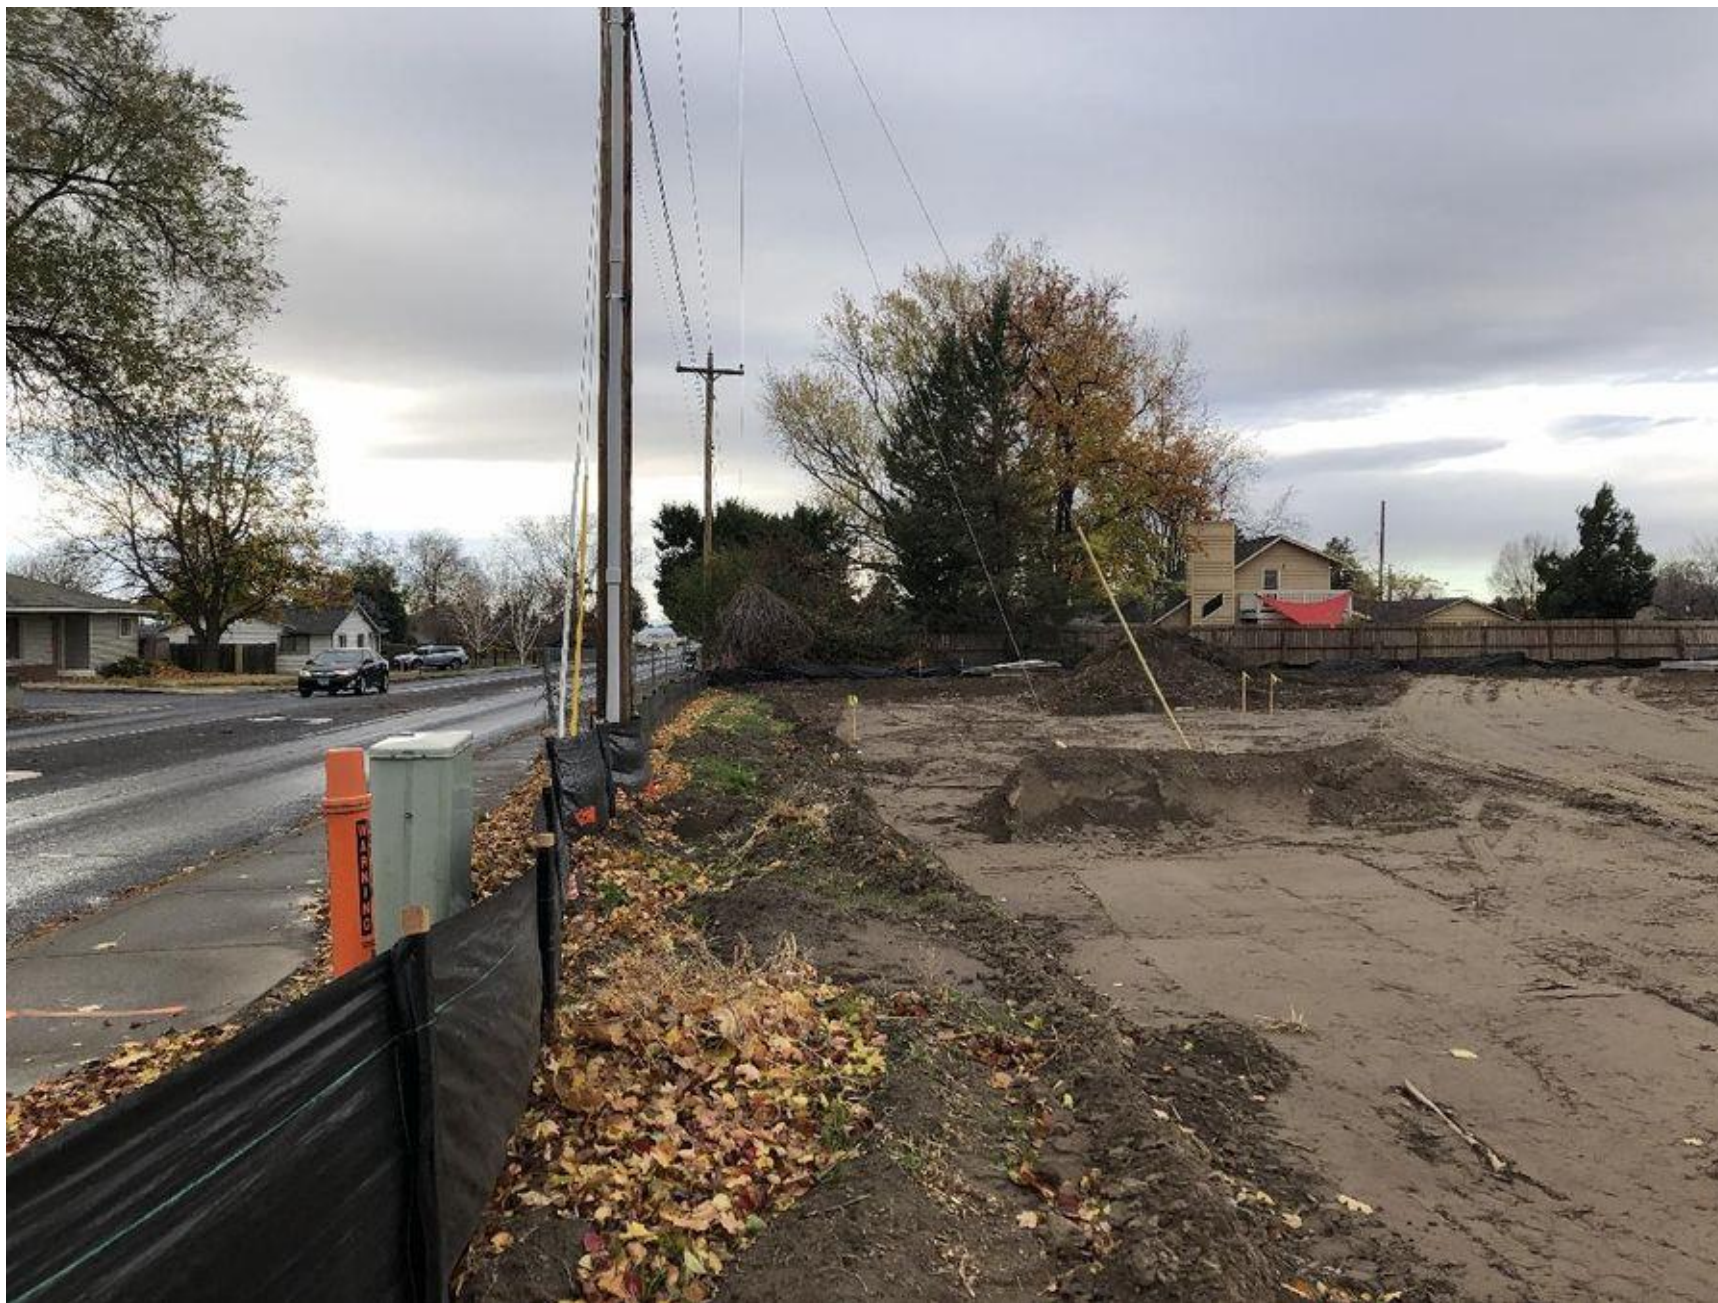
Photo 2

After discussing the required site documentation, we walked the site. I saw the majority of the site now sits below the installed perimeter silt fence. I saw the silt fence remains improperly installed as it was at my previous inspection. We discussed proper installation of the silt fence. The bottom of the silt fence should be buried a minimum of 4 inches below the ground surface. Backfill and tamp soil in place over the buried portion of the geotextile fabric, so that no flow can pass beneath the silt fence and scouring cannot occur. The silt fence installed on site consists of silt fence with soil placed on one side of the fence and the other side sits at the surface. This allows soil to move freely under the silt fence and discharge off site. We discussed that the silt fence should be installed properly in those areas where there is the potential for soil to leave the site under the silt fence, and soil is exposed at the same elevation of the silt fence.

Photo Description: Silt fence installed along the site. This portion of silt fence now sits above the soil exposed on site.

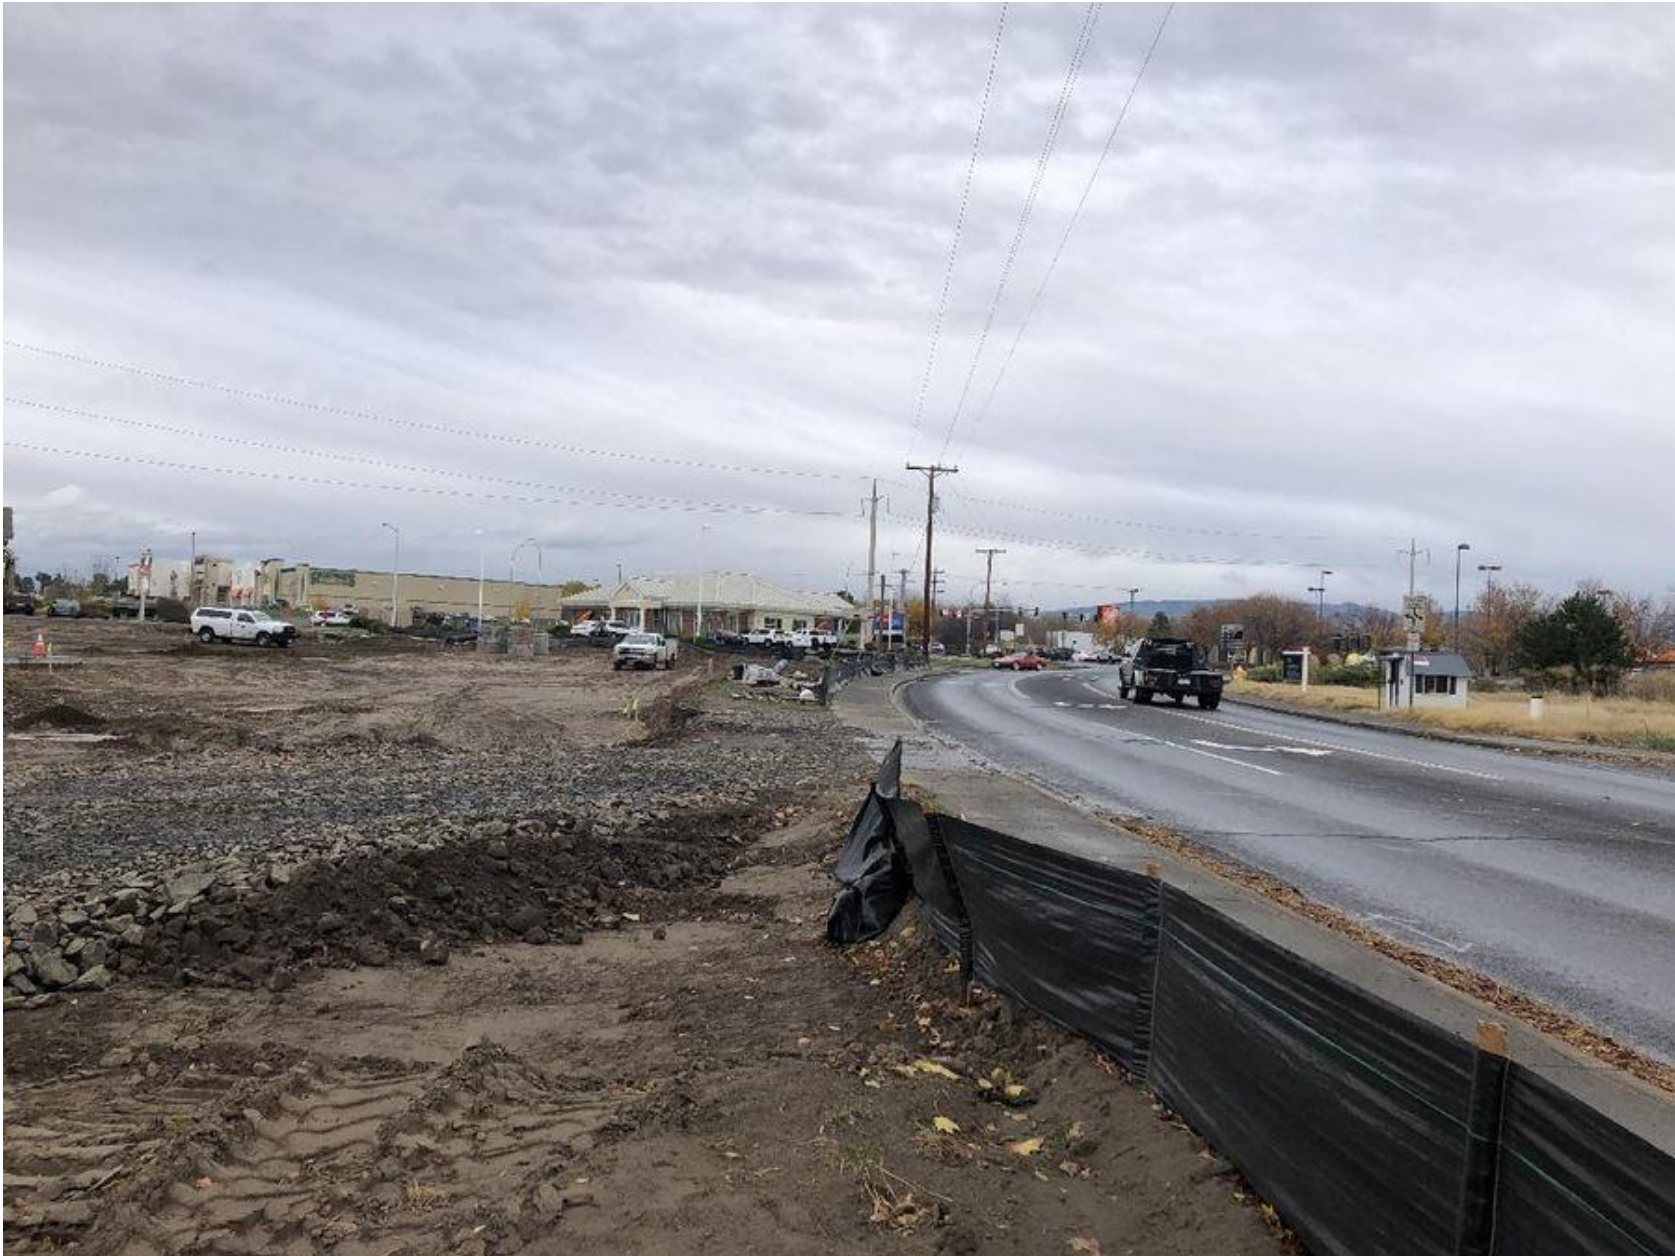
Photo 3

Photo Description: Site access of Northeast C Street.

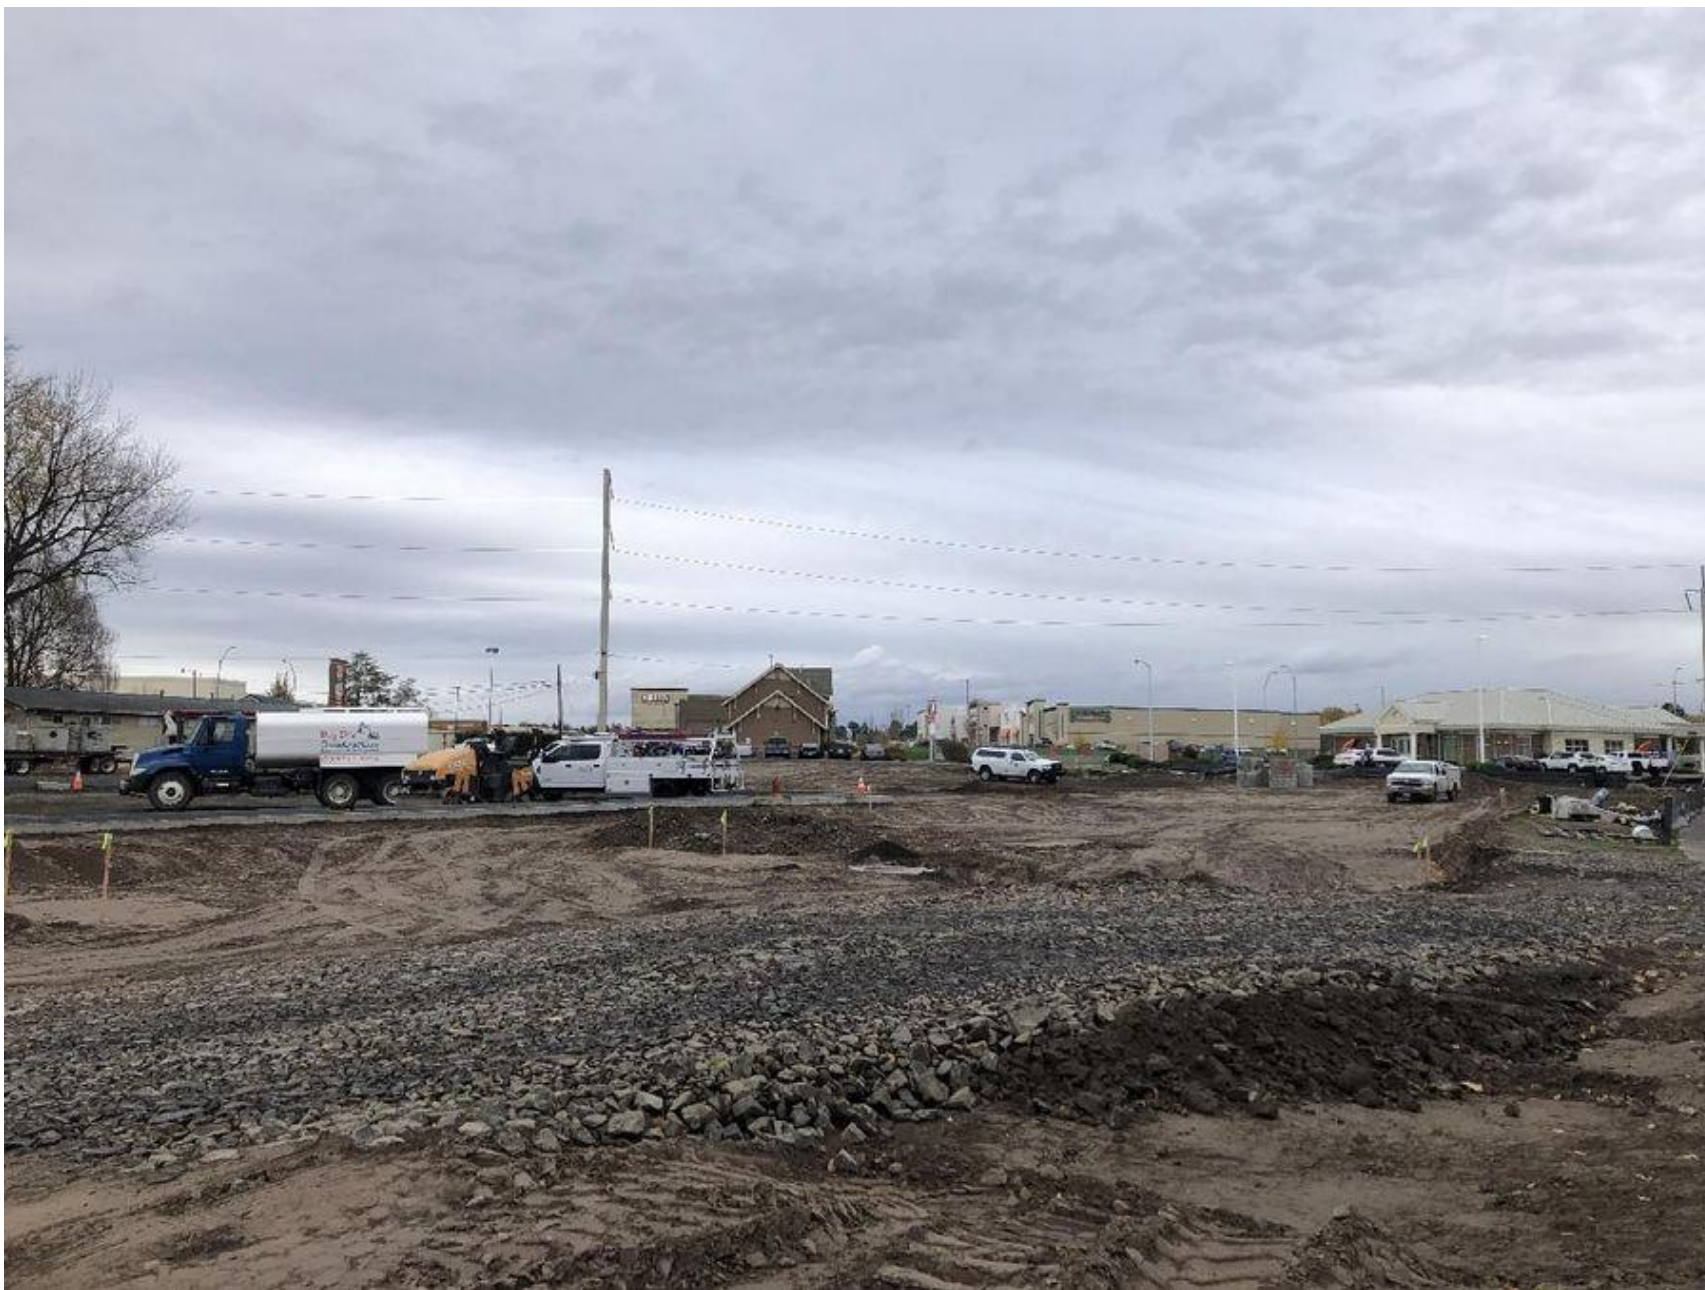
Photo 4

Photo Description: Site overview. The majority of the site now sits below the silt fence.

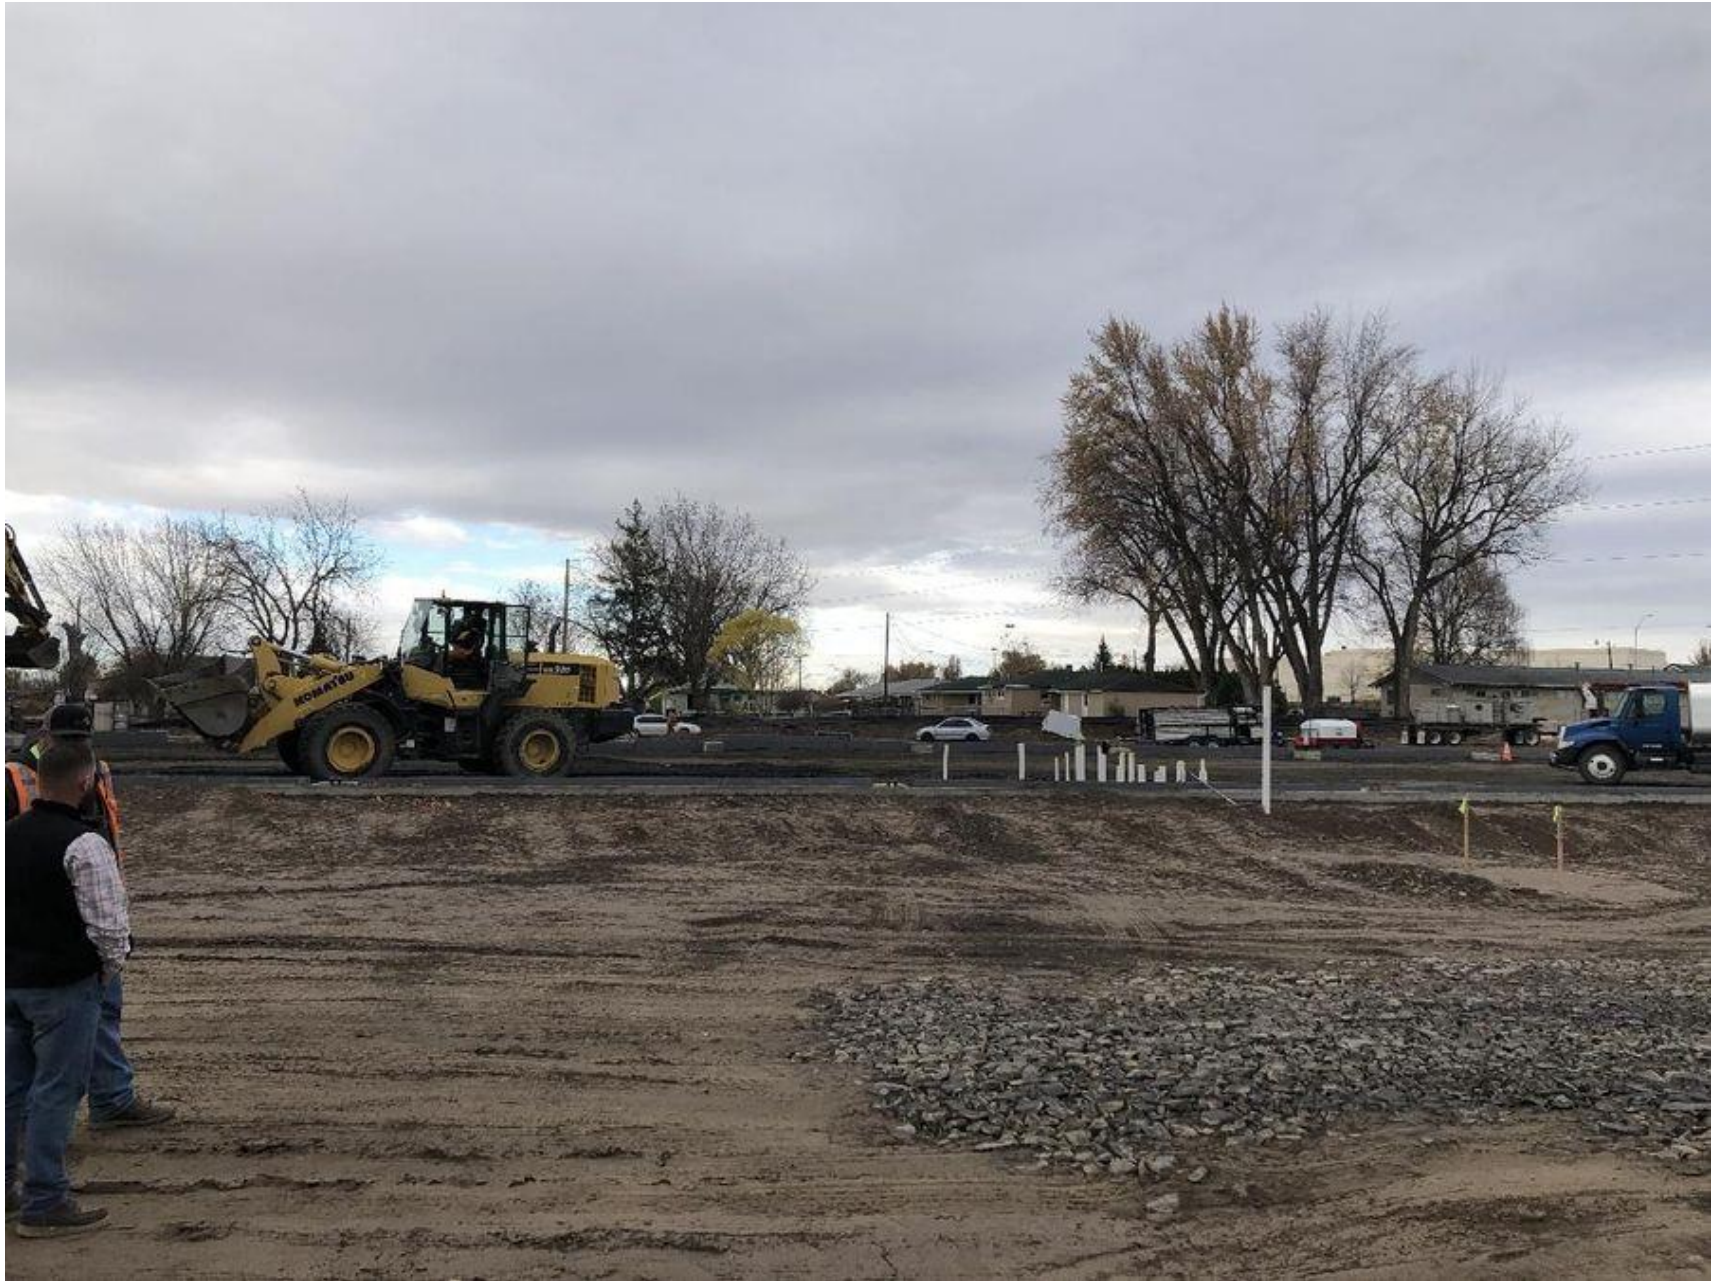
Photo 5

Photo Description: Site overview. The majority of the site now sits below the silt fence.

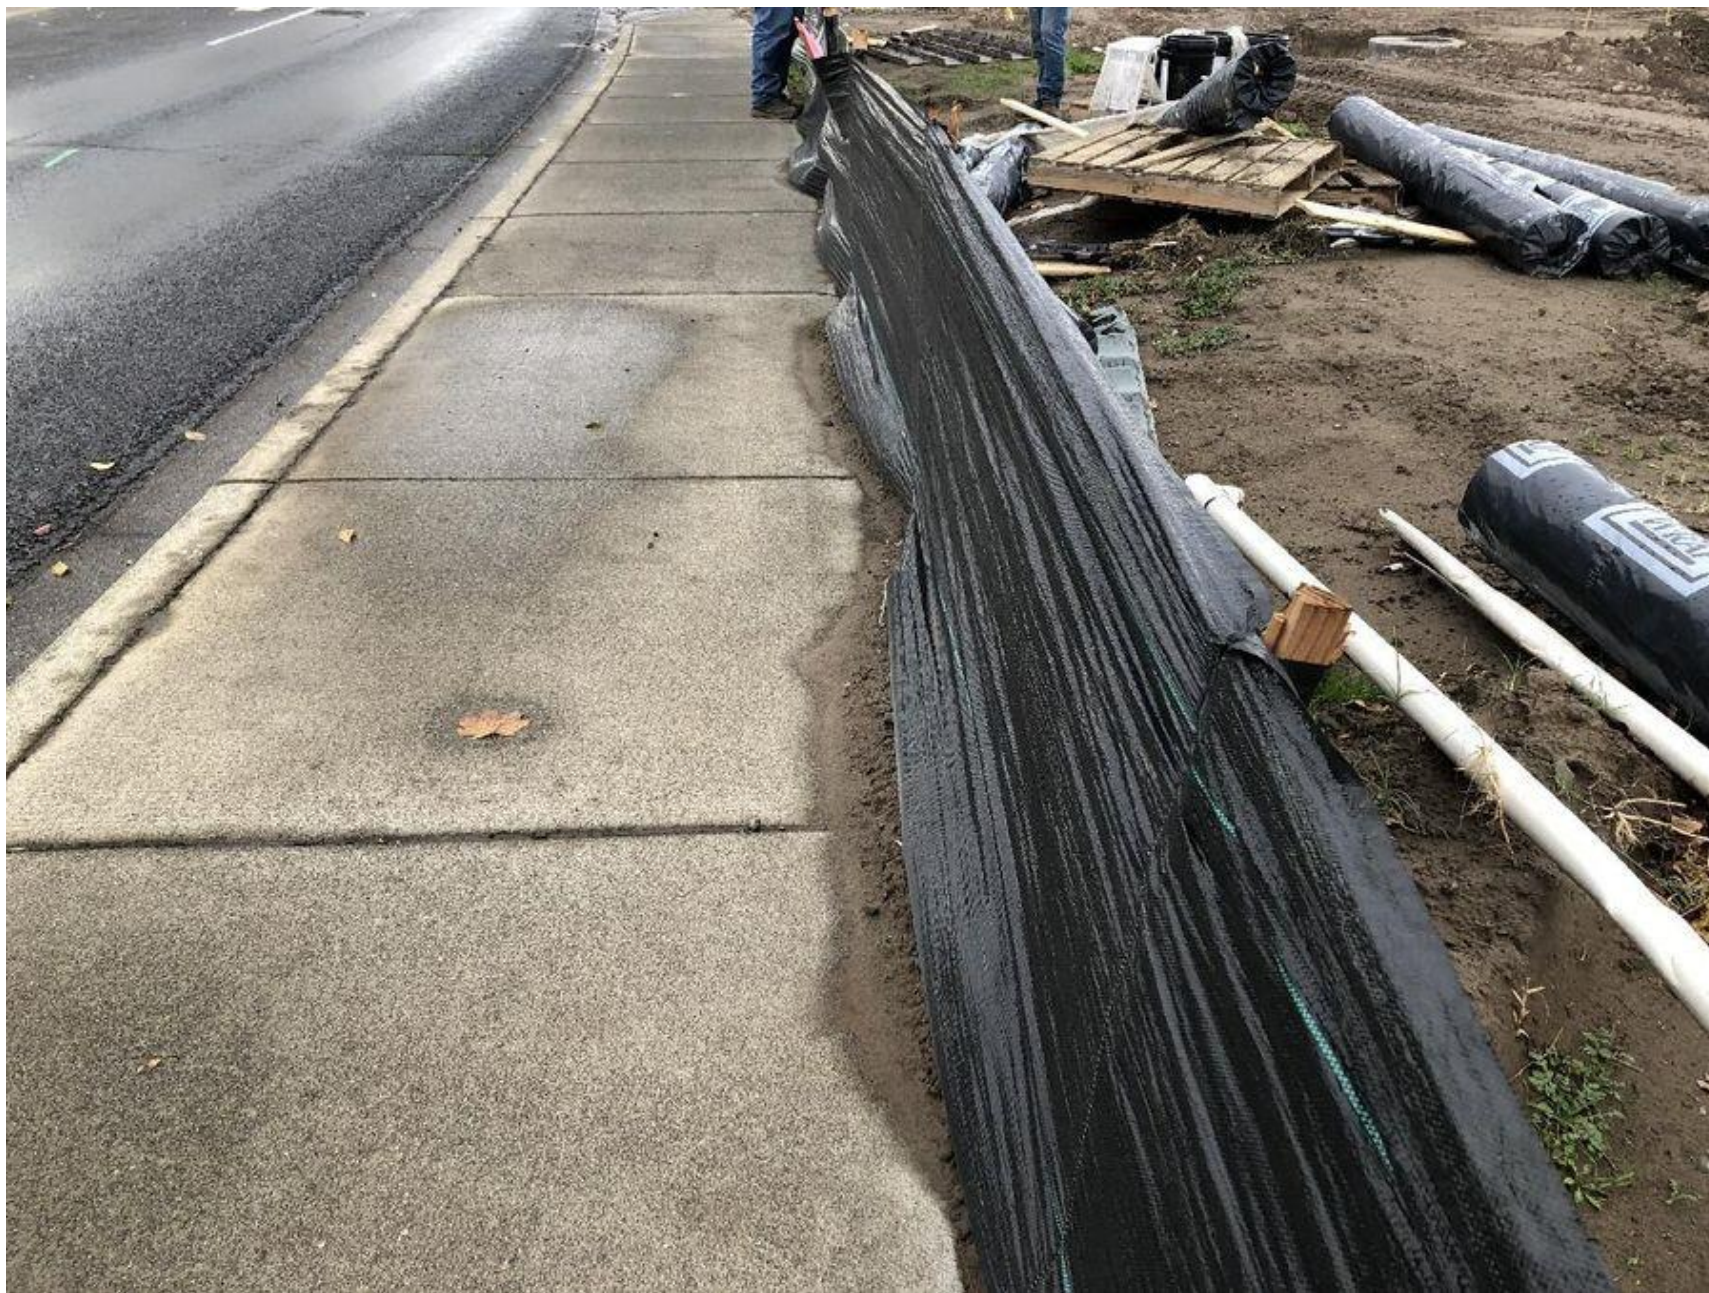
Photo 6

Photo Description: Silt fence on the southeast side of the site is not installed per BMP C233E: Silt Fence. Sediment leaving the site under the silt fence.

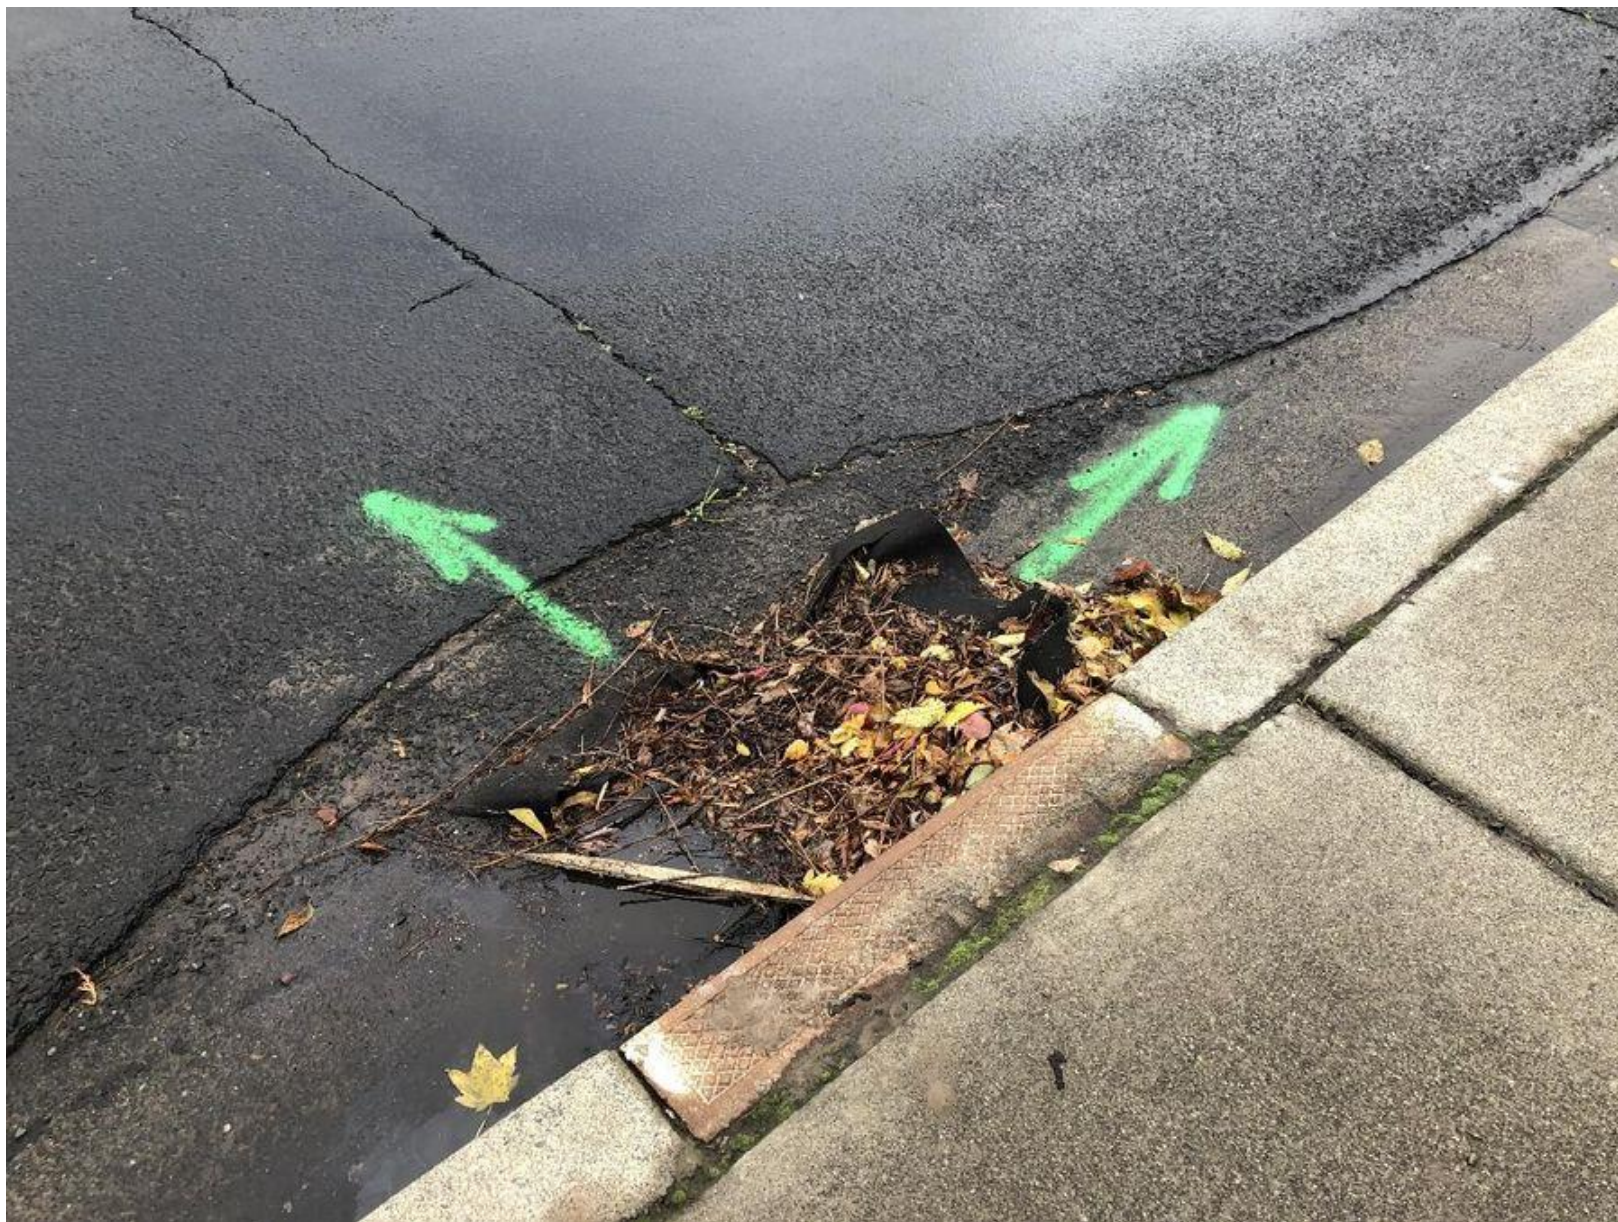
Photo 7

We saw a catch basin in the street that had inlet protection. We discussed keeping the inlet protection clean so that it functions as intended.

Photo Description: Inlet protection in Northeast C Street should be kept clean and free of debris so it performs as intended.

<p><u>S9.D.7 Protect Drain Inlets</u></p> <p>Protect and maintain drain inlets, as set forth in permit condition S9.D.7.a.</p>	<p>Immediately begin. Address the problems no later than 10 days from the date of this inspection.</p>	<p>C220E</p>
<p><u>S9.D.11 Maintain BMPs</u></p> <p>Failure to meet S9.D.11.a: Permittee must maintain and repair all temporary and permanent erosion and sediment control BMPs as needed to assure continued performance of their intended function in accordance with BMP specifications. Maintain and repair all temporary and permanent BMPs, as set forth in permit condition S9.D.11.a.</p>	<p>Immediately begin. Address the problems no later than 10 days from the date of this inspection.</p>	<p>SWMMMEW, Chapter 7 Best Management Practices Standards and Specifications, C150E, C160E</p>
<p>For assistance with any of these compliance issues or recommendations regarding BMPs, please see the 2019 Stormwater Management Manual for Eastern Washington (SWMMMEW), Chapter 7, Construction Stormwater Pollution Prevention which includes BMPs for Source Control and Runoff Conveyance and Treatment BMPs. The full SWMMMEW is available online.</p> <p>The Department of Ecology has the authority to issue formal enforcement actions including issuance of orders and civil penalties of up to \$10,000 per day per violation for violations of your NPDES permit and/or state laws and regulations.</p> <p><i>Noncompliance with the limits, monitoring requirements, terms and/or conditions established in your permit may result in formal enforcement action by the Department of Ecology.</i></p>

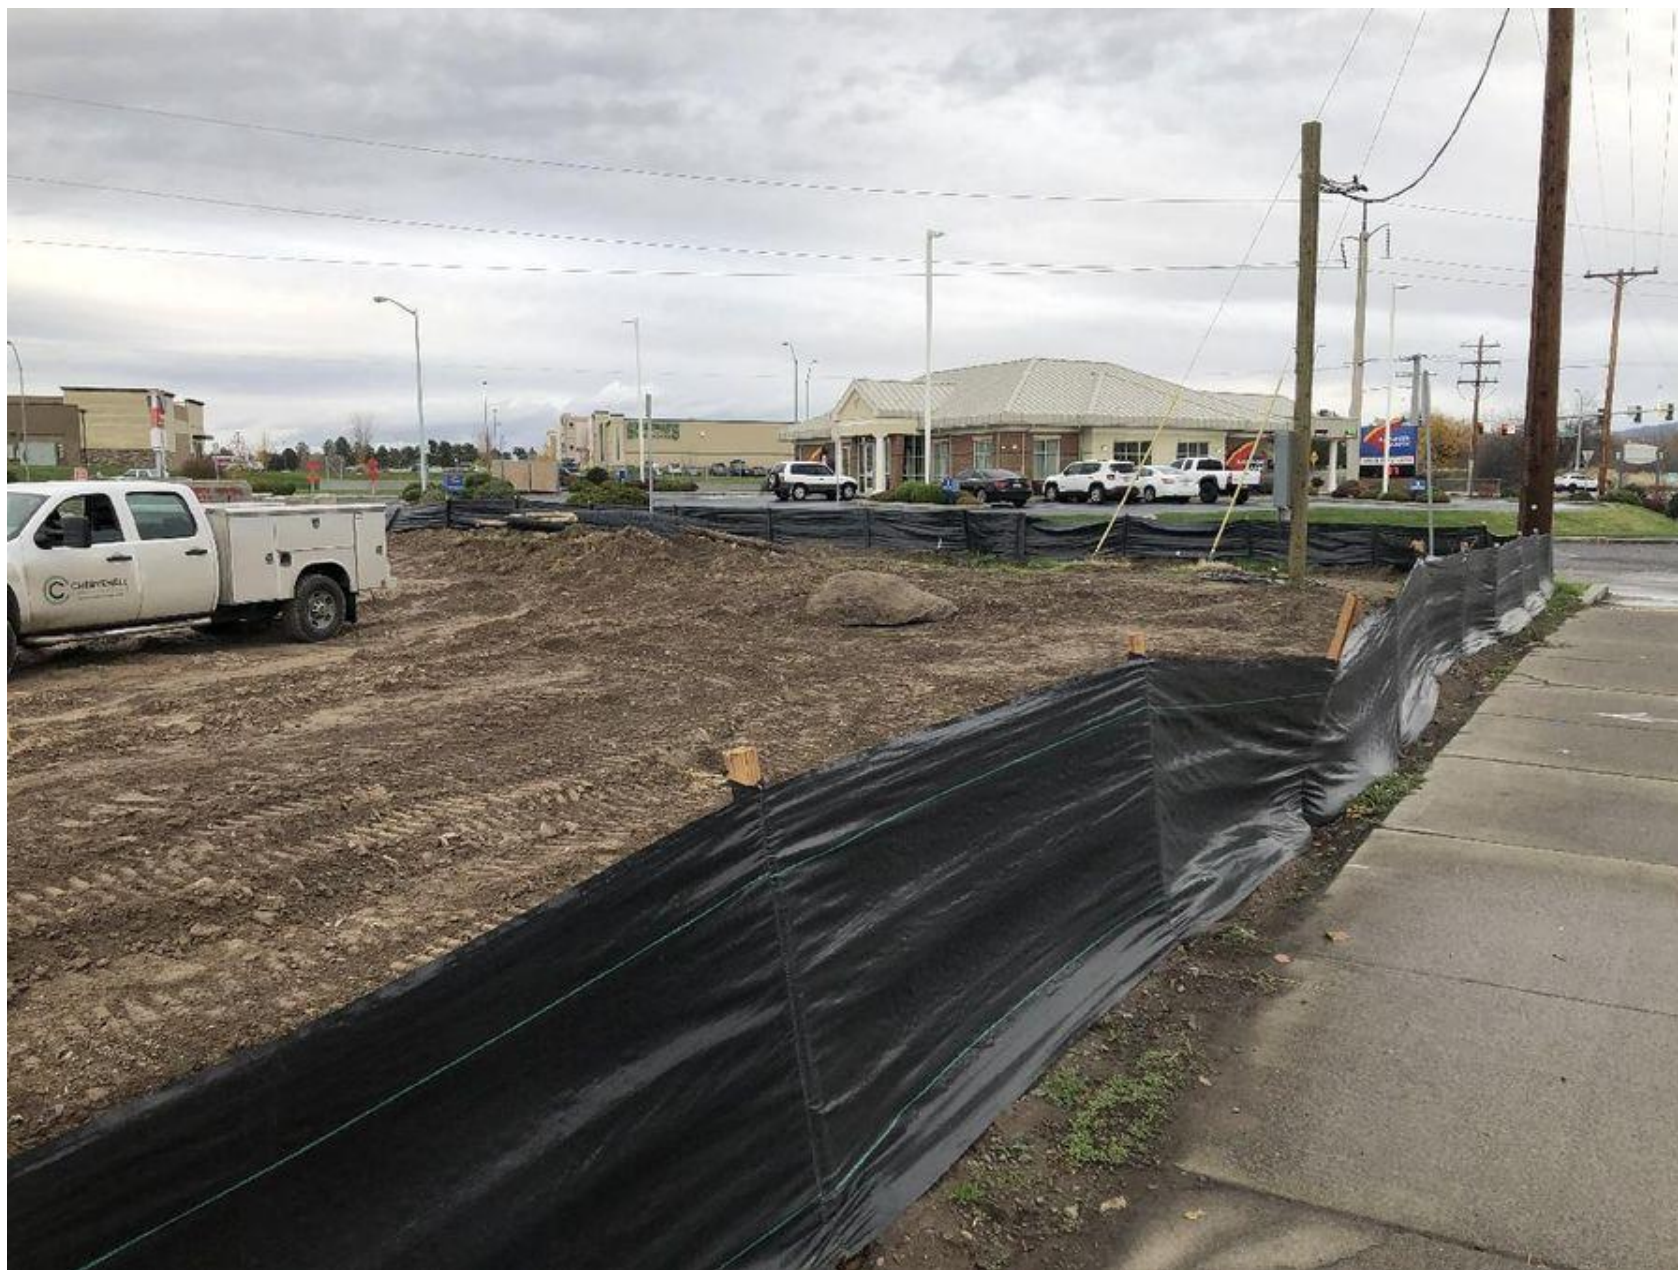
Photo 8

Photo Description: Silt fence in the southeast corner of the site needs to be installed properly so sediment does not discharge under the silt fence. The site exposed soils sit at the same elevation as the silt fence at this location.

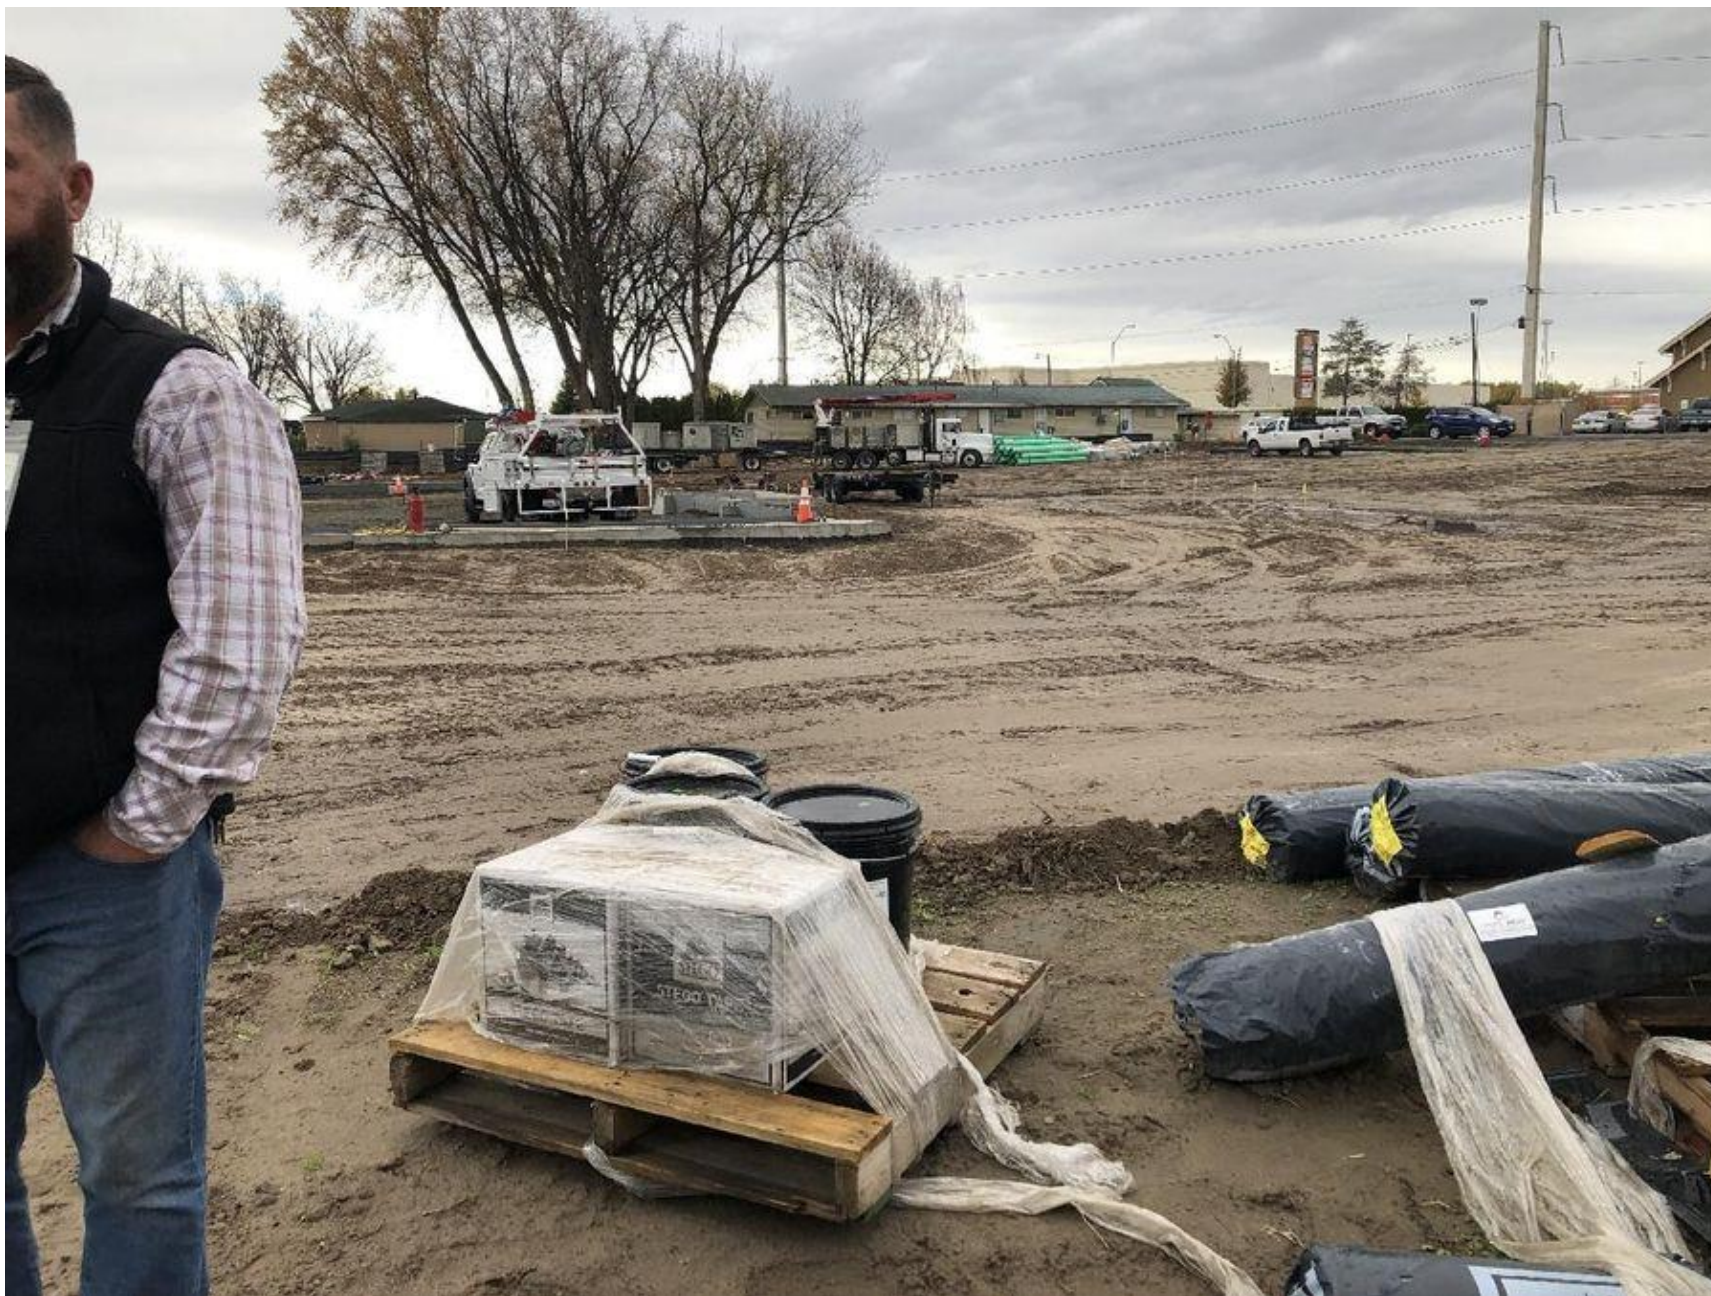
Photo 9

We saw two buckets of foundation sealant sitting on a pallet on the ground. We discussed keeping the sealant in secondary containment to minimize the discharge of pollutants. **Failure to design, install, and maintain effective pollution prevention measures to minimize the discharge of pollutants is a violation of permit condition S9.D.9.**

Photo Description: Foundation sealant sitting on pallet. Must be kept in secondary containment.
