CONSTRUCTION STORMWATER GENERAL PERMIT INSPECTION REPORT

State of Washington Department of Ecology

The Goodwill Industries project has coverage under the State of Washington's Construction Stormwater General Permit (CSWGP). The CSWGP is a National Pollutant Discharge Elimination System (NPDES) and a State Waste Discharge permit for discharge of construction-related stormwater. The purpose of this inspection was to check site conditions and provide technical assistance as appropriate.

The Goodwill Industries project has permit coverage for 2.5 acres of soil disturbing activities. The project consists of the construction of a Goodwill building.

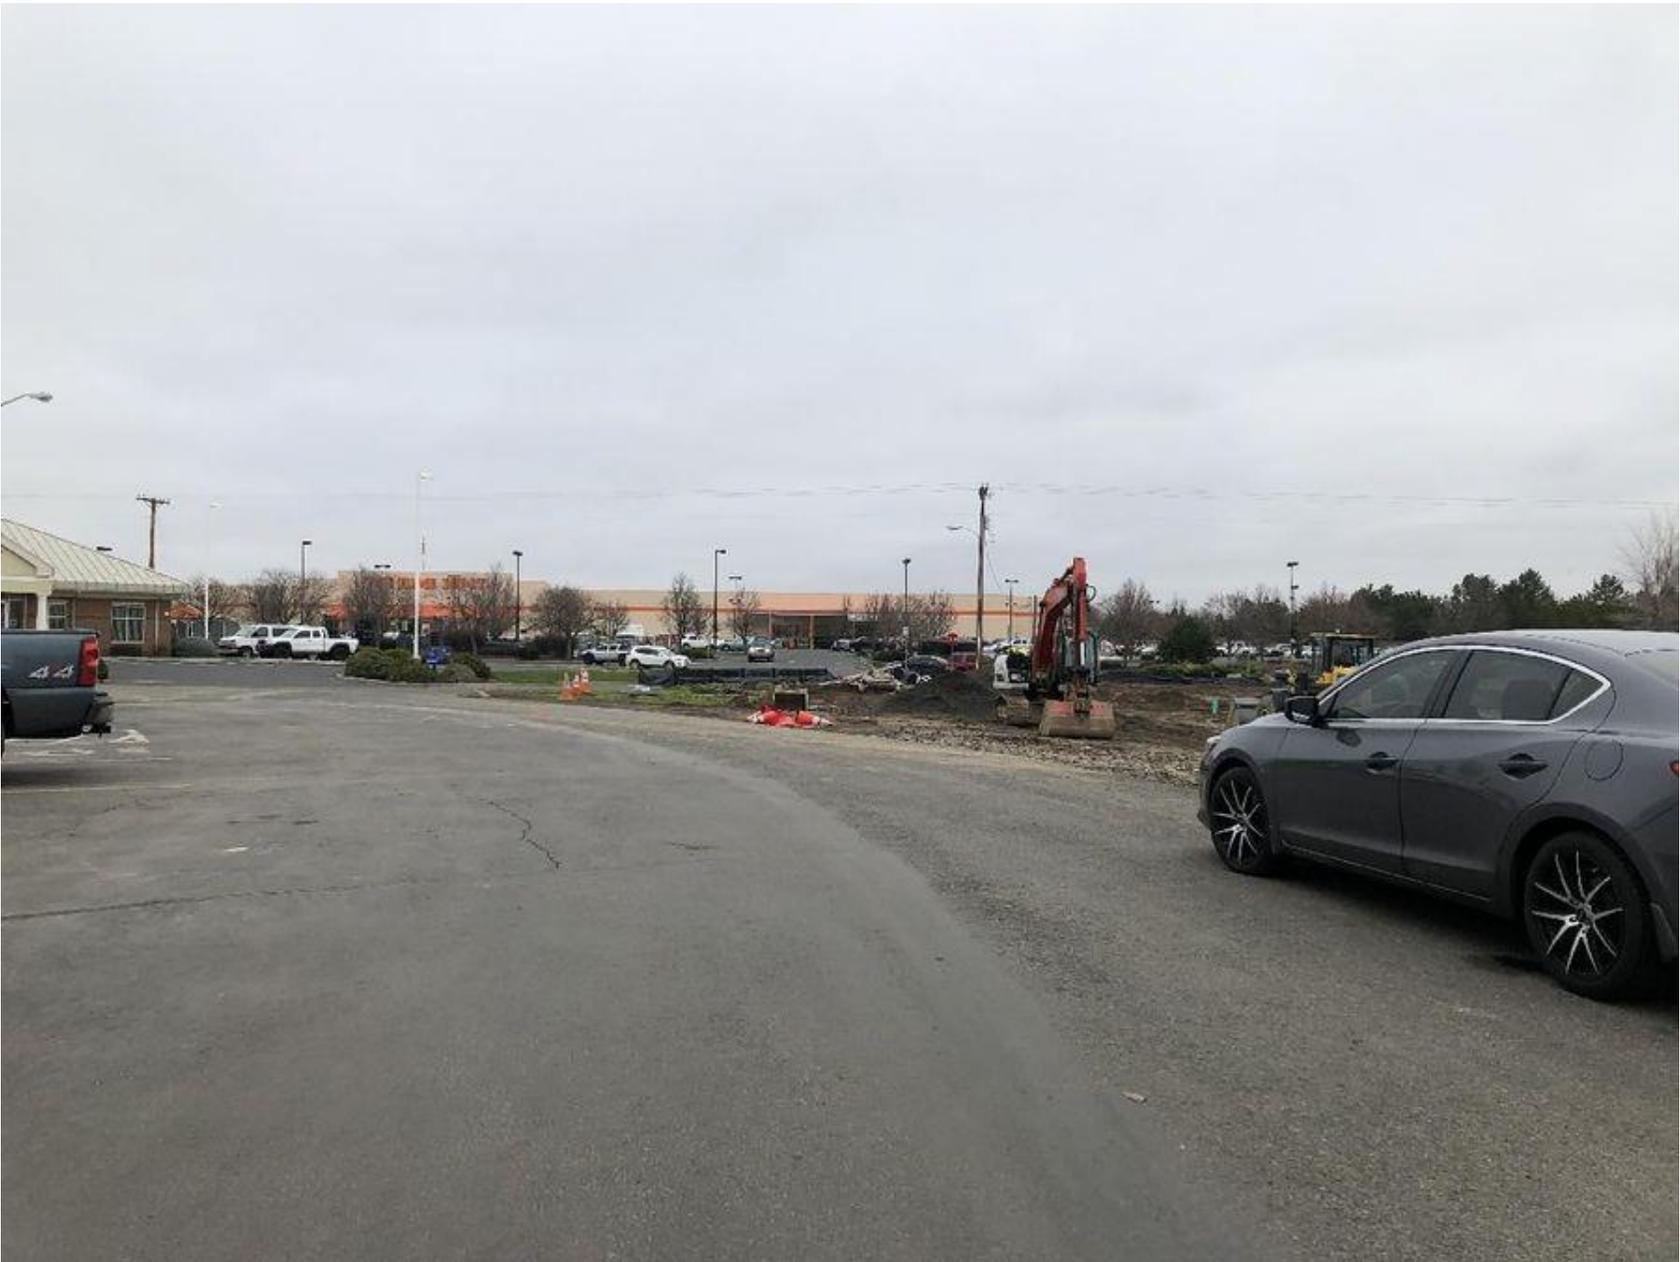
Photo 1

Photo Description: Sediment tracked off site onto Oil Can Henry's paved area.

<u>Violations and action required to achieve compliance</u>	Complete or submit date	Guidance
<p><u>S9.D.2 Establish Construction Access</u> Failure to meet S9.D.2.d: If sediment is tracked off site, clean the affected roadway thoroughly at the end of each day, or more frequently as necessary (for example, during wet weather). Remove sediment from roads by shoveling, sweeping, or pickup and transport of the sediment to a controlled sediment disposal area. Install and maintain adequate construction access to prevent track-out off-site.</p>	<p>Clean the affected roadway thoroughly at the end of each day, or more frequently as necessary. Immediately begin. Address the problems no later than 10 days from the receipt of this inspection report.</p>	<p>BMP C105E, BMP C106E, BMP C107E</p>
<p><u>S9.D.9 Control Pollutants</u> Failure to meet S9.D.9.c: Conduct maintenance, fueling, and repair of heavy equipment and vehicles using spill prevention and control measures. Clean contaminated surfaces immediately following any spill incident. Design, install, implement and maintain effective pollution prevention measures to minimize the discharge of pollutants, as set forth in permit conditions S1.D.1, S9.D.9.</p>	<p>Immediately begin. Address the problems no later than 10 days from the receipt of this inspection report.</p>	<p>C153E</p>

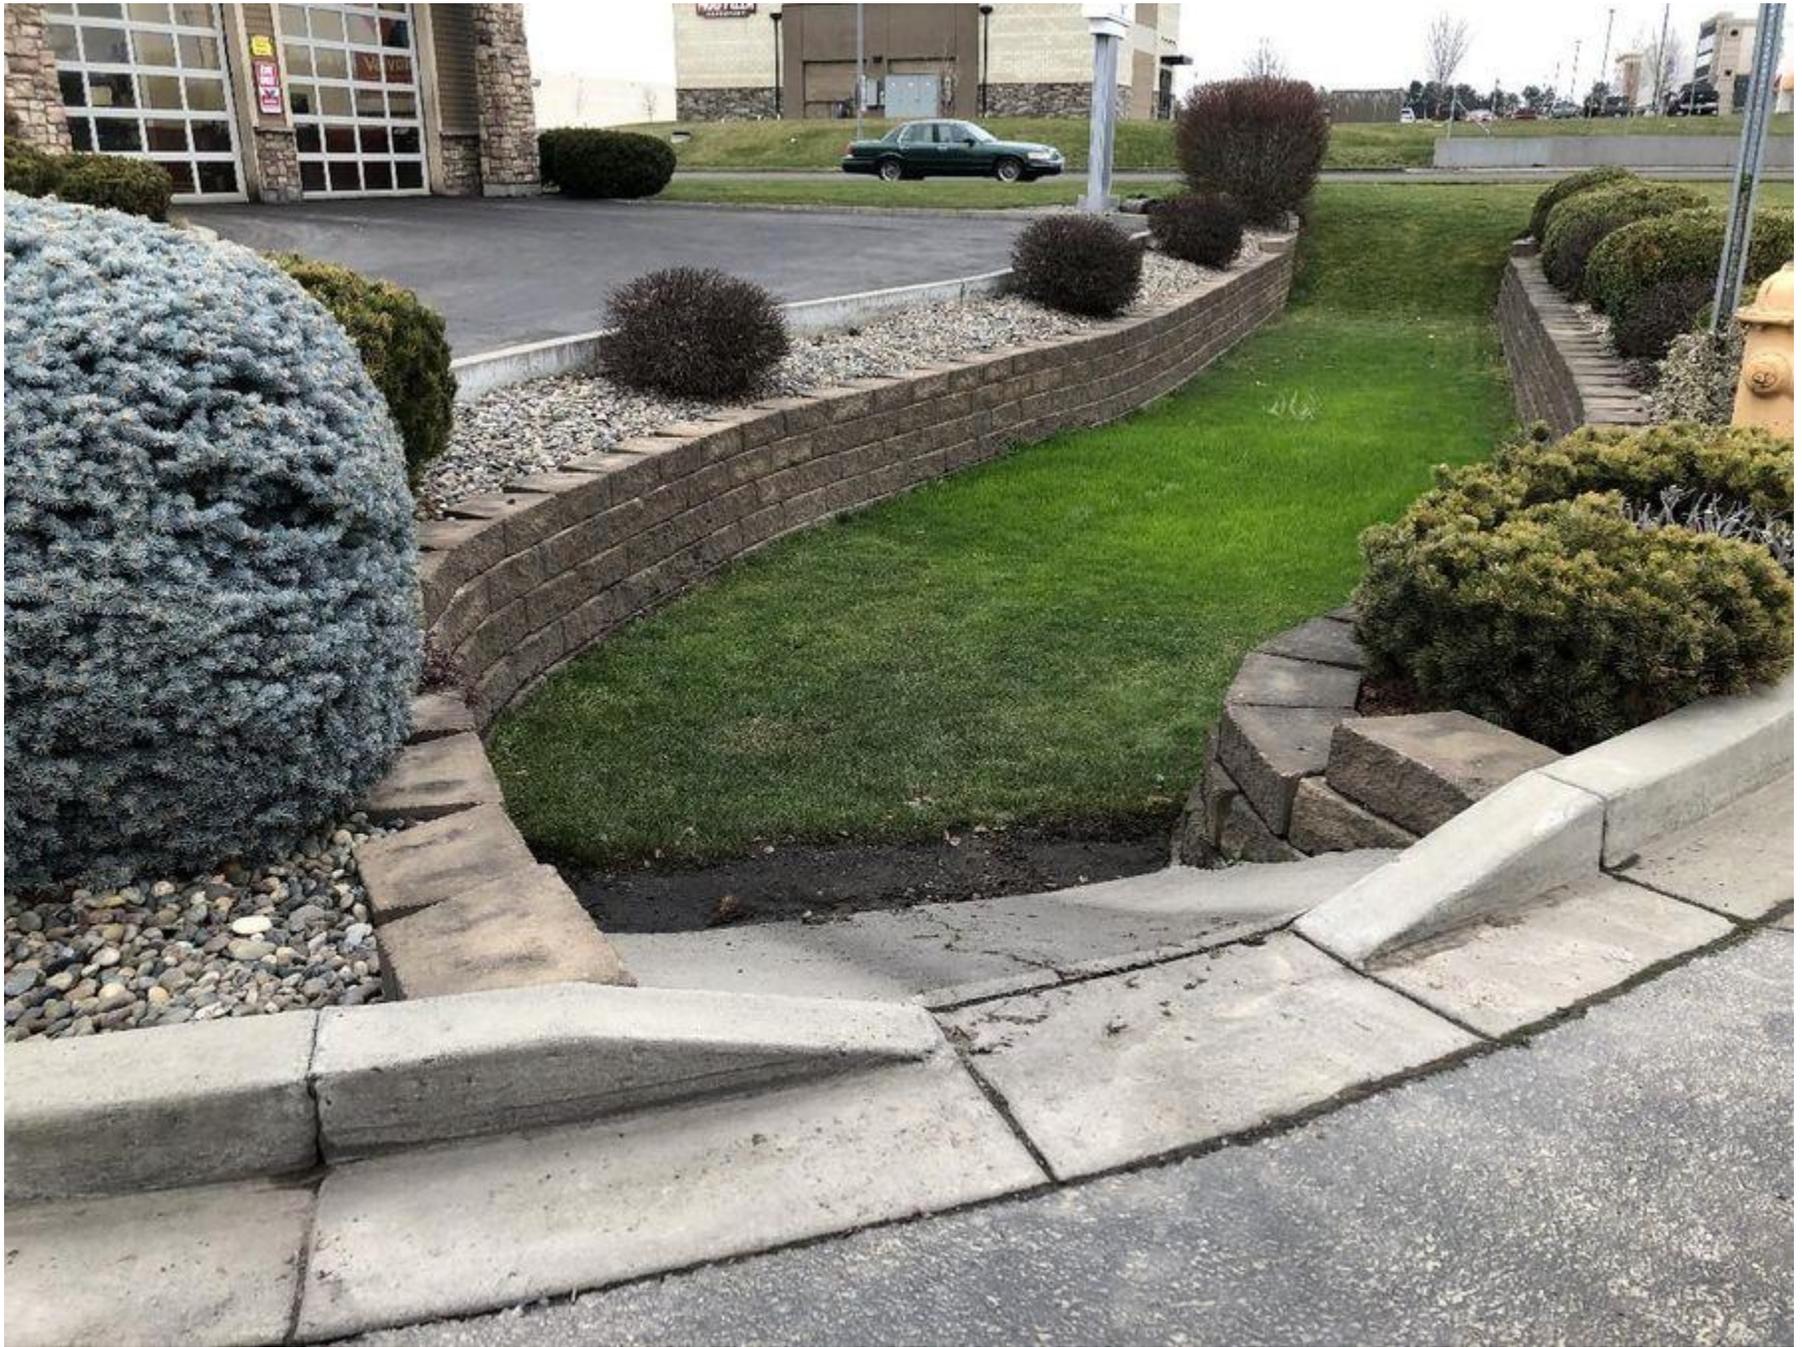
Photo 2

Photo Description: Destruction of stormwater pond. Sediment has discharged into pond.

<p><u>S9.D.13 Protect Low Impact Development (LID) BMPs</u> Failure to meet S9.D.13.a: Permittees must protect all LID BMPs (including, but not limited to, bioretention and Rain Garden facilities) from sedimentation through installation and maintenance of erosion and sediment control BMPs on portions of the site that drain into the Bioretention and/or Rain Garden facilities. Restore the BMPs to their fully functioning condition if they accumulate sediment during construction. Restoring the facility must include removal of sediment and any sediment-laden Bioretention/Rain Garden soils, and replacing the removed soils with soils meeting the design specification. Protect Low Impact Development BMPs, as set forth in permit condition S9.D.13.</p>	<p>Immediately begin. Address the problems no later than 10 days from the receipt of this inspection report.</p>	<p>C102E, C103E, C200E, C201E, C207E, C208E, C231E, C233E, C234E</p>

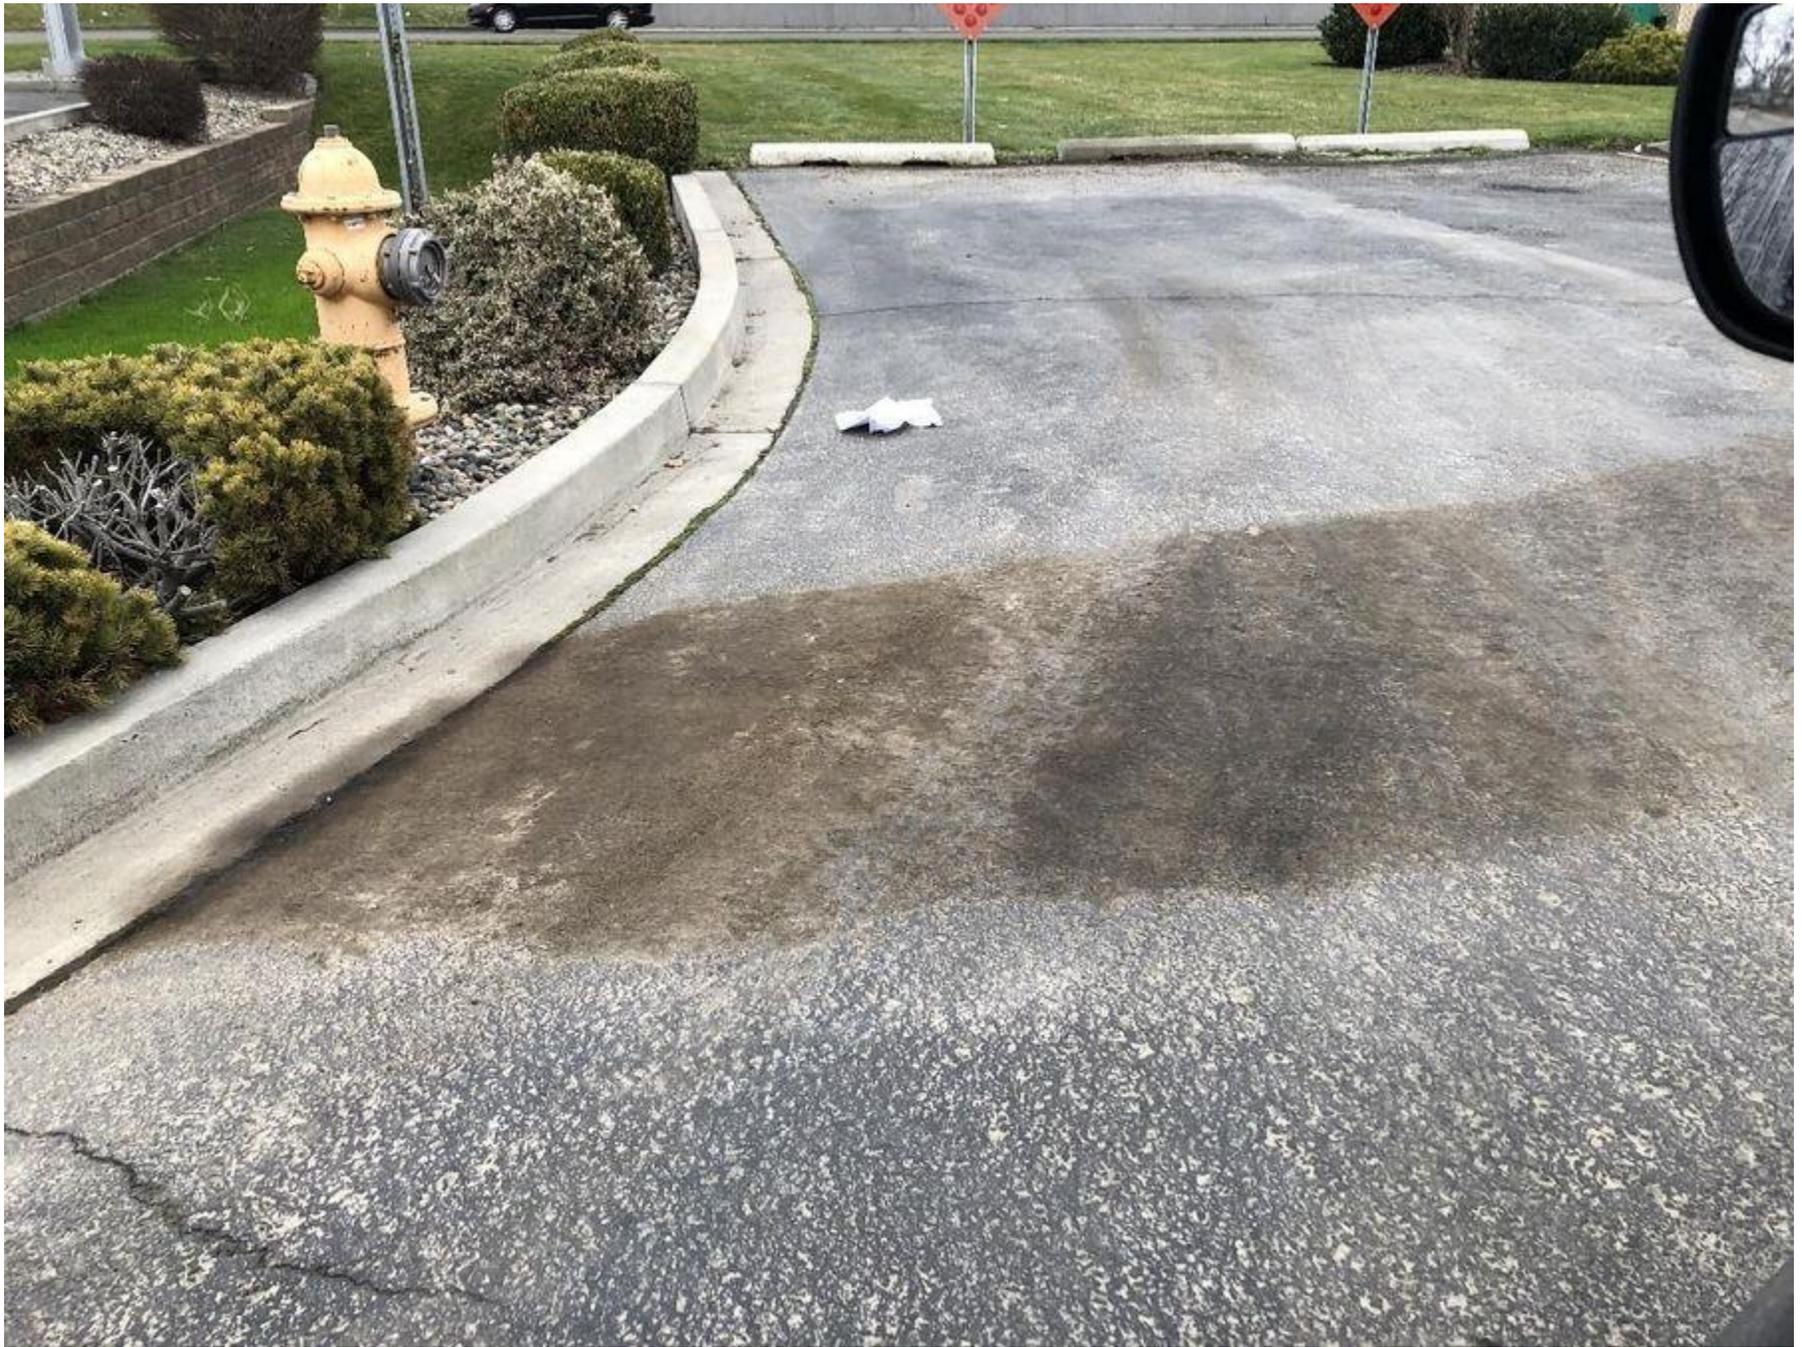
Photo 3

Photo Description: Petroleum spill on paved area.

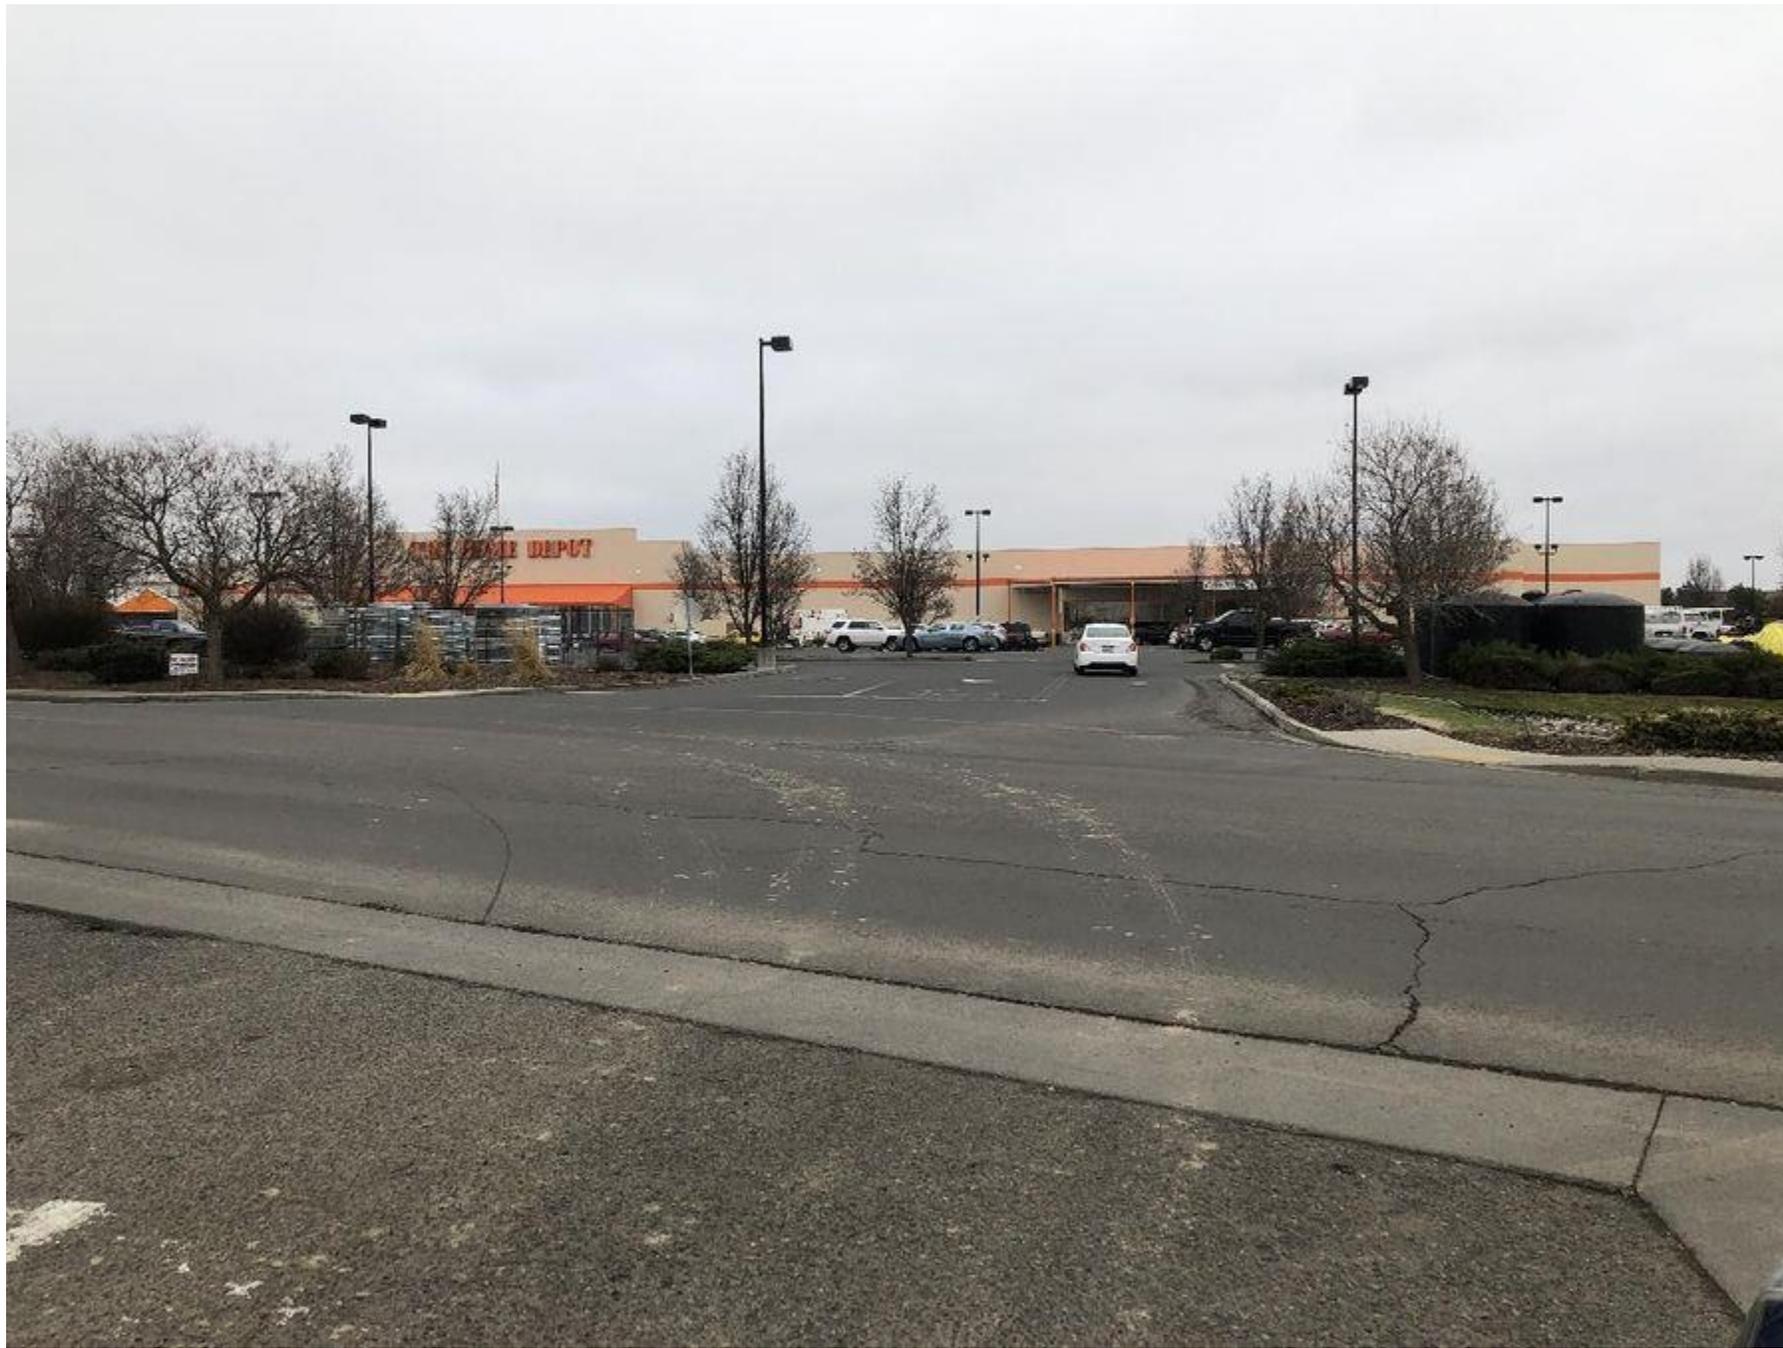
Photo 4

Photo Description: Minor track out on Northeast C Street.
