STORMWATER COMPLIANCE INSPECTION REPORT

Name and Location of Site Inspected Archer Daniels Midland Company (ADM) WILD FLAVORS INC, DBA AM TODD WEST 1501 S Columbia st Goldendale, WA	Entry Time 1pm
	Exit Time 1:47pm
	GPS Lat: Long:
	Entrance: 45.810788, -120.823660
Discharge: 45.811100, -120.824471	
On-Site Representative(s): Name(s)/Title(s)/Contact number(s) or E-mail David Bischoff / Mint Technician-Facility Lead / 509.773.4008 / David.Bischoff@adm.com	Additional Participants: Amanda Richards
Responsible Official(s): Richard Nichols, Plant Manager	
Samples Taken? <input type="checkbox"/> Yes <input checked="" type="checkbox"/> No Photos Taken? <input checked="" type="checkbox"/> <input type="checkbox"/>

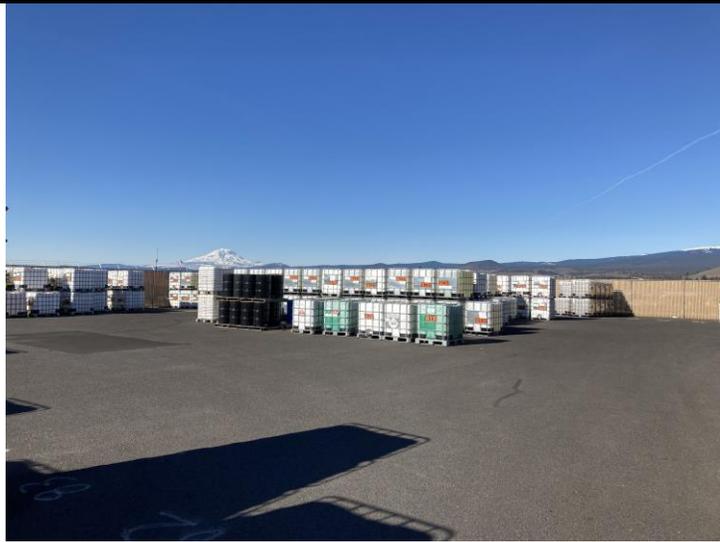
FIGURE 1: STORAGE YARD HAS EMPTY AND FULL MINT OIL CONTAINERS.

There is a small wash bay with a dead-end sump for cleaning containers before they are sent to mint farms. There are both empty and full mint oil intermediate bulk containers (IBCs) stored outside. These IBC's are recertified every 2 1/2 years, and removed after they have passed their life cycle limit. Outside storage yard is accessed often and inspected monthly for valve leaks and drips of oil.

Totes inspected monthly.

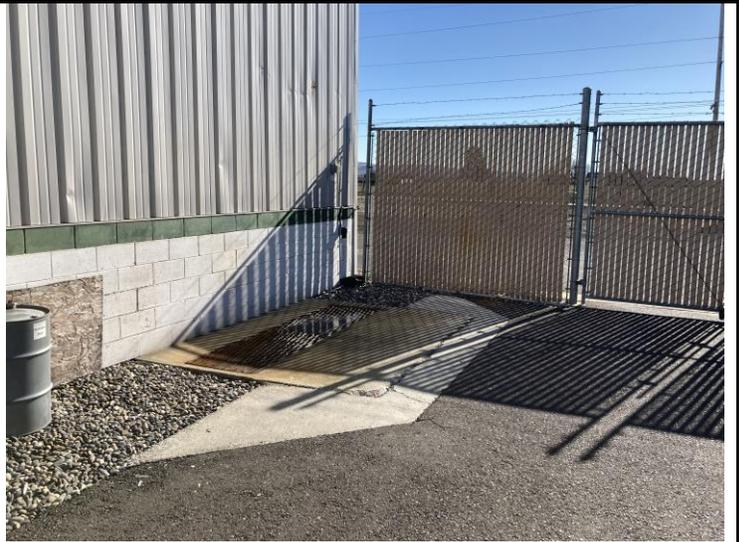
FIGURE 2: SMALL WASH BAY WITH DEAD-END SUMP FOR WASHING CONTAINERS.

Clean tanks before
sending them to growers.

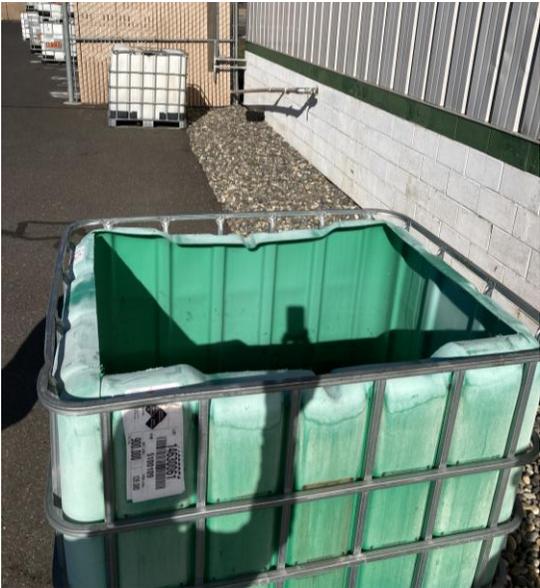
FIGURE 3: EVAPORATION TOTES FOR MINT OIL WATER IMPURITIES

The aqueous impurities found in mint oil mixes are separated out and then stored in several totes outside, and partially evaporated there. The wastewater is discharged to the local POTW, with clear notification given.

Evaporate wastewater
impurities in oil. in IBC tote.

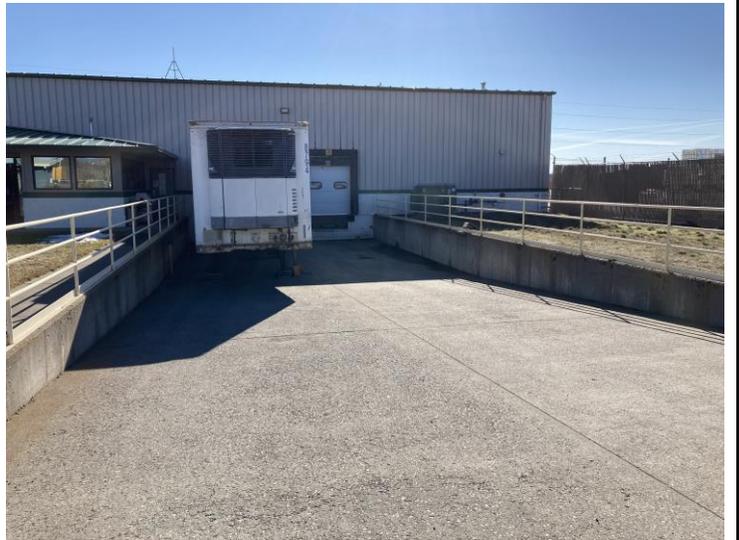
FIGURE 4: TRUCK LOADING BAY. ENTIRE INSIDE OF BUILDING IS PLUMBED TO DISCHARGE TO THIS LOADING BAY IN AN EMERGENCY SPILL SCENARIO.

The facility stores and mixes mint oils received from surrounding production farms. Inside there are mint oil containers ready for shipping, and large mint oil mixing tanks. The building has an emergency spill system that is plumbed to empty into their truck loading bay. The outside yard is sealed asphalt and discharges sheet flow stormwater to a surface infiltration pond. If this pond overflows, it would drain across Industrial way and enter into a dry ditch 1 mile from the Little Klickitat river.

Truck loading bay
is plumbed to receive
all inside building drains.

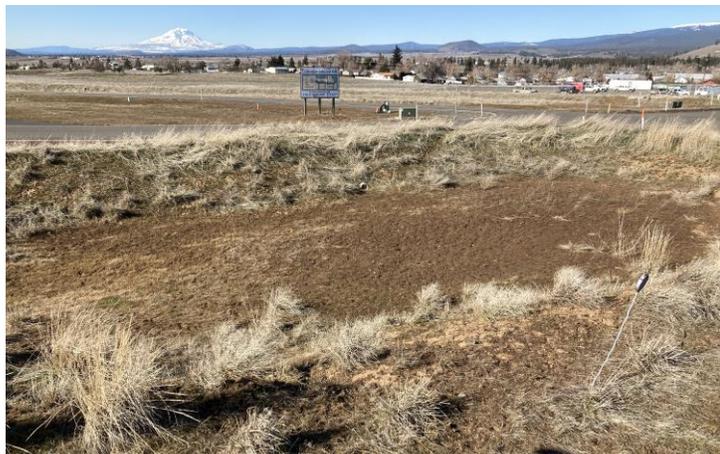
FIGURE 5: STORMWATER INFILTRATION POND. DISCHARGE PIPE REMAINS CAPPED, FOR EMERGENCY USE ONLY.

Citation reference	Page #	Specific Violation	Action	Due date
Condition S3.B.4.b.i.3.b	Pg. 13	Maintain ponds, tanks/vaults, catch basins, swales, filters, oil/water separators, drains, and other stormwater drainage /treatment facilities in accordance with the Maintenance Standards set forth in the applicable Stormwater Management Manual	Monitor and maintain your infiltration pond. Relevant chapters of the EWSWMM include section 6.2.5 on page 537, BMP F6.21 on page 601 and appendix 6.A.7 on page 729.	Recommended

Infiltration Pond takes
all stormwater for out-
side lot.
