**Re: Dickson Company - Waller Rd Pit- Sand & Gravel General Permit No. – WAG501405
Compliance Inspection**

Water Compliance Inspection Report

Photograph Log

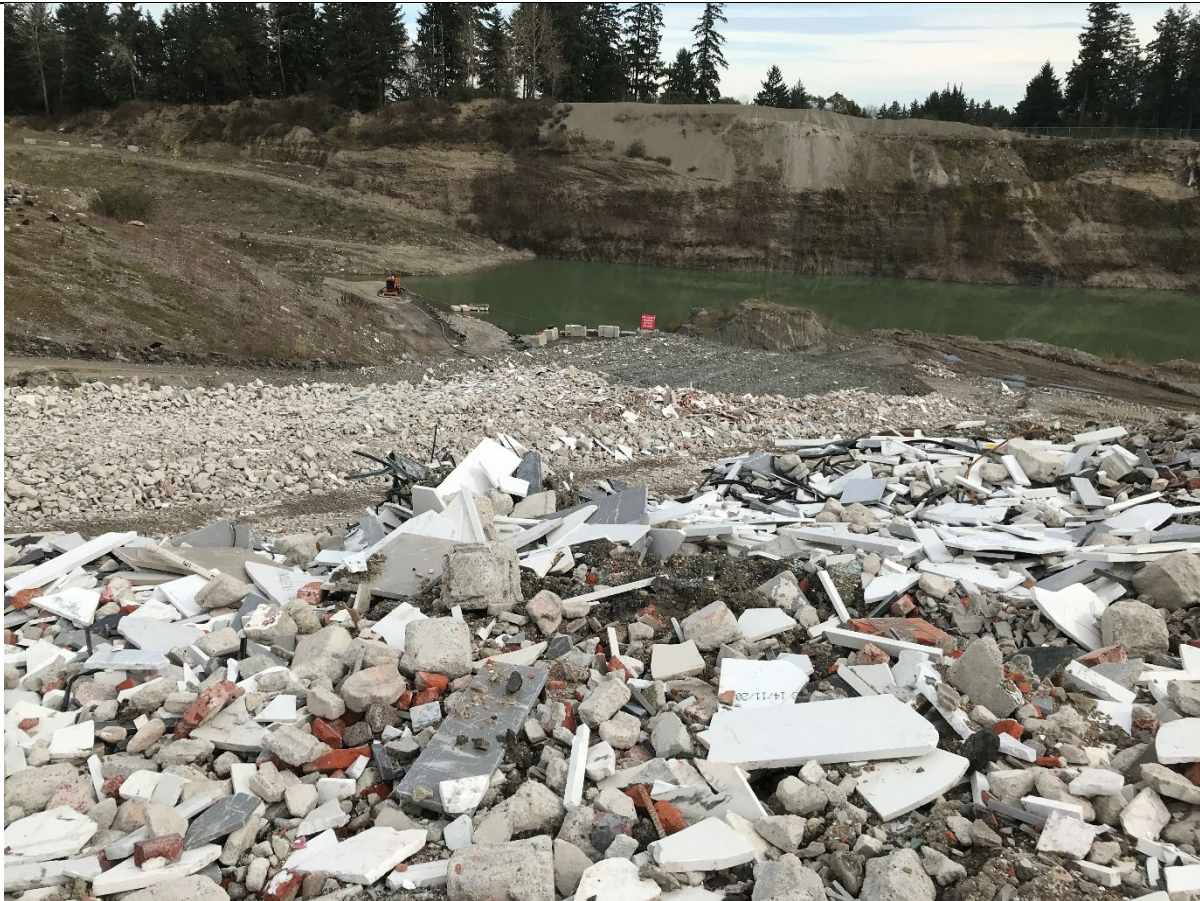
Photograph 1: Solid waste landfill operations and the main infiltration pond below.

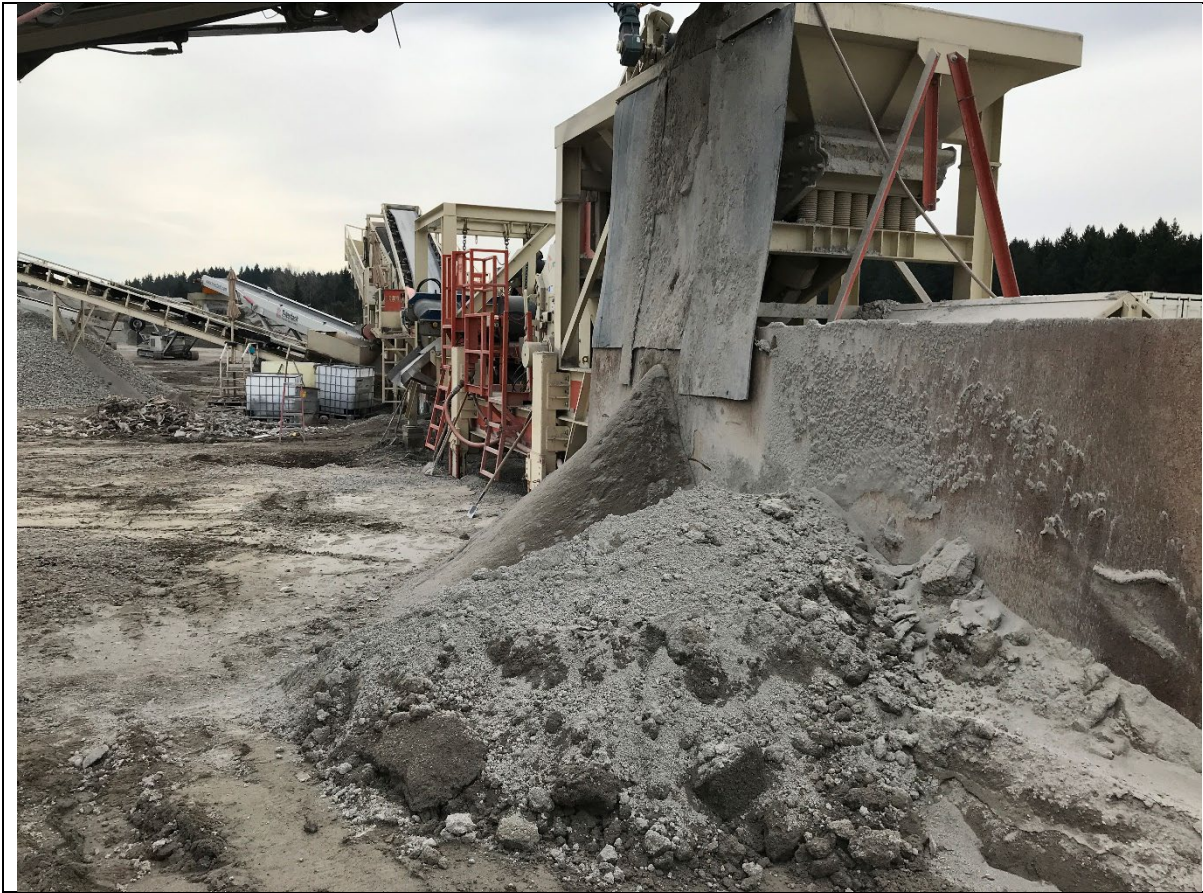
I measured exceedances of the pH effluent limit (6.5-8.5) in ponding water near the concrete recycling area, within an unlined collection impoundment and within the main infiltration pond. There is a significant accumulation concrete crushing by-product (concrete dust) on the ground. Source control Best Management Practices (BMPs) are needed to prevent pH exceedance in discharges to groundwater.

Photogrpah 2: Accumulation of concrete fines from the crusher and concrete recycling operations.

- Immediately conduct housekeeping, and implement source control BMPs to prevent effluent violations.
- Submit a compliance report within 30 days of the inspection that explains the corrections made and re-sampling for pH effluent limits.

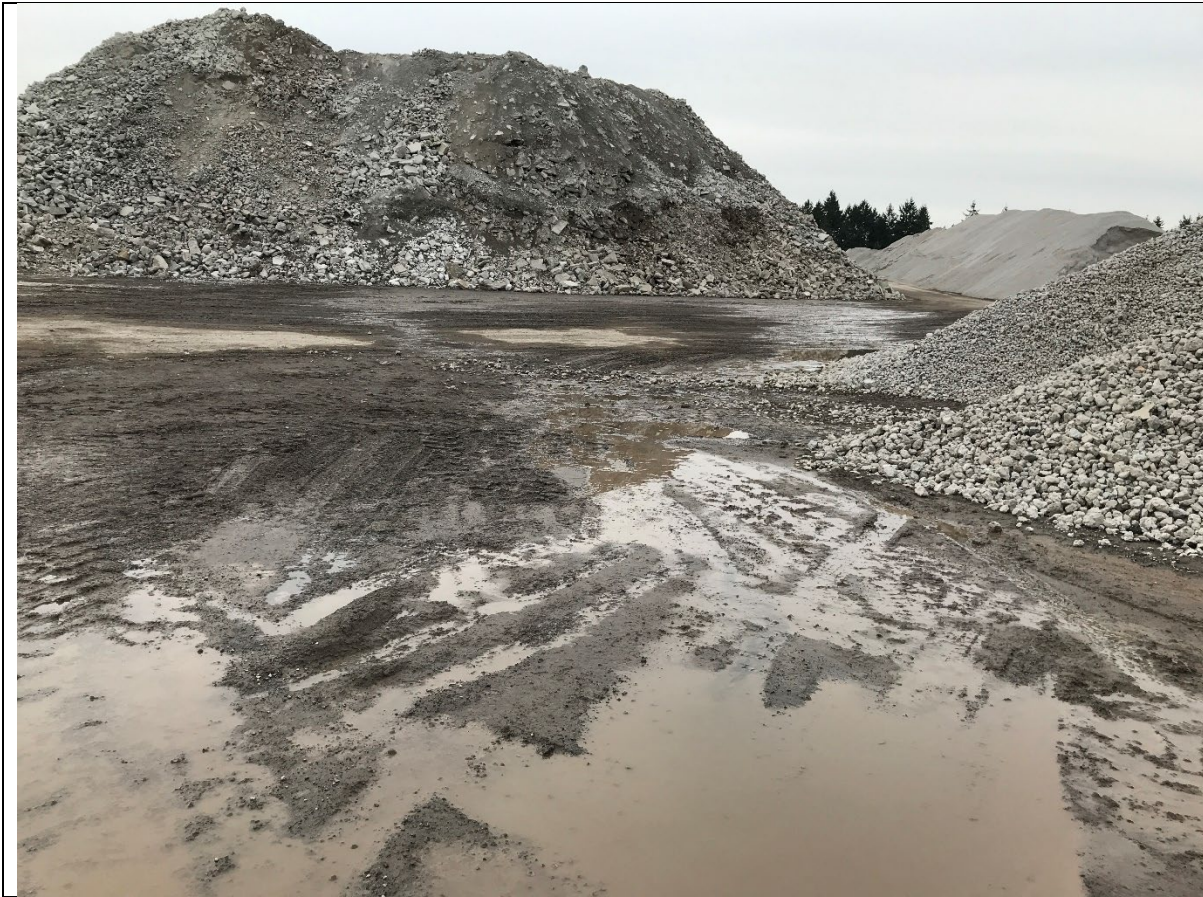
Photograph 3: Drainage path of the concrete crushing and stockpile area runoff. I measured a pH of 10.78 in pooling water on the bare ground.

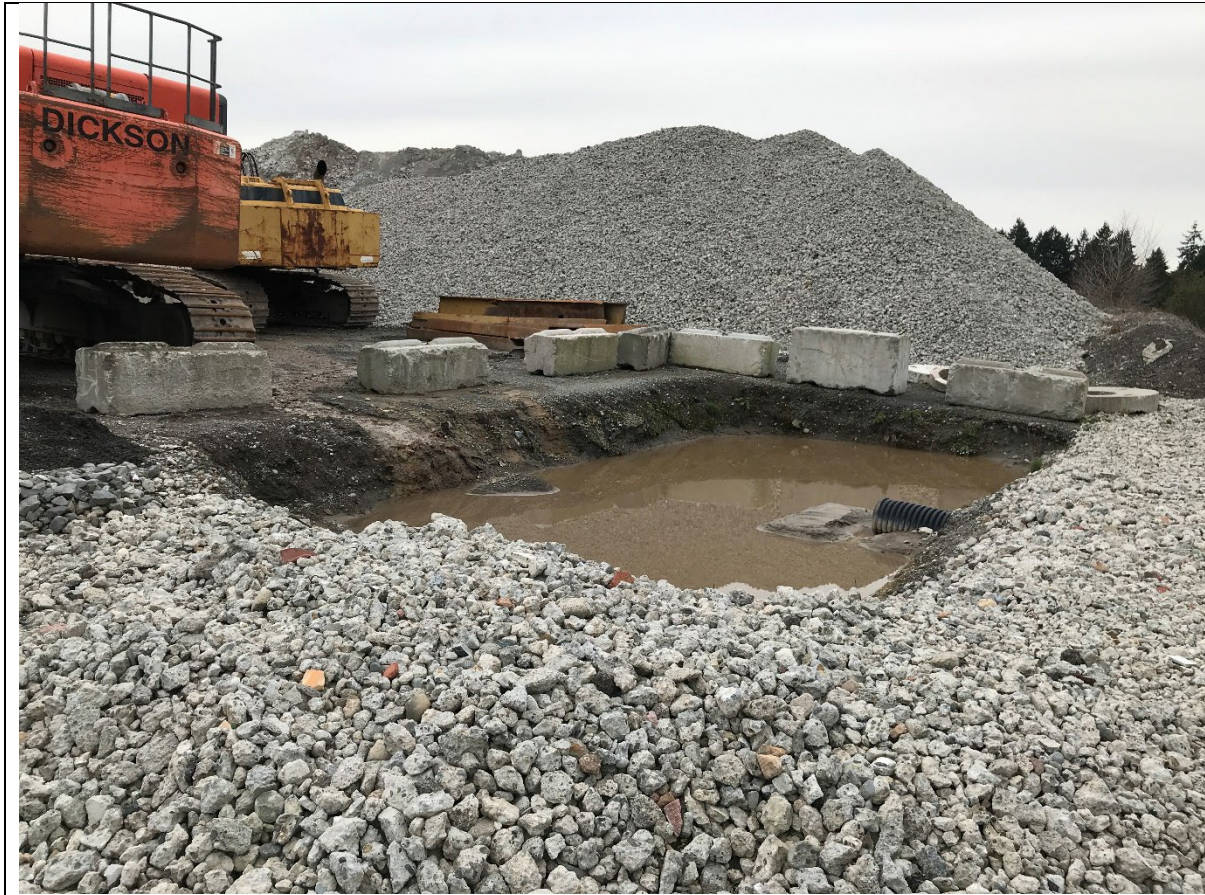
Photograph 4: Impoundment in bare ground where runoff from the concrete crushing and stockpile area is collected before being piped to the main infiltration pond. I measured a pH of 11.57 S.U. in this pond.

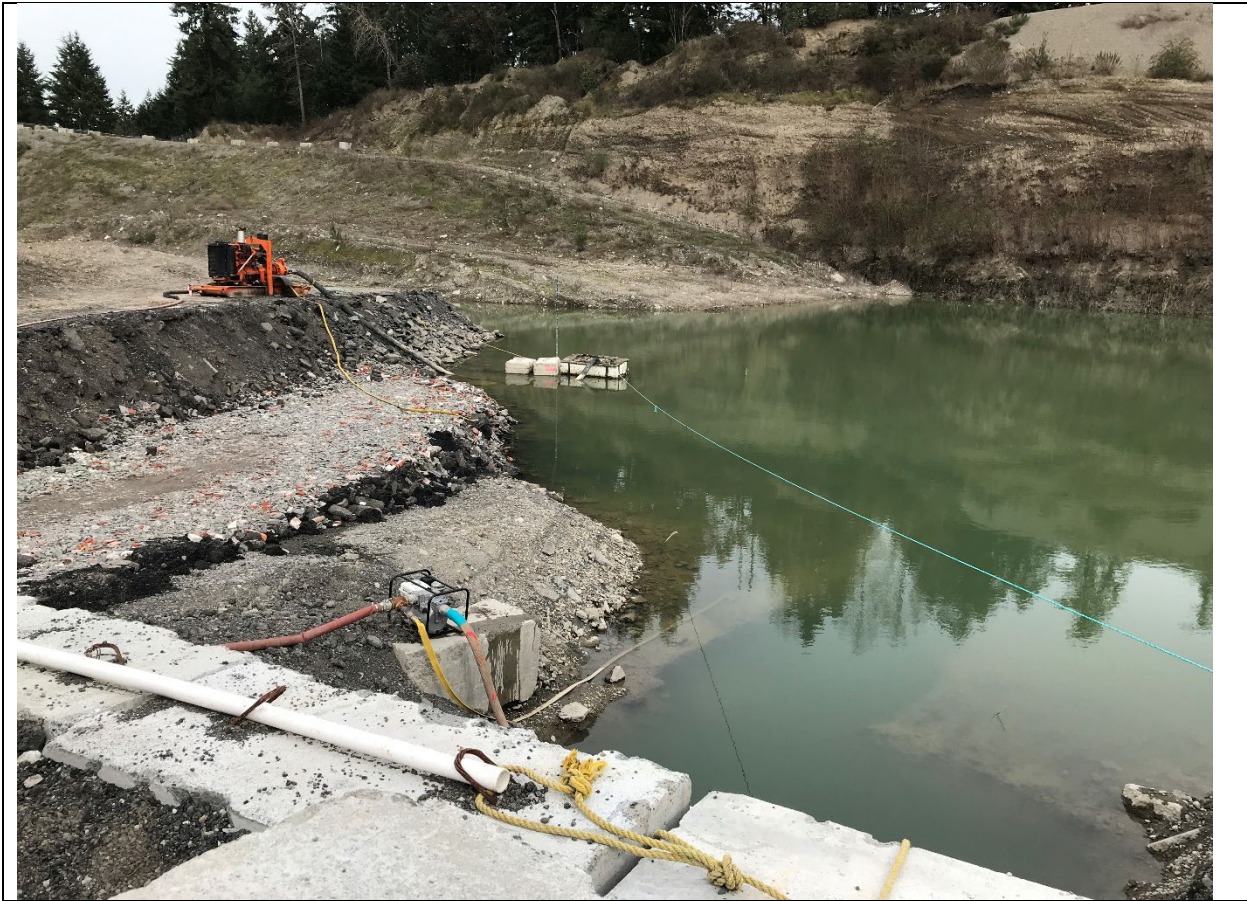
Photograph 5: Main infiltration pond - monitoring point SP2, I measured a pH of 9.07 S.U. The pump was not running and surface water discharge was not occurring during the inspection.

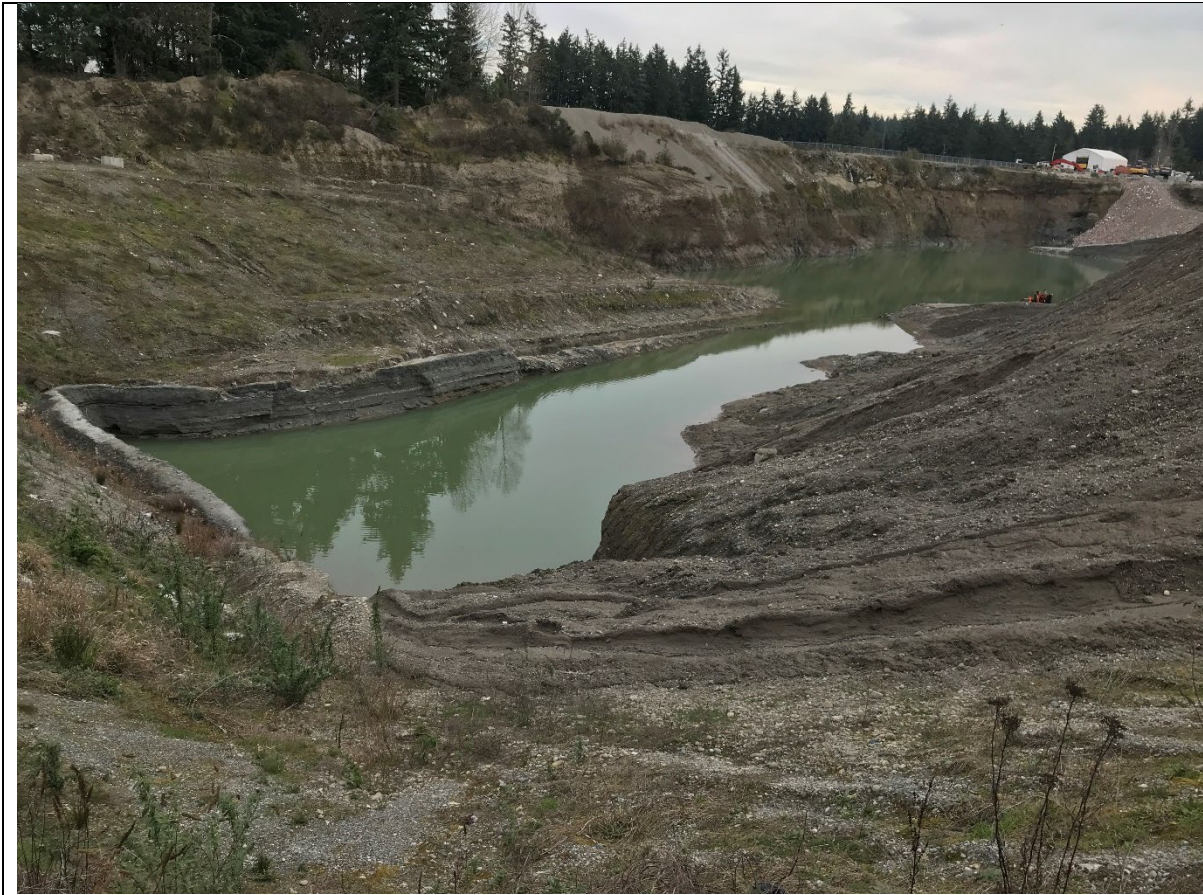
Photograph 6: The site map pond 7 and pond 9 are currently joined as a single main infiltration pond.
