Subject: Noncompliance Notification (June 3, 2022)
Puget Sound Energy's
Lower Baker Dam Seepage Reduction Project
WAR310649
GEI File No. 0186-899-05

Lower Baker Dam Seepage Reduction Project
 Town of Concrete, Washington
 WAR310649
 June 3, 2022 Non-compliant Incident
 Figure 1 - Discharge Locations

LOWER BAKER DAM SEEPAGE REDUCTION PROJECT

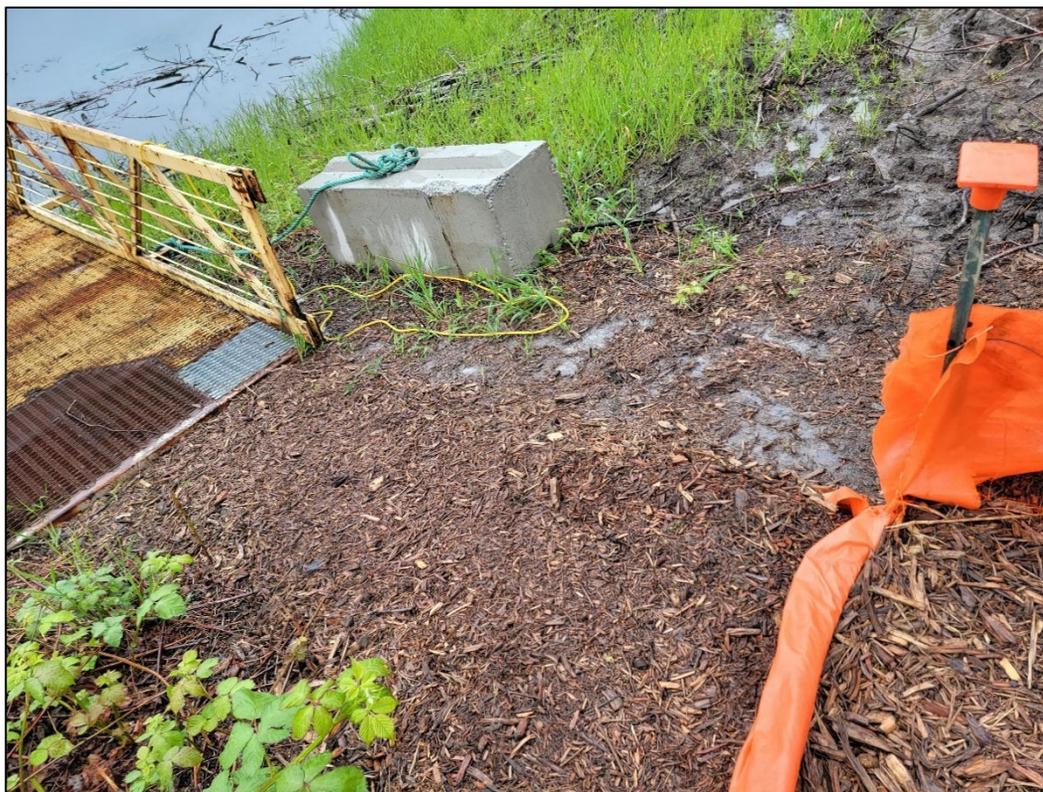
Figure 2. BaR-1 on June 3, 2022; foot path to barge ramp

During the June 3rd rain event, the CESCL observed that a small stormwater conveyance rill with turbid runoff from the construction access road had appeared to the north of the footpath. The water flowed underneath the installed silt fence and the CESCL observed turbid water discharging into Lake Shannon (BaR-1 on Figure 2). A turbidity measurement exceeded the upper measuring limit of the turbidity meter (i.e., exceeded 1,000 nephelometric turbidity units [NTUs]); therefore, the turbidity of the discharge was greater than the permitted upper benchmark of 250 NTUs. To address this turbid runoff, a shallow and narrow hand-dug ditch was created in the construction access road to divert the runoff away from the area and into an area covered with wood mulch for infiltration. Additionally, silt fence previously installed near BaR-1 where stormwater had been observed to flow beneath was reinstalled properly to prevent water from flowing beneath and toward Lake Shannon.

By diverting runoff using the hand-dug ditch, the turbid runoff entering Lake Shannon was stopped in less than 30 minutes after its discovery. No follow up turbidity measurements were taken at BaR-1 because the discharge was stopped. Documentation of BMP installation will be recorded as markups to the Stormwater Pollution Prevention Plan (SWPPP) and TESC Plan and into the CESCL inspection checklist(s), all of which are maintained in the site logbook. The markups to the TESC Plan are attached.

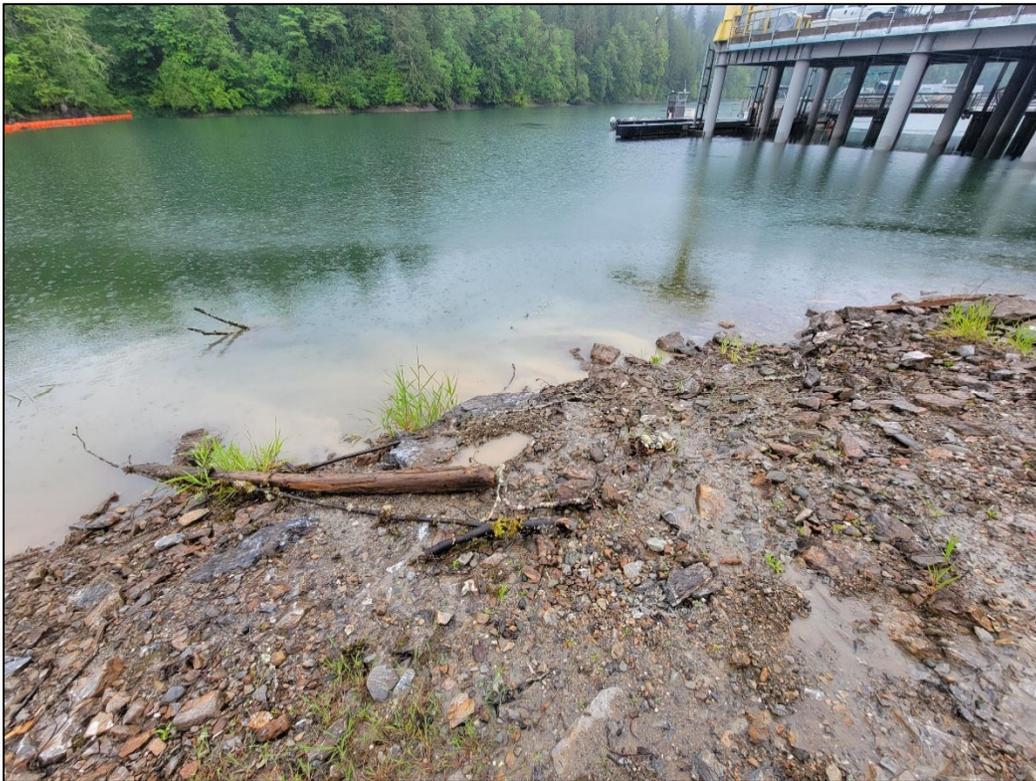
Figure 3. BR-1 on June 3, 2022; boat ramp

During the June 3rd rain event, the CESCL observed a small turbid plume in Lake Shannon at the base of the boat ramp (Figure 3). After tracking the source of the turbid discharge, it was determined that stormwater run-on from the construction access road at the top of the intermediate slope had a turbidity measurement exceeding the upper measuring limit of the turbidity meter (i.e., 1,000 NTUs). To address this turbid runoff, the contractor placed a straw wattle across the width along the top of the boat ramp on June 6 (Figure 4), when they returned to work after the weekend. Additionally, a shallow and narrow ditch was hand-dug within the construction roadway leading toward the boat ramp to divert stormwater back toward the construction site (Figure 5).

The contractor will install a floating silt curtain around the boat ramp during the week of June 13. Documentation of BMP installation will be recorded as markups to the SWPPP and TESC Plan and into the CESCL inspection checklist(s), all of which are maintained in the site logbook. The markups to the TESC Plan are attached to this noncompliance notification.

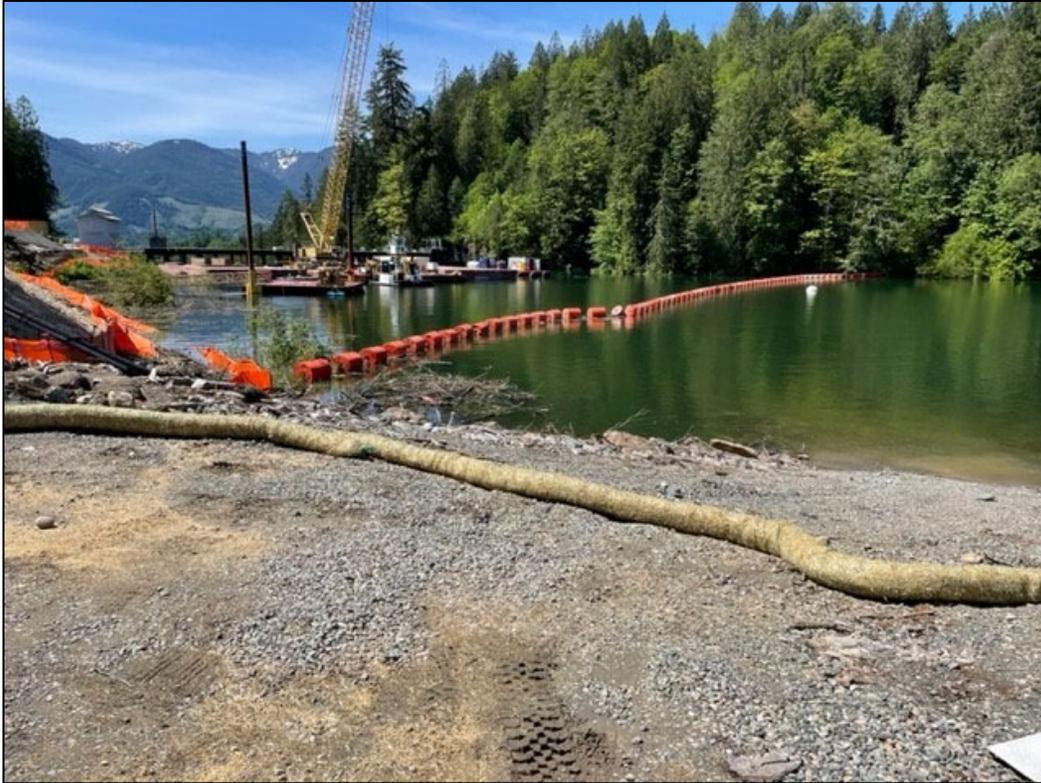
Figure 4. BR-1 on June 6, 2022; boat ramp with straw wattles installed across the width of the top of the ramp.

The BR-1 location was monitored daily from June 6 through 8 by PSE's CESCL. No discharge was observed at BR-1. However, the CESCL measured turbidity at BR-1 on June 9 during a rain event. The turbidity was 826 NTUs and turbid runoff from the construction access road was observed flowing through the gravel beneath the wattle and down the boat ramp to the lake.

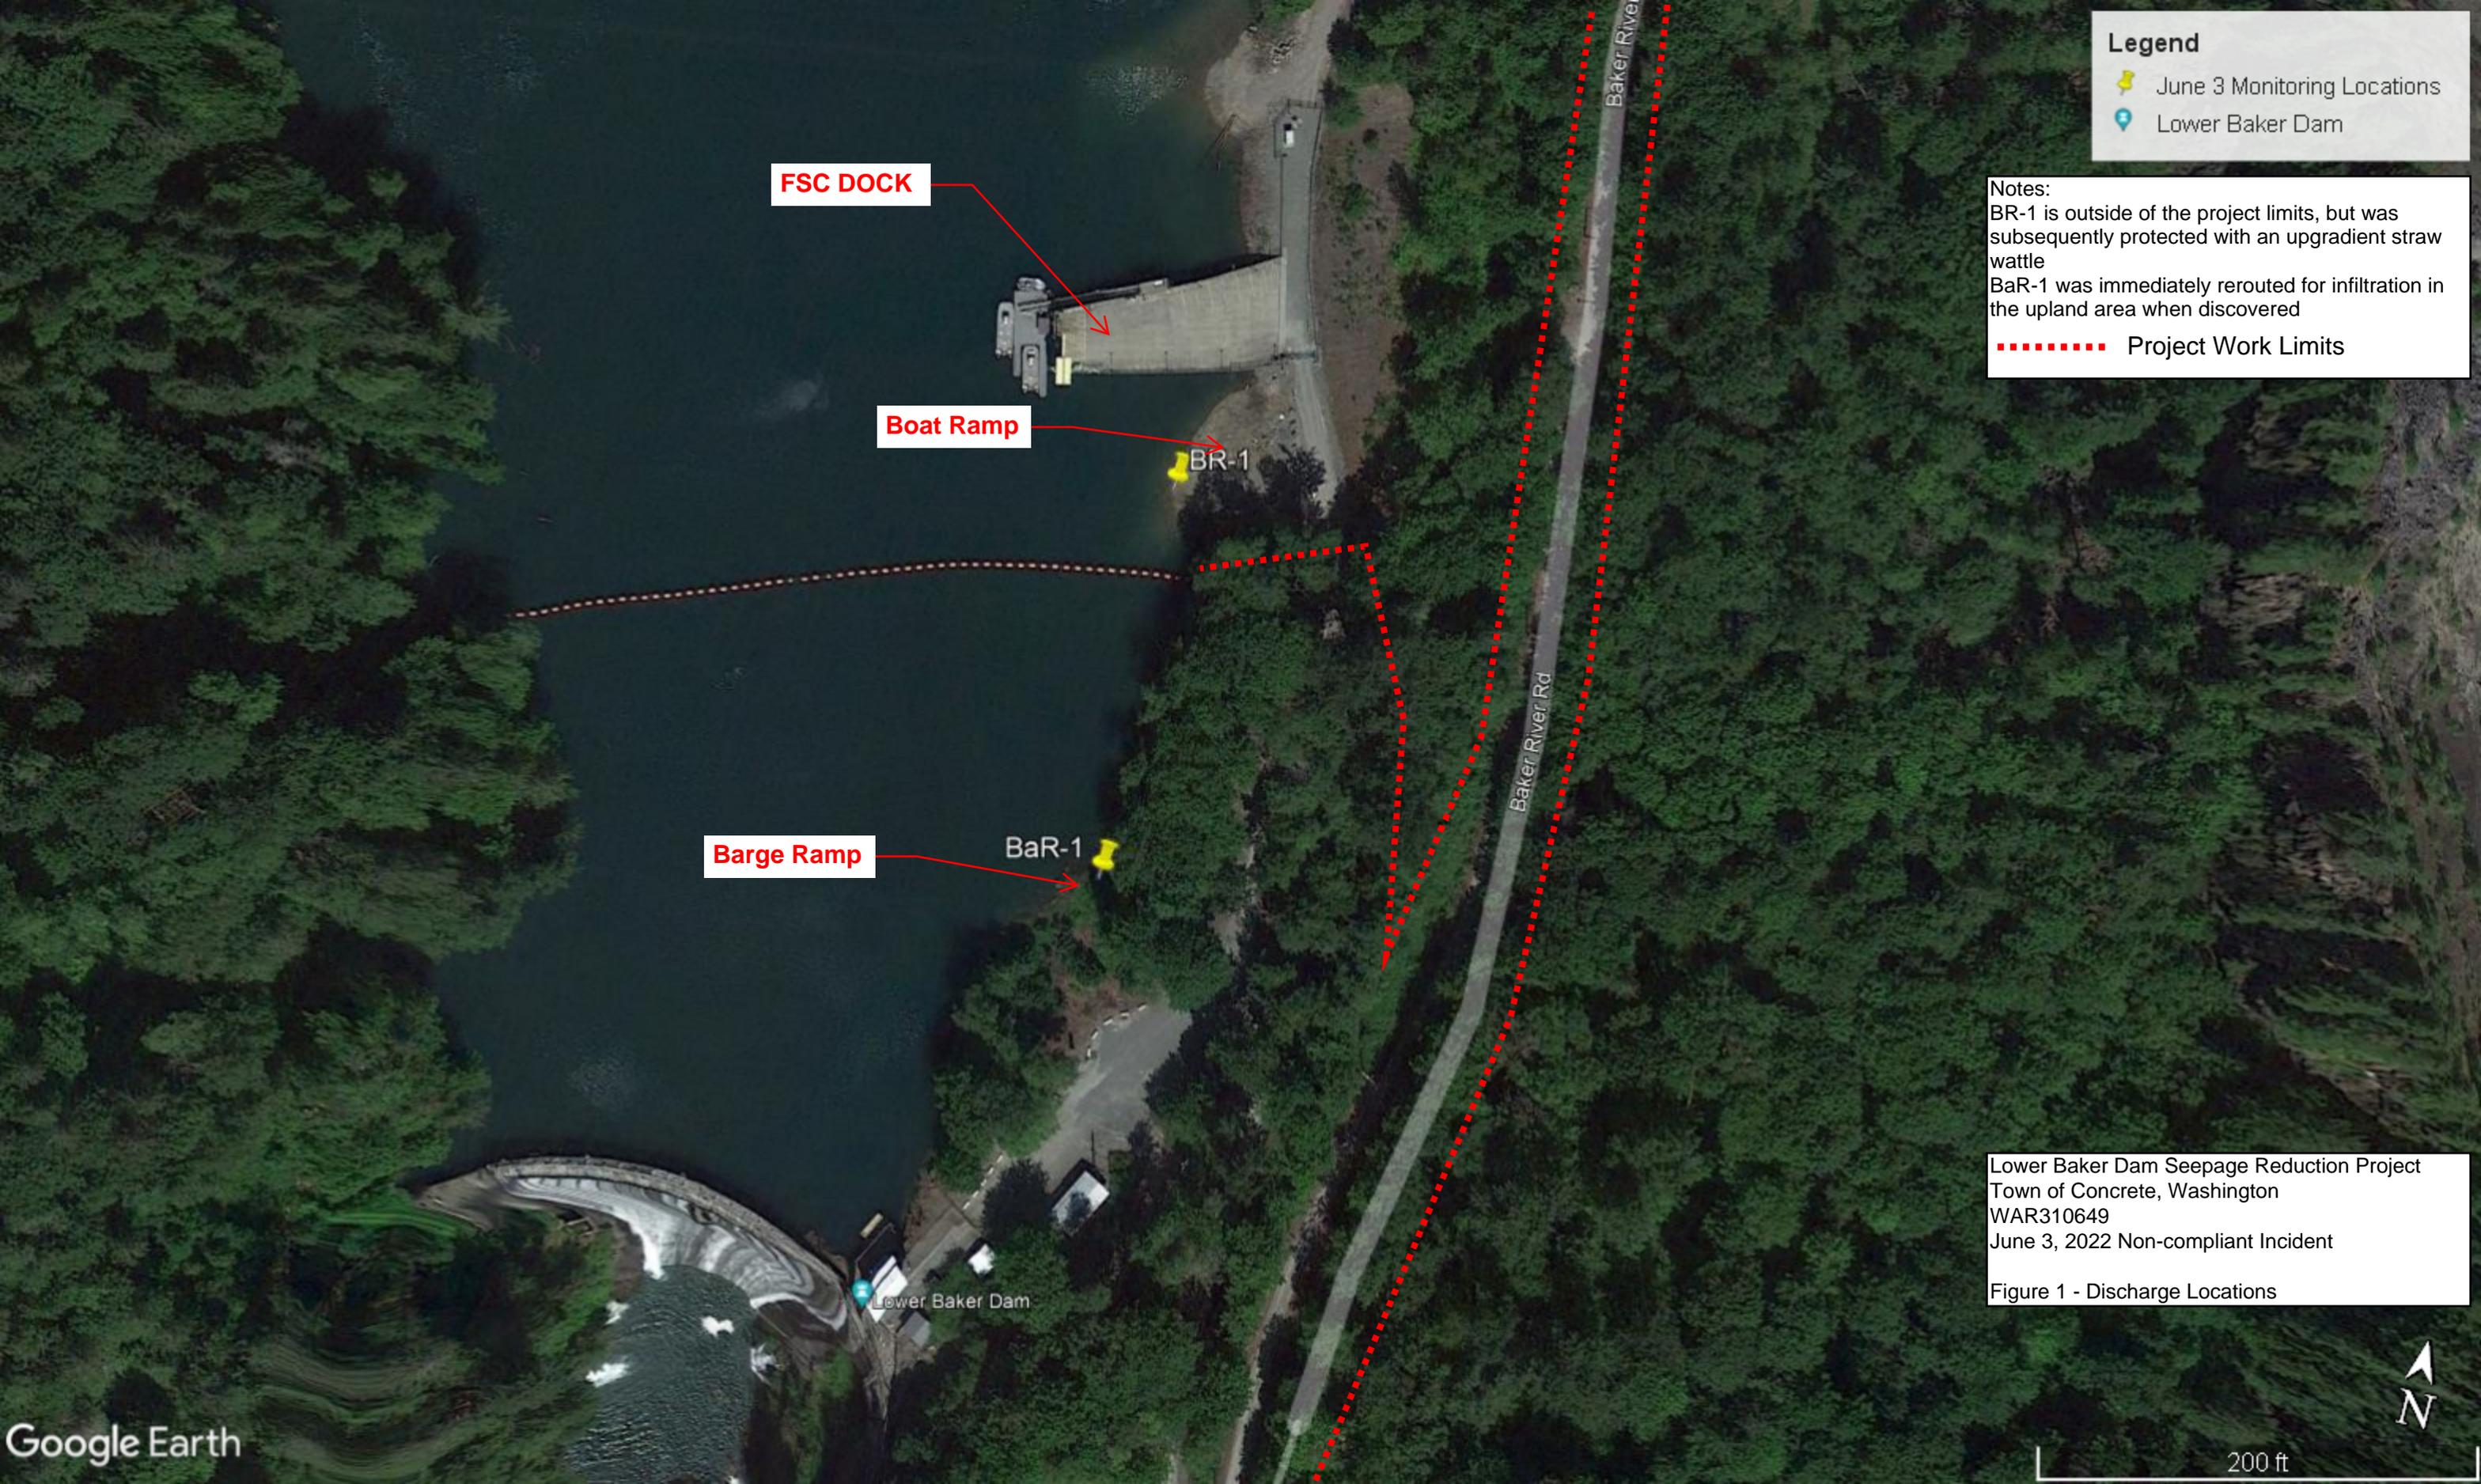
On June 3, 2022, during a weekly Certified Erosion and Sediment Control Lead (CESCL) site inspection during a rainfall event, the CESCL observed discharge of turbid stormwater runoff into Lake Shannon at two locations: a barge ramp (BaR-1) and an unused boat ramp (BR-1) just south of the Floating Surface Collector dock (Figure 1).

Notes:
 BR-1 is outside of the project limits, but was subsequently protected with an upgradient straw wattle
 BaR-1 was immediately rerouted for infiltration in the upland area when discovered
 ----- Project Work Limits
