CONSTRUCTION STORMWATER COMPLIANCE INSPECTION REPORT

State of Washington Department of Ecology

Name and Location of Site Inspected: SR 520 I-5 to Medina Bridge Replacement SR 520 connection with I-5 Seattle, WA 98102	Permit webpage: https://fortress.wa.gov/ecy/paris/FacilitySummary.aspx?FacilityId=33246	Receiving waters: Portage Bay and Lake Union
Acres Disturbed /Total: 11.5/111.57		
On-Site Representatives: David Shillinglaw with Walsh (206) 457-3337 dshillinglaw@walshgroup.com Dylan Kennard with Walsh, Safi Alzeer with WSDOT, and Cheyenne Ness with WSDOT

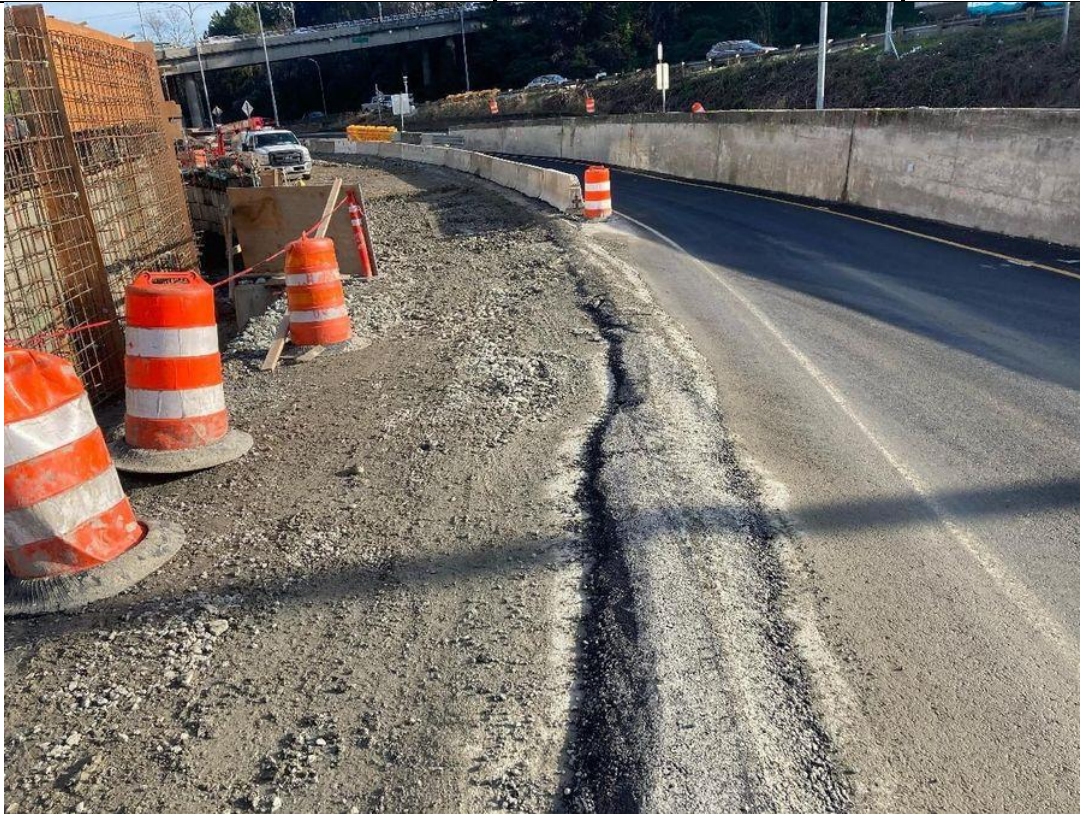
I met David and reviewed paperwork. We discussed ERTS follow-up that procedure is to have a CESCL on site during work but assumed unneeded with paving work during ERTS. Sampling outfall into Portage Bay is not possible as the pipe outfalls underwater. We walked the storage yard. Then drove to view the project from Delmar Dr E and walked E Roanoke St to overlook I-5. We also stopped at the gore, I-5 and Mercer St. Exit to I-5 north on ramp needed maintenance (Photo 1). I-5 access road had no BMPs to direct sediment flows towards a sump (Photo 2).

Photo 1 Description: Minor track out observed. Maintain exit as needed.

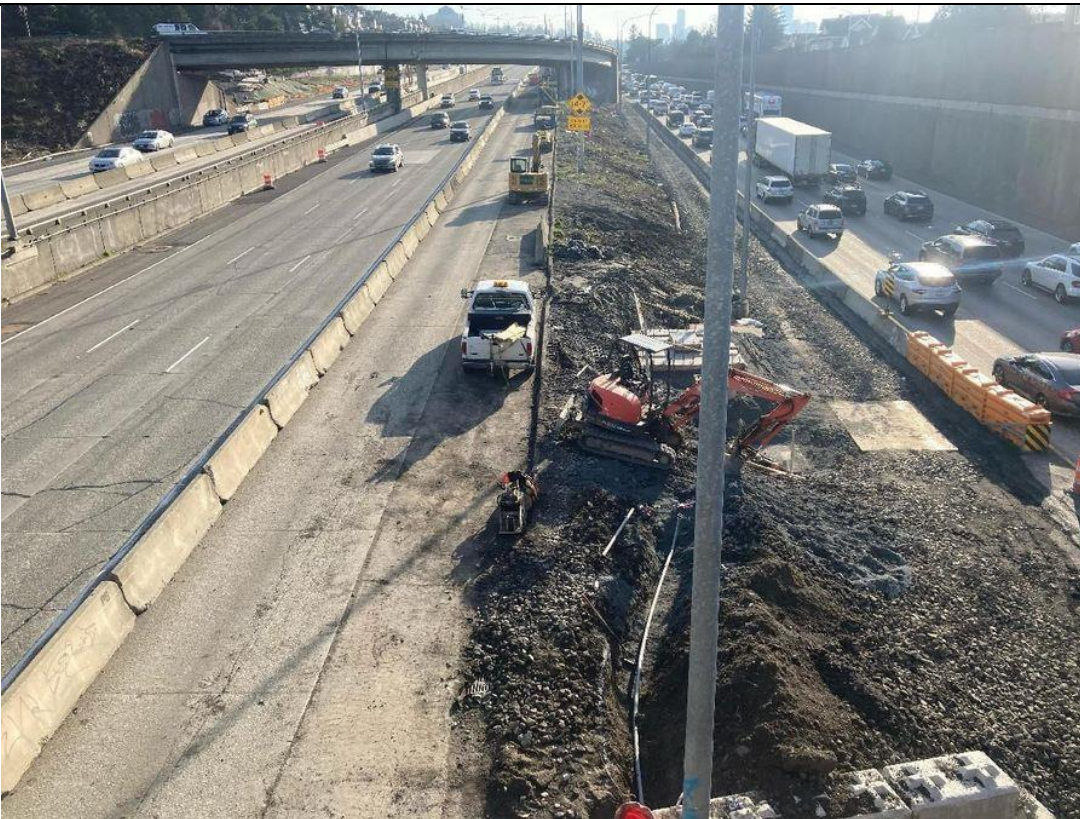
Photo 2 Description: Access road had no BMPs to direct any sediment flows towards a sump.

Violations and action required to achieve compliance	Complete or submit date	Guidance
S9.D.4 Install Sediment Controls Failure to meet S9.D.4.c: Direct stormwater runoff from disturbed areas through a sediment pond or other appropriate sediment removal BMP, before the runoff leaves a construction site or before discharge to an infiltration facility. <i>I-5 access road had no BMPs to direct sediment flows towards a sump.</i>	Immediately begin. Address the problems no later than 10 days	C231 , C232 , C233 , C234 , C235 , C240 , C241 , C250 , C251
S9.D.11 Maintain BMPs Failure to meet S9.D.11.a: Permittee must maintain and repair all temporary and permanent erosion and sediment control BMPs as needed to assure continued performance of their intended function in accordance with BMP specifications. <i>Exit from SR-520 work area needed maintenance.</i>	Address the problems no later than 10 days	SWMMWW, Chapter II-3 Construction Stormwater BMPs, C105, C106, C107
