LEVELS 2 AND 3 SOURCE CONTROL REPORT HAMBLETON LUMBER COMPANY

HAMBLETON LUMBER COMPANY, LLC

December 3, 2009

Maul Foster & Alongi, Inc.

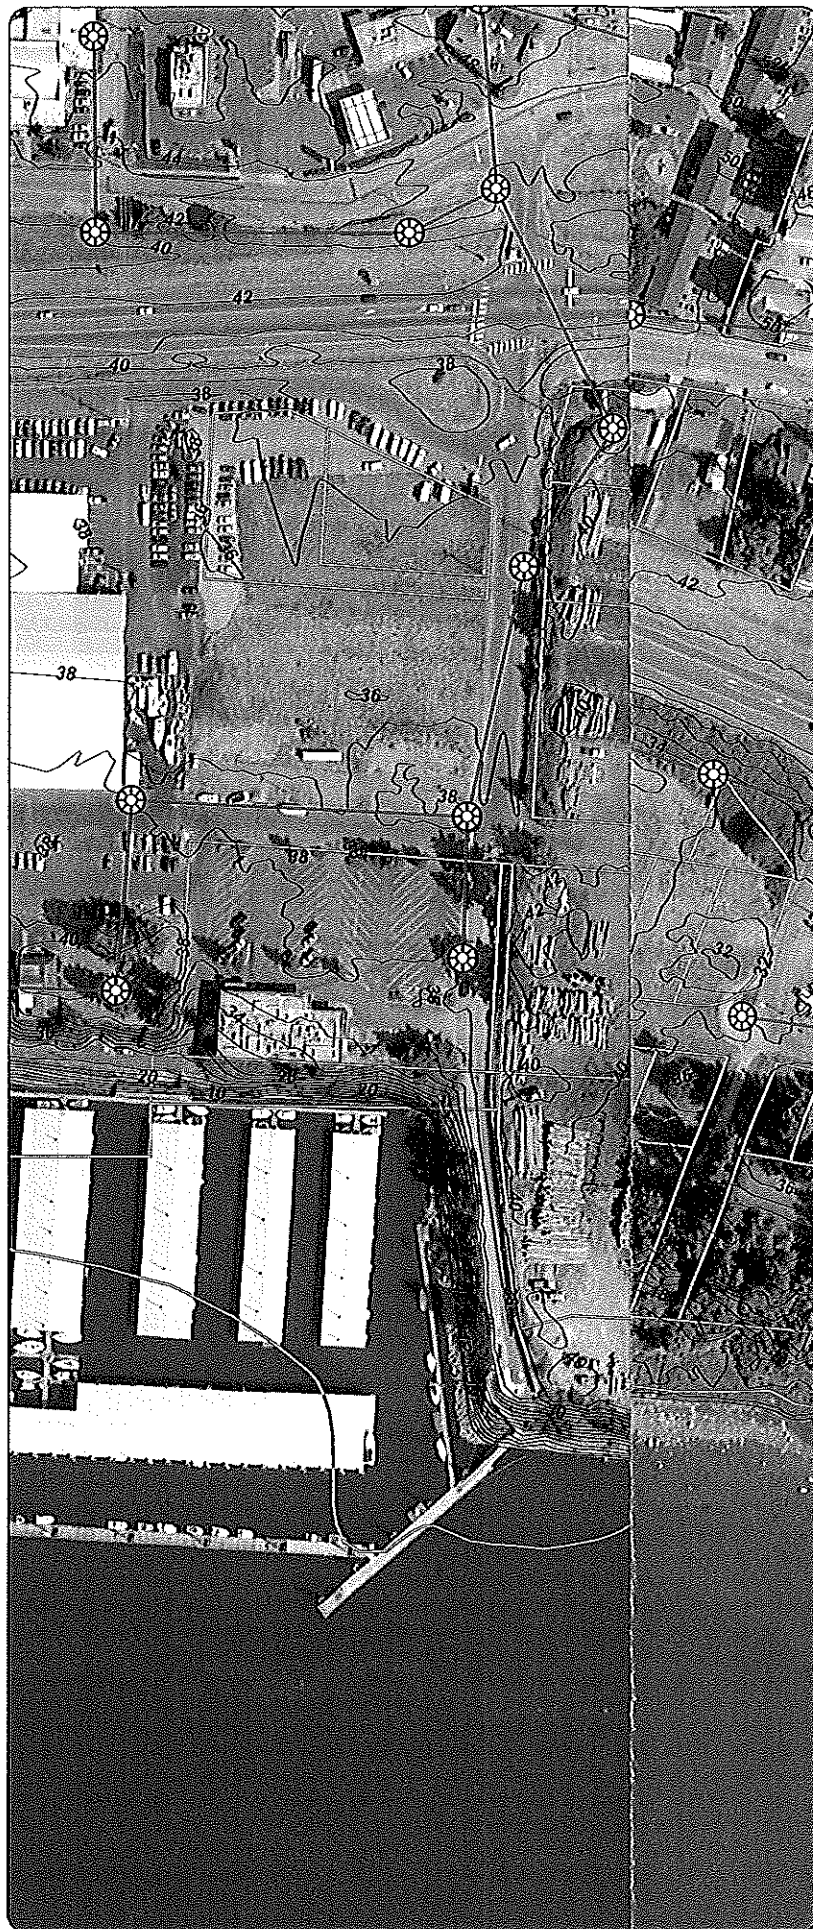
Figure 2 Site Features and Stormwater System

Stormwater at the Site infiltrates in the pervious areas and/or sheet-flows or drains towards a stormwater outfall that discharges to the Columbia River (see Figure 2). Stormwater drains toward a storm manhole located just south of the Mill and is routed through a newly installed Contech StormFilter® treatment facility prior to discharge to the river via Outfall 2. Much of the area draining to Outfall 2 is paved, however stormwater runoff in this drainage area tends to mobilize sawdust and other wood particulates as it drains toward the collection system.

1. Extent and location of site storm lines are approximate and based on field observations and/or historical site maps.

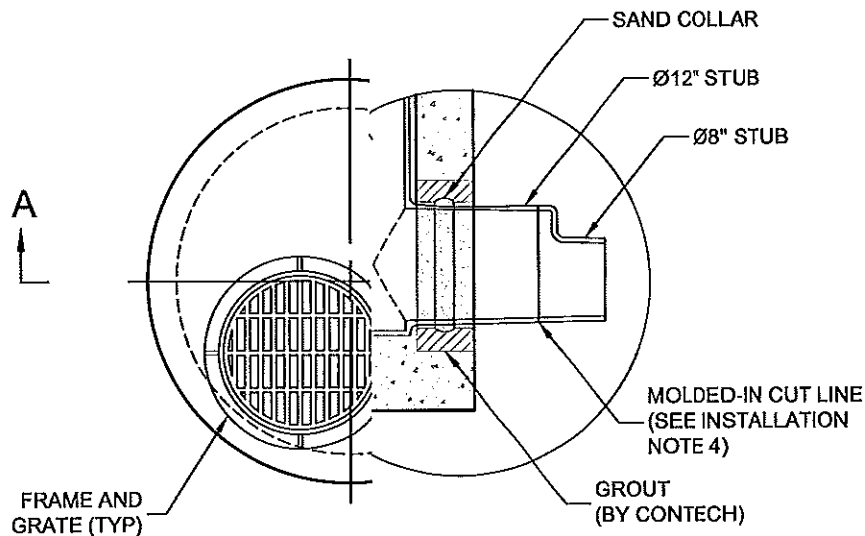
Ø72" MANHOLE STORMFILTER - 400327-01
HAMBLETON LUMBER SAW MILL
WASHOUGAL, WA
SITE DESIGNATION: XXX

PLAN OUTLET DETAIL

FILTER
CARTRIDGE
FLOW KIT

WATER QUALITY	
FLOW RATE	0.211 cfs
PEAK FLOW	
RATE	<1.5 cfs
RETURN PERIOD	
OF PEAK FLOW	25 yrs
SPECIFIC FLOW RATE	
OF STORMFILTER	2 gpm /sq ft
FILTER MEDIA TYPE	CSF

Hambleton recently installed a Contech StormFilter® treatment facility that filters stormwater prior to discharge to Outfall 2. This treatment unit is designed to remove metals, oils and suspended solids from stormwater and Hambleton will be testing the reliability of this system to consistently reduce contaminant levels to below Permit benchmarks. Hambleton is also evaluating pretreatment measures to enhance the treatment efficiency of the StormFilter® and prolong the life of the filtration media.

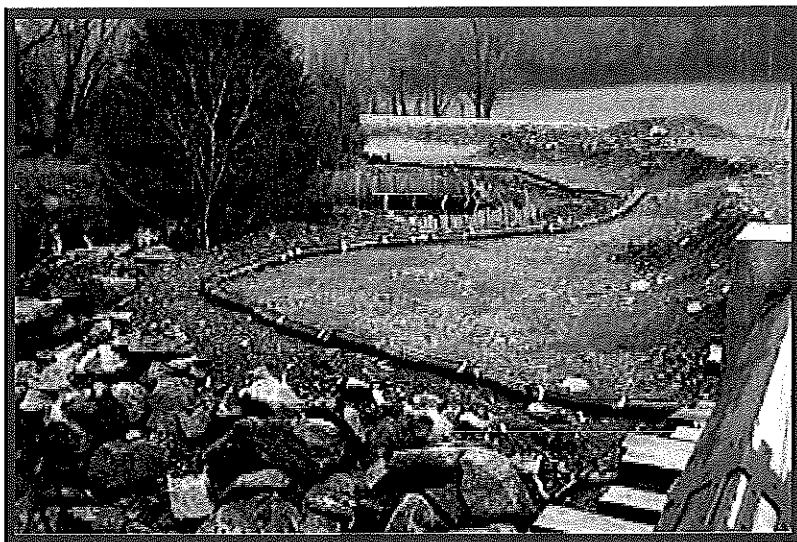
The ErosionEEL™ is an environmentally friendly, low impact erosion and sediment control device.

Hambleton proposes to use sediment control measures to reduce the solids loads in stormwater at the Site. The amount of sediment and woodwaste (sawdust, chips, bark) from the site operations can negatively impact the quality of stormwater generated at the Site. Installing reusable devices that can trap this material before entering the stormwater system will be beneficial to water quality and to maintenance efforts. An example of a product that may have an application at the Site is the Erosion Eel, by ACF Environmental which consists of washed recycled shredded rubber inside a woven geotextile envelope (see Appendix D for product brochure).
